Urban Drainage and Flood Control District

2001 ALERT Maintenance

Summary Report

December 2001

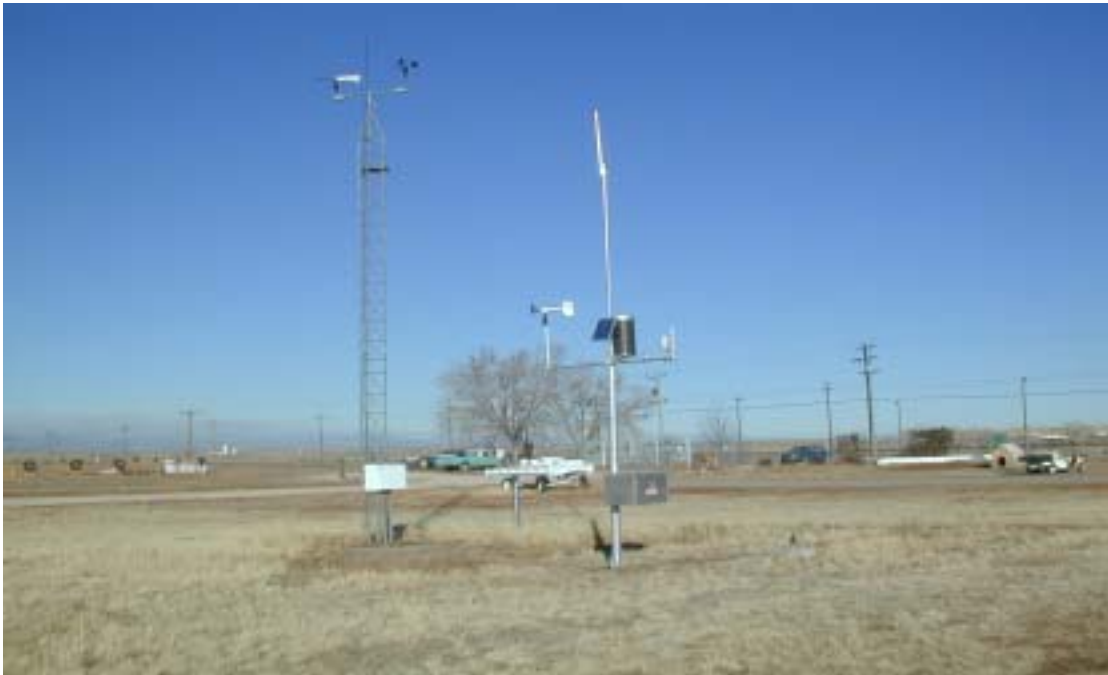
The Urban Farm site incorporates an alternative structural design for a weather suite configuration (see Figures 1 and 2) that required more sensors than the “traditional” ALERT weather suite. In large part, the design was derived by DIAD to be able to accommodate the use of a Campbell Scientific CR10X datalogger in conjunction with a High Sierra Electronics 3210 serial transmitter to broadcast ALERT data. The CR10X has an external, detachable wiring panel that includes screw terminals for sensor connections, and therefore is unsuitable for pulling up or dropping down a standpipe, hence the inclusion of the weatherproof enclosure with dropdown door. The CR10X is a mature, stable product that lends itself extremely well to applications that require more sensor inputs than a typical ALERT transmitter can handle with a standard standpipe configuration.

Figure 1. Site 1460, Urban Farm Weather Suite

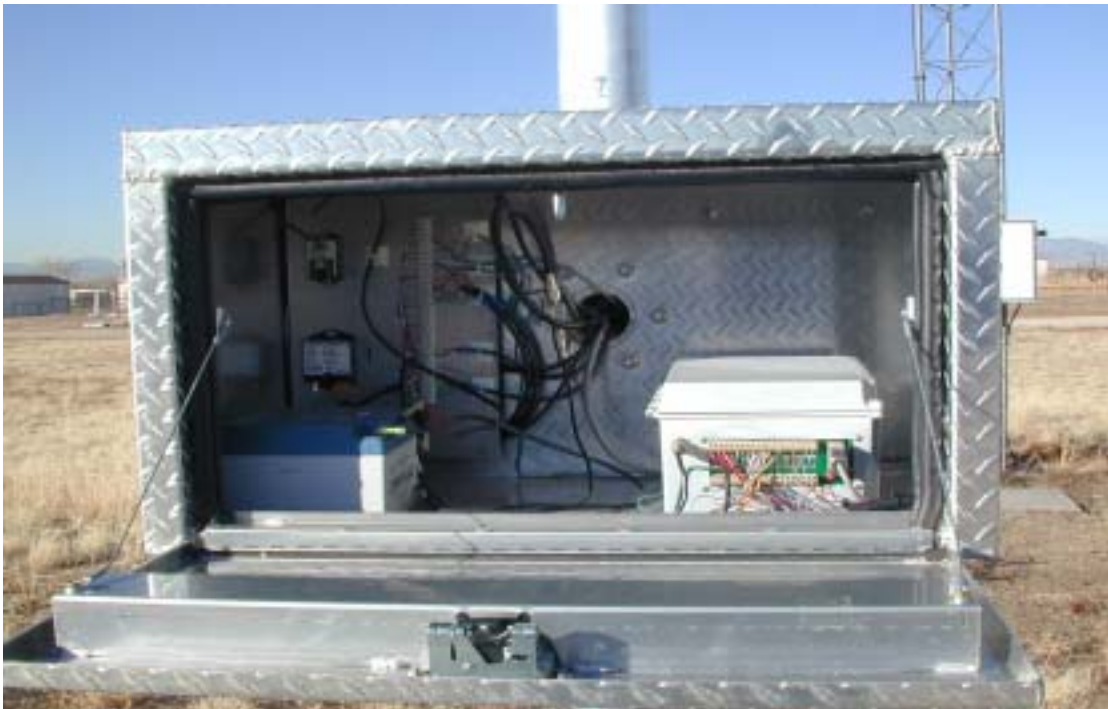
Figure 2. Urban Farm enclosure interior

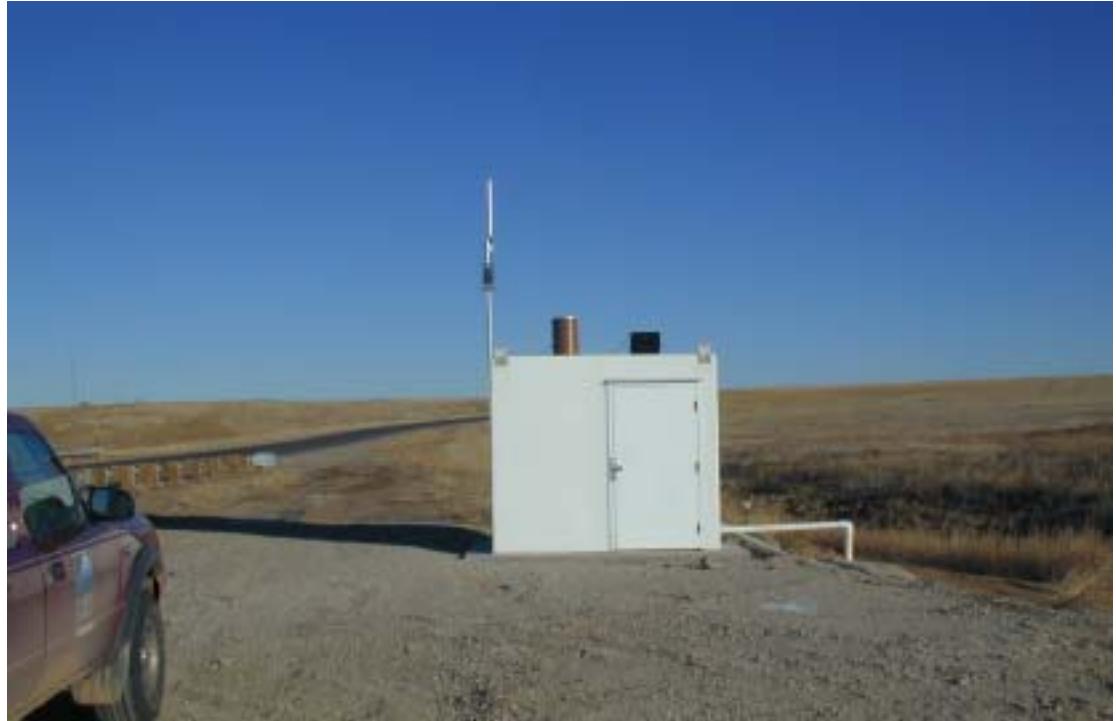
The CR10X was also chosen for the DIA @ Third Creek installation (see Figure 3), not only because it provides the necessary flexibility to be able to add numerous other sensors in the future, but it also provides superior control capabilities to respond to specific site conditions (e.g., automatically collecting water samples based on specific water depth or discharge thresholds), features that are very important for the DIA Environmental Services Group.

Figure 3. Site 1480, DIA @ Third Creek
