# Urban Drainage and Flood Control District 2003 ALERT maintenance summary report

December 2003

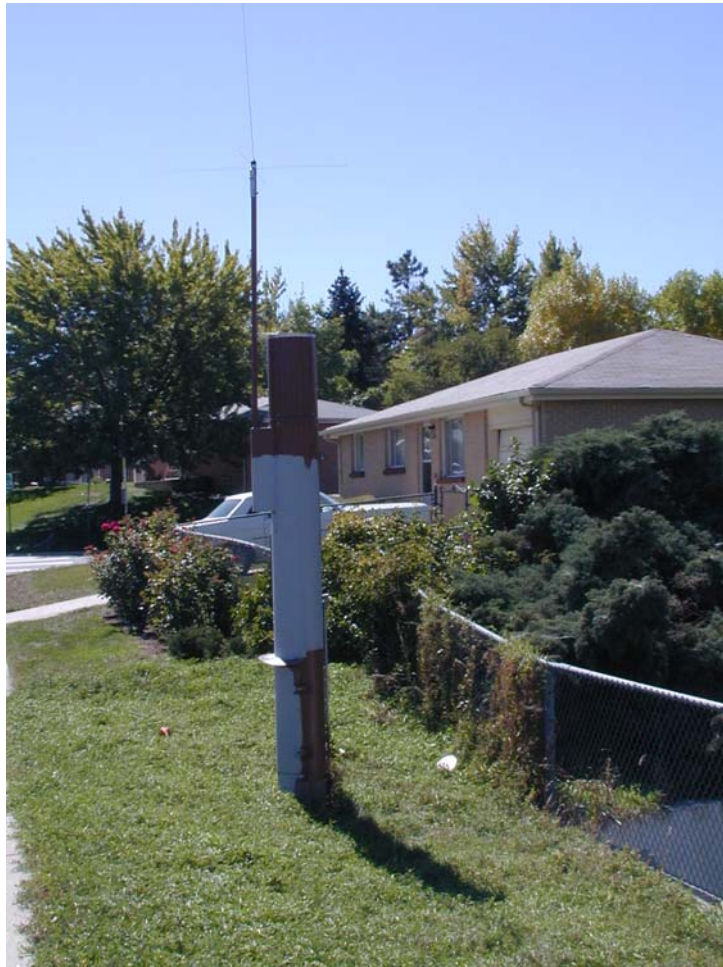
**Figure 1. Site 1340, Sanderson Gulch**

The Sanderson Gulch site was vandalized shortly after installation and two other times thereafter. The City of Lakewood has painted over “tags” that were applied to the standpipe (see **Figure 1**). Additionally, the door below the moisture “eyebrow” of the standpipe has been permanently sealed with epoxy by OneRain, as vandals broke off both metal tabs on the door that are supposed to accommodate the shackle of the door lock. Fortunately, vandals have not (yet) targeted either the antenna, PT housing, or tipping bucket top section.

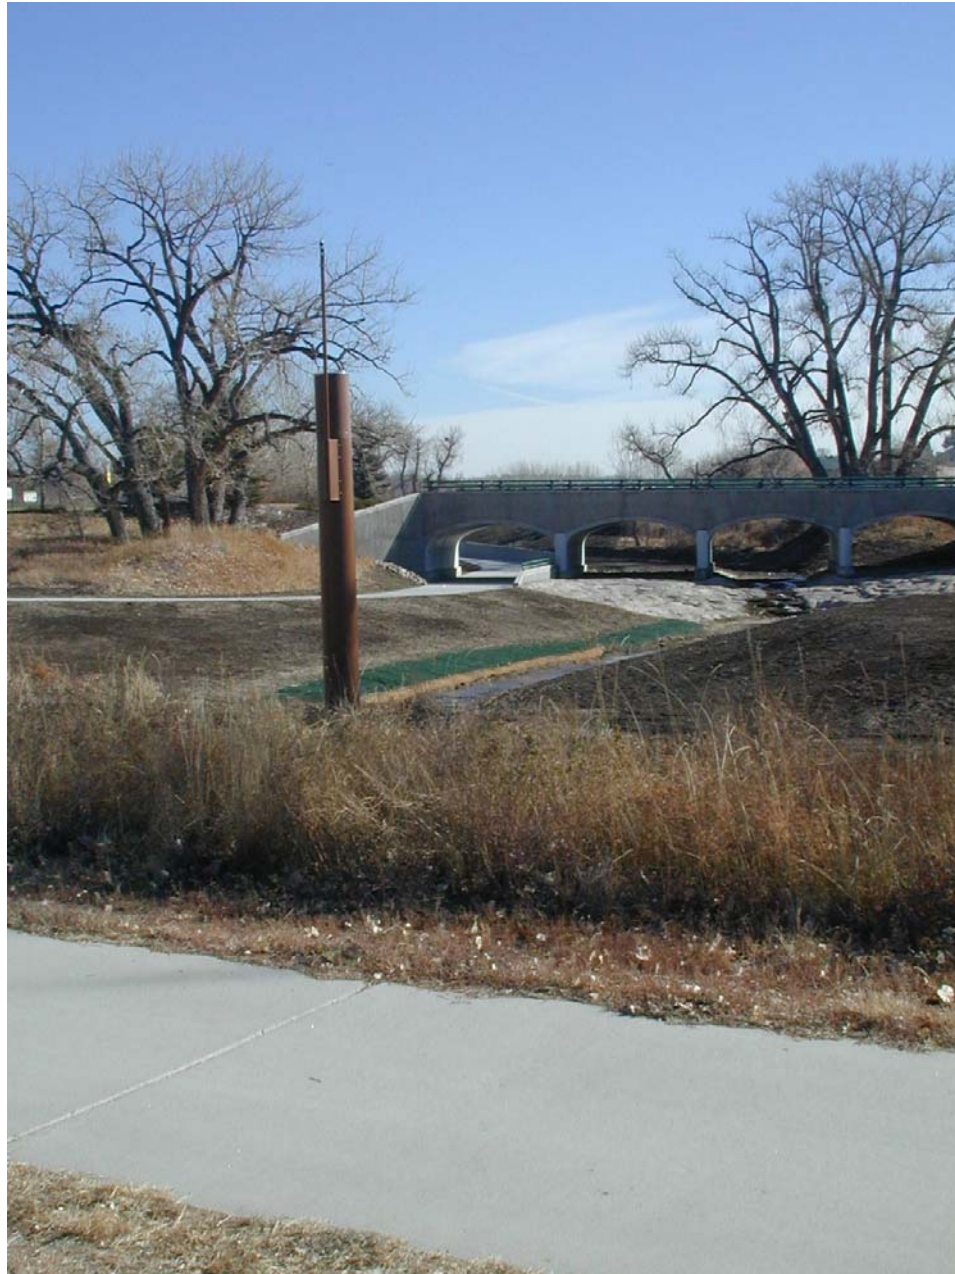
**Figure 6. Site 2840, Sulphur Gulch**

Another new rain and stage site was installed shortly after shutdown at Sulphur Gulch in Parker (see **Figure 6**) on the southeastern edge of the ALERT network.

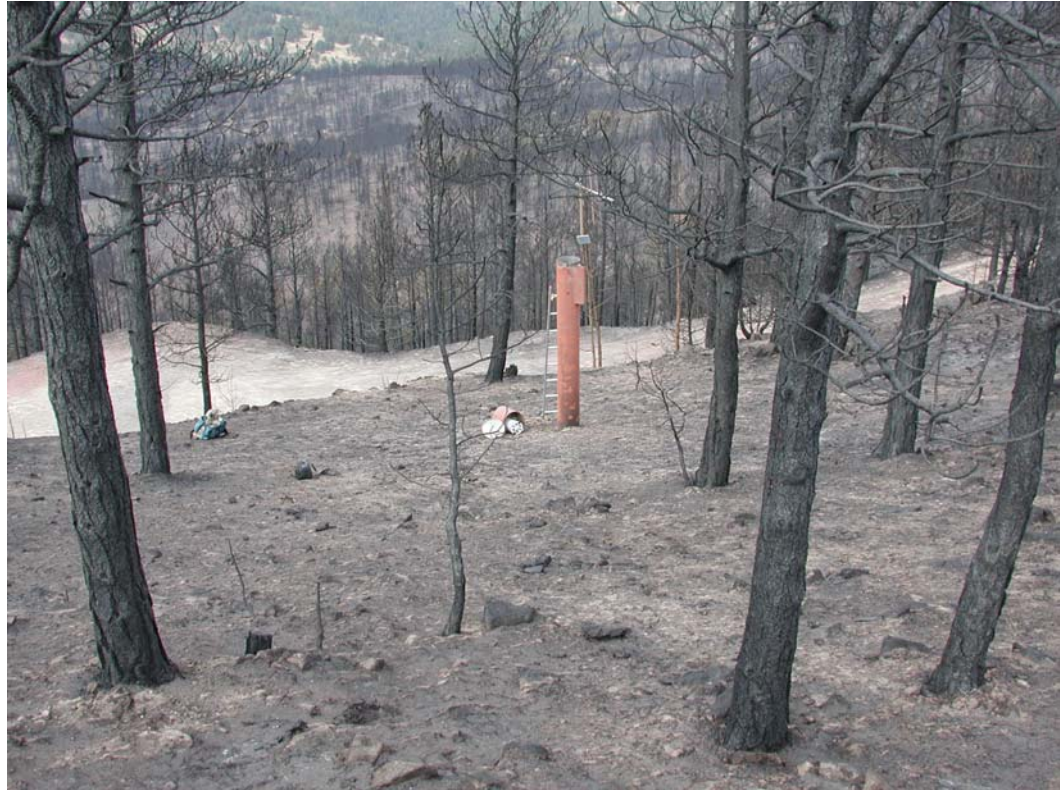
The Overland Fire of October 29<sup>th</sup> effectively destroyed the rain only site at Golden Age (see **Figure 7**) in Boulder County. The site was reinstalled on November 14<sup>th</sup>, with a combination of new and old spare hardware and sensors.

**Figure 7. Golden Age burn area**
