Re: ALERT Gaging System Maintenance Agreement 06-02.08, Final Report

ALERT Gaging System Maintenance Agreement 06-02.08

**Annual Report
December 15, 2006**

**Presented To
Kevin Stewart
Urban Drainage and Flood Control District
Denver, Colorado**

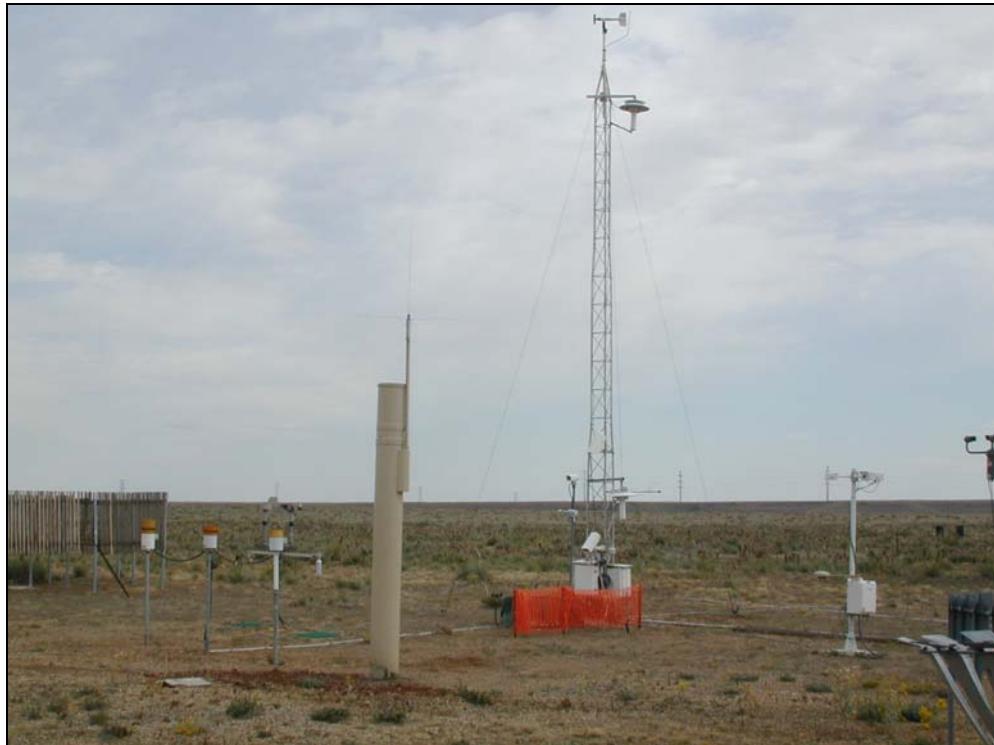
**Figure 1: Marshall Rain Gage**

The Marshall site is located in the National Center for Atmospheric Research (NCAR) Marshall Test Site surrounded by other meteorological measurement stations. The site is located at N 39° 56' 57.21", W 105° 11' 43.38" (WGS84 datum). This site reports via the Blue Mountain repeater.

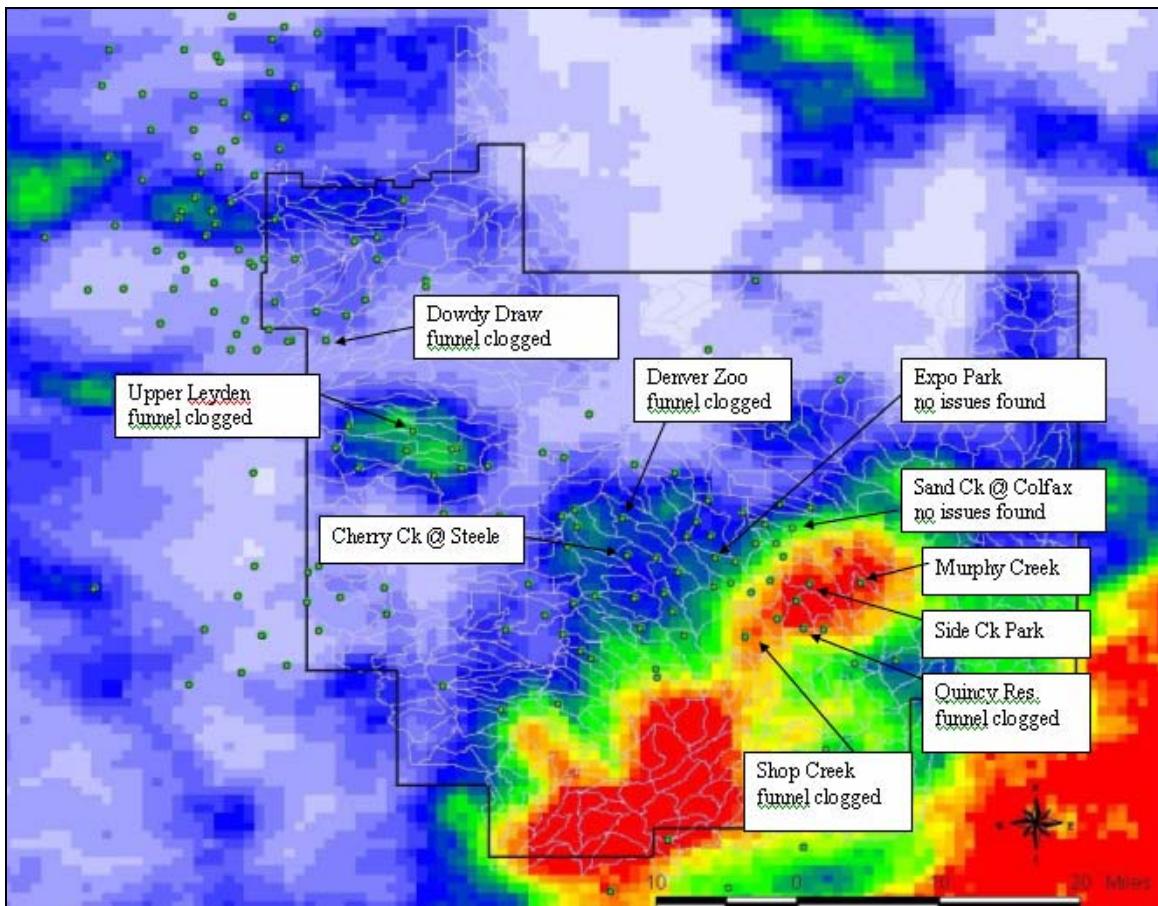
Table 4: Unadjusted Radar Rainfall Accumulation 7/7/2006 – 7/10/2006

In addition to analyzing each gage individually to evaluate it's RF performance OneRain compared gages to each other (nearest neighbor analysis), and qualitatively compared the gages to radar data (unadjusted radar rainfall analysis). The graphics below show the results of the radar rainfall comparison.
