Re: ALERT Gaging System Maintenance Agreement 07-02.05, Final Report

ALERT Gaging System Maintenance Agreement 07-02.05

**Annual Report
December 28, 2007**

**Presented To
Kevin Stewart
Urban Drainage and Flood Control District
Denver, Colorado**

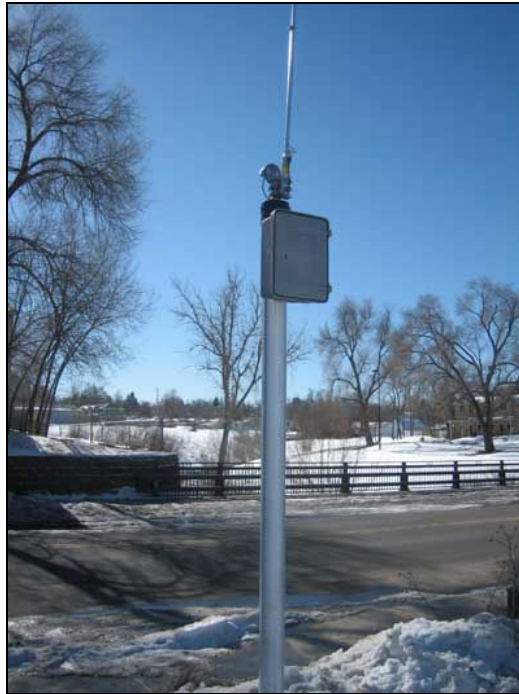
Figure 1: Lakewood Gulch Stage Gage

Lakewood Gulch was the only new site installed this year. This site’s identifier is 1560; it is a stage only site. The site is located at N 39°43'59.16", W 105° 2'16.80" (WGS84 datum). This site reports via the Blue Mountain repeater.

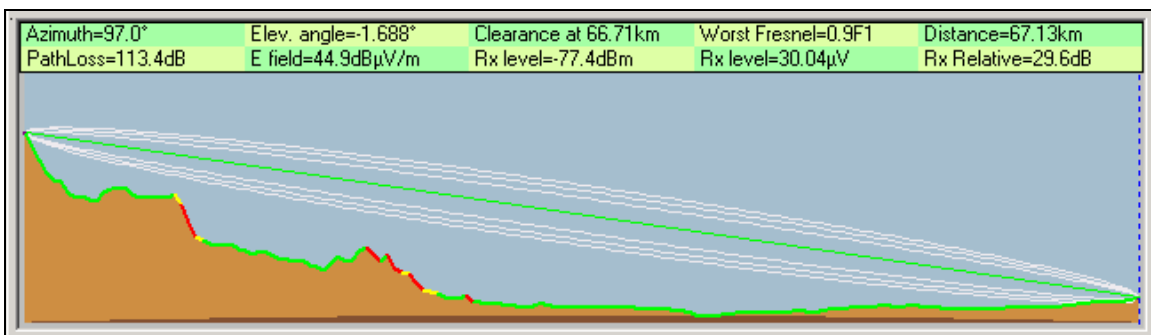
Figure 3: Radio Path from Squaw Mountain (left) to Smoky Hill (right)

Problems at the repeater would include: a desensitized receiver due to an intermittent noise source, weakened signal strength from Squaw due to environmental changes or intermittent repeater hardware operation. The Squaw Mountain transmitter is the farthest away of all the sites reporting to Smoky Hill. Even though the path is line of sight, the signal is attenuated along this 67 kilometer (41 mile) distance. No matter which of these three problems is the cause, Squaw’s reception is the canary in the coal mine.

OneRain found that there is a statistically significant difference in Smoky’s output reliability between when Squaw is coming through and when it isn’t. In other words, the Smoky Hill repeater’s performance is periodically, and chronically, being degraded. The cause of this failure is not known. However, OneRain intends to investigate the RF environment around the repeater in the next couple of months.

This remains a priority for OneRain because the RF path between our receiver and this site has been marginal. The East Cherry Creek Water and Sanitation District owns the property where this repeater is located. They have expressed a strong desire to have this station moved as well.

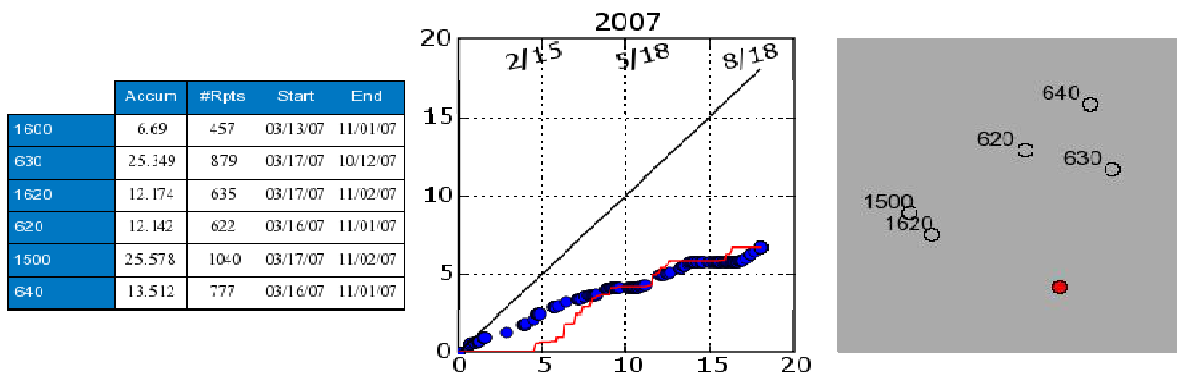
Figure 6: Double-mass plot for the Englewood Dam rain gage (affected by poor transmitter output)

OneRain used these double-mass plots to identify problems with gages that would otherwise be difficult to quantify. Here, problems can be quickly targeted and then addressed with corrective maintenance.

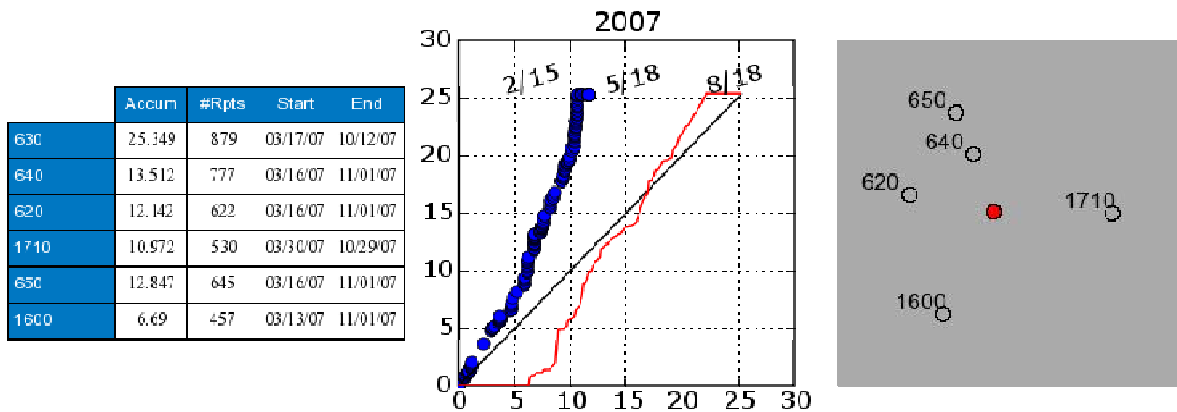
Figure 7: Double-mass plot for the Temple Pond rain gage (affected by sprinkler systems)
