Re: ALERT Gaging System Maintenance Program - FINAL End of Year Report

UDFCD ALERT Gaging System Maintenance

**Annual Report
December 14, 2008**

**Presented To
Kevin Stewart
Urban Drainage and Flood Control District
Denver, Colorado**

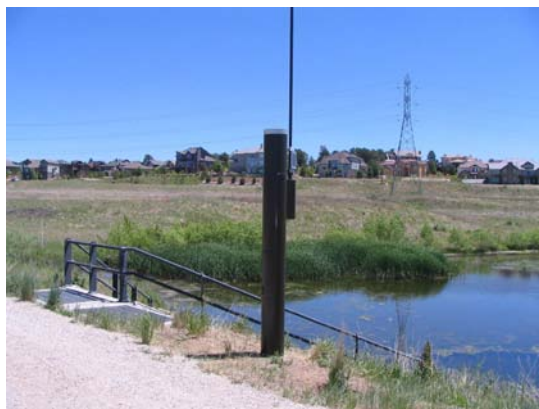
- ◆ Aurora Regional Pond. This site is identified as site #940, and consists of both rain and stage sensors. The site is located at Latitude 39.5831,

Longitude -104.709, Elevation 5931 feet. This site reports via the Smoky Hill Repeater. A site picture follows:

Figure 1: Aurora Regional Pond Rain/Stage Gages

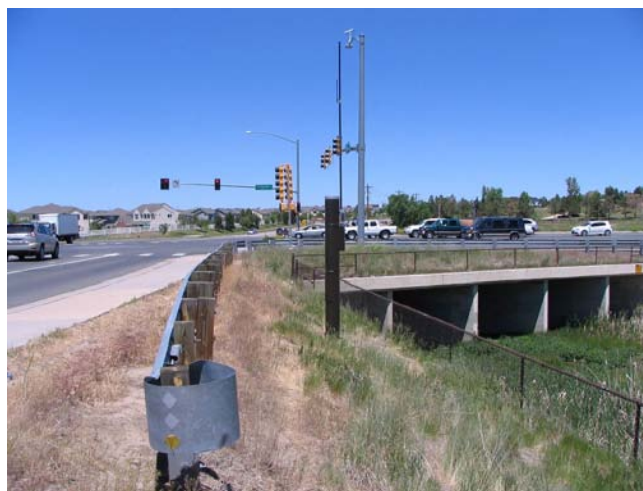
- ◆ Piney Creek @ Liverpool. This site is identified as site # 950, and consists of both rain and stage sensors. The site is located at Latitude 39.595, Longitude -104.744, Elevation 5823 feet. This site reports via the Smoky Hill Repeater. A site picture follows:

Figure 2: Piney Creek @ Liverpool Rain/Stage Gages

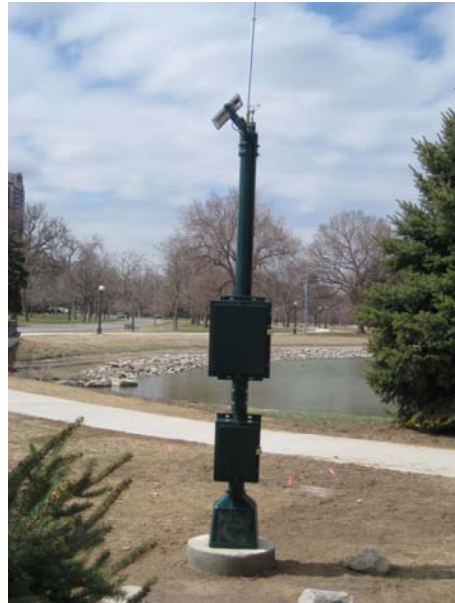
Bubbler problems – Four service visits to the Ferril Lake Site (1380) were a direct result of the bubbler. A latent internal design flaw related to the firmware was acknowledged by the manufacturer and repaired by OneRain.

- ◆ Ferril Lake. This site is identified as site # 1380, and consists of a stage only sensor. The site is located at Latitude 39.744, Longitude -104.946, Elevation 5271 Feet. This site reports via the Blue Mountain Repeater. A site picture follows:

Figure 3: Ferril Lake Stage Gage

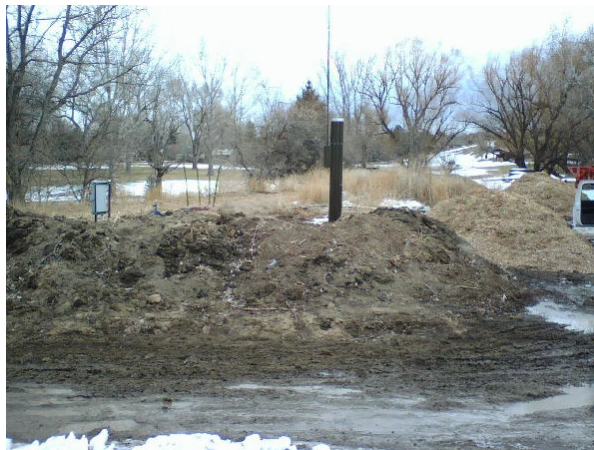
- ◆ Lakewood Country Club. This site is identified as site # 1550, and consists of a rain only sensor. The site is located at Latitude 39.7276, Longitude -105.07, Elevation 5400 Feet. This site reports via the Blue Mountain Repeater. A site picture follows:

Figure 4: Lakewood County Club Rain Gage

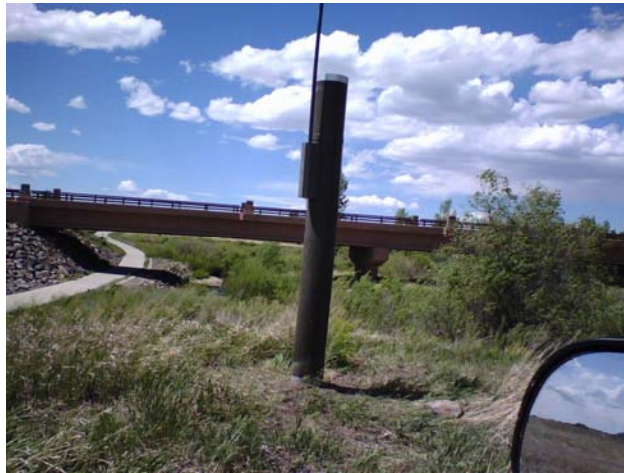
- ◆ Bayou Gulch. This site replaces the prior site of Castle Oaks (2830) taken out of service in 2004. The site's new identifier is site #2850, and consists of both rain and stage sensors. The site is located at Latitude 39.4356, Longitude -104.77, Elevation 6016 Feet. This site reports via the Blue Mountain Repeater. A site picture follows:

Figure 5: Bayou Gulch Rain/Stage Gages

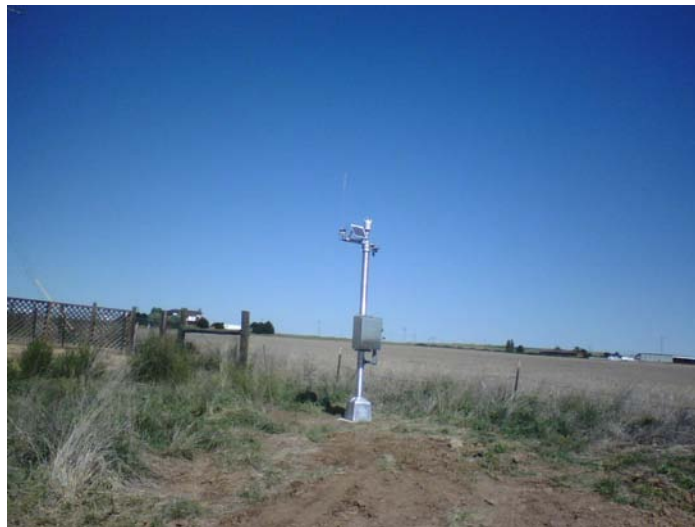
- ◆ Pump Station #3 (Aurora Airpark Weather Station). This site is identified as site #970, and is a full weather station. The site is located at Latitude 39.7364, Longitude -104.669, Elevation 5614 feet. This site reports via the Smoky Hill Repeater. Note that this site is not maintained by UDFCD, but by Aurora Water. A site picture follows:

Figure 6: Pump Station #3 (Aurora Airpark)

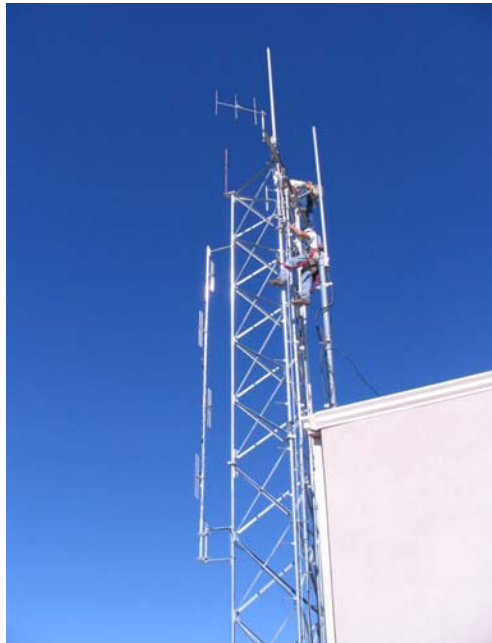
In August and September of this year the repeater at Smoky Hill was moved into the building of the East Cherry Creek Valley (ECCV) Water and Sanitation District. Additionally, new antennas were installed on ECCV's new tower. The repeater is located in the garage where ECCV has their other communication equipment (SCADA, amateur radio repeater, etc). Previously, the ALERT repeater was solar powered and installed in a standpipe on their grounds, which has subsequently been removed.

Figure 6: Smoky Hill Antenna

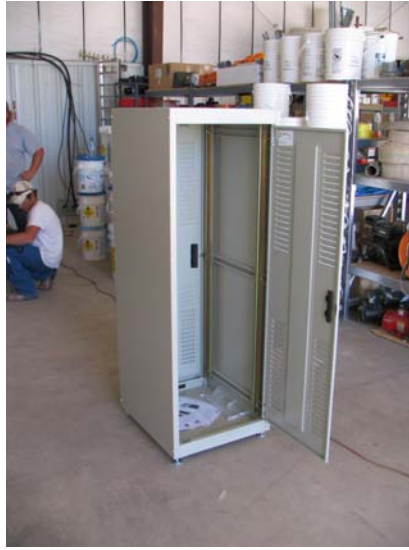
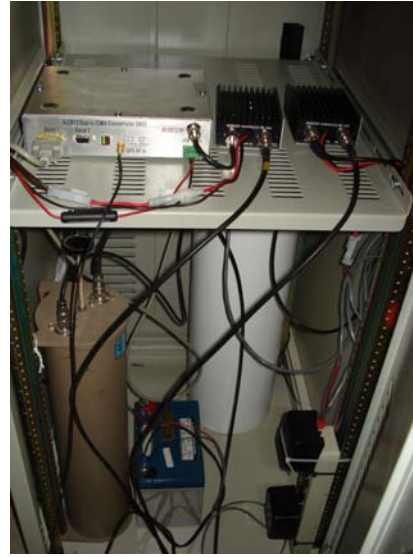
It is now enclosed in a new UDFCD supplied equipment rack, and supplied AC power with back-up battery. A cavity filter was installed in the receive path, to reduce interference from nearby transmitters. The receive antenna is a 4-bay omni, and the transmit antennas are directional yagis, aimed between UDFCD and OneRain. The antennas are installed at a higher elevation than the originals on the standpipe, and are expected to give equal or better performance. The tipping bucket that had been at that site was removed, and was not reinstalled on the building, as it was no longer considered necessary because of newly installed nearby precipitation gages at Sites 940 and 950 that give adequate coverage.

Figures 7/8: Equipment housing
