UDFCD ALERT Gauging System Maintenance 2012 Annual Report

Kevin Stewart
Urban Drainage and Flood Control District
Denver, Colorado

Prepared By
OneRain Incorporated
1531 Skyway Drive, Unit D
Longmont, Colorado 80504

Report Date: December 10, 2012

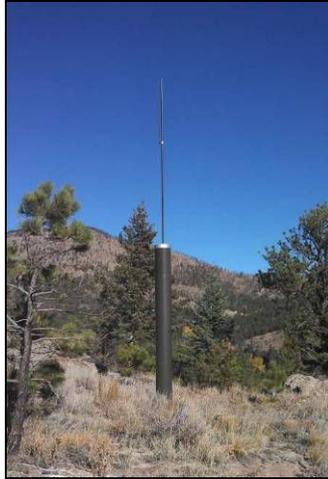
Figure 1: Whispering Pines

A new site was installed within the four mile burn area on 4/27/2012. The site is located at Latitude 40.0605556°, Longitude -105.3647222°. This site reports via the Lee Hill Repeater. Whispering Pines is a rain only site.

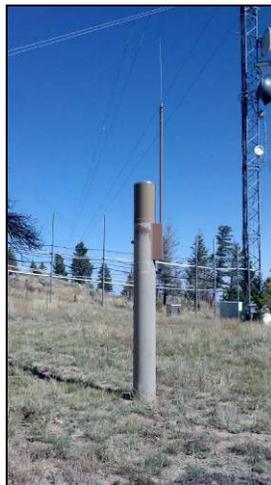
Figure 2: Lee Hill Rain

A new site was installed within the four mile burn area on 4/27/2012. The site is located at Latitude 40.0719444°, Longitude -105.3541667°. This site reports via the Lee Hill Repeater. Lee Hill Rain is a rain only site.

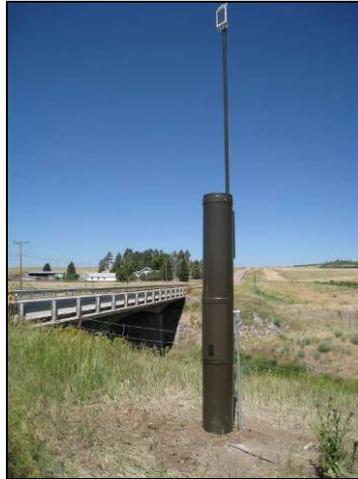
Figure 3: Antelope Creek

A new site was installed for Douglas County on 6/21/2012. The site is located at Latitude 39.2636111°, Longitude -104.7161111°. This site reports via the West Creek Repeater. Antelope Creek is a stage only site.

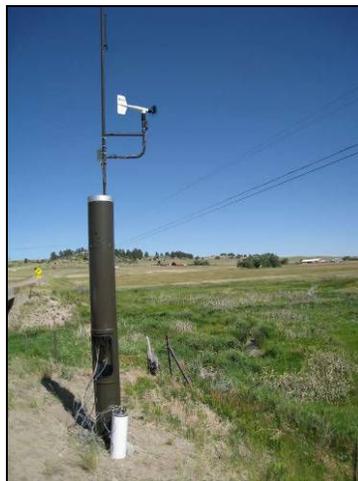
Figure 4: W. Cherry Creek Wx

A new site was installed for Douglas County on 6/21/2012. The site is located at Latitude 39.2619444°, Longitude -104.7088889°. This site reports via the West Creek Repeater. W. Cherry Creek Wx is a full weather station including relative humidity, air temperature, barometric pressure, wind direction, wind speed, peak wind gust, precipitation, and stage.
