# UDFCD ALERT Gauging System Maintenance 2014 Annual Report

Kevin Stewart  
Urban Drainage and Flood Control District  
Denver, Colorado

**Prepared By**  
OneRain Incorporated  
1531 Skyway Drive, Unit D  
Longmont, Colorado 80504

Report Date: December 31, 2014

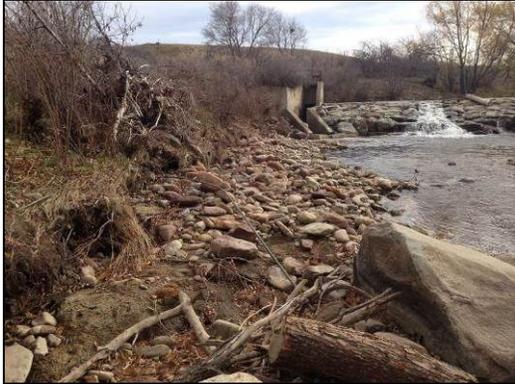
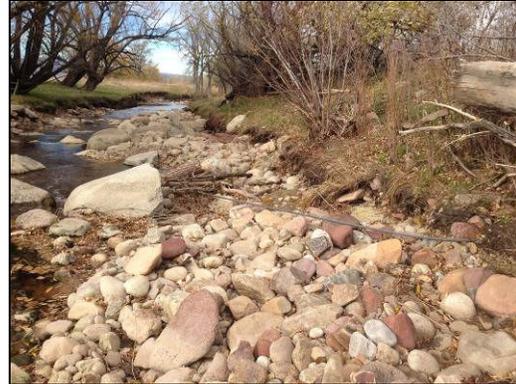
### **SBC @ Canon Ditch (4840)**

During the September flooding the stream channel at Canon Ditch had altered and destroyed all conduit. Currently the City of Boulder does not have funds to repair the site. The site has been changed to a rain only station.

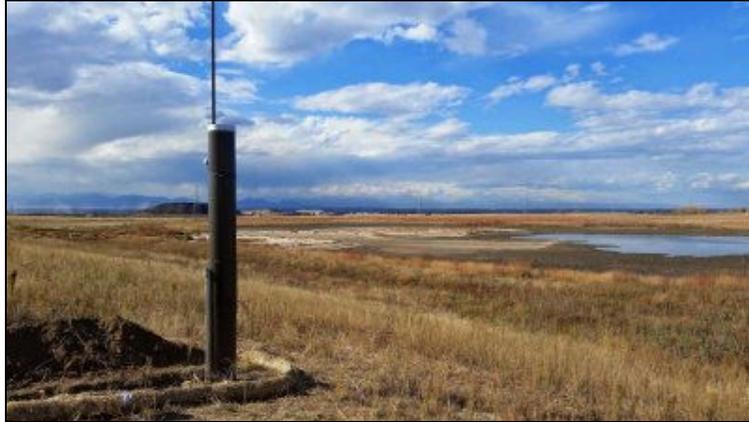
### Havana Pond (10023)

Installation was completed on 10/21/2014. Havana Pond utilizes ALERT2 technology and is powered with a Campbell Scientific ALERT2 transmitter. It is currently configured for rain and stage.

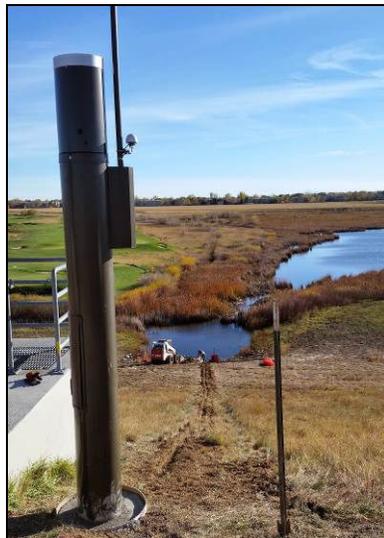
### Westerly Creek Dam (10024)

Installation was completed on 11/5/2014. Westerly Creek Dam is powered with a Campbell Scientific ALERT2 transmitter. It is currently configured for rain and stage.

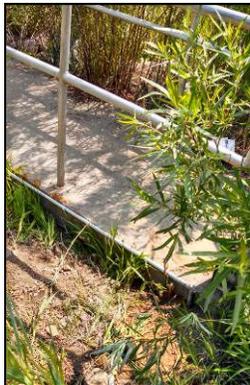
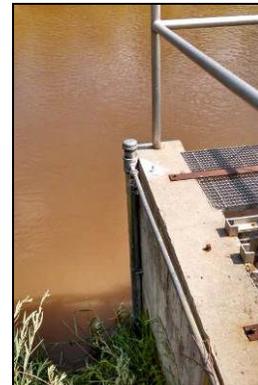
### **Cold Spring Gulch (2240)**

A new PT Riser and intake was reinstalled on July 17, 2014 after being destroyed from the September 2013 flood. Conduit was run to the standpipe and a new pressure transducer was installed.

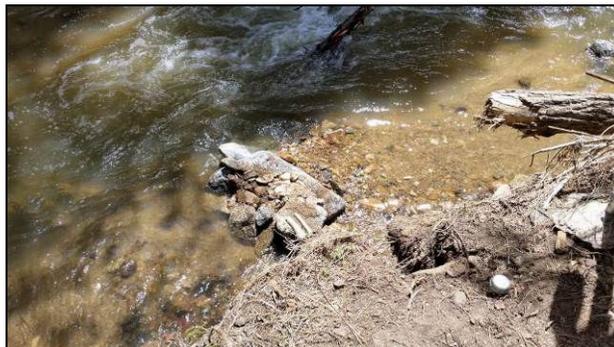
### **Fourmile (4410)**

A new PT Riser and intake was reinstalled on May 6, 2014 after being destroyed from the September 2013 flood. The original pressure transducer survived the flooding.

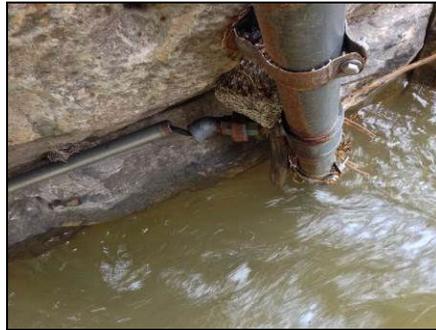
### **Bridge (4420)**

After the September 2013 flood, the riser attached to the concrete wall was knocked off its anchors and sections of conduit were destroyed. The pressure transducer was unharmed and is in working order. On 4/20/2014 all conduit was repaired and the riser was remounted to the wall.

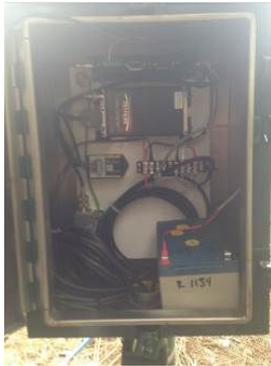
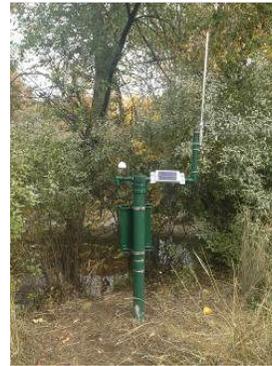
## **Nolte Pond (10025)**

Nolte Pond was relocated to a more accessible location on the south side of the pond on 10/24/2014. Pelco infrastructure was installed along with an ALERT2 transmitter. Rigid conduit was run to the pond.

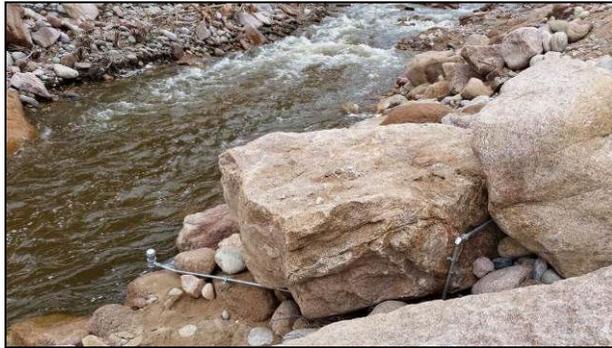
### Little Narrows (4470)

A new PT riser and intake was reinstalled on May 9, 2014 after being destroyed during the September 2013 flood. A new pressure transducer was installed.

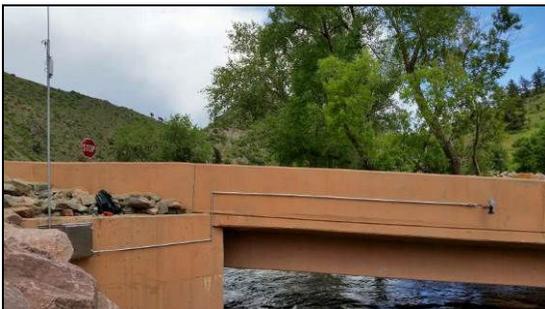
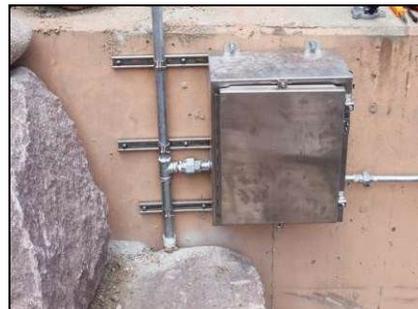
### Lyons Diversion (4560)

Lyons Diversion was moved upstream to the Highway 80 bridge. with coordinates: Latitude 40.2429083°, Longitude -105.3136444°. A radar and an enclosure were installed on the upstream side of the bridge for measuring stage. Excessive moisture was found inside the NEMA enclosure. Moisture is intruding from condensation build up in the conduit. All access ports were completely sealed off and additional desiccant was added.

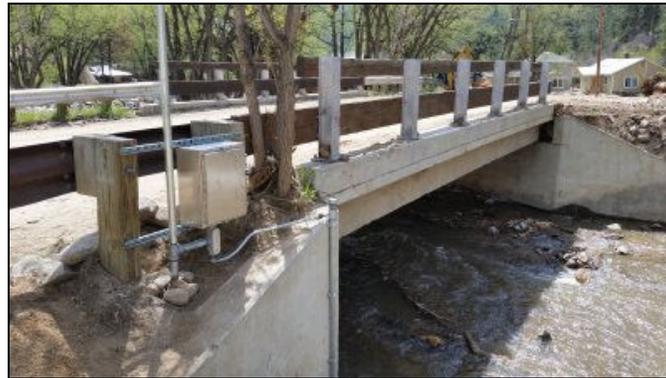
### **James Creek (10017)**

After being completely destroyed in the 2013 September flooding, James Creek was relocated upstream and installed in downtown Jamestown on 5/5/2014. The new GPS coordinates are Latitude 40.1149180°, Longitude - 105.3859350°. The site was also upgraded to the ALERT2 protocol.

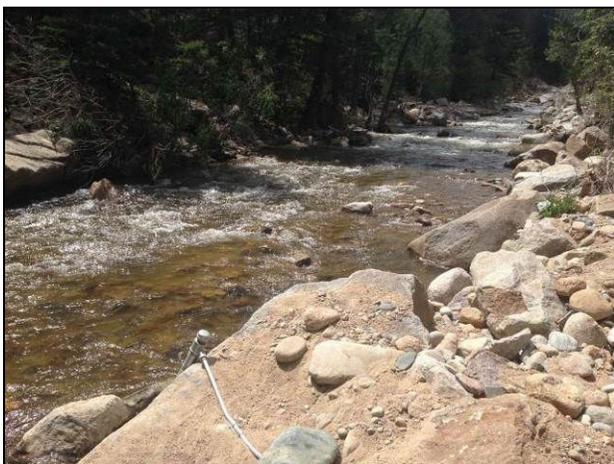
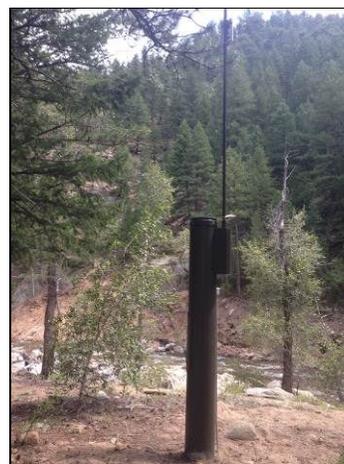
### **S. St. Vrain @ Berry Ridge (10021)**

On 8/13/14 South St. Vrain @ Berry Ridge was relocated and installed after being destroyed in the September 2013 flooding. Its new location is Latitude 40.16765500°, Longitude - 104.8814670°. It is an ALERT2 site with a standpipe and door, solar panel, Campbell Scientific AL200 and RDP-120 transmitter installed. Conduit was run and installed with a riser which houses a Keller PT. This is a stage only site.

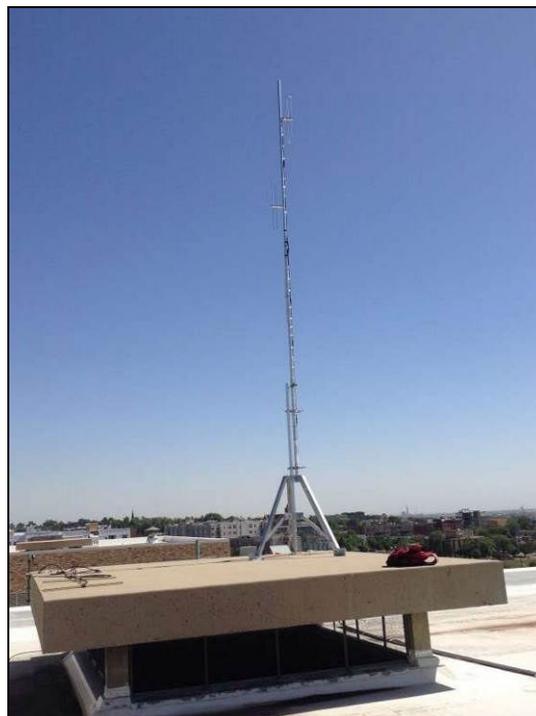
### Dimond Hill Antenna Install

In mid-September it was found that Diamond Hill was not receiving ALERT data reliably. Upon inspection it was found that Building Maintenance had taken down the original antenna that had been in operation for 20+ years. OneRain installed a new, more robust, antenna on September 10, 2014. During the installation all aging RF cables were replaced with new cable and connectors.
