# UDFCD ALERT Gauging System Maintenance 2015 Annual Report

Kevin Stewart  
Urban Drainage and Flood Control District  
Denver, Colorado

**Prepared By**  
OneRain Incorporated  
1531 Skyway Drive, Unit D  
Longmont, Colorado 80504

Report Date: December 30, 2015

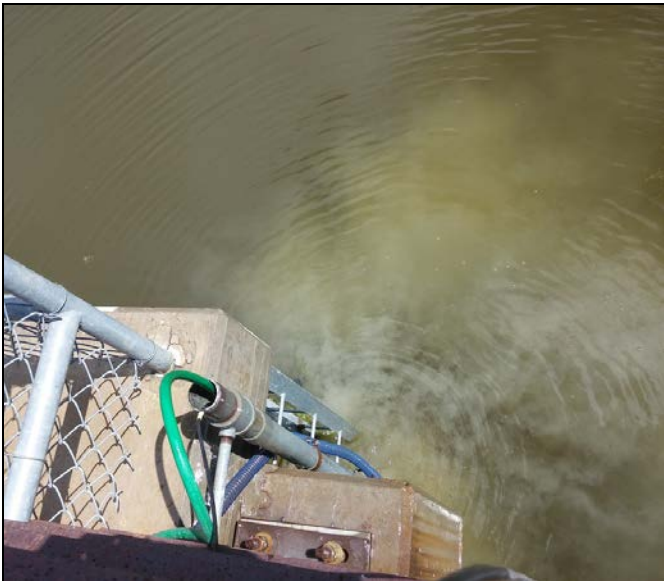
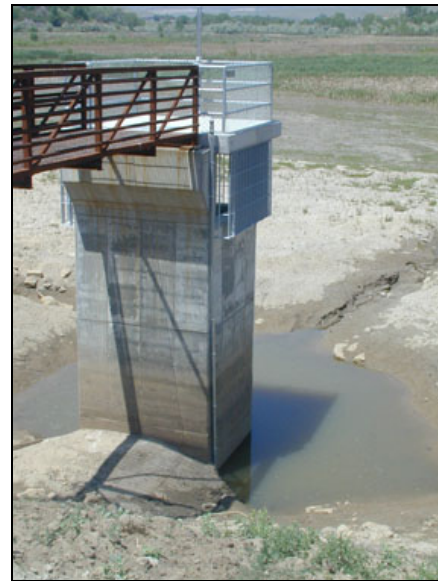
### **Leyden Reservoir (200)**

The Pressure transducer was replaced on March 31, 2015. In recent years this site is prone to sediment deposition. On May 11<sup>th</sup> it was noticed that the PT was not reporting accurately; the riser was flushed with a gasoline engine pump. A noticeable amount of sediment was removed. A review of install pictures revealed that the PT resides close to the floor of the reservoir channel. Over the years we assume that this location has filled with silt resulting in erroneous PT readings. The site will need to be continually monitored and flushed of sediment.

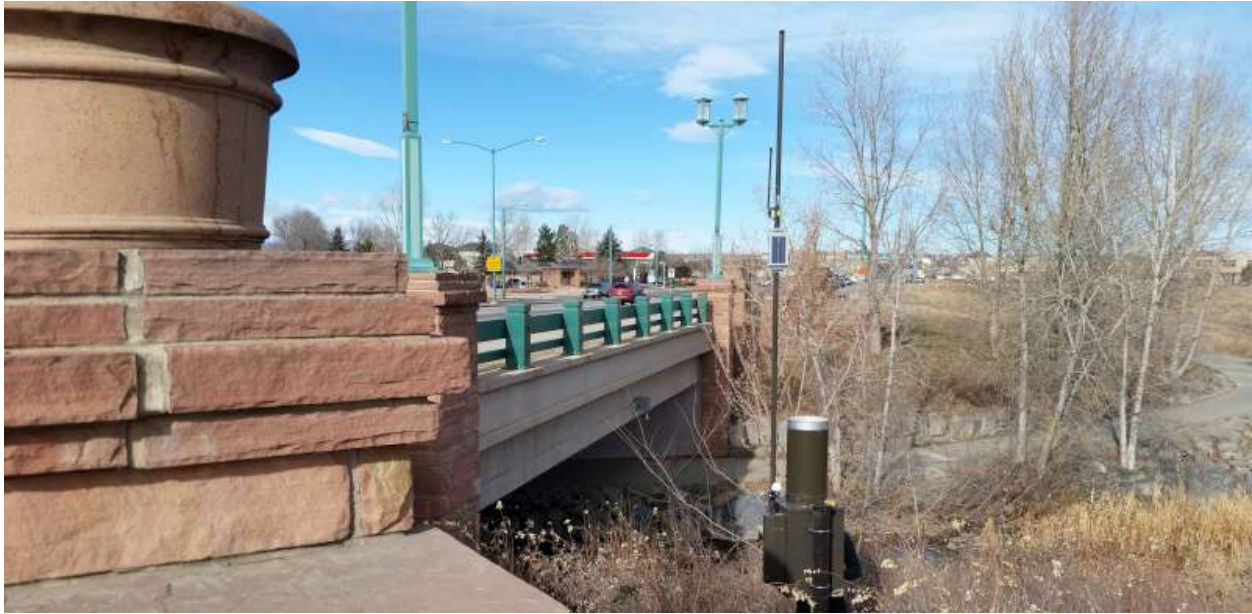
### Coal Creek at McCaslin (10030)

Installation was completed on 12/08/2015. Coal Creek at McCaslin utilizes ALERT2 technology and is powered with a Campbell Scientific ALERT2 transmitter. It is currently configured for rain and stage. The stage sensor is a non contact radar.

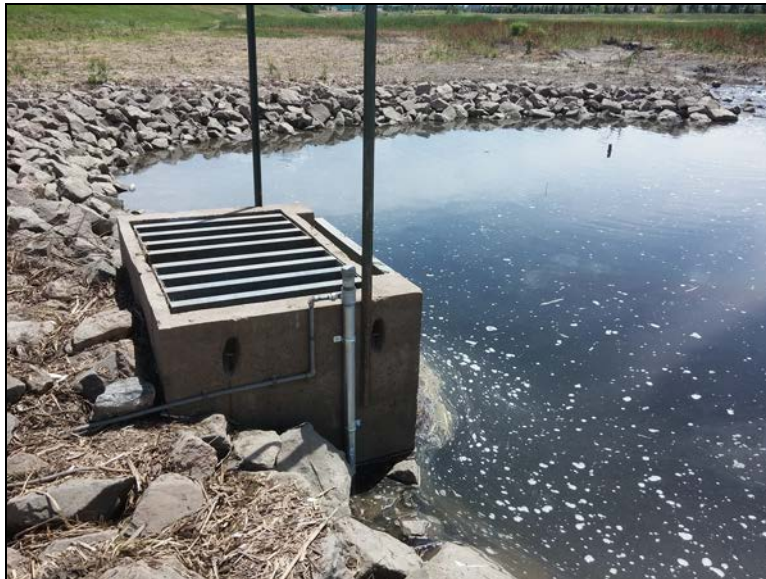
### **Kelly Dam (410)**

During high water events the pressure transducer elevation differs from on site readings. This was due to the stage sensor being located inside the outlet structure. The structure has a tendency to clog with debris, resulting in different elevations from inside and out. On July 14<sup>th</sup>, the water level subsided enough to re-locate the conduit to the outside of the structure.

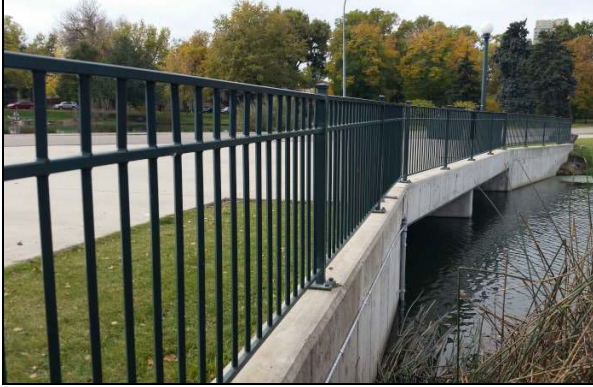
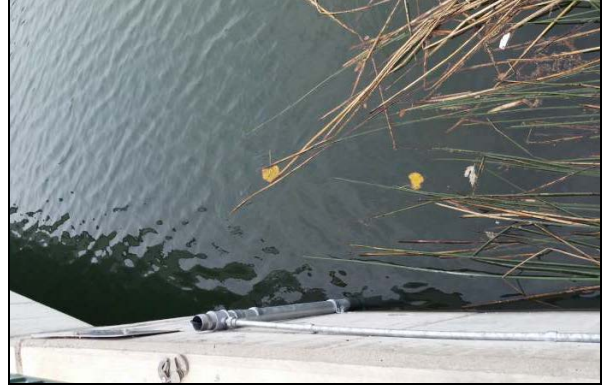
### **Ferril Lake (1380)**

The bubbler at Ferril Lake failed last year. The site was put out of service on May 12<sup>th</sup> until funding for a new sensor could be provided. On October 20<sup>th</sup>, the bubbler was replaced with a freeze-resistant pressure transducer. The conduit was extended to allow ease of access and maintenance. The site is now transmitting both stage and water temperature.

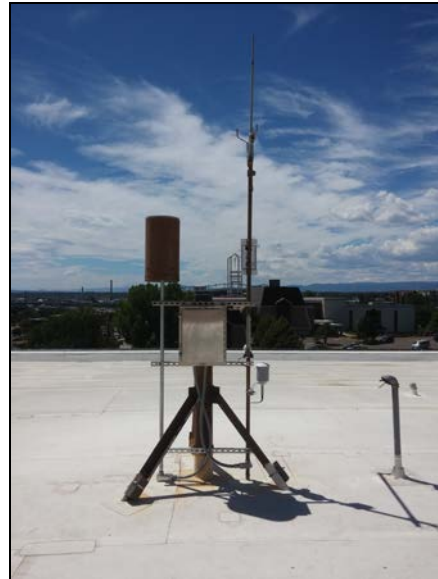
### **Diamond Hill Wx (1420)**

The Diamond Hill Weather Station was moved from the corner of the roof to an existing satellite antenna mast in the center. During the move the electronics were upgraded to ALERT2. The existing standpipe was scrapped and the site is now contained in a NEMA enclosure.

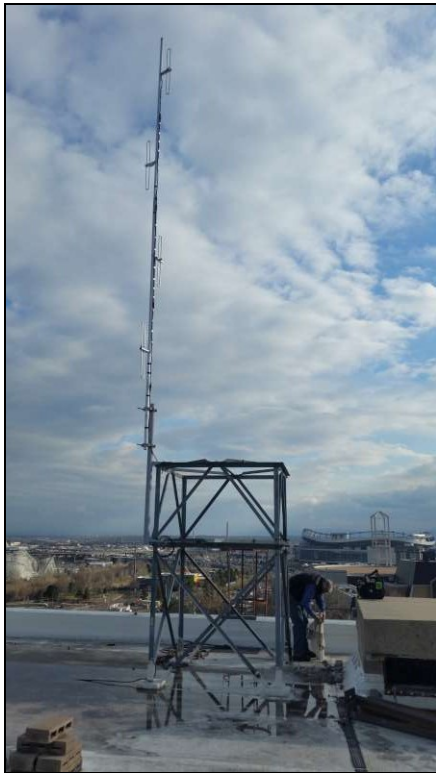
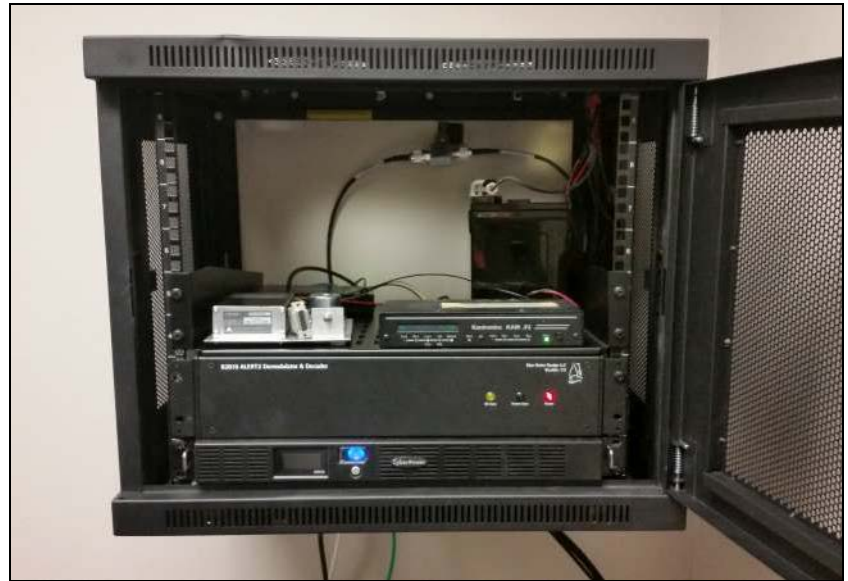
### Diamond Hill Base Station Issues

ALERT2 latency at Diamond Hill continues to be an issue. On March 19<sup>th</sup>, all ALERT and ALERT2 equipment was re-located from the roof to the UDFCD server room. During this re-location the antenna was moved to a new location at the corner of the roof. A single RF feed line runs from the antenna to their server room, where it is split to all equipment.
