UDFCD ALERT Gauging System Maintenance 2017 Annual Report

Kevin Stewart
Urban Drainage and Flood Control District
Denver, Colorado

Prepared By
OneRain Incorporated
1531 Skyway Drive, Unit D
Longmont, Colorado 80504

Report Date: December 22, 2017

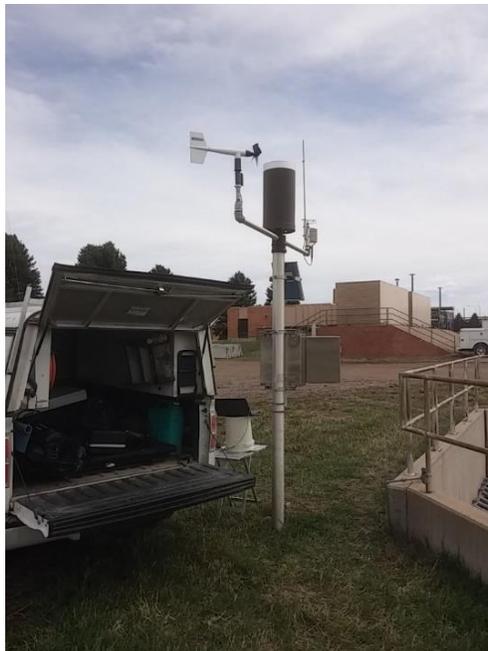
Figure 1: Marston RM Young Wind Sensor

During startup in mid-March, it was determined that the ultrasonic wind sensor was malfunctioning. This sensor was subsequently “turned off” in the datalogger program to prevent it from reporting erroneous data until it could be replaced. On April 4 the old wind sensor was replaced with a new RM Young unit (Figure 1). This unit has reported reliably since that time.

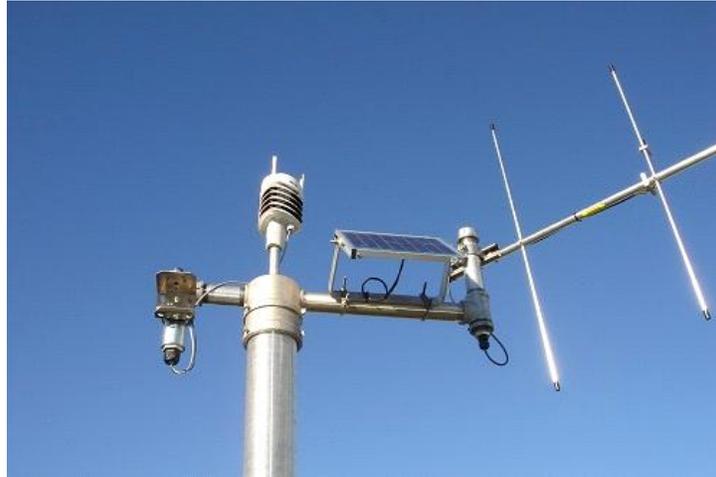
Figure 2: Aurora Town Hall WXT520 Weather Sensor

In late June the WXT520 weather sensor (Figure 2) at Aurora Town Hall malfunctioned. Diagnostic tests performed during a site visit in early July proved inconclusive and the sensor was brought back to the OneRain shop for further testing where it was determined that the sensor cable had been damaged. The sensor was returned to the site with a new cable on July 14 and the sensor has reported reliably since then.

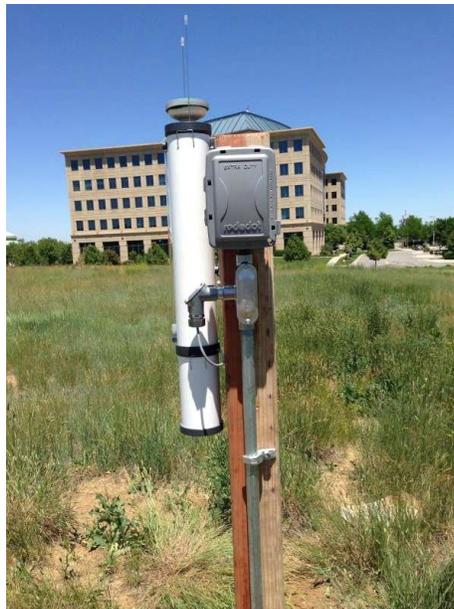
Figure 3: Aurora Town Hall ET Gauge

The reservoir of the ET gauge ran empty at the end of August (Figure 3). While it is not unusual for this sensor's reservoir to require refilling during the summer, in order to minimize the sensor's downtime between fillings in the future, OneRain created a Contrail alarm that will alert its field personnel when the sensor has failed to "tip" for 24 hours.

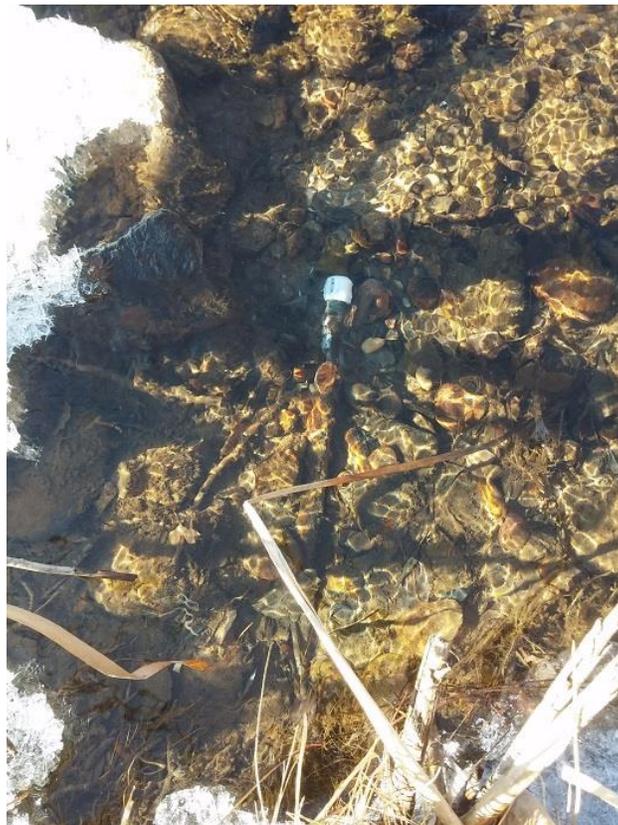
Figure 4: SBC @ SBR PT Intake Pipe

On December 19, the damaged section of the PT intake pipe was removed. The intake pipe was flushed, and a perforated plastic cap was placed on the end of the pipe (Figure 4). The PT now has good hydraulic contact.

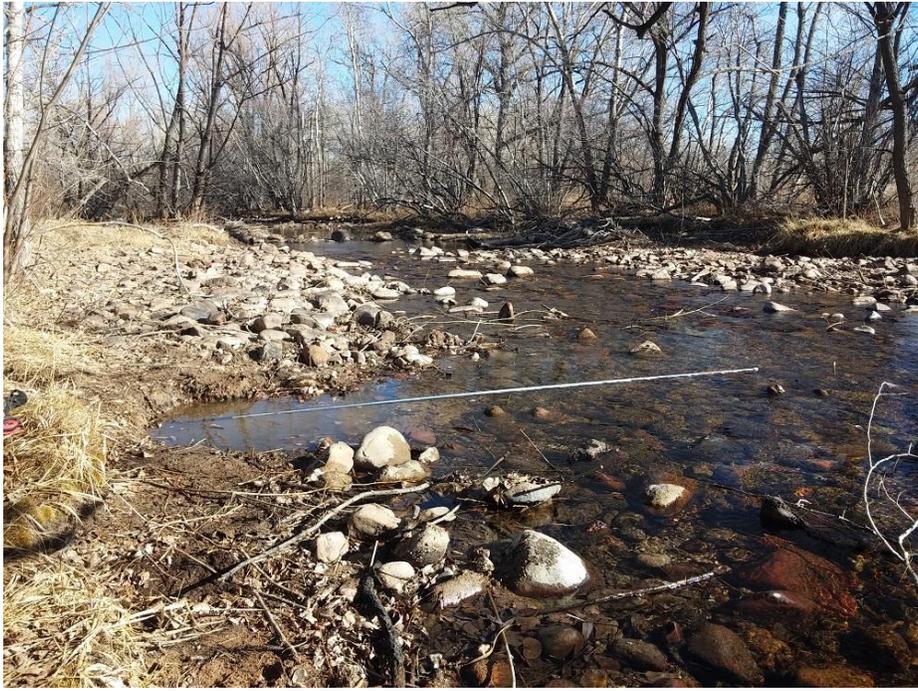
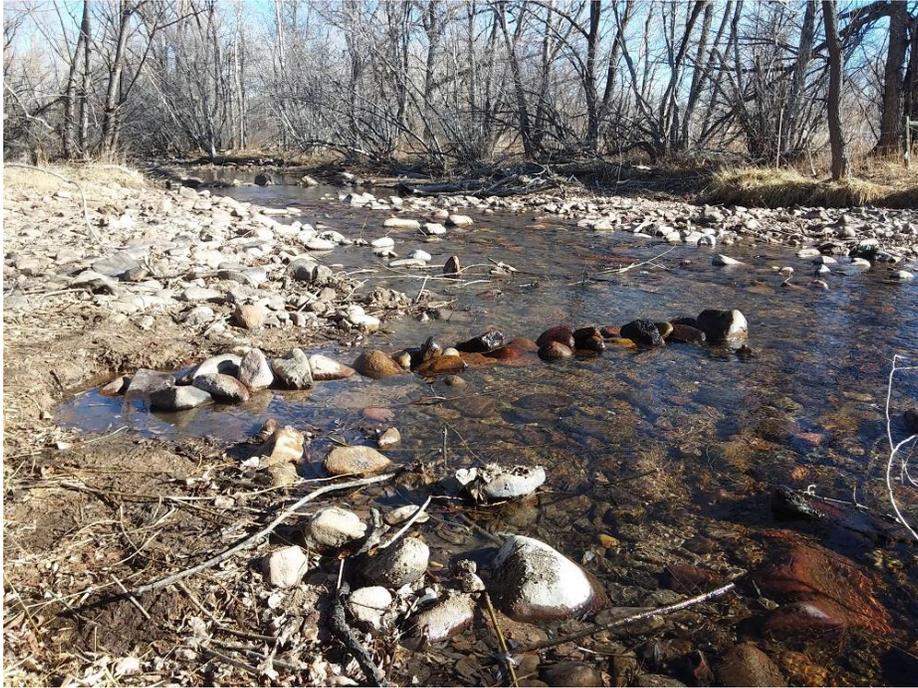
On December 20, a new 10' section of 1/2" pipe was coupled to the existing intake pipe emerging from the channel bank, replacing the old, rusted, damaged section (Figure 5 and Figure 6). A perforated plastic cap was placed on the end of the intake, and the PT now has good hydraulic contact.

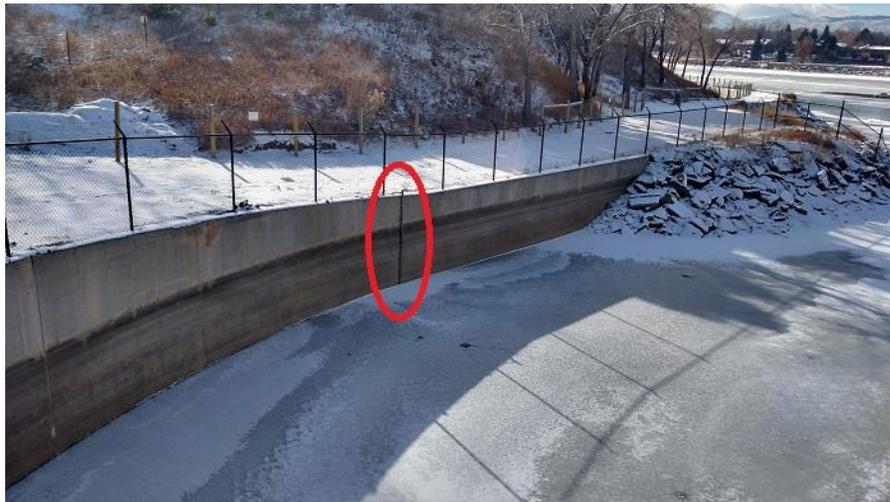
Figure 7: Maple Grove Reservoir Riser Pipe

Historically, PTs installed at Maple Grove have been periodically damaged by ice. This is a high priority, year-round site. Accordingly, on February 9, in order to combat potential ice damage in the future, the PT was replaced with a freeze-resistant OTT PLS unit and the riser pipe was lowered 1' ¼" (5 ¾" from the channel bottom) in order to ensure that the PT resides below the ice layer that typically forms on top of the water during the winter months (Figure 7). The PT reference was adjusted in Contrail.

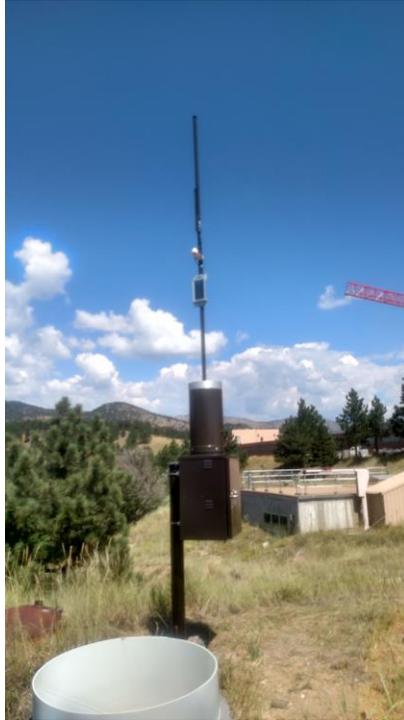
Figure 8: New Site Infrastructure at Filter Plant

The startup visit revealed that the standpipe had been knocked over during recent construction activities. The site was upgraded to ALERT2 and reinstalled with a Pelco pole and a High Sierra cabinet (Figure 8).

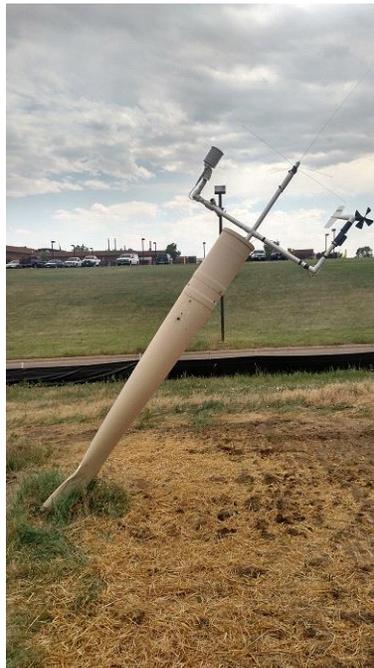
Figure 9: Damaged Standpipe at Quincy Reservoir

Sometime during the summer, the standpipe at Quincy Reservoir was severely damaged by construction activities taking place in the area (Figure 9).

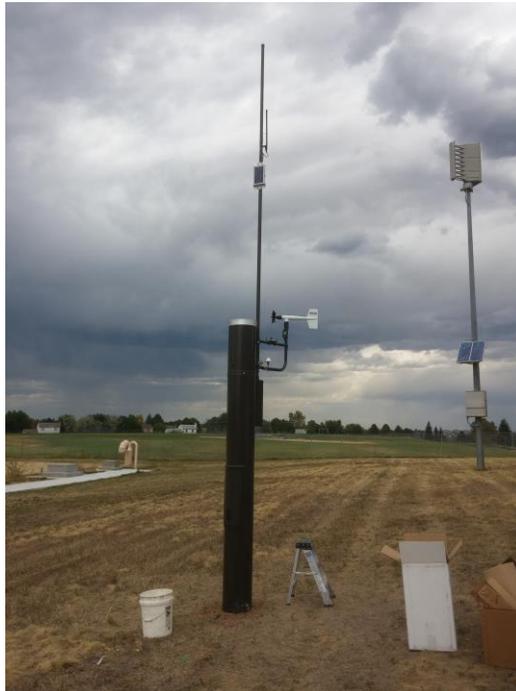
Figure 10: Quincy Reservoir ALERT2 Upgrade

On September 13 the site was relocated to the northeast corner of the property. The site was upgraded to ALERT2 (High Sierra A2 3306 transmitter) and a new standpipe was installed (Figure 10). In addition, the tipping bucket, solar panel, RM Young wind sensor, and relative humidity/air temperature sensor were replaced with new units. The pyranometer from the old site was found to be operating correctly so it is still in use at the new site. The barometric pressure sensor was irreparably damaged by the construction activities and no replacement was installed at the new site.

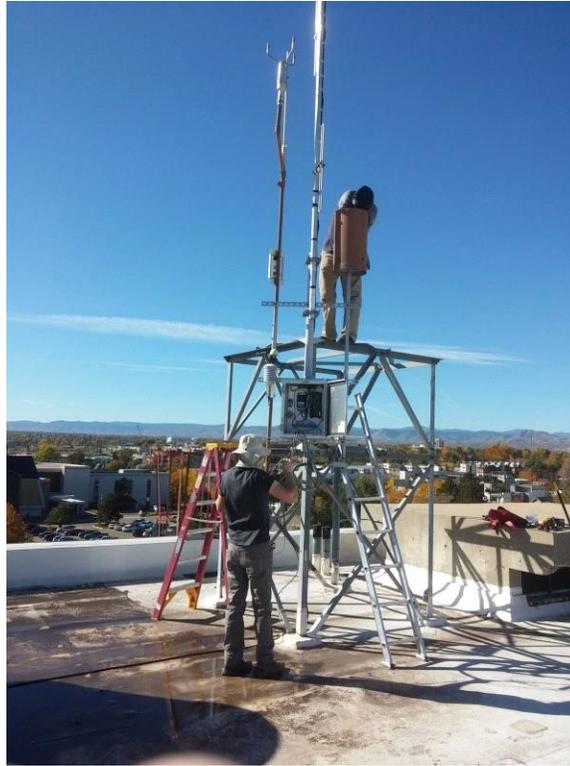
Figure 11: Diamond Hill Site Relocation to Penthouse Roof

On October 17 the Diamond Hill weather station was relocated to the penthouse roof (Figure 11). All equipment and components that were present at the former location are still in use at the new location. The weather station is mounted to the angle iron structure on the penthouse roof, and no portion of the station is in contact with the roof surface, which should obviate any conflicts in the future if repairs to the roof are required.

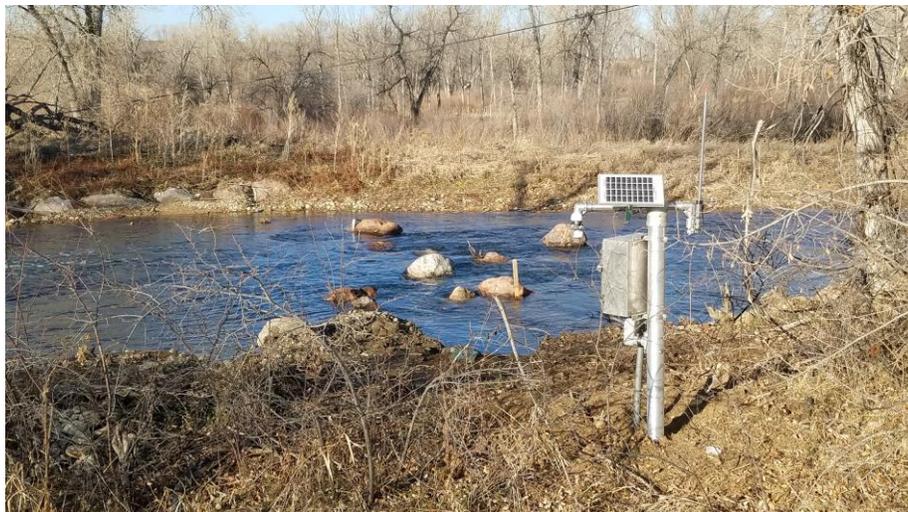
Figure 12: Green Ditch Relocation

The City of Boulder performed stream reconstruction in the vicinity of the original location of this site. The site was relocated with new infrastructure and upgraded to ALERT2 (Figure 12). The newly installed site became operational December 14th, 2017.

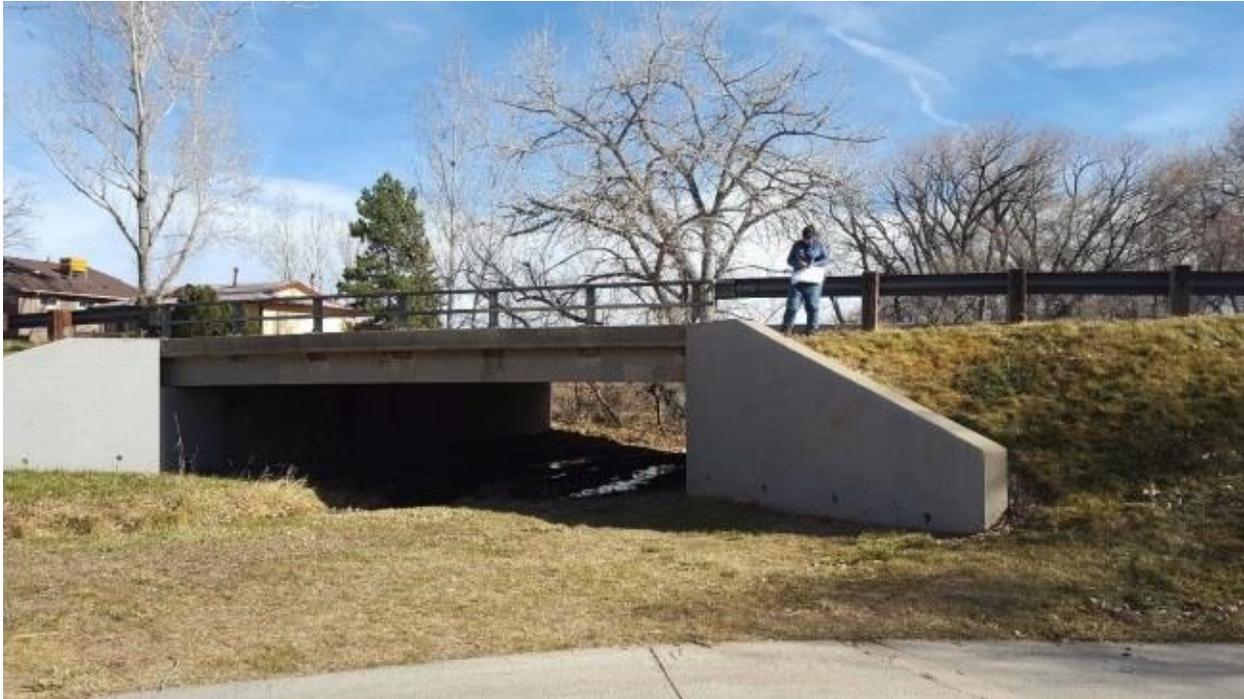
Figure 14: Proposed New Location for Van Bibber at Crestone Street Bridge

Since the flooding of 2013, maintaining hydraulic contact at the current PT riser location has been an ongoing challenge. The channel has shifted greatly and a substantial layer of rocks and sediment has been deposited in the vicinity of the PT. In addition, the standpipe top section is in disrepair and access is difficult in its current location due to the sloping topography.

The site will likely be relocated to the bridge on Crestone Street (Figure 14). We recommend replacing the PT with a non-contact radar unit mounted to the bridge, similar to Coal Creek at McCaslin. The site will also be upgraded to ALERT2 prior to installation.

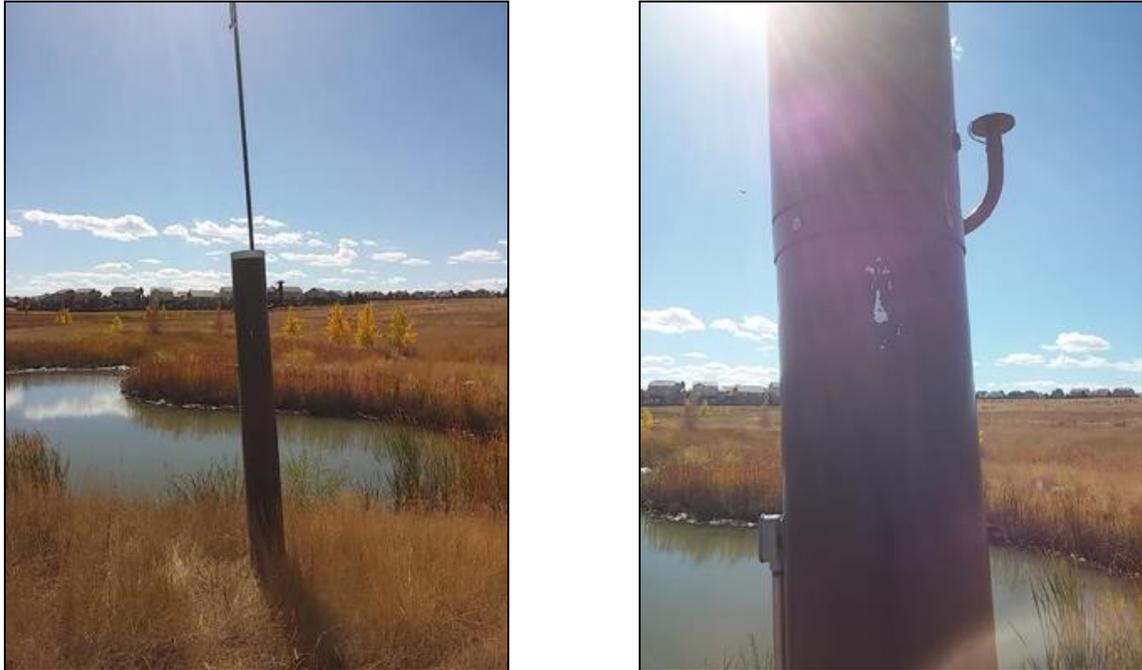
Figure 15: Damage to ETG @ Hampden

During 2016 takeout, it was discovered that the standpipe was leaning to one side, and evidence that it had been struck by a large (construction?) vehicle was apparent (Figure 15). The site is functioning correctly, and while the standpipe does not appear to be in imminent danger of toppling over, it should be repaired when possible.

- \$1,860 Labor and supplies to realign the standpipe
