Re: ALERT Gaging System Maintenance Agreement 06-02.08, Final Report

# **ALERT Gaging System Maintenance Agreement 06-02.08**

**Annual Report  
December 15, 2006**

**Presented To  
Kevin Stewart  
Urban Drainage and Flood Control District  
Denver, Colorado**

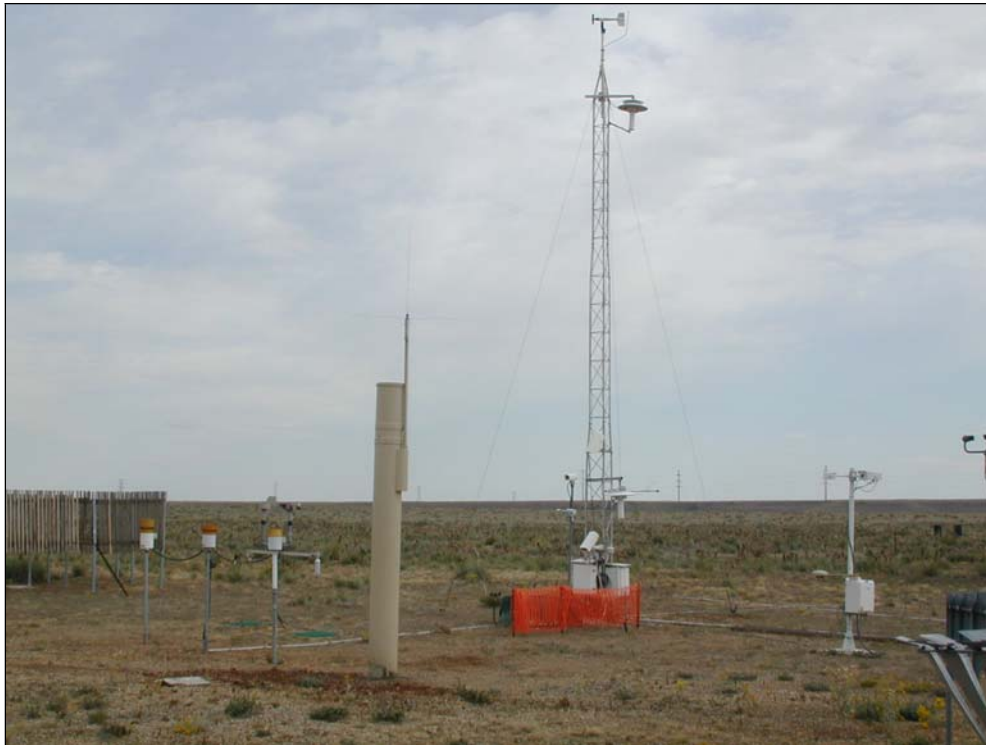
**Figure 1: Marshall Rain Gage**

The Marshall site is located in the National Center for Atmospheric Research (NCAR) Marshall Test Site surrounded by other meteorological measurement stations. The site is located at N 39° 56' 57.21", W 105° 11' 43.38" (WGS84 datum). This site reports via the Blue Mountain repeater.

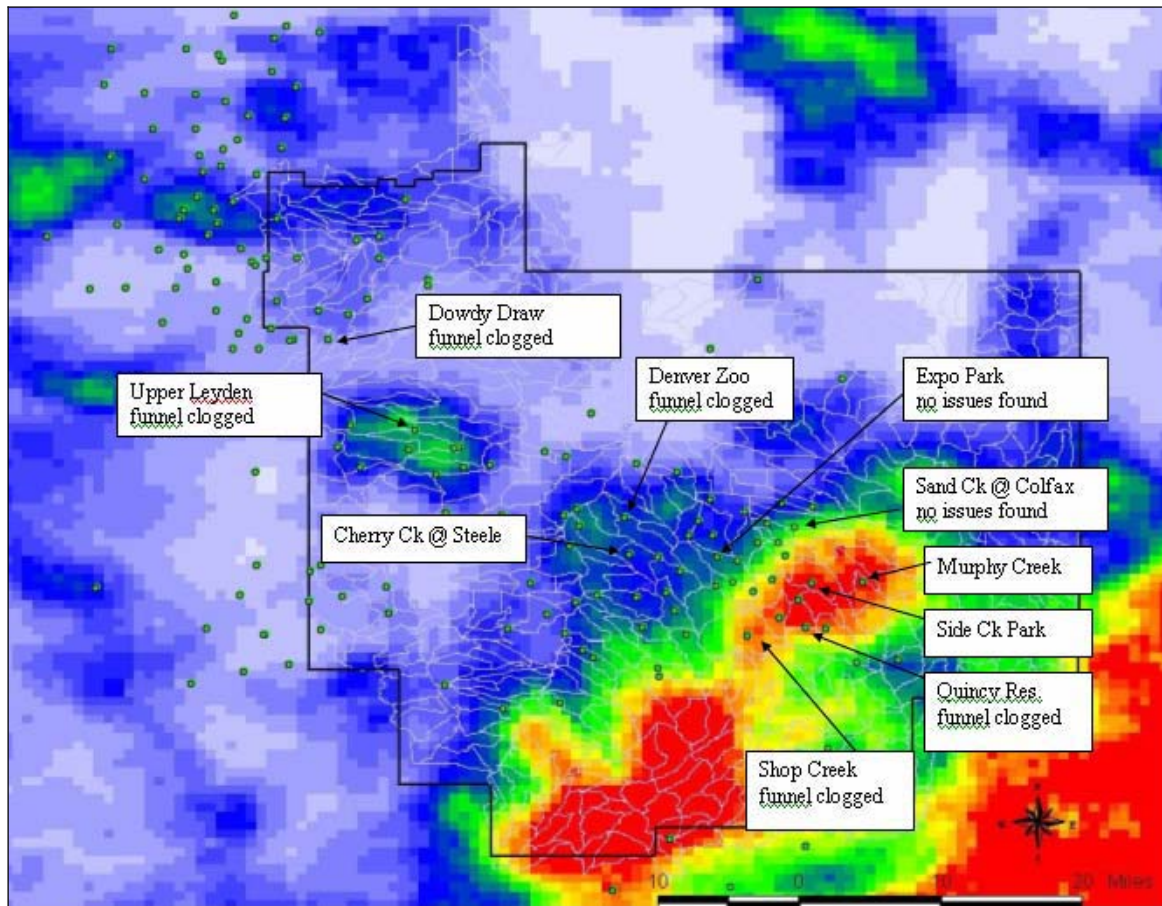
**Table 4: Unadjusted Radar Rainfall Accumulation 7/7/2006 – 7/10/2006**

In addition to analyzing each gage individually to evaluate it's RF performance OneRain compared gages to each other (nearest neighbor analysis), and qualitatively compared the gages to radar data (unadjusted radar rainfall analysis). The graphics below show the results of the radar rainfall comparison.
