Urban Drainage and Flood Control District

E-19 Surveys

Sports Complex Gage
ALERT ID: 323
LID: SEXC2

HDR Engineering, Inc.
303 E 17th Ave. Suite 300
Denver CO, 80203

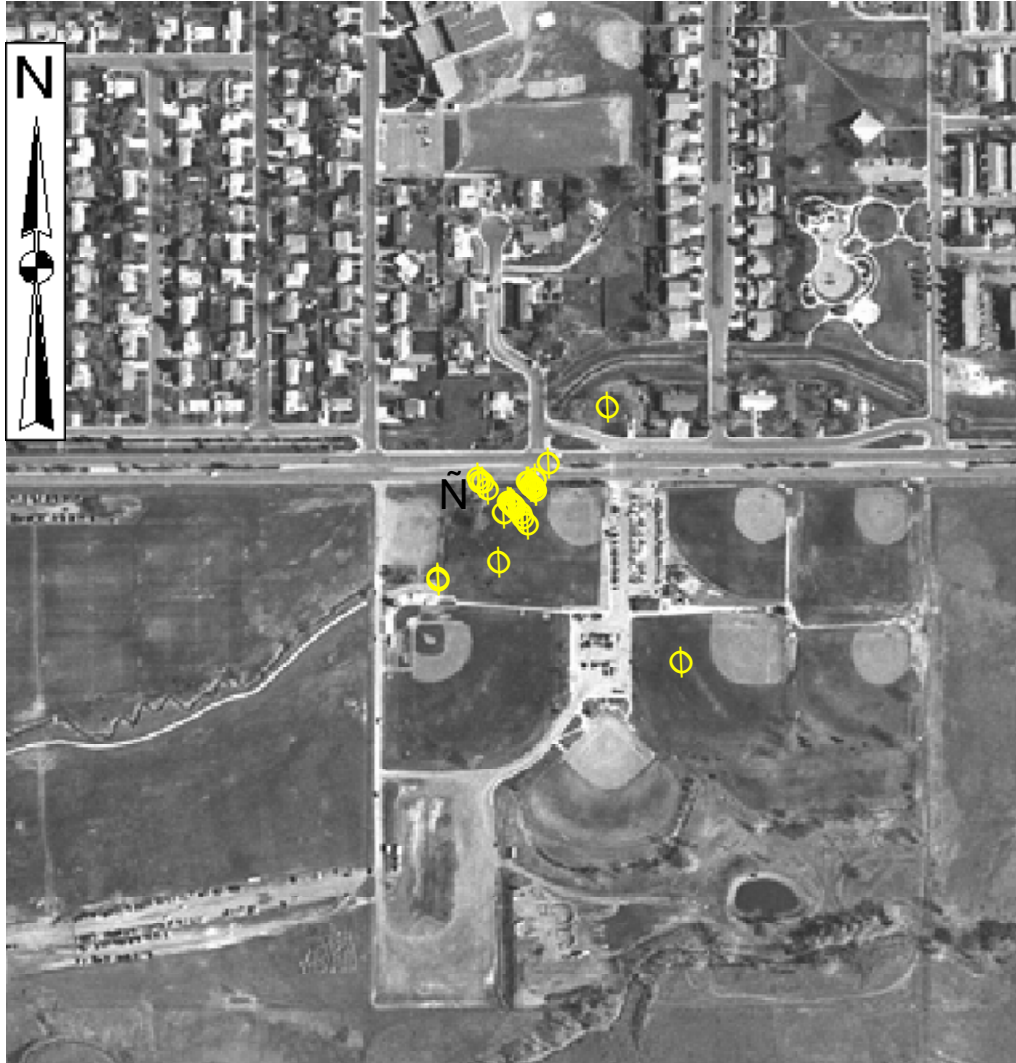
Figure – 2 Surveyed Points

The elevations and locations of any buildings near the gage site were surveyed, along with water surface elevations up and down stream from the gage. In addition ground elevations were surveyed along a cross section for a possible future rating curve for the site. Figure 2 shows locations of the surveyed points in the vicinity of the gage. The base of the ALERT transmitter was surveyed at an elevation of 100.00 for a temporary benchmark. The flow line elevation is 95.8 feet. The bankfull stage is at 4.5 feet above the flow line. The levee on the East will be overtopped at 5.9 feet above the flow line. At 7.5 feet above the flow line West 58th Street will be overtopped. Based on the topography of the area, the estimated channel energy slope is 0.7 percent.

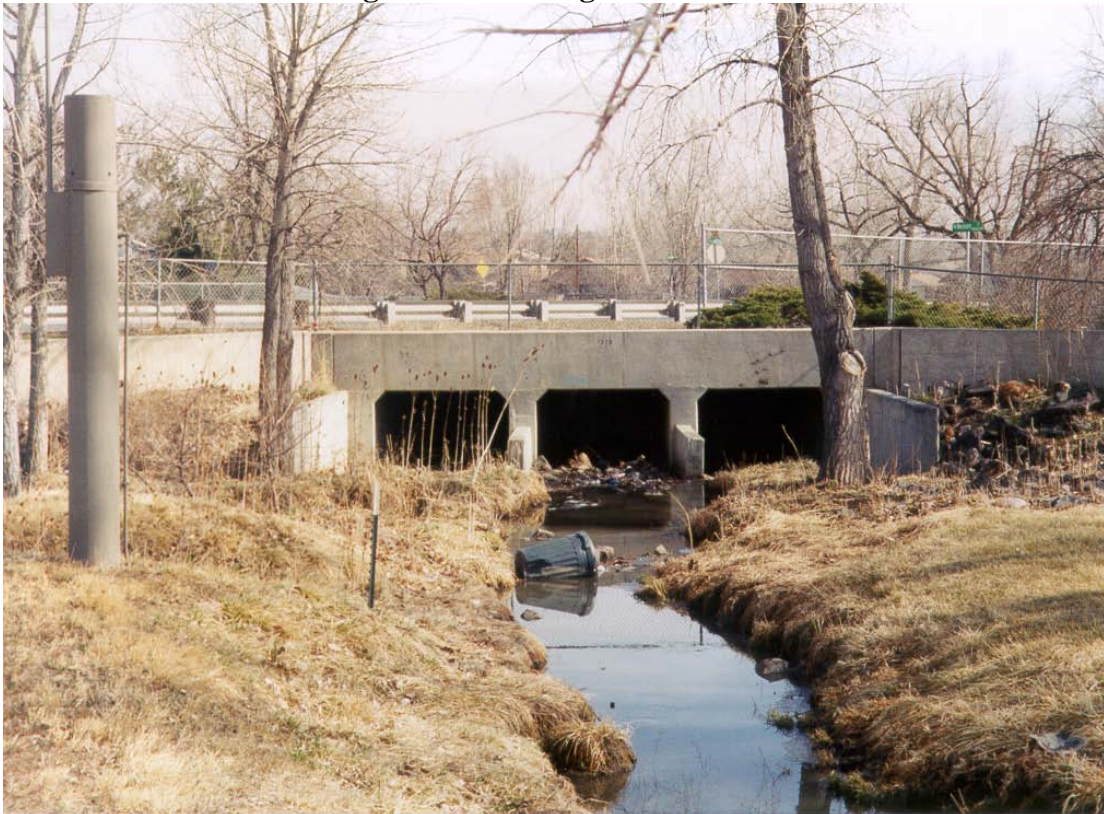
Figure – 3 Looking Downstream

Several photographs were taken of the site. Figure 3 shows Van Bibber Creek at the gage location looking downstream. Figure 4 shows Van Bibber Creek at the gage location looking upstream.

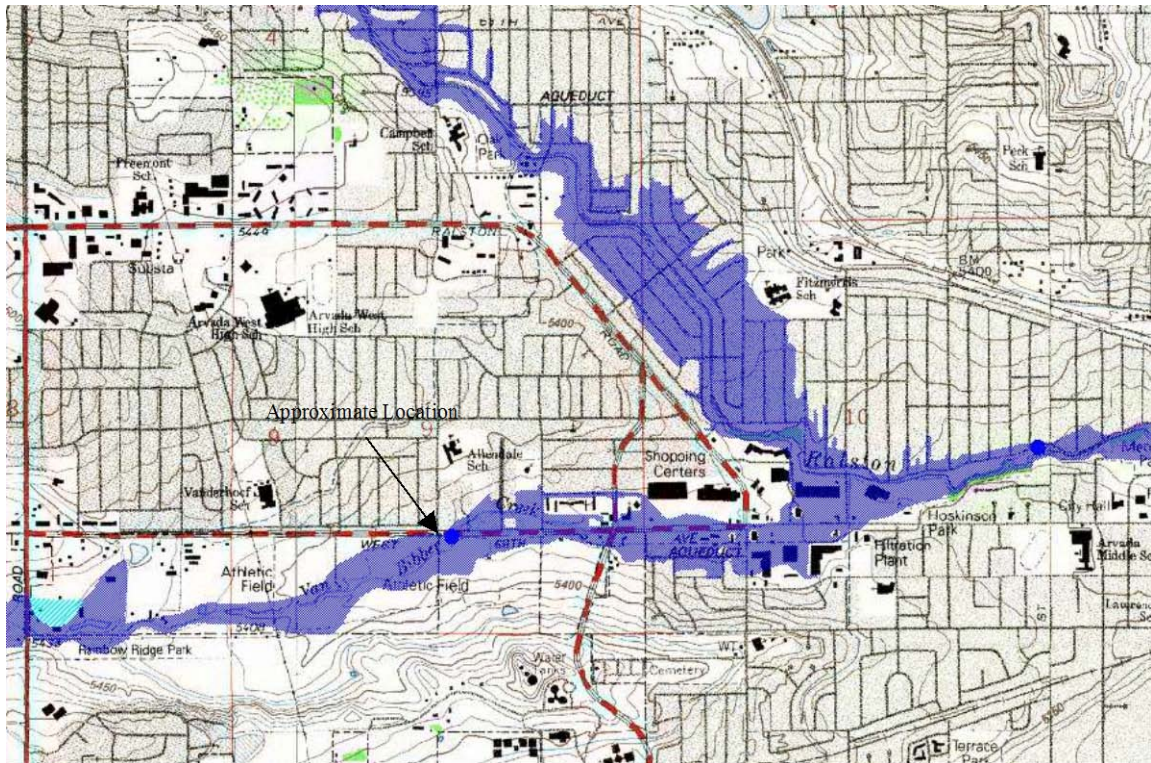
Figure - 5 Approximate 100-Year Flood Boundary As Depicted on District's Annual Flood Hazard Information Brochures

There is limited information available for this gage. The location has been recently converted to a pressure transducer with an ALERT transmitter. Since the gauge installation date in July, 1989, a peak stage of 3.7 feet (corresponding to 440 cfs) was recorded on July 22, 1991. Records of flooding previous to the gauge installation could not be identified during the reconnaissance and library searches. Figure 5 shows the approximate 100-year flood boundary as depicted on district's annual flood hazard information brochures.
