Urban Drainage and Flood Control District

E-19 Surveys

Eldorado Springs Gage

HDR Engineering, Inc.

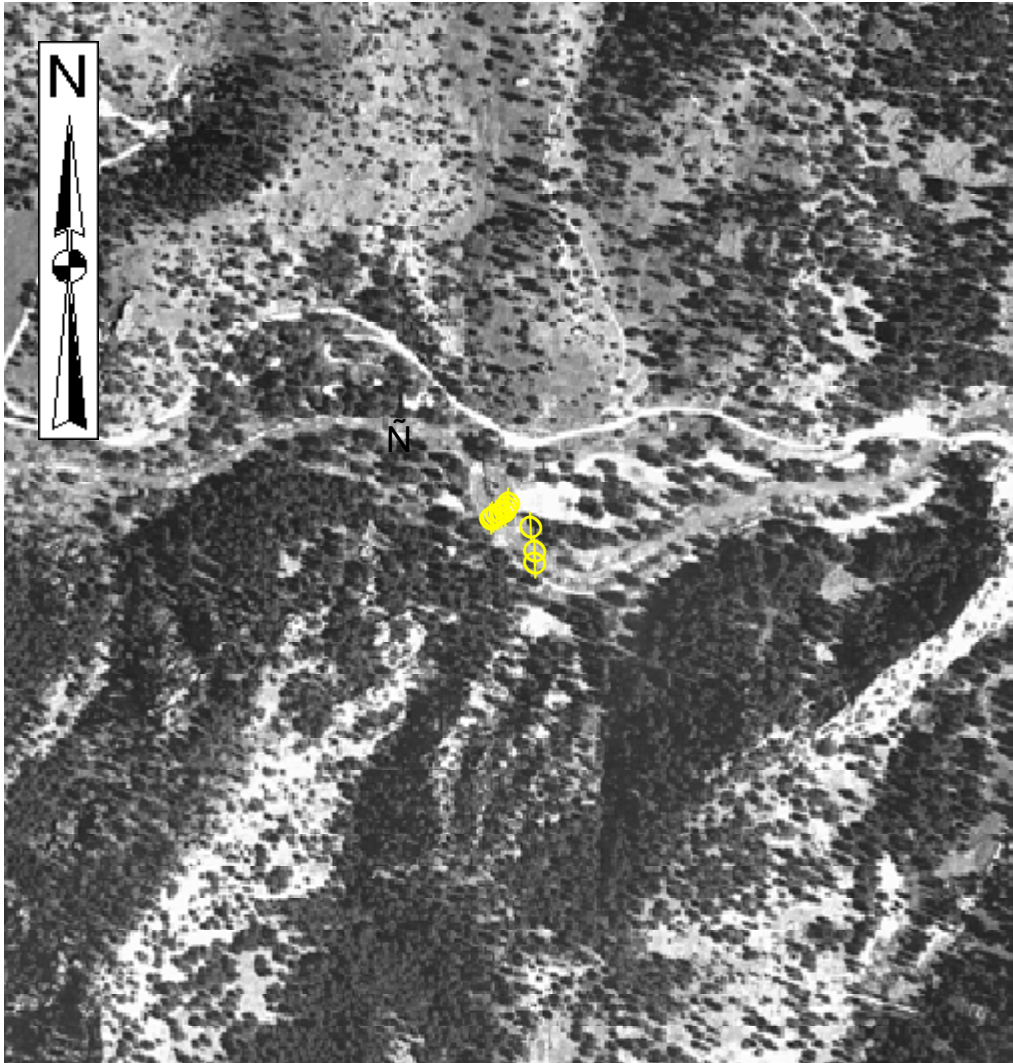
Figure – 2 Surveyed Points

The ground elevations near the gage were surveyed for a potential cross-section in conjunction with previous rating studies of the gage. In addition the top of the bank protecting the homes in the right overbank were surveyed, along with water surface elevations of the stream upstream and downstream to estimate the channel slope and this reach. Figure 2 shows locations of the surveyed points in the vicinity of the gage. It is estimated that the instruments will be flooded and transmission will be lost at approximately stage 8. The top of the right berm is a stage 6.31. Inundation of the parking area occurs at approximately stage 5. Based on spot elevations of the water surface, the estimated channel energy slope is 2.2 percent.

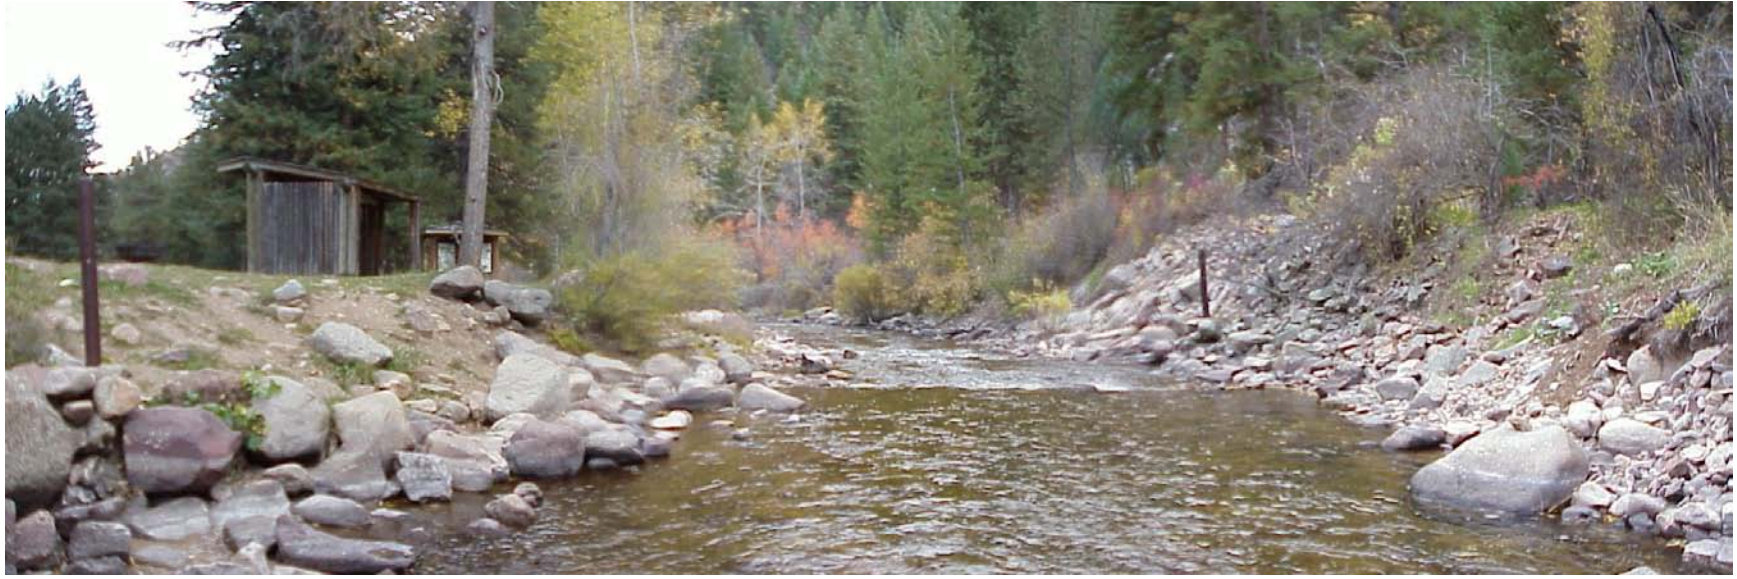
Figure – 3 Looking Downstream

Several digital photographs were taken of the site and several panorama views were created based on the site photographs. Figure 3 shows South Boulder Creek at the gage location looking downstream. Figure 4 shows South Boulder Creek at the gage location looking upstream.
