# Annual Maintenance Report 2000

## by Bob Cress, DIAD Incorporated

The following was excerpted from a December 4, 2000 letter from Bob Cress to Kevin Stewart, UDFCD.

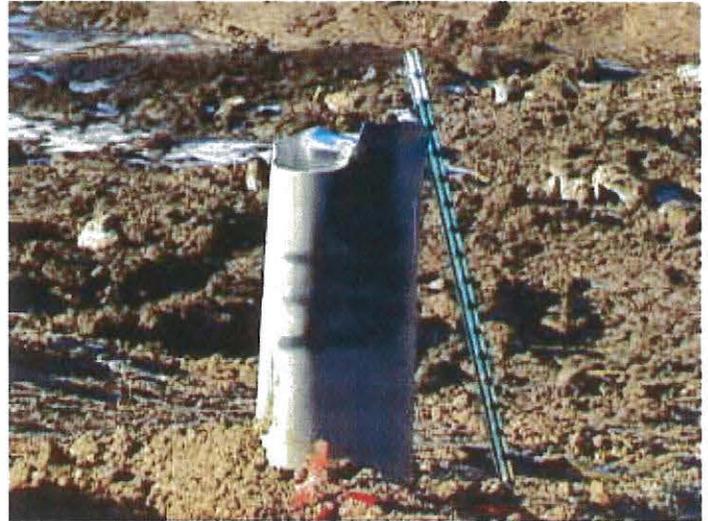
The combined UDFCD/Boulder County network received its normal dose of damage via both vandalism and heavy equipment malpractice during the 2000 season. The Mission Viejo site was taken out in June by an out-of-control truck boom that sheared the standpipe off 36" above grade (Figure 1). Aside from cabling, all the equipment was salvaged. At last inspection, heavy equipment was still all over the place. The site will be reinstalled when construction is complete. Expo Park was taken out of service early in 2000 in order to accommodate the reconstruction of the detention pond there. Construction is nearing completion and the site shall be brought back to life for the 2001 season. Harvard Gulch received destructive influences from either vandals or Denver maintenance crews. The PT conduit had been bent and breached at 2 different locations, leaving the pressure transducer cable fully exposed. We suspect the real culprit was a park maintenance snowplow that got a bit carried away. Polypipe that runs from the standpipe to the culvert headwall was near ground level on the culvert end, and was not buried deep enough to survive a wayward plow blade. The breaches were repaired and the conduit is buried deeper and extends farther out from the wall before it mates to the polypipe, making it more secure than before.

**Figure 1. Negligent destruction of Mission Viejo standpipe**

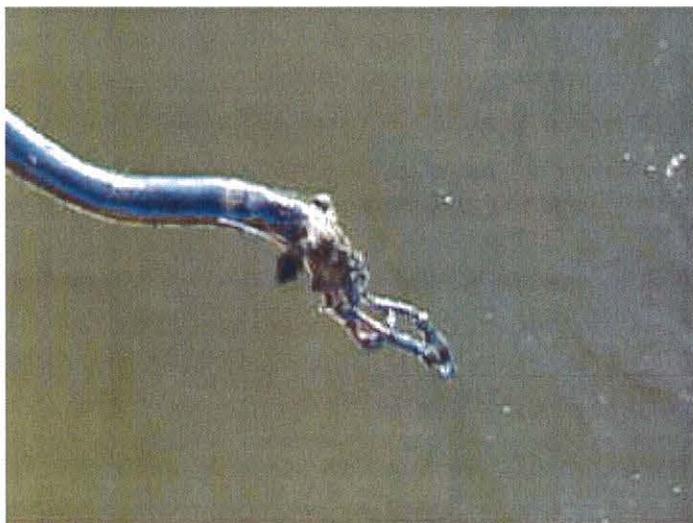
**Figure 2. Utah Park vandalism**

Utah Park stopped reporting around October 11th due to devious vandals. The pressure transducer had been ripped off of its cable (Figure 2) at the housing end, and the cable was reinserted into the water inside the PT housing. (The cap was reinstalled on the riser to make it appear that all was well.) The resulting short caused damage to the splice box and fried the 5050 logic board. In addition, the antenna was missing. All components (with the exception of the tipping bucket) at the site will require replacement. In more minor incidents, the solar panel was shot to bits (again) at Big Elk Park (along with the antenna base and the mast). Two ground planes were MIA at Red Garden, as well as the antenna at Jewel Detention. The antenna and ground planes were bent at SPR @19th, and ground planes were found bent at the Broomfield site.

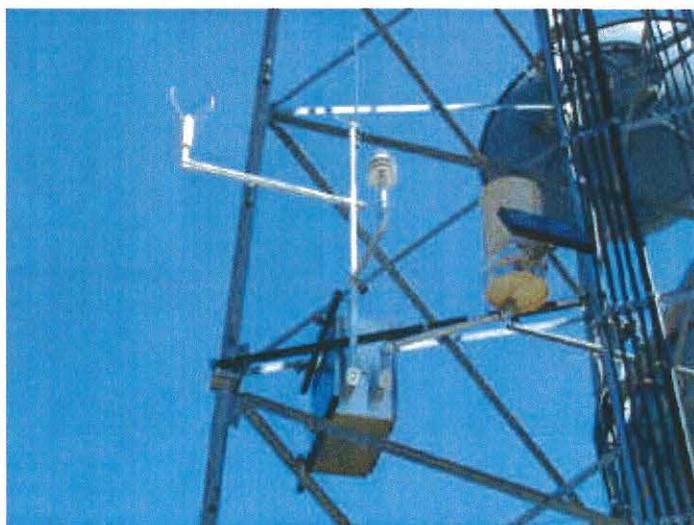
A Handar weather suite was installed at the 20' level on the State of Colorado telecommunications tower at Squaw Mountain in early June (Figure 3). After resolving initial RF issues, the site performed reliably through the summer and early fall. However, concurrent with colder temperatures, wind data has become somewhat less reliable. A gap in wind data correlated with the passage of a cold, wet front on September 20, 2000. Wind speeds of 181 mph were reported for several hours. We hypothesize that the sonic wind device was subject to ice buildup, effectively inhibiting its functionality until warmer conditions eliminated the ice. Similar wind data were noted at Elbert as well, again correlating with probable ice buildup. It seems likely that in order to eliminate these gaps in wind data, the sonic devices will require heating during those periods where ice buildup will otherwise occur. Handar offers a heated version of the 425, called the 425AH. The transducer heads are internally heated when a temperature sensor in the 425AH senses some predetermined value. The Handar 425-7006 power supply provides the recommended 36V required by the sensor. Depending on importance of wind data, the District may want to consider acquiring the 425AH, at least for Squaw Mountain. Eliminating ice buildup at Elbert would be less cost effective since the problem is very likely less frequent there. The cost of one heated sonic wind sensor/power supply combo plus cable is close to \$3,000 (ouch!). If replaced, the original 425 could either serve as a spare unit for Elbert, or could replace the conventional vane/anemometer configuration at Hiwan.

**Figure 3. Squaw Mountain weather suite. Omni antenna is now mounted on opposite plane of tower facing SE.**

The Squaw Mountain installation is by far subject to the most extreme environmental conditions in the UDFCD network. Unfortunately, it is also by far the most difficult site to maintain in the entire system as well, even in optimum weather. Maintenance/service activity can become hazardous in just a matter of minutes with rapidly changing weather conditions. This stems partly from its location on the tower, which requires full extension of a 24' ladder to reach. Even after tying the ladder to the tower, the person providing maintenance still must use great care ascending to and descending from the NEMA enclosure and sensors. High wind and precipitation make the situation increasingly risky. Once the road to the site has drifted in with snow later in the year, winter and early spring access to the site is impossible with a 4WD vehicle. We are entirely dependent on "hitching a ride" with the State of Colorado snowcat, which takes occasional trips to Squaw to maintain and service their own equipment. The State will not provide trips on the snowcat until they are required to go there for their own work. Thus, after requesting a "trip" with the State, it could conceivably be weeks before we could get to the site. And, upon arrival, poor weather could possibly preclude effective service. We know this sounds like serious whining, but we simply want to stress that both "scheduled" and "unscheduled" maintenance for Squaw Mountain involves a unique set of logistics and working conditions, thus the District cannot expect the usual response time to service requests for this weather station during the winter and early spring.

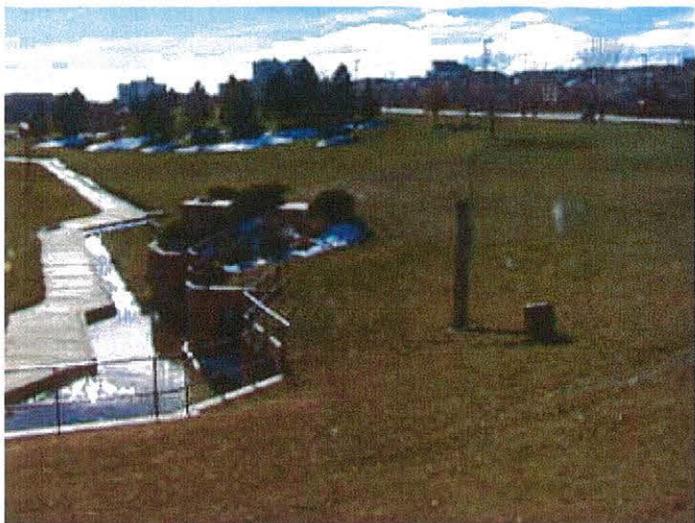
**Figure 4. Result of Temple Pond relocation.**

In July, the Temple Pond precipitation and stage site was successfully relocated from the north side of Union Street to the south side, about 15 feet from the pressure transducer housing (Figure 4). The relocate transformed this site from one of the most difficult to maintain in the system to one of the simplest. The PT cable run was reduced from 330+ feet to less than 40 feet. Contamination from irrigation at the new location occurs at about the same degree as that of the old location.
