Urban Drainage and Flood Control District 2002 ALERT maintenance summary report

December 2002

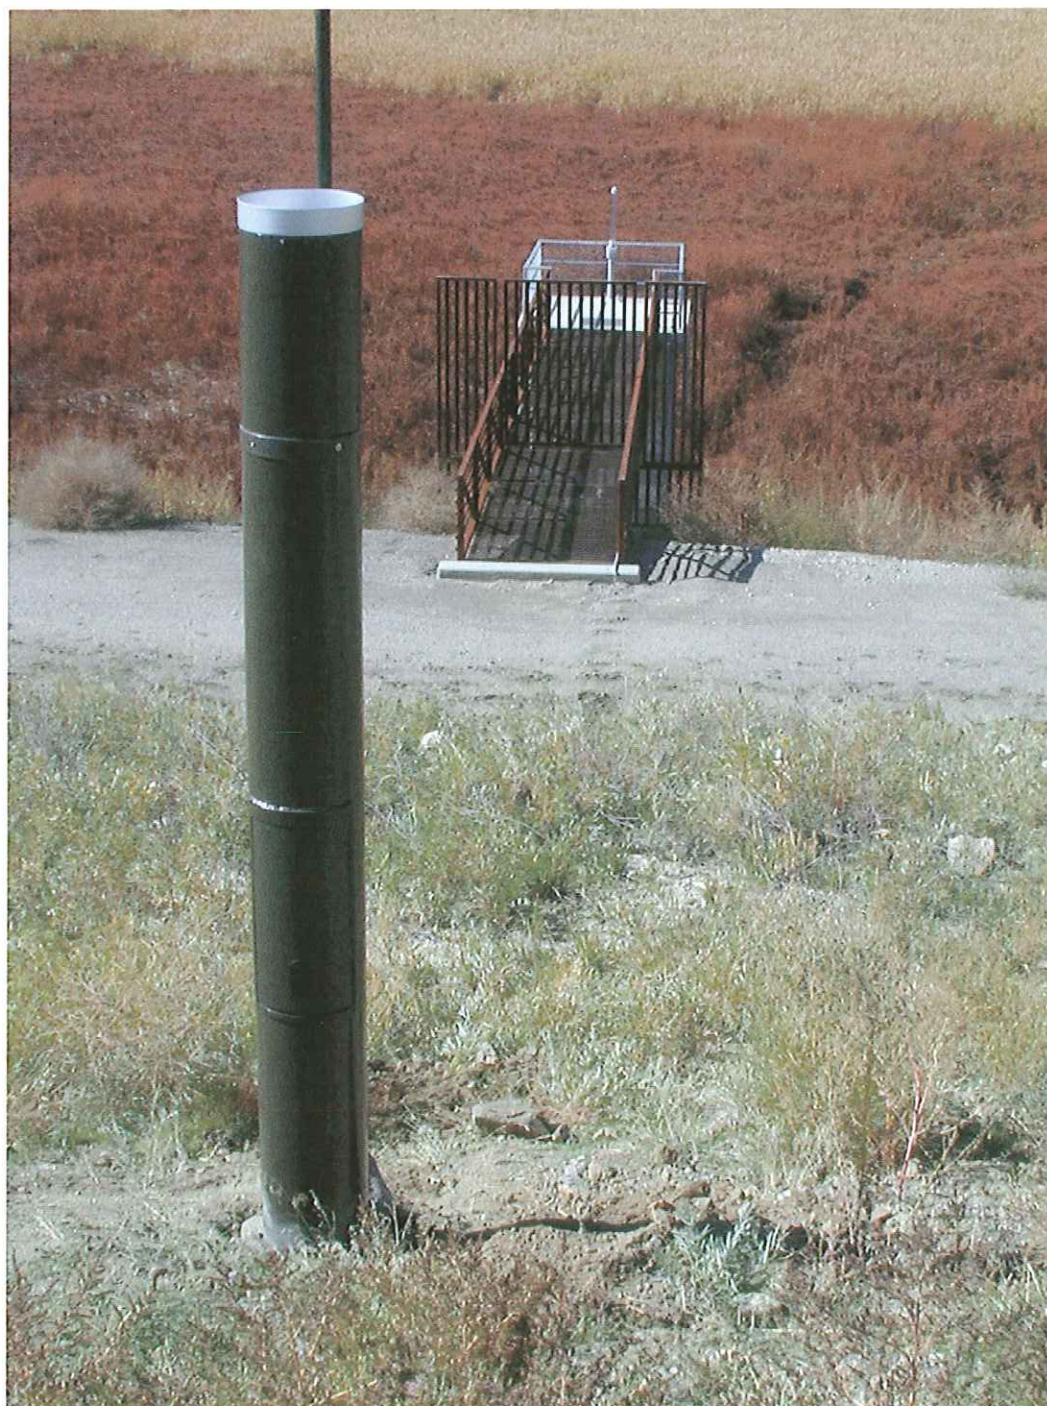
temporary removal in 2001: site 1050 (Jefferson County Fairgrounds, rain only), site 200 (Leyden Reservoir, rain and stage, see Figure 1), and site 1010 (Denver West, rain only). Two other sites were reinstalled after incurring damage the previous year: site 1610 (Holly Dam, stage only) and site 1110 (Gunbarrel, rain and stage).

Figure 1. Site 200, Leyden Reservoir reinstatement

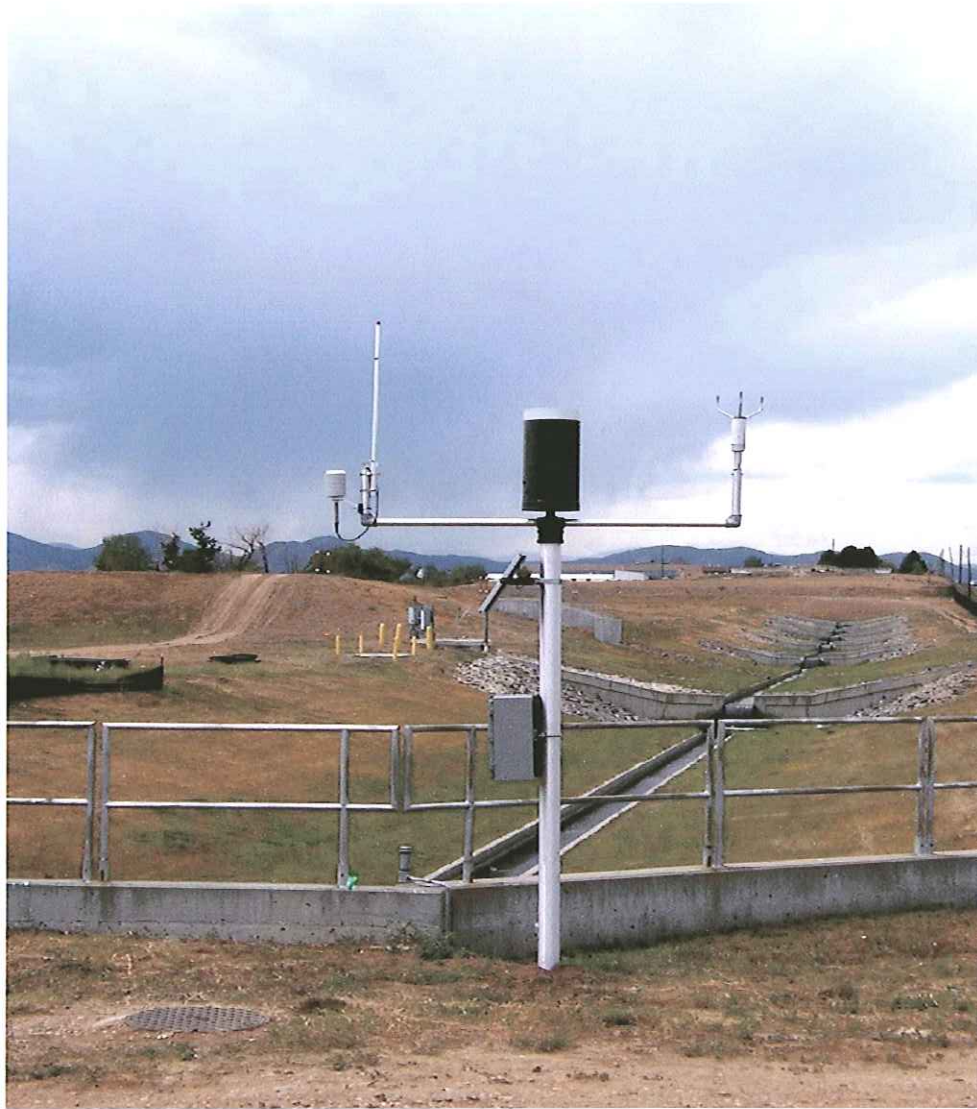
Figure 2. Site 1520, Marston Lake Weather Suite

Three new monitoring sites were added to the District's ALERT system during 2002: site 1500 (Powers Park, rain and stage), site 1520 (Marston Lake, weather station and stage, see Figure 2), and site 1530 (Bear Creek @ Lowell, rain and stage). (The Powers Park site was originally assigned site ID 1670, but the signal was unreliable going through the Smoky Hill repeater. The ID was subsequently changed to 1500 to allow the signal to go through the Blue Mountain repeater, and performance has improved substantially.)

The Marston Lake site incorporates a structural design that was in part patterned after the "alternative" Urban Farm installation the previous year. The new structural differences are a new crossarm housing used on top of the mast and a smaller NEMA enclosure housing the DCP and sensor cable terminations. The DCP at Marston Lake is a Campbell Scientific CR10X datalogger. With the aid of a second-party consultant, DIAD has developed a new ALERT Serial Interface (ASI) board that can accept ALERT ID and data in a variety of serial data formats, including those provided by the CR-10X. The new interface has proven to be reliable since the site began broadcasting this summer.

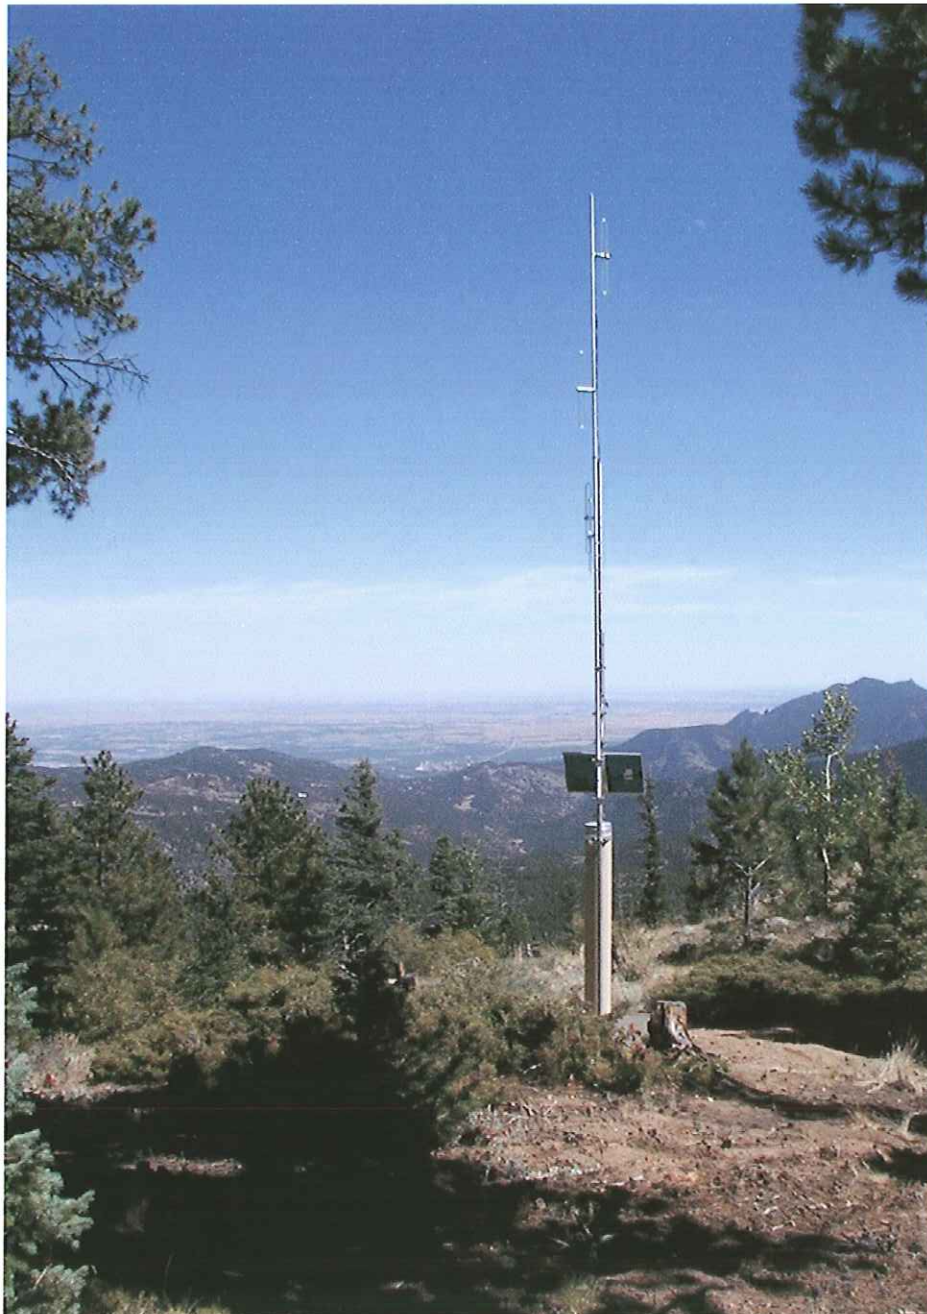
The lockup issue was found with two of the new repeaters that were deployed (Blue Mountain and Gold Hill). This problem was discovered to be software related. The microprocessor is supposed to set a "sleep" mode flag if it does not receive certain instructions in a specific time frame. The microprocessor would always successfully enter sleep mode, but would intermittently fail to properly set its "sleep" flag on when doing so. The PIC (Processing Interface Circuit), after receiving data from a remote ALERT station, would first examine the microprocessor "sleep" flag status. If it saw the flag "on", it would then send an instruction to reset the flag to the "off" condition, then proceed to send the appropriate instructions. If it saw the flag "off", it immediately sent its instructions to the microprocessor. The problem was that the PIC would test the flag "sleep" mode and see an "off" condition, when in actuality the microprocessor was asleep but had failed to set the flag to its true state. "Sleeping Beauty", indeed.

An additional repeater in the Boulder County portion of the system (Gold Hill, see Figure 3) will now provide backup to the Lee Hill repeater in the same fashion that the two Denver area ALERT repeaters back each other up. An additional benefit to the Gold Hill backup repeater in Boulder County is that the ALERT radio traffic can be redistributed over two repeaters instead of one. This will decrease the traffic load on the Lee Hill repeater and either allow for expansion of the system, or improved performance under the existing traffic demand. The combination of 1) the new Gold Hill repeater and 2) having all primary repeaters be PC programmable and remotely controllable improves the reliability of the entire system and help ensure that real time ALERT data is available to emergency managers at all times. This will provide for faster, automatic switching of repeater function if or when one of the primary repeaters fails.

Figure 3. Site 8015, Gold Hill Repeater

After the problem was verified, a series of software updates were forwarded from the manufacturer. Additionally, the microprocessors and PICs in each repeater have been upgraded/replaced (as there is no reason to believe that the remaining repeaters that had not yet exhibited the lockup condition were any less susceptible to the problem).
