Re: ALERT Gauging System Maintenance Program - End of Year Report

UDFCD ALERT Gauging System Maintenance

**Annual Report
January 4, 2011**

**Presented To
Kevin Stewart
Urban Drainage and Flood Control District
Denver, Colorado**

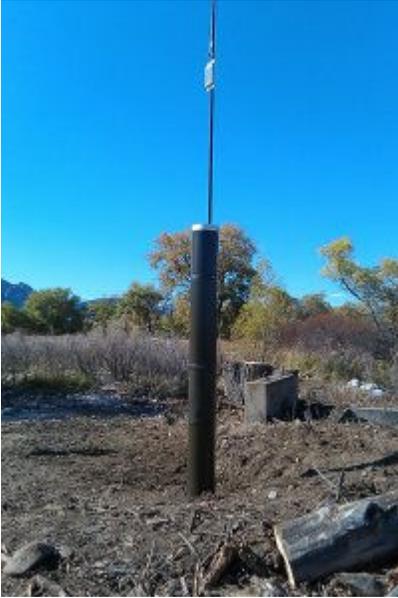
South Boulder Creek @ South Boulder Road (4870)

A new site was installed along South Boulder Creek on 10/24/2011. The site is located at Latitude 39° 58' 25", Longitude -105° 13' 1", Elevation. This site reports via the Gold Hill Repeater. In addition to rainfall, the site also reports stage via a pressure transducer.
