Mile High Flood District ALERT Network 2020 End of Year Report

Prepared for: Kevin Stewart Mile Hight Flood District Denver, Colorado

Prepared by: Water & Earth Technologies, Inc. 1225 Red Cedar Circle, Suite A Fort Collins, CO 80524 (970) 225-6080

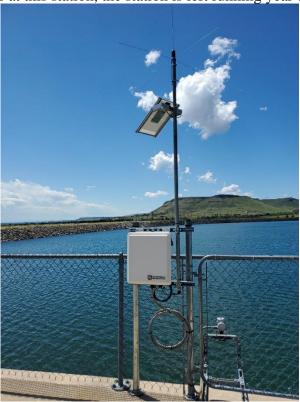
Figure 3-1: Arvada Blunn (10022) radar

The radar at Arvada Blunn is left running year-round to monitor the water level at Blunn Reservoir. The station was inspected on April 24th. All equipment was checked, cleaned and tested. All equipment was in working order. The radar and staff gage values matched.

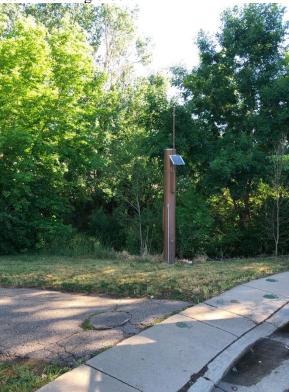
Figure 3-2: Weir Gulch Station

The station at Weir Gulch was activated on March 18th. All equipment was checked, cleaned, and tested. All equipment was in working order. The intake was full of sediment causing no water to get into the riser. The intake was flushed of all sediment.

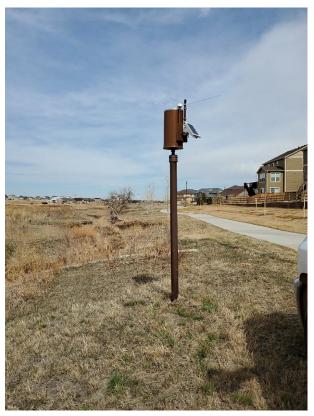
Figure 3-3: Brantner Gulch near Syracuse St

On October 23rd, winter shut-down activities were performed. The PT was pulled up into its winter position and the battery was brought back to be charged. The top section was also brought back for repairs to the base and was reinstalled.

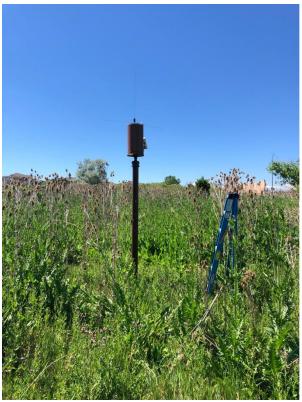
Figure 3-4: Big Dry Creek at Thorncreek Golf Course

On October 23rd, winter shut-down activities were performed. The PT was pulled up into its winter position, tipping bucket was covered, and the battery was brought back to be charged over winter.

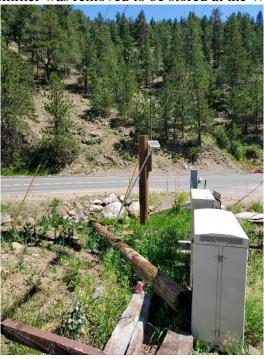
Figure 3-5: Coal Creek at Twin Spruce

The station Coal Creek at Twin Spruce was activated on March 18th. All equipment was checked, cleaned and tested. The SDI-12 PT was not reading correctly so a 6-point calibration was executed, and a -0.63 offset was programmed which keeps growing. All equipment was in working order.

A mid-season inspection was conducted on June 30th. The PT was recalibrated to an offset of -0.21. All other equipment was in working order.

WET recommends making periodic manual streamflow measurements at these locations in 2021 to supplement the theoretical ratings. WET also recommends the purchase of a spare CS451 SDI-12 pressure transducer in case the PT at Twin Spruce fails.

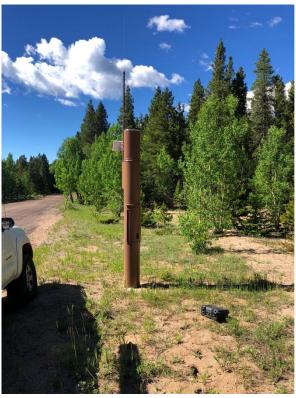
Figure 3-6: Upper Coal Creek at Camp Eden Road

On October 23rd, winter shut-down activities were performed. The transmitter was removed to be stored at the WET office.
