MHFD ALERT Gauging System Maintenance 2020 Annual Report

Kevin Stewart
Mile High Flood District
Denver, Colorado

Prepared By
OneRain Incorporated
1531 Skyway Drive, Unit D
Longmont, Colorado 80504

Report Date: December 16, 2020

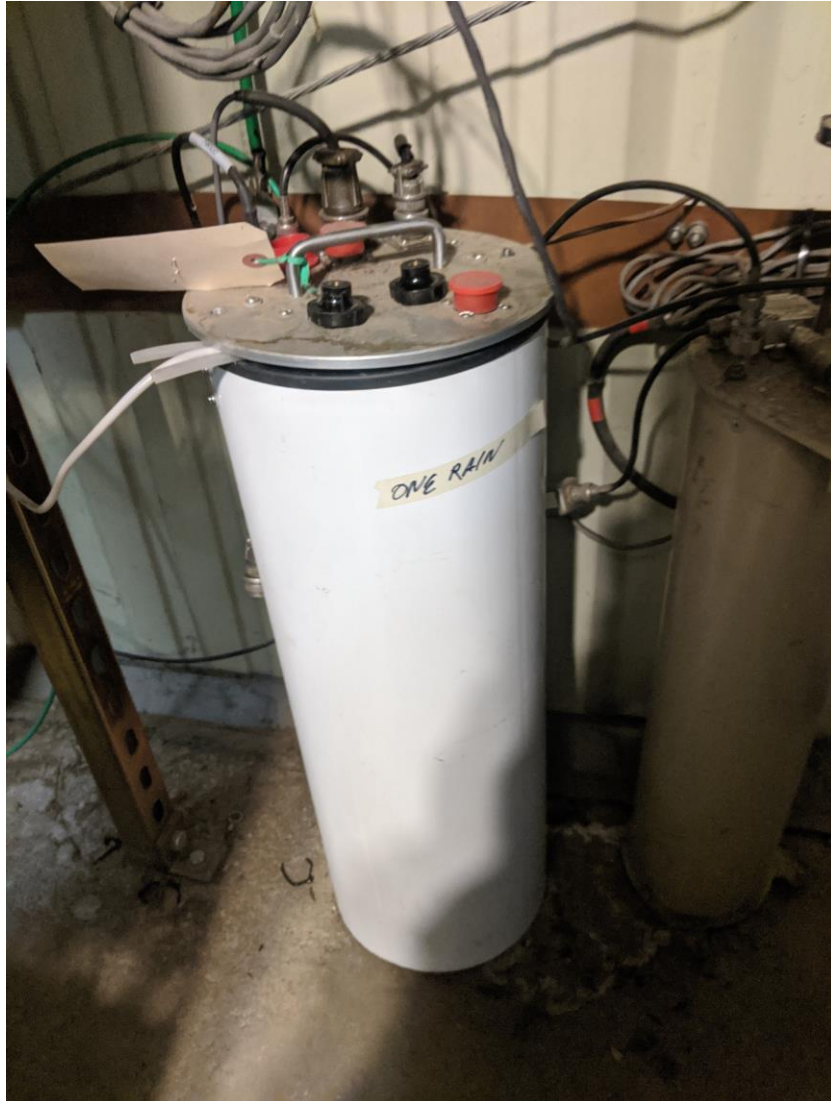
Figure 1: Lee Hill ALERT Repeater

In early March, several ALERT sites stopped reporting and were down for over 2 weeks. A visit to Lee Hill repeater was made after conducting analysis and site visits to the non-reporting gauges. The ALERT repeater was found to be locked up. It was power cycled and its batteries were replaced. Lee Hill repeater has been working as expected ever since. This is a good candidate for a hardware upgrade in the future.

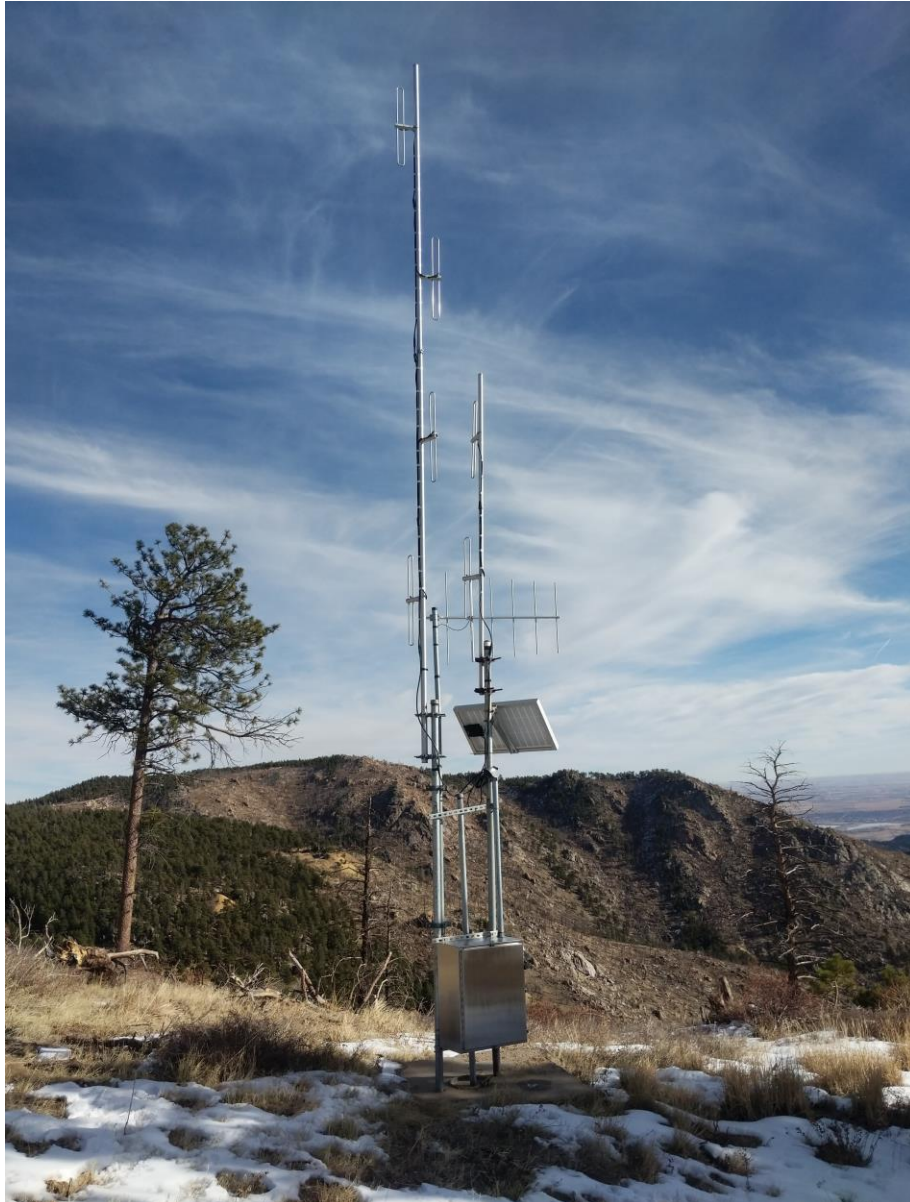
Figure 2: Gold Hill Repeater with antenna resecured

OneRain visited this site in late November as part of end-of-season maintenance. The receive antenna mount was loose and angled off vertical. It was reoriented to the correct position and resecured.

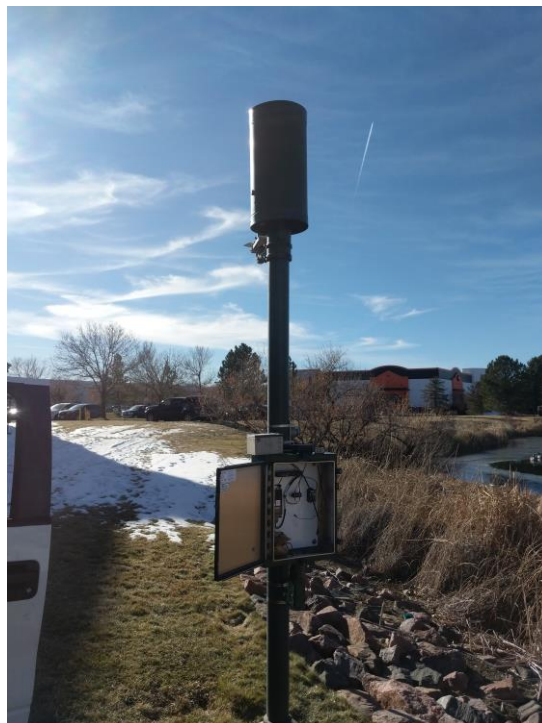
Figure 3: New enclosure at Flying J.

At the beginning of September during a site visit to replace a low battery, the enclosure was found to be heavily corroded and waterlogged. It had been getting worse over time, especially in the last year. On December 8th, the enclosure was replaced. Now the sensor and antenna wires enter through the bottom of the enclosure which should help keep water out.

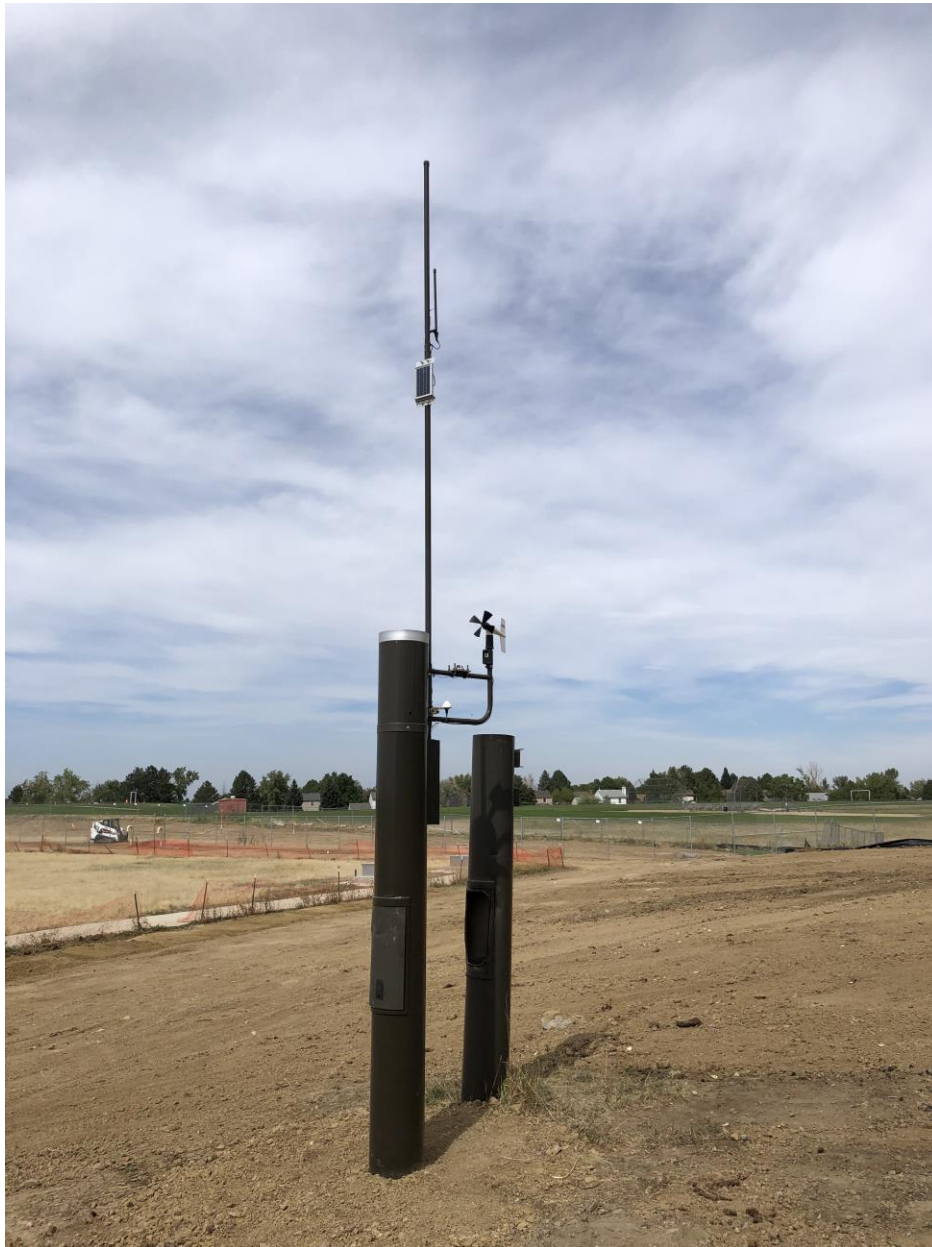
Figure 4: New standpipe for Quincy Reservoir.

The standpipe was damaged by construction activities in early May. The construction company paid for a new standpipe and installed it in the ground. On September 24th OneRain transferred the electronics and sensors from the original standpipe to the new one. All sensors are reporting as expected except for the air temperature and relative humidity sensor which has occasionally been reporting erroneous data.

This sensor has been reporting erratically since it was relocated to the new standpipe in September. The MHFD does not have a spare sensor with the proper MS connector. The cost of a replacement 5722-01 Temp / RH sensor is **\$793**.

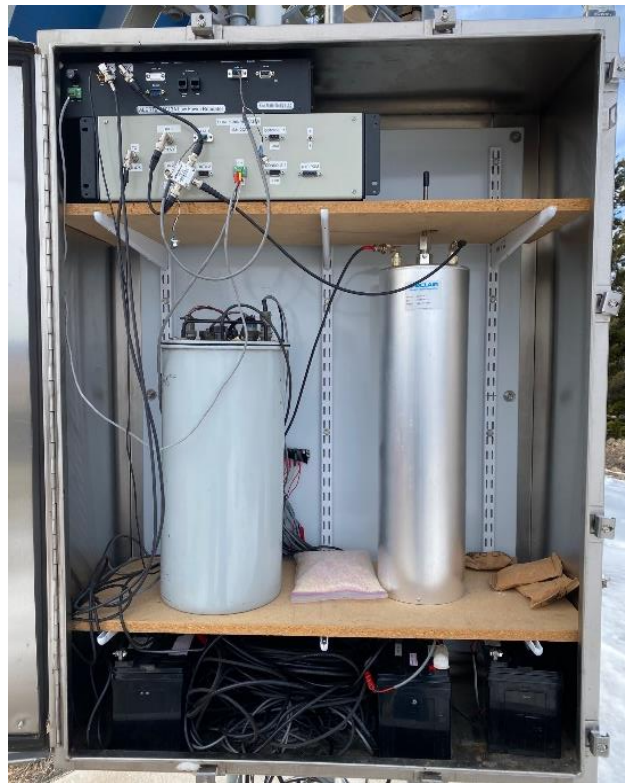
Figure 5: Legacy Cabinet Configuration

The repeater at Blue Mountain was updated on January 22nd, 2020. OneRain removed legacy equipment from the site including an R2013A ALERT2 repeater, a 50386 ALERT repeater, and the CR1000 controlling the Blue Mountain weather station. The removed R2013A ALERT2 repeater will be used to replace the repeater at Gold Hill sometime in the future. The CR1000 was returned to the MHFD spare inventory.

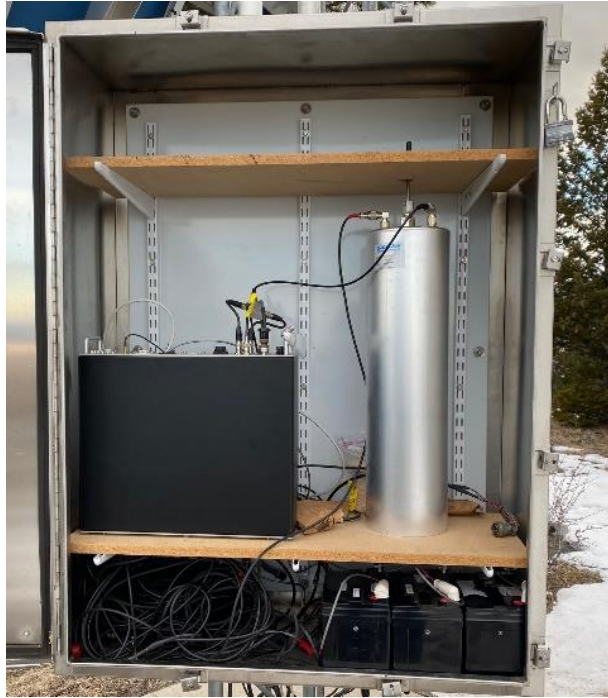
Figure 6: New Cabinet Configuration

A High Sierra Electronics Model 3336 Series A2X was installed to replace the ALERT and ALERT2 repeaters. This model repeats received messages in two ways. Received ALERT messages are decoded and repeated as concentrated ALERT2 messages. ALERT2 messages are repeated in the same form in which they were received. This new piece of hardware has a smaller form factor and is more serviceable than the previous configuration. Battery voltage and GPS status are reported hourly to ensure batteries remain healthy and GPS time is accurate.

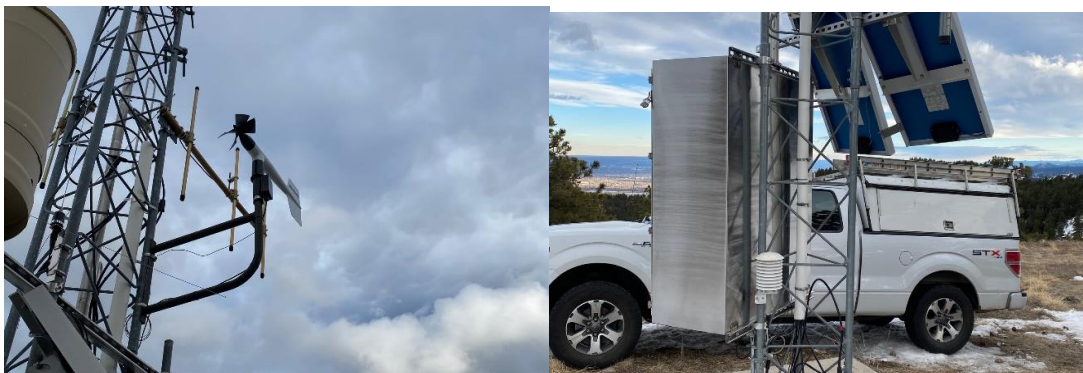
Figure 7: New RM Young wind sensor (left) and HMP 45A RHAT (right).

The weather station at Blue Mountain is now being controlled by the 3512 board within the 3336. The Handar 435 RHAT and the Vaisala ultrasonic wind sensor were removed from the site and returned to MHFD inventory due to interoperability issues with the 3512 board. A new HMP45A RHAT and RM Young wind sensor were installed at the site. Precipitation is still being measured by the HSE 2400-03 tipping bucket. The fuel moisture sensor was not integrated into the new weather station due to deterioration.

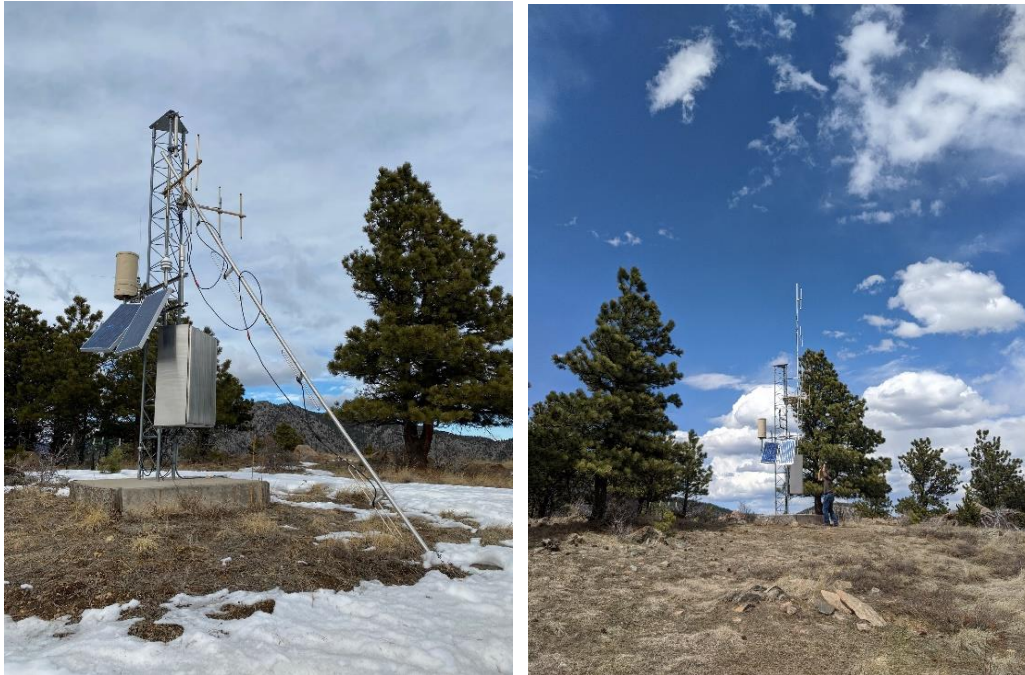
As a separate matter, upon arrival, the receive antenna was found separated from the tower. The bottom 3 ft. of the antenna broke from the mounts due to fatigue. The broken antenna was temporarily secured to the side of the tower with 2 worm drive hose clamps. On April 10th a replacement antenna was installed.

Figure 8: Separated antenna (left). Newly installed antenna (right).

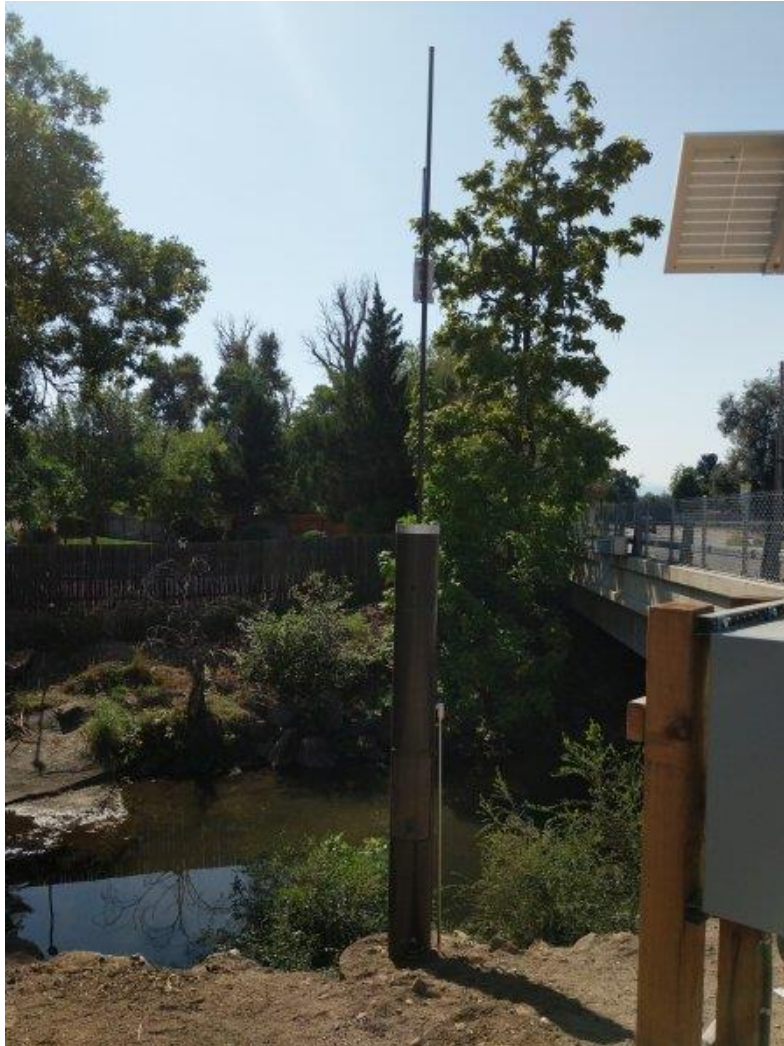
Figure 11: New ALERT2 site at Bear Creek at Lowell.

The original site was collocated with the Colorado Division of Water and USGS until it was destroyed by a car accident in May. This site was reinstalled as an ALERT2 site on September 30th with the standard standpipe configuration provided by High Sierra Electronics. Its new ALERT2 source address is 10089. This site measures both rain and stage.

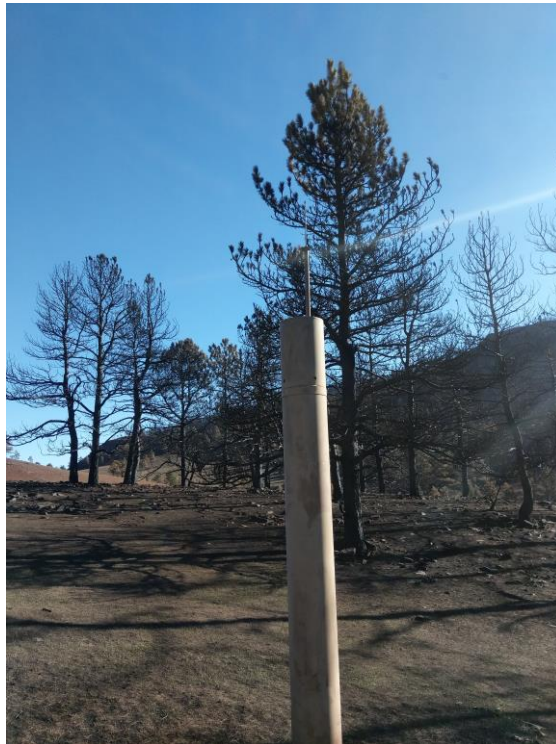
While remaining relatively unscathed this site's antenna cable was melted from the Calwood Fire in October. While the site was still transmitting, its radio had a high forward-reverse power ratio, indicating damage to the antenna assembly. The ALERT transmitter was removed and will be reinstalled after a replacement antenna assembly is purchased.

Figure 13: Geer Canyon ALERT gauge surrounded by wildfire damage.
