ALERT Gaging System Maintenance Agreement 05-01.23

**Annual Report
January 2, 2006**

**Presented To
Kevin Stewart
Urban Drainage and Flood Control District
Denver, Colorado**

ALERT System Maintenance 2005 Annual Report

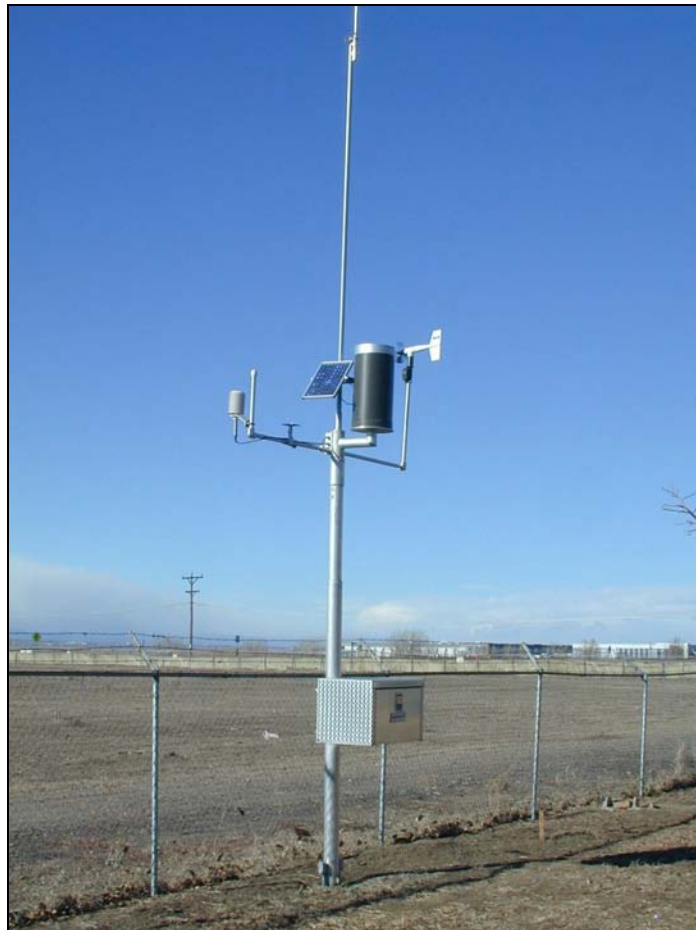
One additional site was added to the network in 2005. The Stapleton site is a reincarnation of the original Urban Farm weather station. This site includes nearly all of the same equipment and sensors, and maintains the original base ID of 1460. There were a few changes from the original to the new installation. The telemetry system is now controlled by a Blue Water Design CommEngine which replaces the much older ALERT serial interface (ASI) board. This site now includes the following sensors (and sensor IDs):

Figure 1, Stapleton Weather Station

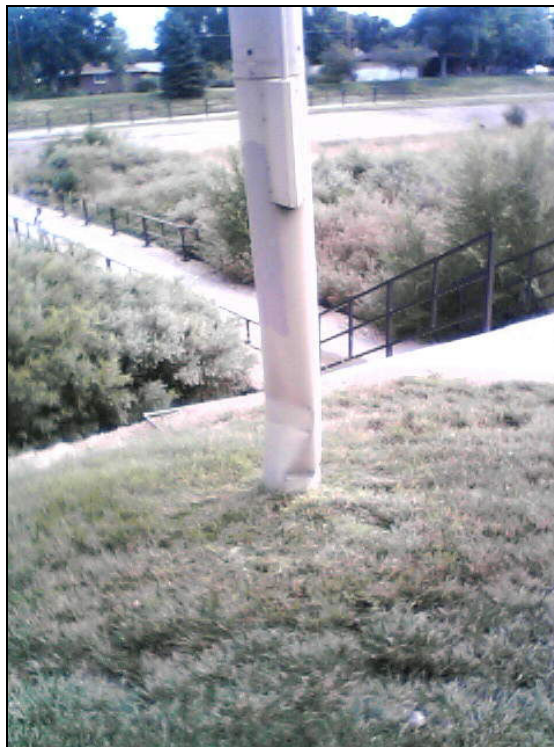
The Sand Creek Park (1800) standpipe was hit by a car (see Figure 2). According to the gentlemen who lives across the street, the perpetrator was a young man who thought that he should be somewhere other than in police custody. OneRain replaced the standpipe and re-ran the PT conduit to a more secure location.

Figure 2, Sand Creek Park, damaged standpipe

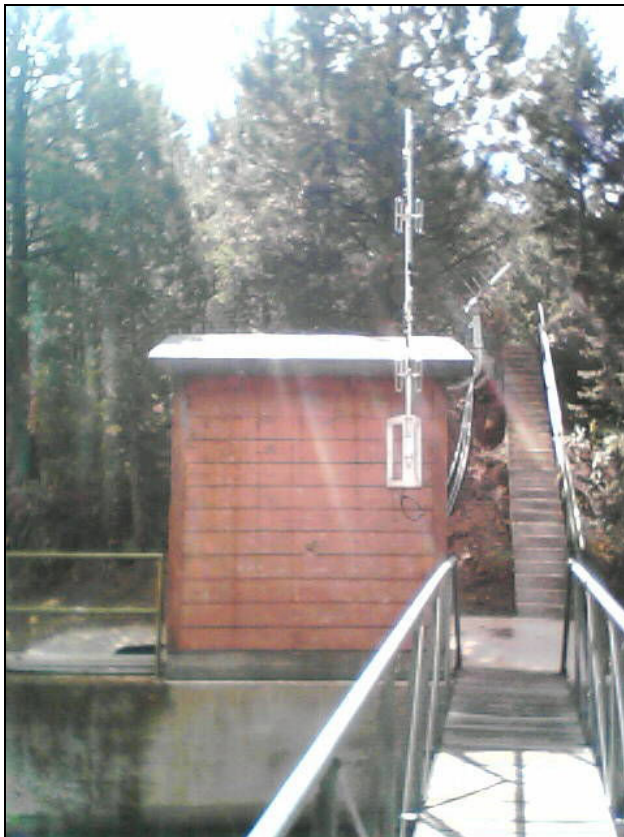
OneRain removed the equipment from the site at South Boulder Creek below Gross Reservoir (4370) prior to building replacement. The original equipment has been reinstalled in the new structure and OneRain constructed a new antenna mount to accommodate the concrete roof eave. Please see Figures 3 and 4, below.

**Figure 3, South Boulder Creek at Gross,
new building exterior with antenna mount**

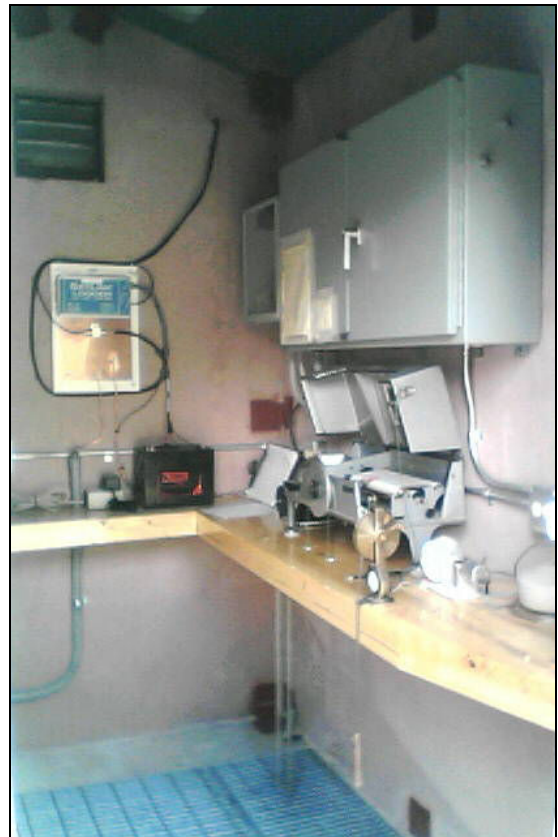
**Figure 4, South Boulder Creek at Gross,
inside new structure**

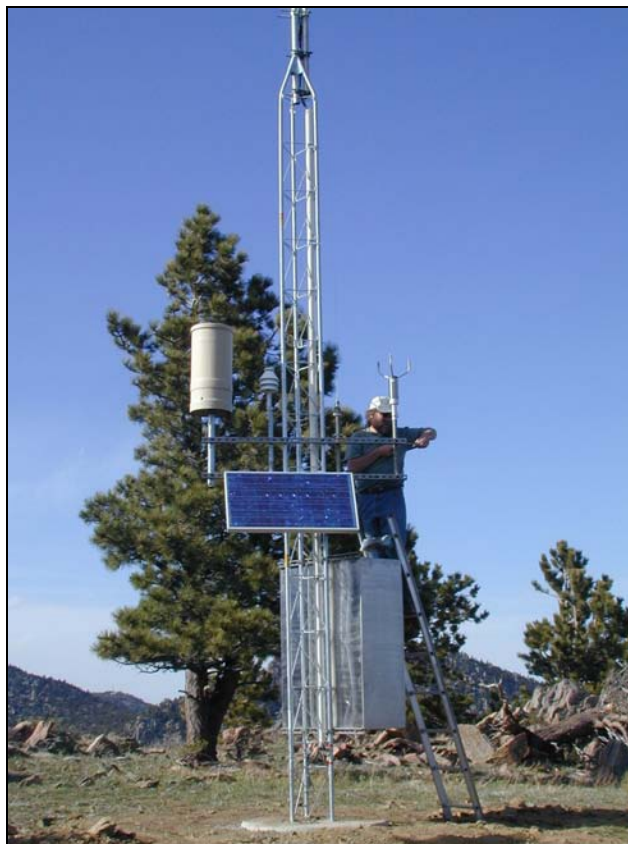
OneRain re-built the Blue Mountain weather station (140) and the West Repeater (950) in May. The original standpipe had been modified to accommodate a taller mast for the DB-224, but the unintended consequence was the introduction of fatigue from cyclic loading. Ultimately, the standpipe was compromised by fatigue failure. The equipment was remounted in a large NEMA enclosure on a section of Rohn-25 tower.

OneRain selected a larger enclosure to allow the transmitter “cans” to rest side by side (rather than one on top of the other) and to permit ease of maintenance in what can often be a harsh environment. Please see Figure 5, below.

Figure 5, Blue Mountain/West repeater remount

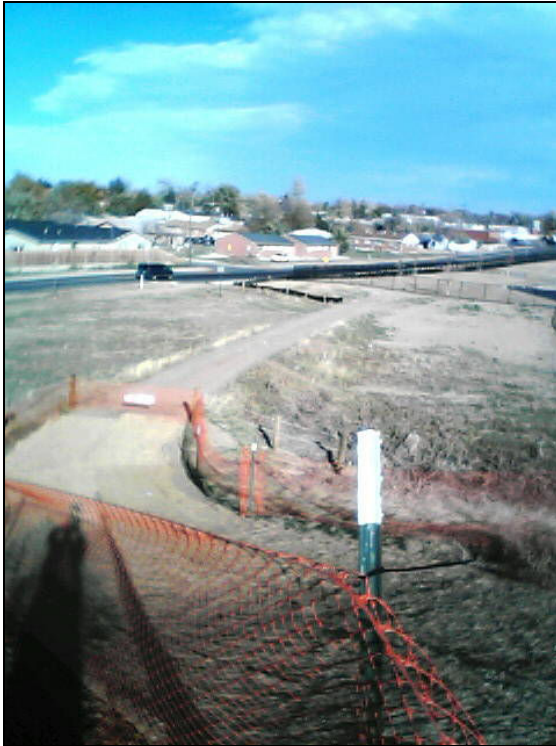
At Kelly Dam (410) it appears the access road is being reclaimed, both up onto the dam crest standpipe location and over to the bottom of the detention area PT location. This will make maintenance visits in the future more difficult. Please see Figures 6 and 7, below.

Figure 6, Kelly Dam access road reclamation

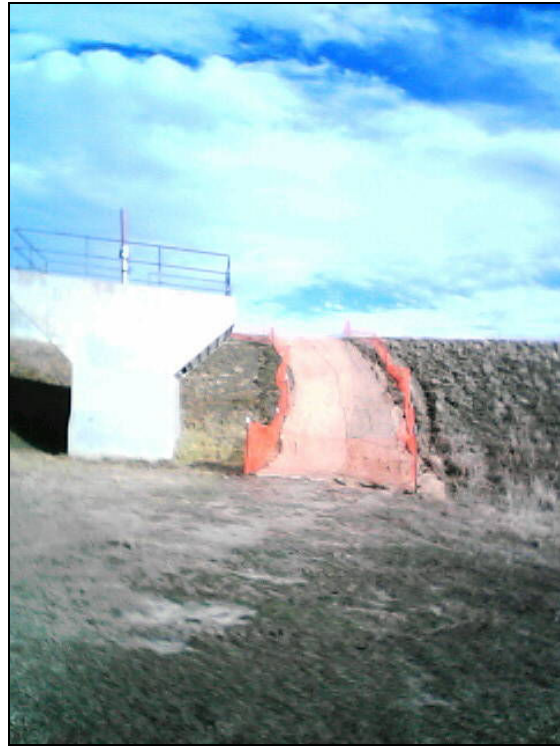
Figure 7, Kelly Dam PT access reclamation
