Re: ALERT Gaging System Maintenance Program - FINAL End of Year Report

UDFCD ALERT Gaging System Maintenance

**Annual Report
December 15, 2009**

**Presented To
Kevin Stewart
Urban Drainage and Flood Control District
Denver, Colorado**

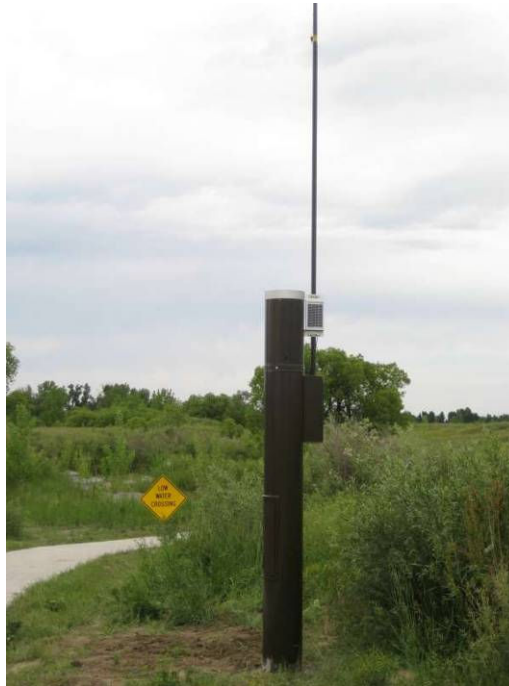
Figure 1: Stroh Road

- ◆ Stroh Road. This site is identified as site # 2860, and consists of both rain and stage sensors. The site is located at Latitude 39.479, Longitude -104.769, Elevation 5903 feet. This site reports via the Smoky Hill Repeater. A site picture follows:

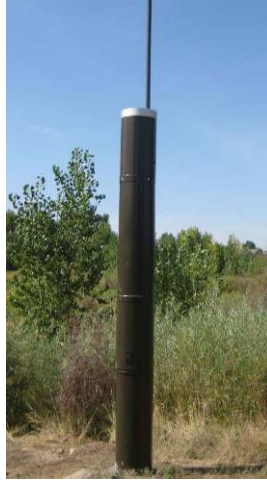
Figure 2: Cottonwood Park

- ◆ Cottonwood Park. This site is identified as site # 2870, and consists of both rain and stage sensors. The site is located at Latitude 39.5578, Longitude -104.786, Elevation 5728 feet. This site reports via the Smoky Hill Repeater. A site picture follows:

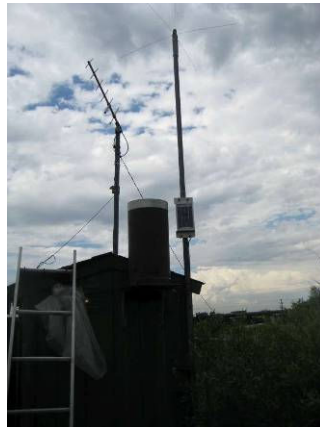
Figure 3: Sand Creek Mouth

- ◆ Sand Creek Mouth. This site is identified as site # 1810, and consists of both rain and stage sensors. The site is located at Latitude 39.806, Longitude -104.941, Elevation 5150 feet. This site reports via the Blue Mountain Repeater.

The USGS abandoned this site. A PT was installed in lieu of maintaining the existing stilling well. The serial transmitter at this site was replaced by a HSE 3206 transmitter to accommodate the new PT and existing tipping bucket. A site picture follows:

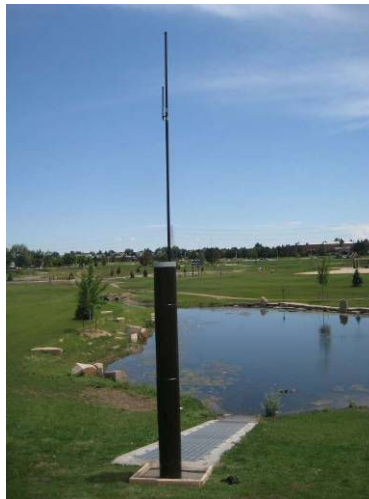
Figure 4: Utah Park

- ◆ Utah Park. This site is identified as site # 430, and consists of both rain and stage sensors. The site is located at Latitude 39.685, Longitude -104.844, Elevation 5536 feet. This site reports via the Smokey Hill Repeater.

This site was a re-installation with a new standpipe and PT due to a complete re-structuring of the park lake and outflow structure. A site picture follows:

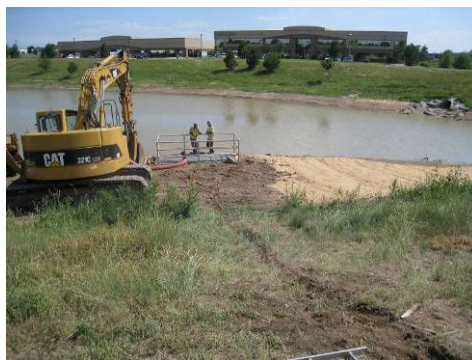
Figure 5: Grandby Ditch

- ◆ Grandby Ditch. This site is identified as site # 810, and consists of both rain and stage sensors. The site is located at Latitude 39.725, Longitude -104.797, Elevation 5455 feet. This site reports via the Smokey Hill Repeater.

This site was a re-installation of the PT due to a complete re-structuring of the outflow structure. A site picture follows:

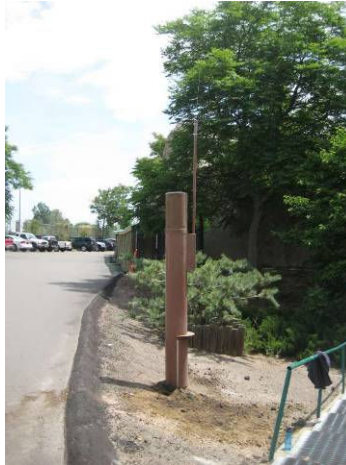
Figure 6: Denver Zoo

- Denver Zoo. This site is identified as site # 1360, and consists of a rain sensor. The site is located at Latitude 39.751, Longitude -104.954, Elevation 5266 feet. This site reports via the Blue Mountain Repeater.

This site was a re-installation of the standpipe due to scheduled zoo construction. A site picture follows:

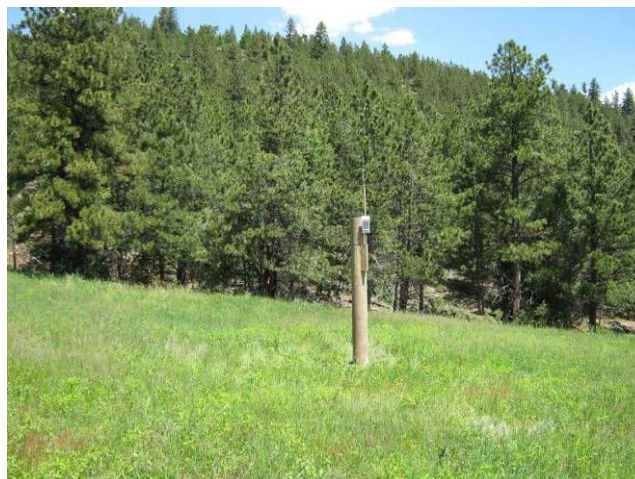
Figure 7: Hansen

- Hansen. This site is identified as site # 4330, and consists of a rain sensor. The site is located at Latitude 40.1686, Longitude -105.329, Elevation 7325 feet. This site reports via the Lee Hill Repeater.

This site was formerly Indian Ruins and was relocated due to loss of lease on private property. A site picture follows:

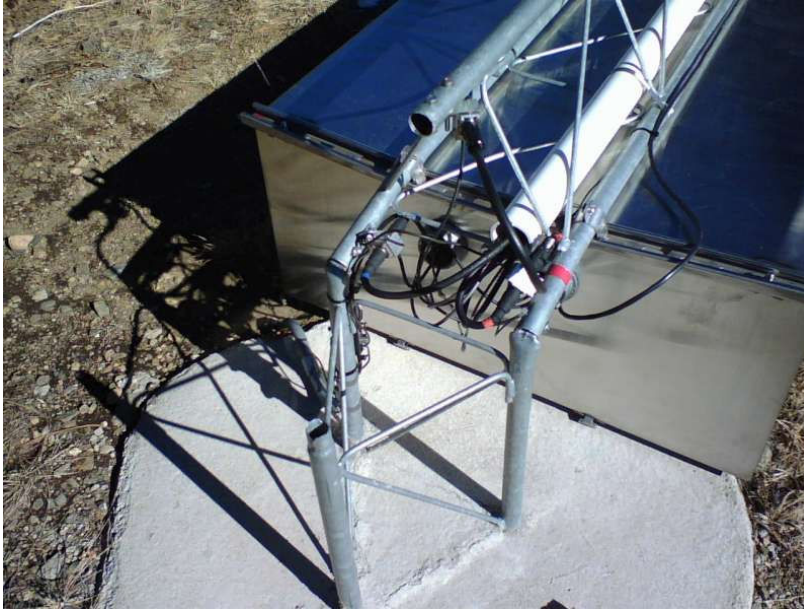
In January of this year, the Rohn 25G tower at Blue Mountain was damaged due to high winds which separated the tower from its base. On February 12th, the equipment was removed from the downed tower for testing and evaluation.

Figure 8: Damaged tower

After your approval to install a much heavier duty replacement Rohn 55G tower, the tower was ordered and the infrastructure work scheduled with contractors. Unfortunately, the tower arrived damaged and was unusable. On April 3rd, the repeater was temporarily placed at the site in a pick-up truck to support the flood warning system operation while the replacement tower was on order, and the contractors were rescheduled.

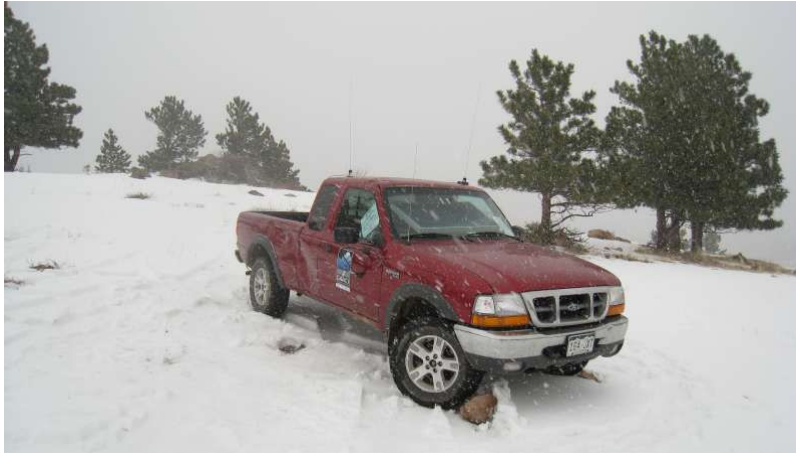
Figure 9: Temporary Repeater Installation

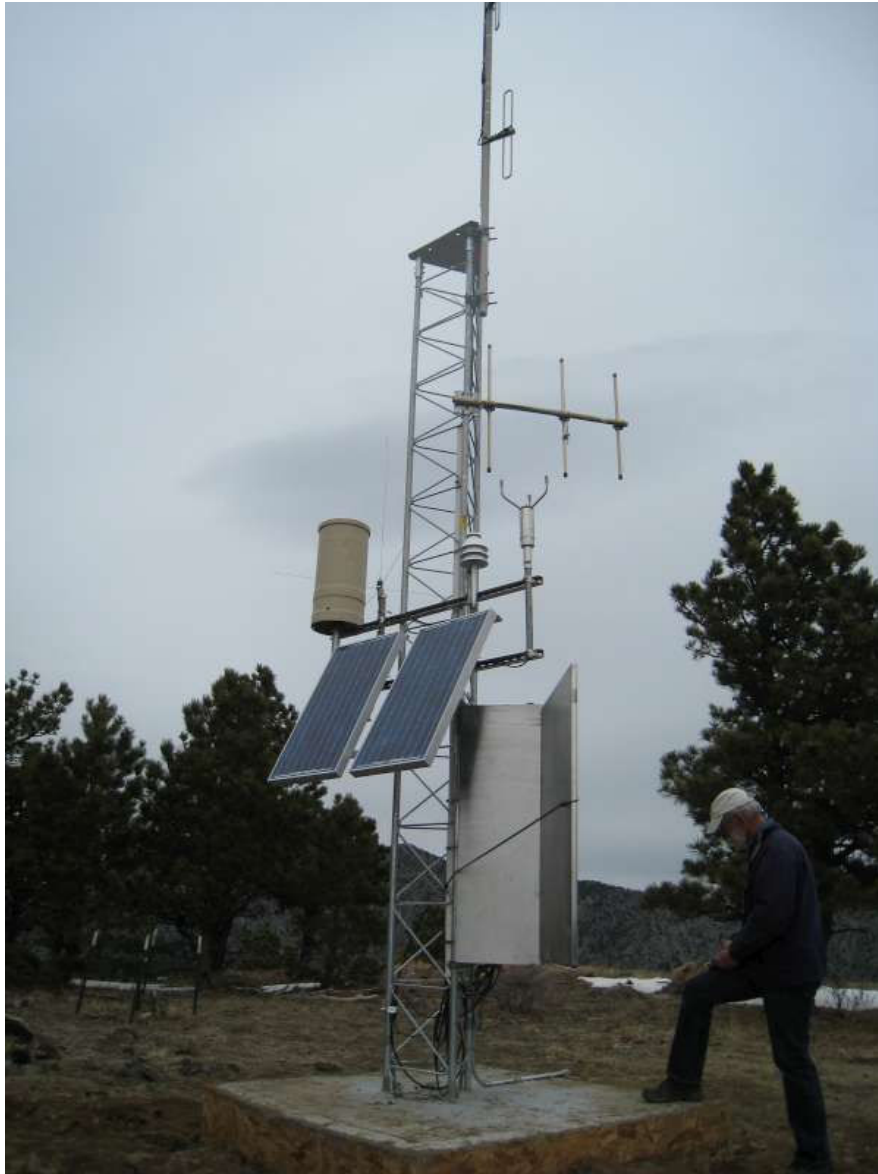
The tower infrastructure was re-installed on April 8th. By April 14th, the repeater and weather station electronics and sensors had been re-installed and were functional. The Rohn 55G tower will provide a stronger, more permanent installation.

Restoration of the area was arranged to repair the deep ruts caused by the cement truck in the soft ground.

Figure 10: Current Blue Mountain Installation
