# UDFCD ALERT Gauging System Maintenance 2013 Annual Report

Kevin Stewart  
Urban Drainage and Flood Control District  
Denver, Colorado

**Prepared By**  
OneRain Incorporated  
1531 Skyway Drive, Unit D  
Longmont, Colorado 80504

Report Date: December 20, 2013

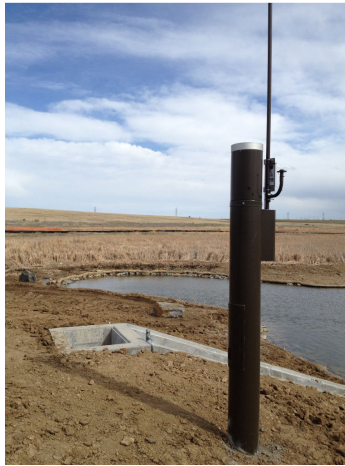
**Figure 1: ETG @ Hampden**

A new site was installed along a newly constructed detention pond located on Hampden Avenue, Latitude 39.6527270°, Longitude -104.7274610. Installation was complete on 5/03/2013. ETG @ Hampden utilizes ALERT2 technology and is powered with a High Sierra 3306 ALERT2 transmitter. It is currently configured for rain and stage.

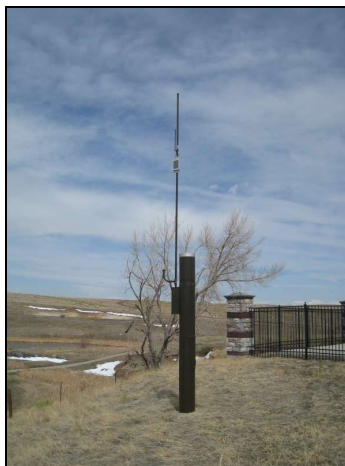
**Figure 2: Blackstone**

A new site was installed along the newly constructed Blackstone golf course, Latitude 39.5783830°, Longitude -104.6614240. Installation was complete on 3/29/2013. Blackstone utilizes ALERT2 technology and is powered with a Campbell Scientific ALERT2 transmitter. It is currently configured for rain only.

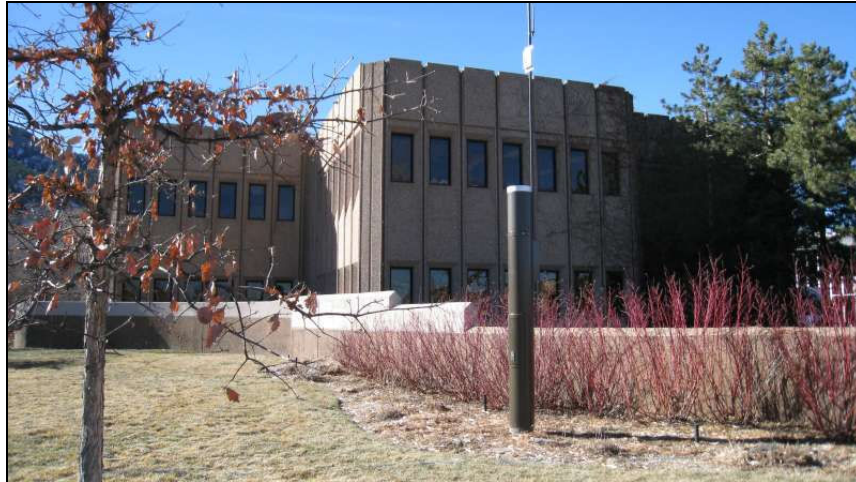
**Figure 3: Justice Center**

Justice Center was re-located from the roof of the Justice Center on 1/22/2013. The new infrastructure is located at Latitude 40.01400°, Longitude -105.28800°. It is currently configured for rain only.

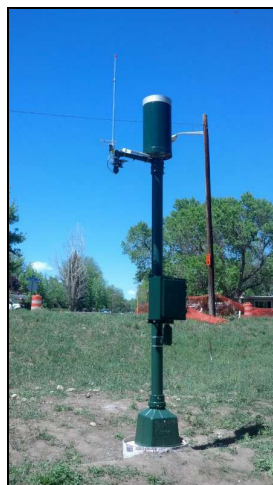
**Figure 4: Carr St.**

Carr Street was re-located after park construction on 5/30/2013. The new infrastructure is located at Latitude 39.80500°, Longitude -105.09100°. Carr Street utilizes ALERT2 technology and is powered with a Campbell Scientific ALERT2 transmitter. It is currently configured for rain and stage.

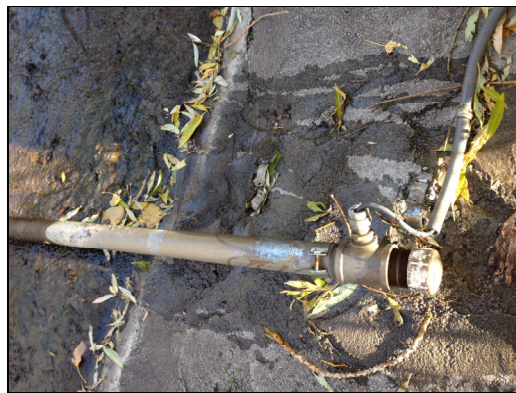
**Figure 5: Nolte Pond**

The Flex conduit has separated from the PT riser. Furthermore, the flex conduit is now exposed from the riser to the standpipe. To properly fix this site it is recommended that galvanized rigid conduit be installed replacing all flex lines.

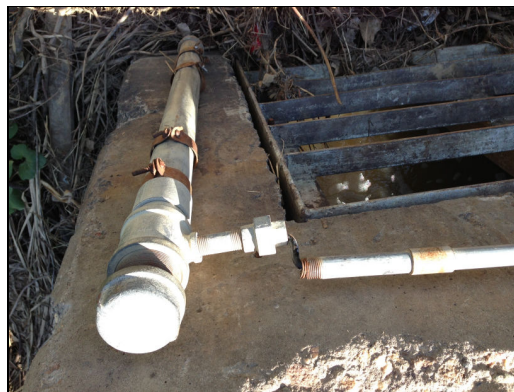
**Figure 6: Niver Detention**

The concrete anchors holding the riser and conduit to the detention outlet structure are damaged and have begun to show signs of age. New riser anchors and conduit will be installed in the spring to replace the damaged infrastructure.

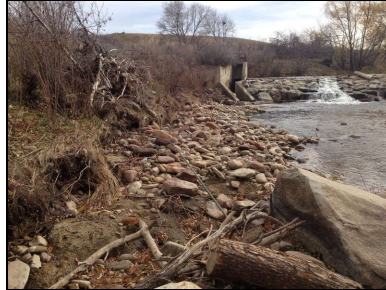
**Figure 9: Cannon Ditch**

The pressure transducer infrastructure was completely destroyed at Cannon Ditch. The stream channel has re-located and transported large boulders, making re-installation unfeasible. The transmitter was altered for rain only. It is recommended that this site be re-located.

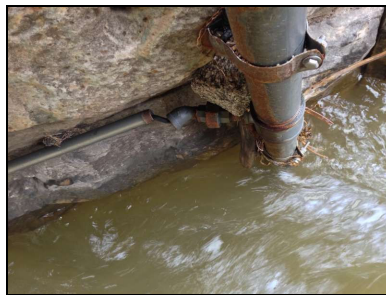
**Figure 10: Bridge**

During the high waters the conduit fitting attached to the riser was damaged. This fitting will be replaced in spring.
