PHASE I INSPECTION REPORT  
NATIONAL DAM SAFETY PROGRAM

MAPLE GROVE RESERVOIR DAM  
JEFFERSON COUNTY, COLORADO  
DIVISION I  
DISTRICT 7

OWNER: CONSOLIDATED MUTUAL WATER COMPANY

INSPECTED: AUGUST 6, 1979

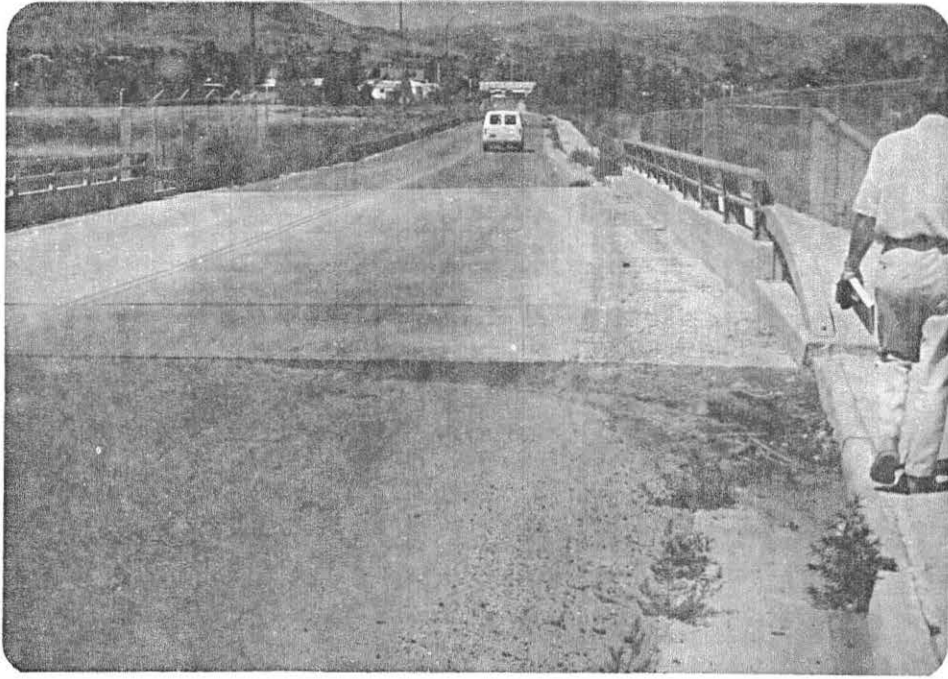
1. Crest. The crest is topped by a two-lane asphalt thoroughfare. Some breaking up of the asphalt was noted along the north side and a noticeable depression was noted at the abutment of the bridge over the spillway, as shown in Photos 1 and 2 of Appendix B.

The settlement in the pavement at the bridge abutment is not too excessive, but if allowed to continue, further deterioration of the pavement surface will occur.

Photo No. 1 Crest of Maple Grove Dam, looking west.  
Note erosion and depression at right bridge abutment.

- a. The City of Lakewood, which has the maintenance responsibilities for W. 27th Avenue, should be notified in writing that the pavement surface is deteriorating and its resurfacing should be given a high priority on their schedule.

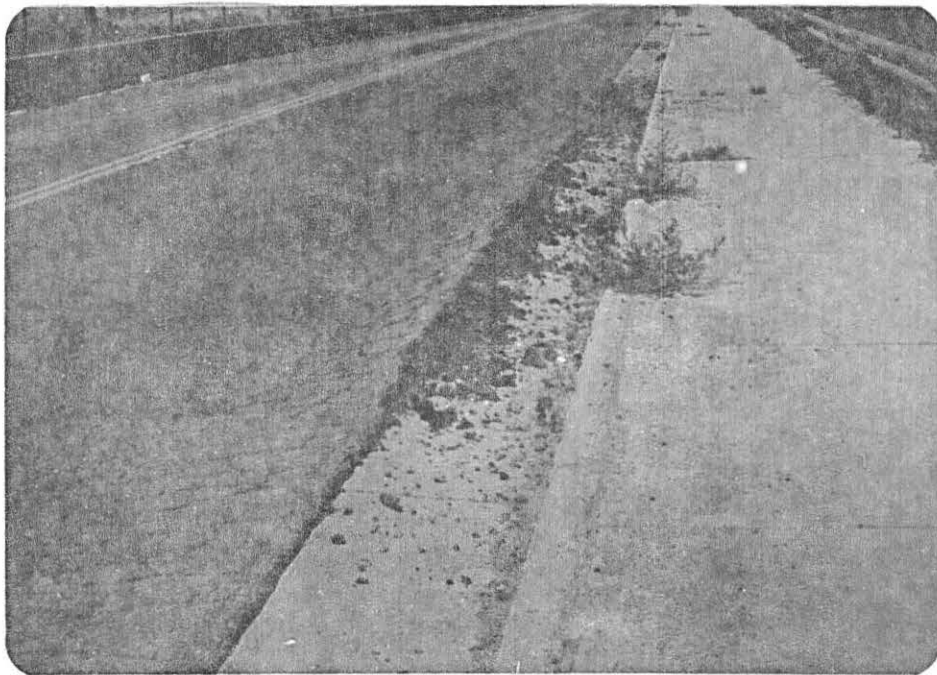
Photo No. 2 Pavement deterioration on north side of crest.

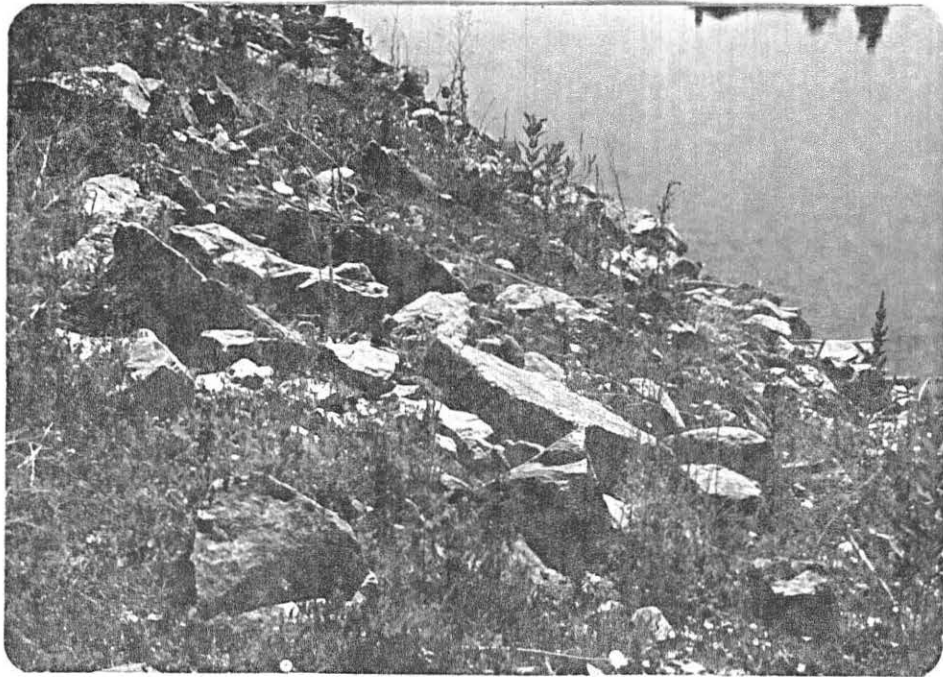
2. Upstream Slope. Considerable settlement of the riprap was noted, with large pockets of unprotected slope evident all along the slope above the high water line, as shown in Photos No. 3. Several significant areas of erosion also were noted close to the crest on this slope, as shown in Photo No. 4.

Photo No. 3 Upstream slope, showing misgraded riprap.  
Typical of entire upstream slope.

- b. A yearly maintenance program of backfilling eroded areas and stabilizing the upstream and downstream slopes should be implemented.
  - c. A stability analysis should be prepared to assure that the steep downstream slope is stable for a maximum pool elevation.

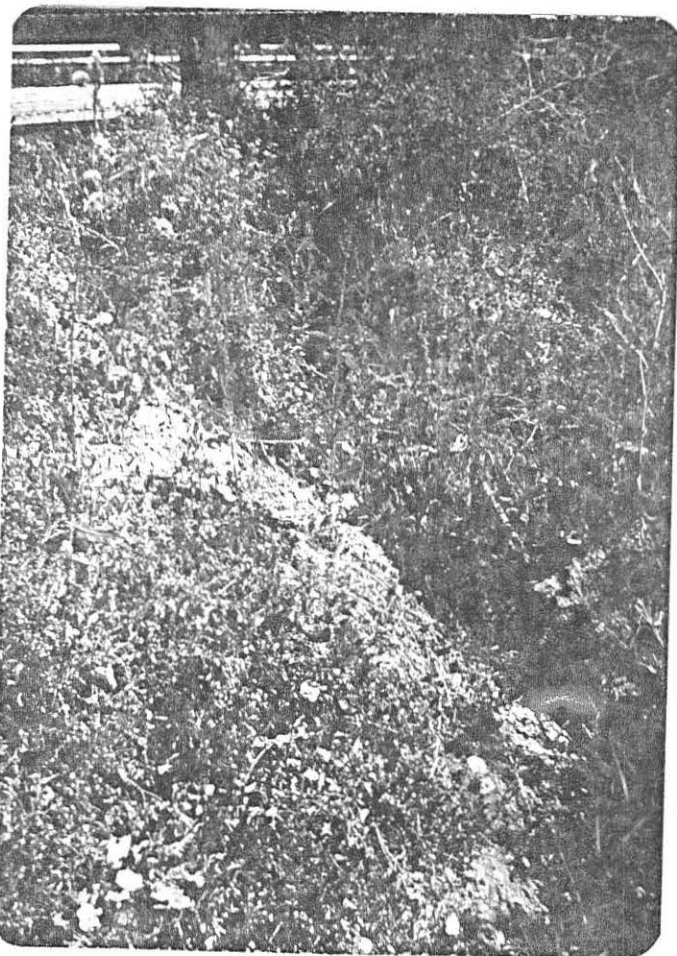
Photo No. 4  
Eroded area on upstream  
slope near crest.

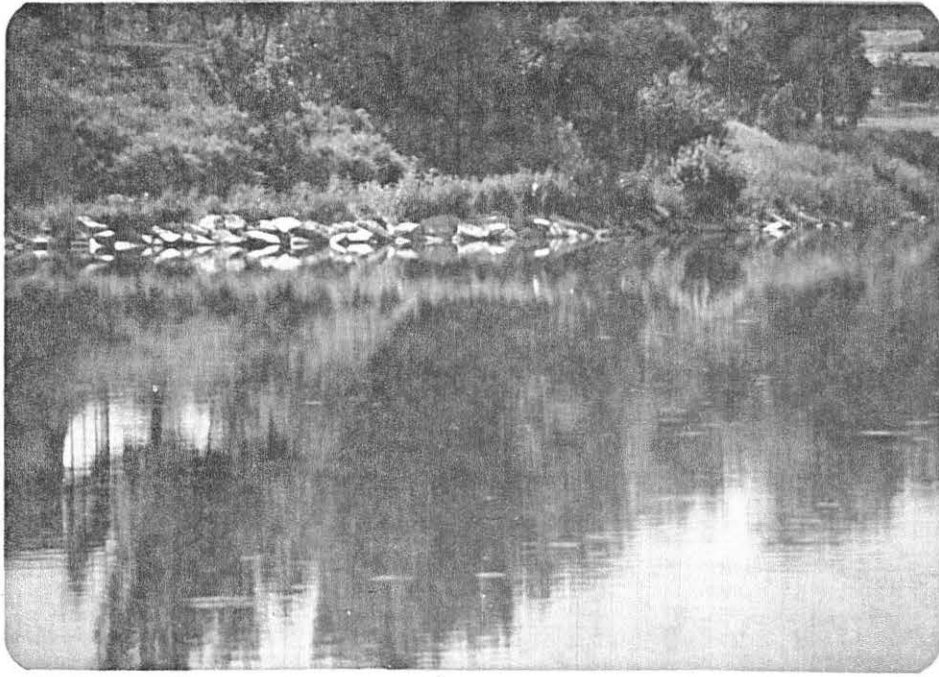
Riprap protection on the east side, however, which sustains the most wave action, appeared to be in good condition, as shown in Photo No. 5.

Photo No. 5 Riprapped eastern shore of reservoir.

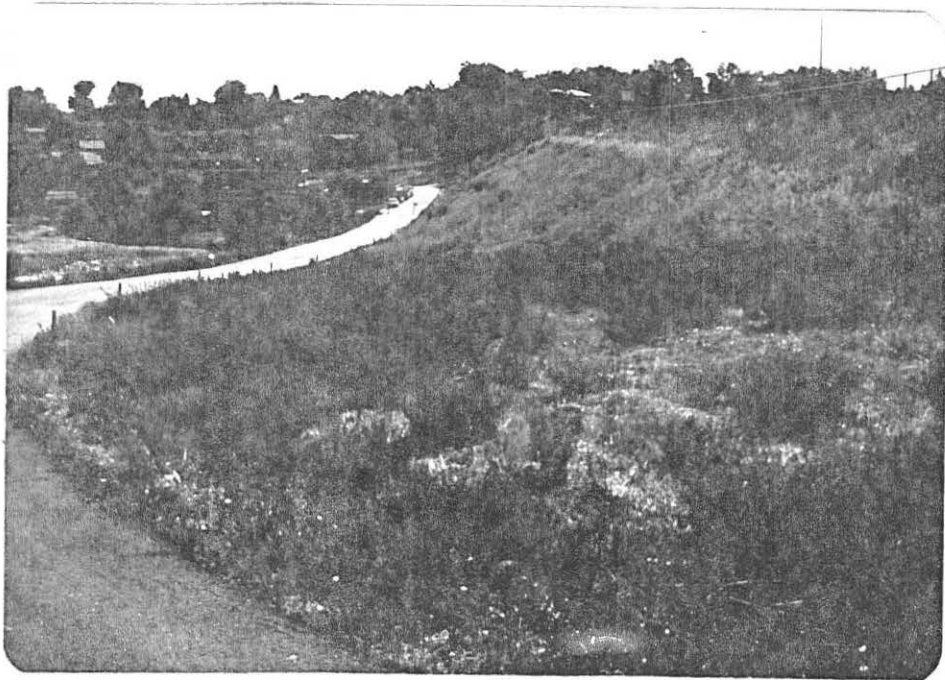
Photo No. 6 Downstream slope of embankment, with service road to filter plant at left.

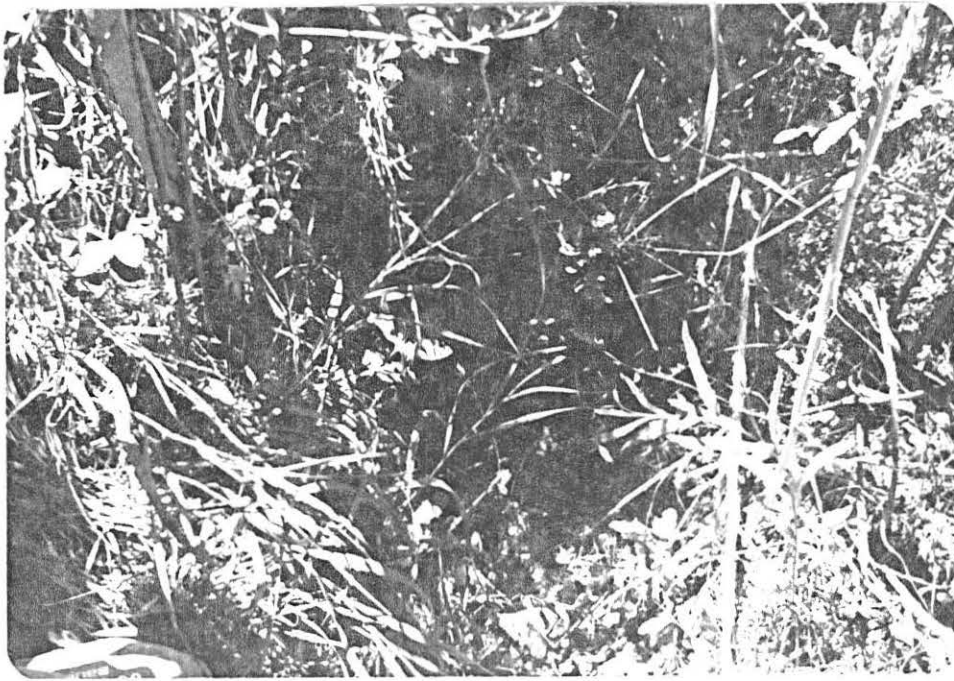
Photo No. 7 Toe drain downstream of left toe, with small amount of water flowing from drain. (Arrow)

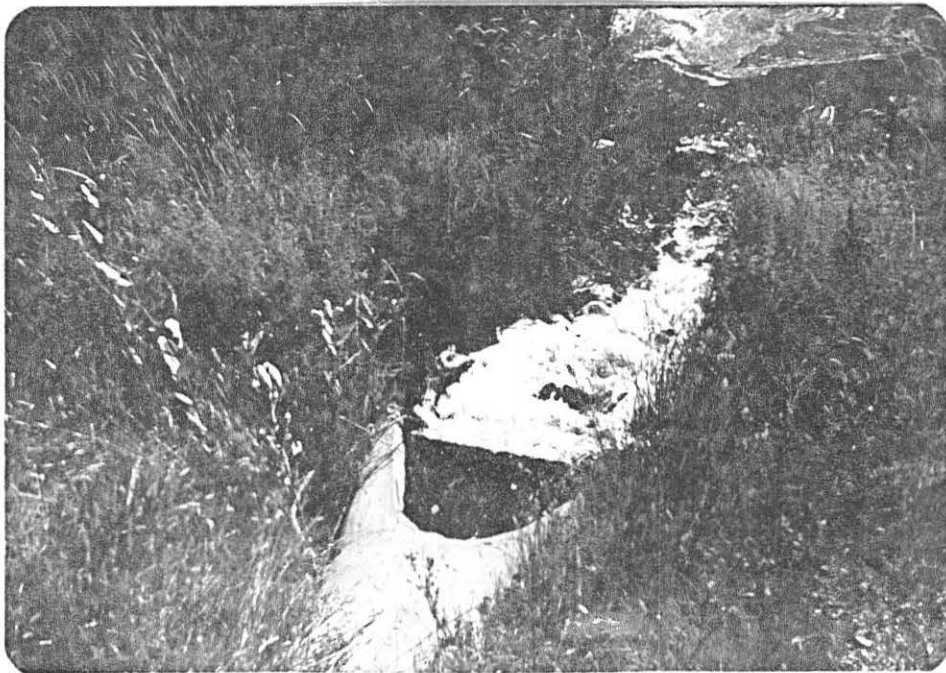
- D. Inlet. On the day of the inspection water from the Lee, Stewart & Eskins Ditch was flowing into the reservoir through the concrete inlet located at the left end of the dam, as shown in Photo No. 8. No erosion was noted in the area of this inlet.

Photo No. 8 Lee, Stewart and Eskins inlet near the west end of the dam.

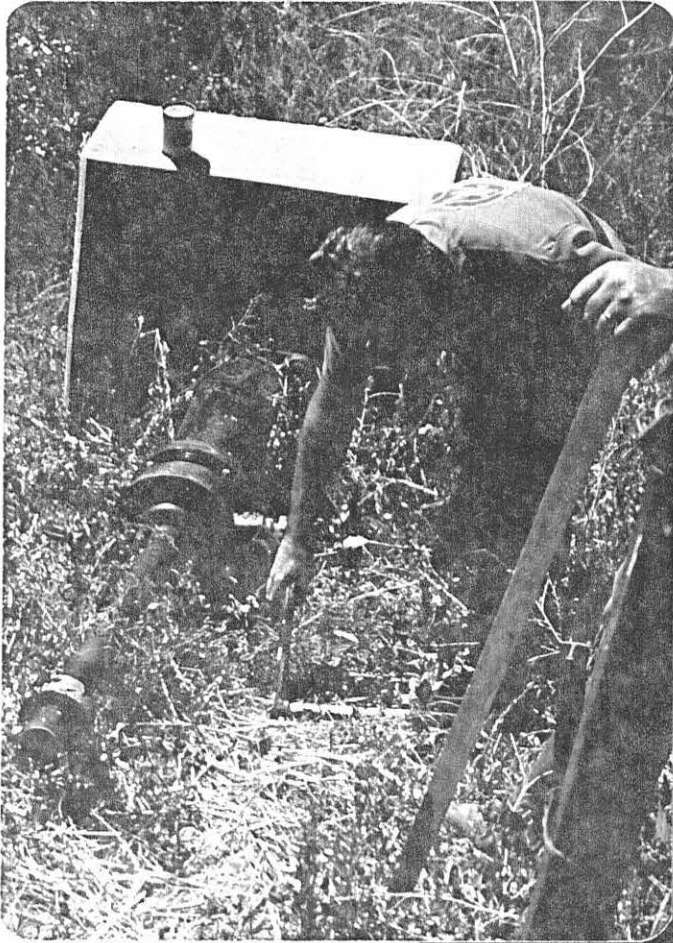
Photo No. 9 Manual operation of the gate screw. Slope of the embankment prevents full turning of the gear with handle.

- d. The upstream gate control on the outlet works should be secured in an open position to prevent unauthorized closure.
  - e. The outlet works conduit and the Rocky Mountain Ditch culvert through the embankment should be periodically inspected to determine if any leakage is present. Soil resistivity in these areas should be checked to estimate the life expectancy of the pipe material.

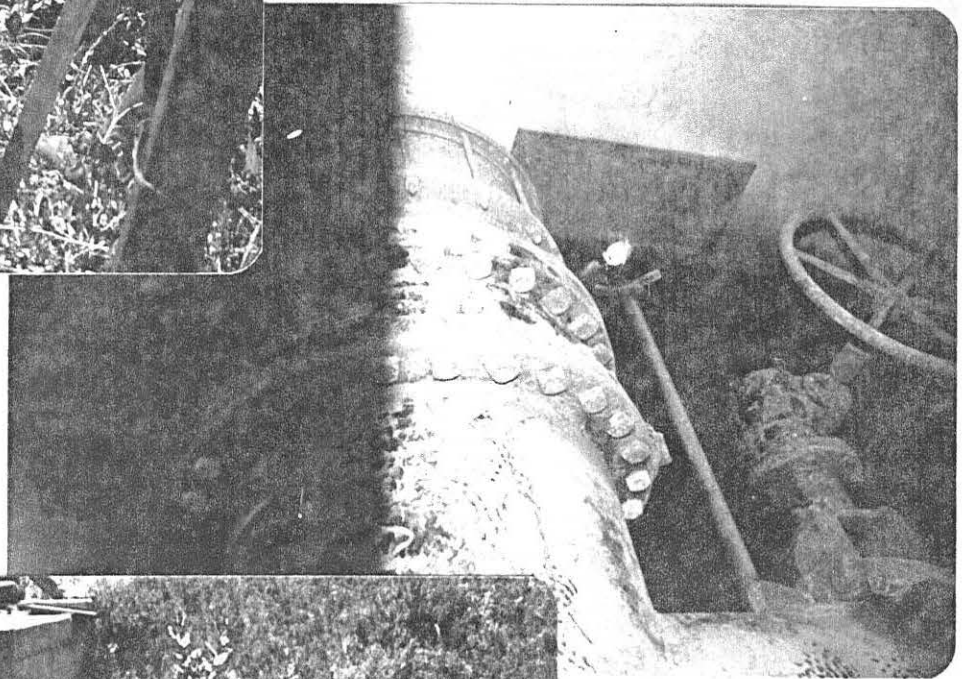
Photo No. 10 Interior of gate house for releases into filter plant and small irrigation ditch.

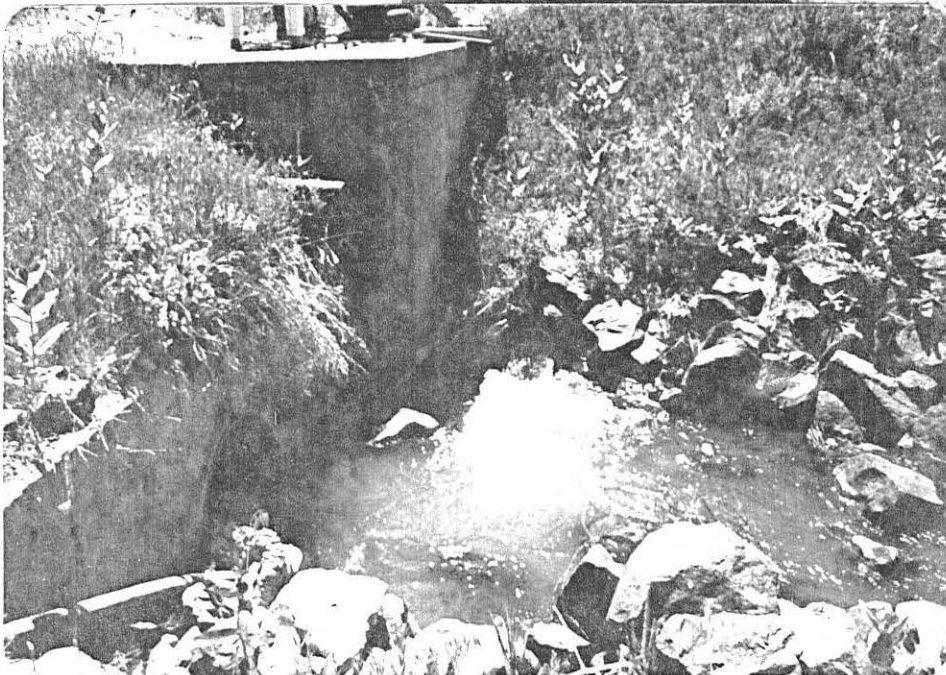
Photo No. 11 Irrigation ditch outlet and stilling basin adjacent to gate house.

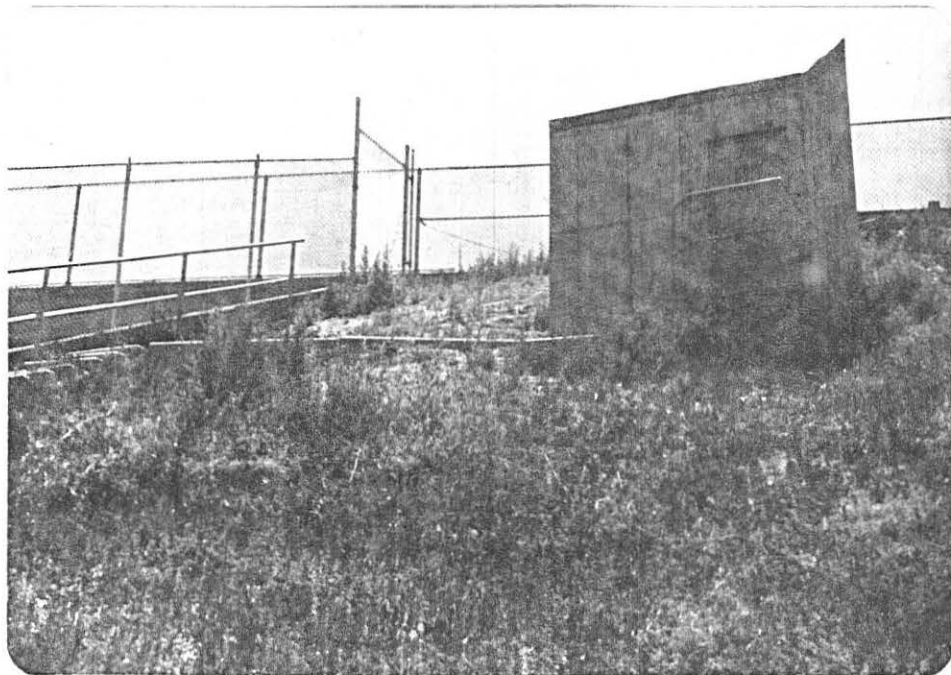
Photo No. 12 Exterior of Fabridam control tower with security fencing in background.

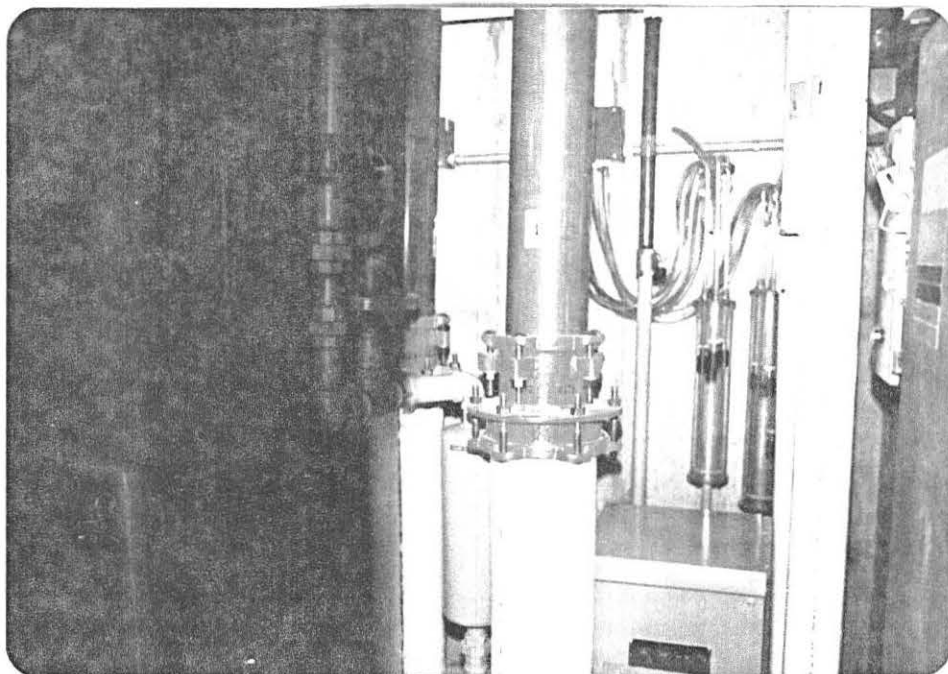
Photo No. 13 Interior of control house, showing valves which monitor Fabridam pressures and water levels.

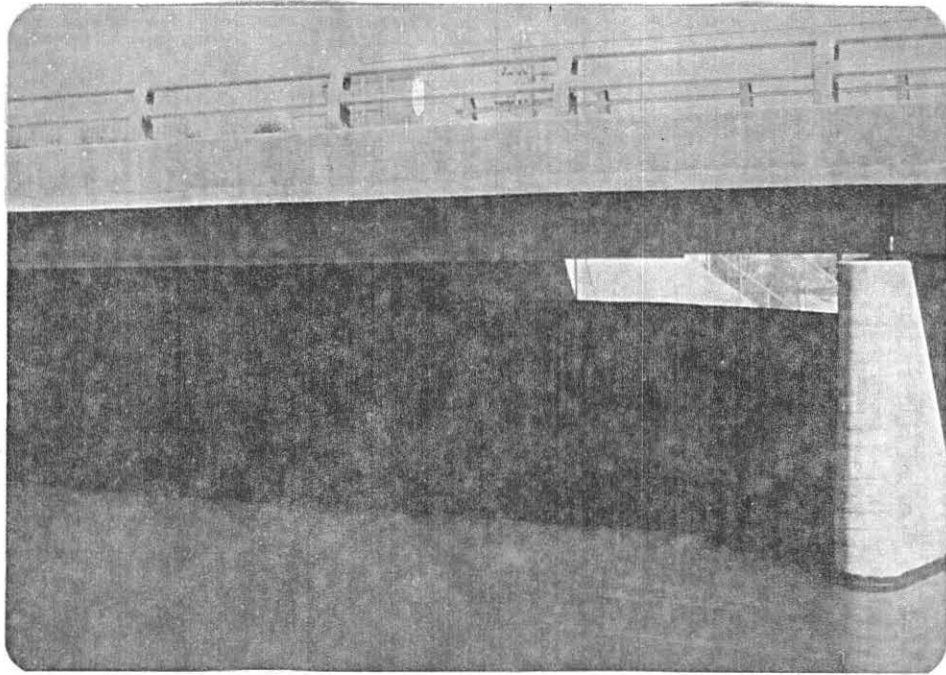
- F. Spillway. On the day of inspection the 6 foot high Fabridam located in the east bay of the ogee spillway was filled to capacity with 100 percent water. (See Photo No. 14). The 10-ft. high Fabridam located in the west bay of the spillway was filled with 60 percent water and 40 percent air. There were no signs of leakage through or around the Fabridams, with the patches made in March apparently holding well. (See Photos 15 and 16). The anchor bolts and other hardware that hold the Fabridams in place appeared to be in good condition. The stilling basin at the bottom of the spillway contained about 4 feet of water. This, according to Mr. Hahn, acts as a deterrent to unauthorized persons

Photo No. 14 Upstream view of 10-ft. high Fabridam in west bay of spillway.

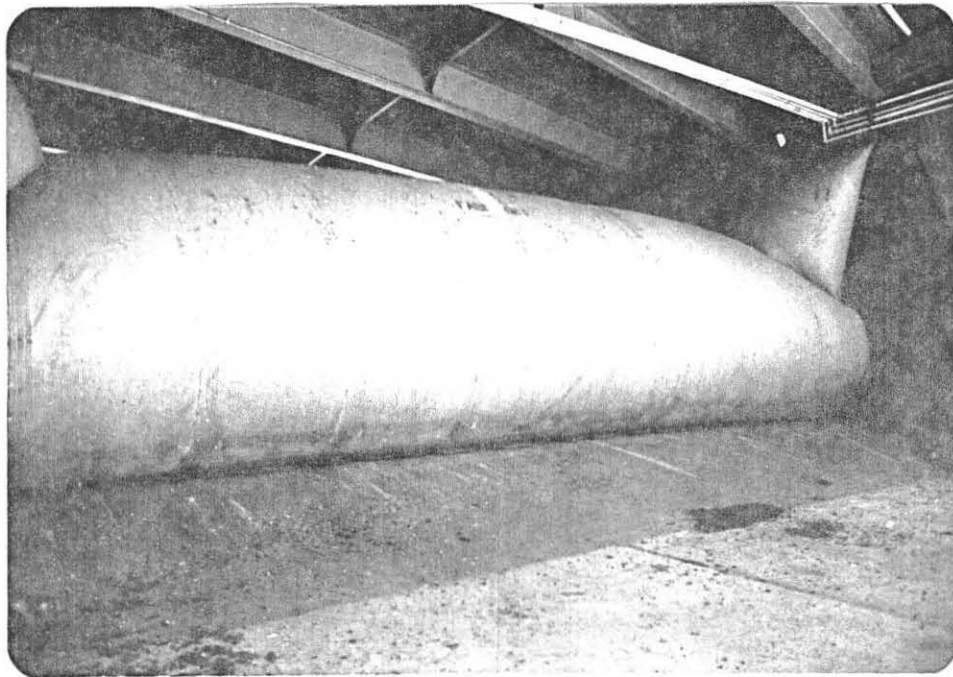
Photo No. 15 Downstream view of 10-ft. high Fabridam.

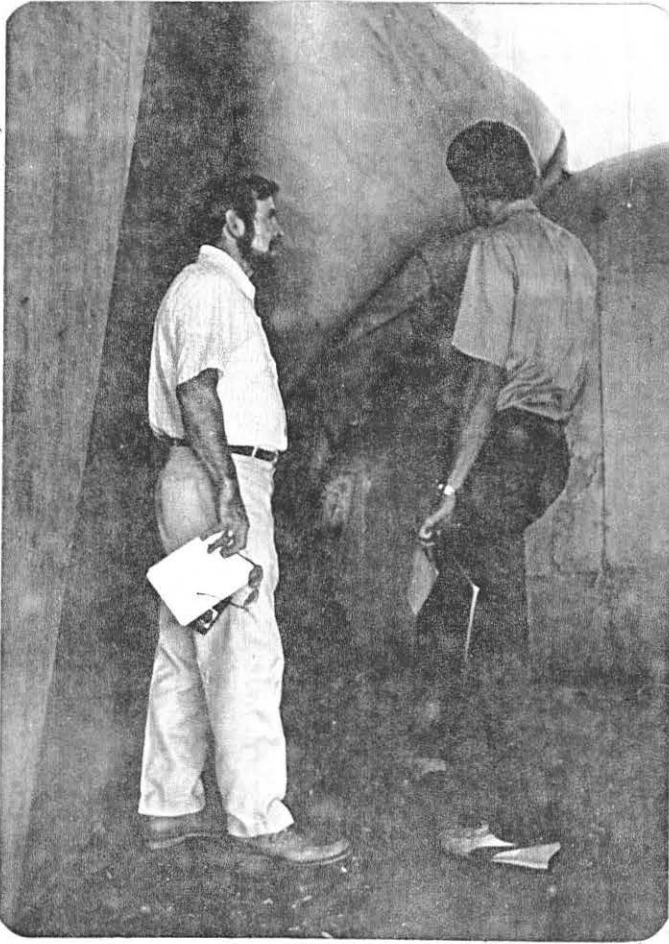
C. Spillway. The concrete spillway, chute and settling basin are all in excellent condition. As noted previously, the 6 foot high Fabridam was punctured in two locations by vandals. These holes have been repaired by the manufacturer's representative with a patch on the inside and a double patch on the outside. One of these patches is shown in Photo No. 16 and they are

Photo No. 16 View of repaired area in fold of 6-ft. Fabridam.

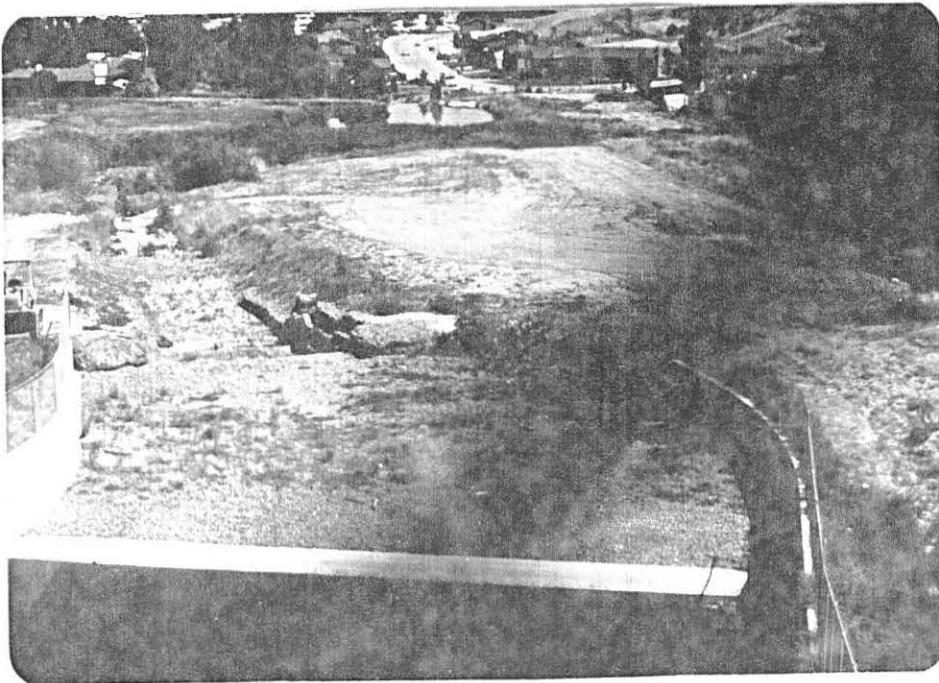
who might want to gain access to the spillway and Fabridams. There is a drain in the bottom of the stilling basin that can allow the basin to be emptied of water. All concrete surfaces of the spillway were in excellent condition and the entire chute and channel were free of obstructions, as shown in Photo No. 17.

Photo No. 17 Stilling basin, spillway channel and floodplain of Maple Grove Dam.
