MEMORANDUM

SUBJECT: Inspection of Niver Creek after heavy rainfall on the night of May 24, 1976

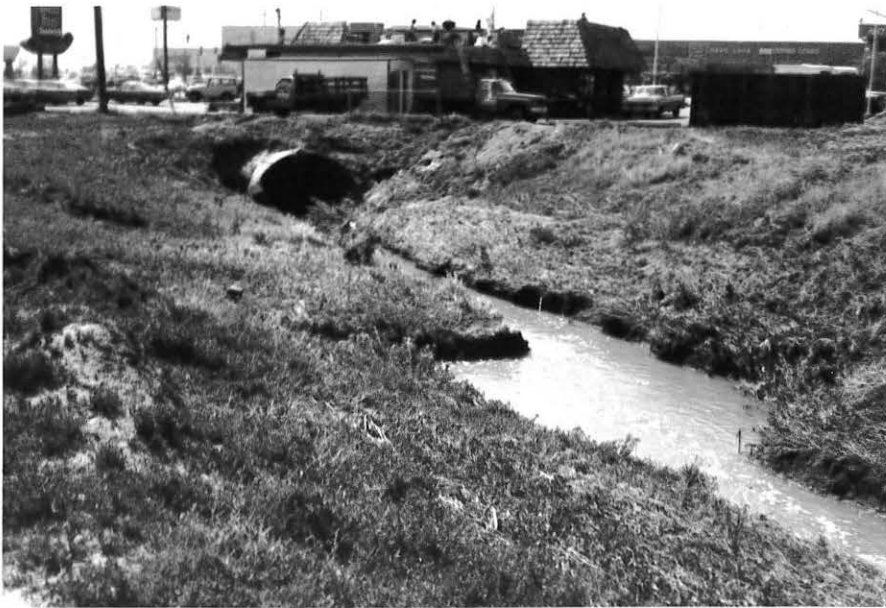
1.
Niver Creek - upstream end
culvert under parking lot
for Arby's, Red Barn and
Bonanza Steak Pit at 84th Ave
5/25/76

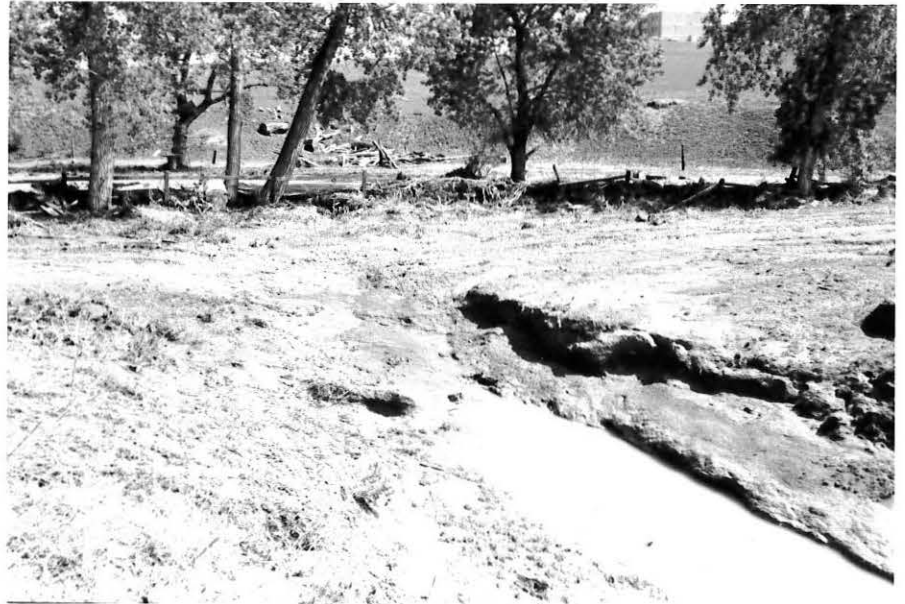
2.
Road overtopped at 86th
(dirt access road) by
Niver Creek
5/25/76

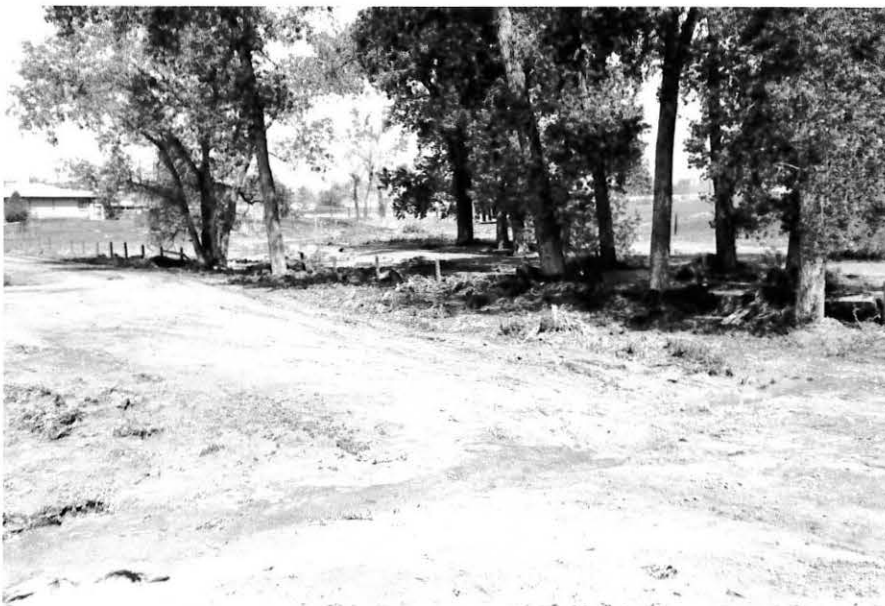
3.
Looking upstream from
86th (dirt road) at
Niver Creek
5/25/76

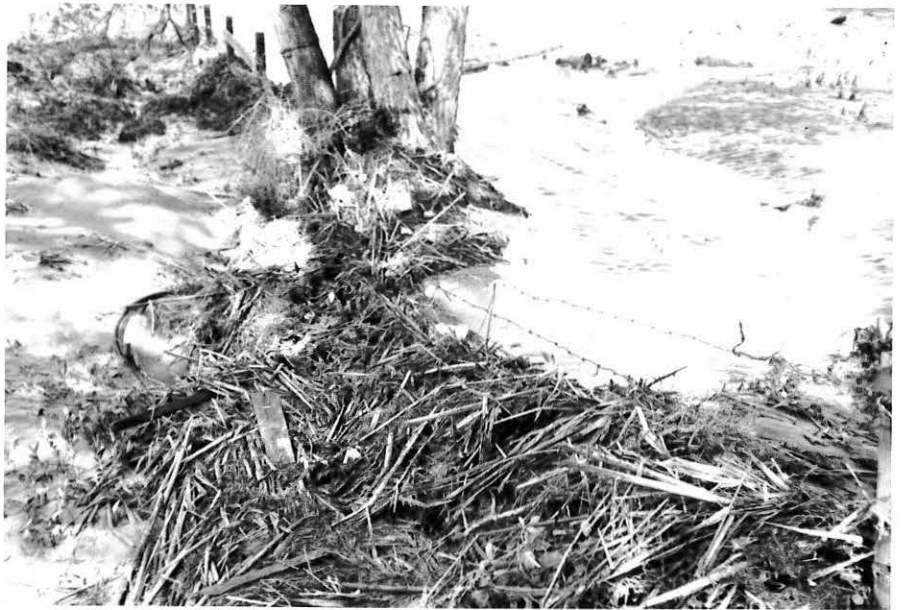
4.
Plugged RCP culvert at
86th Avenue.
Niver Creek
5/25/76

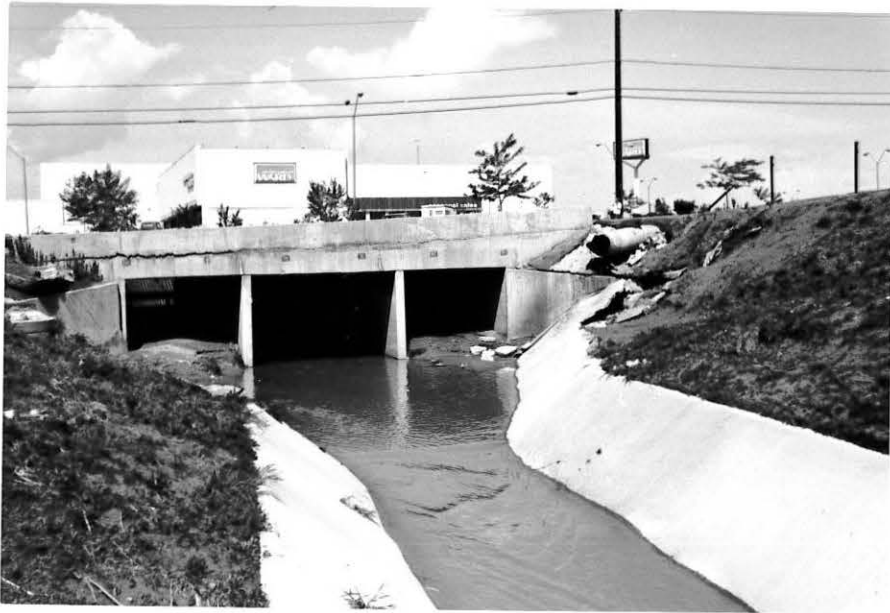
water from Niver Creek. The downstream end of the culvert under the parking lot for the shopping center appeared to be in good condition. No trash had collected. (5) A photograph was taken ~~looking upstream~~^{of} at the downstream end of the culvert under Washington St. There was ~~evidence of~~ erosion at the right and left abutments at the culvert but this may have been due to water which ~~was~~^{ed} flowing south along Washington Street. Both the right and left barrels were silted approximately a third of the way up. (6) A photograph was taken at this point looking downstream at the concrete lined channel below Washington Street which shows trash which has collected approximately 6" above the top of the concrete lining. This is perhaps a good estimate of the maximum depth of water which flowed last night. The channel appeared to be in excellent shape.

5.
Downstream end culvert at
Washington Street.
Niver Creek
5/25/76

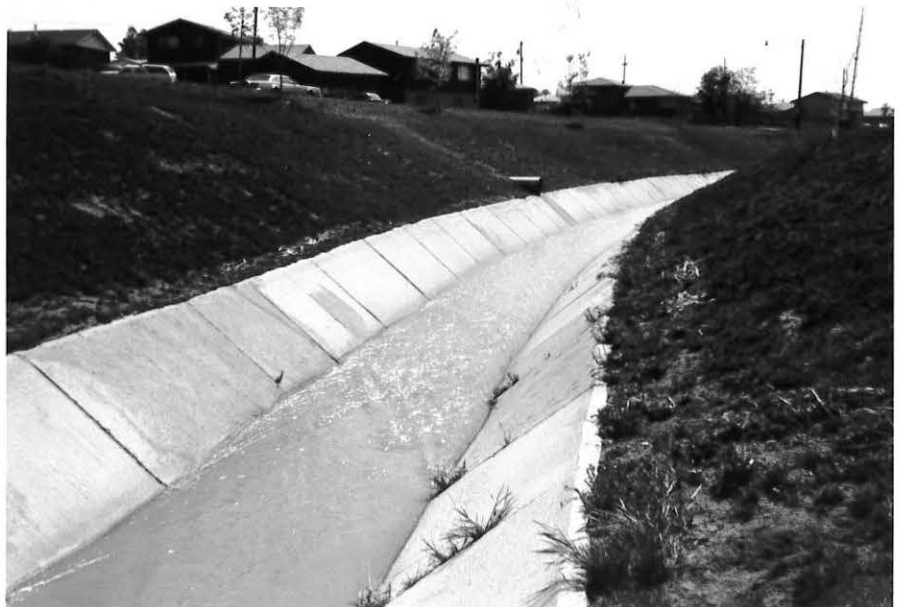
6.
Channel downstream of
Washington Street.
Niver Creek
5/25/76

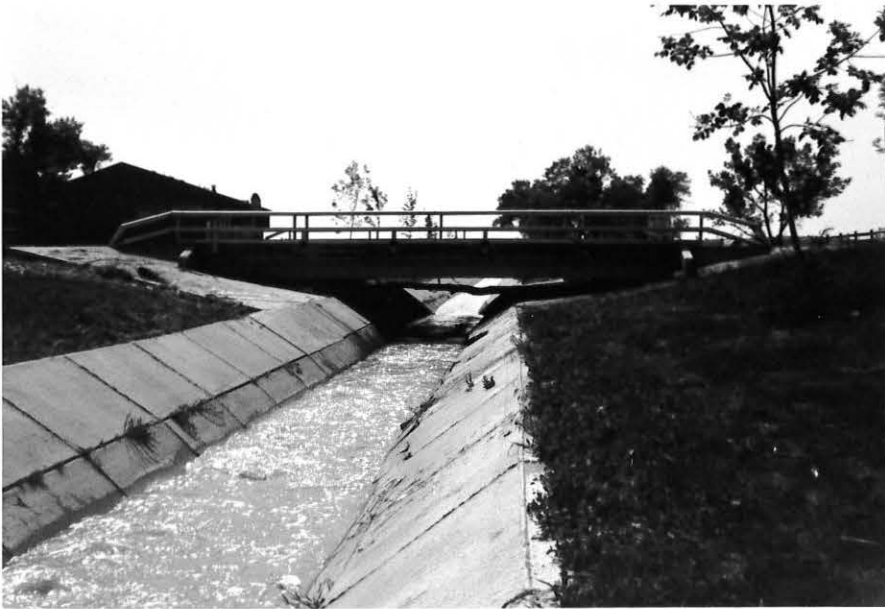
The bridge crossing at Explorador Calle was in much worse shape. (7) A photograph was taken looking downstream at the bridge which showed^S that a large log had lodged underneath. (8) Another photograph was taken which showed^S that considerable debris had lodged behind the bridge, perhaps up to the depth of the roadway. (9) Another photograph was taken which shows that the concrete lining on the right side of the channel upstream of the bridge has been damaged.

7.
Looking downstream at
Exploradore Calle Bridge.
Niver Creek
5/25/76

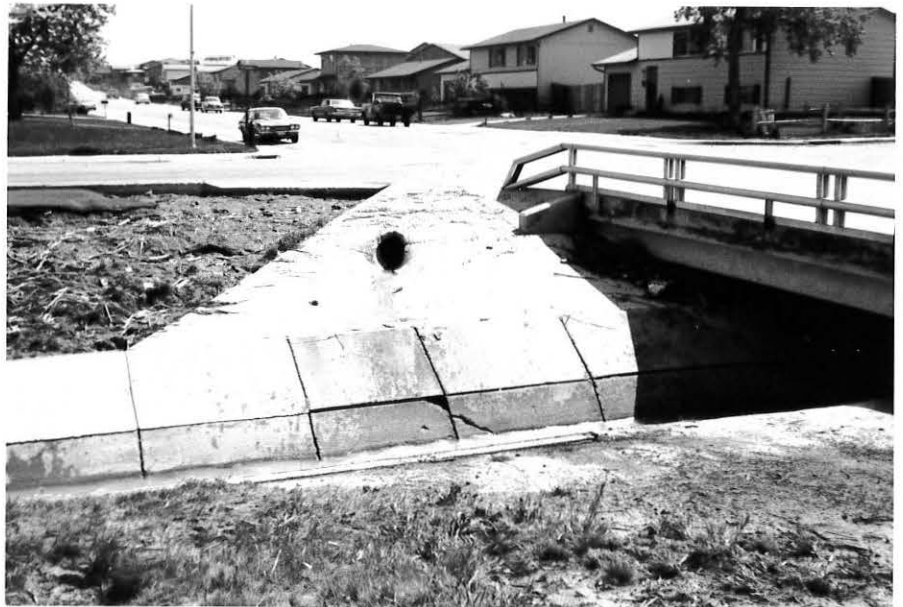
8.
Left abutment Exploradore
Calle Bridge (upstream
side).
Niver Creek
5/25/76

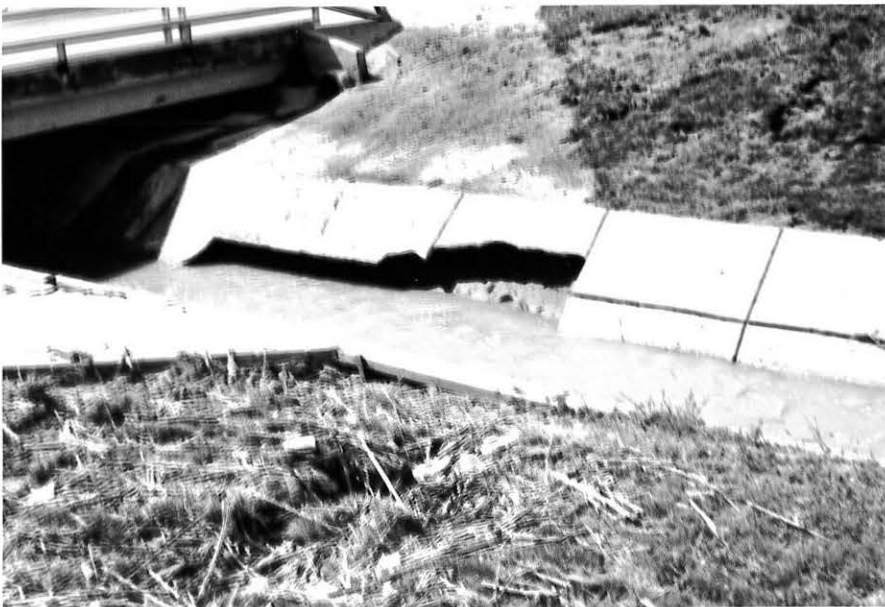
9.
Right abutment Exploradore
Calle Bridge (upstream
side).
Niver Creek
5/25/76

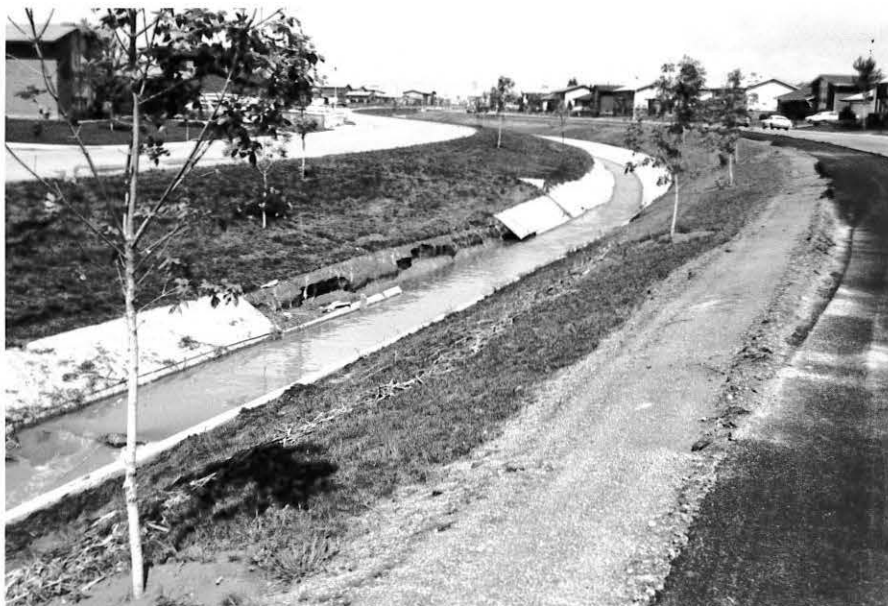
(10) Further upstream near the bend a large section of concrete lining has been damaged and much concrete lay in the bottom of the channel along this reach. (photo taken). I took a photograph of a man from Adams County who was cleaning up the debris. (11) The debris is perhaps four or five feet above the top of the concrete lining at this point. The concrete lining on the

10.
Damaged lining, right
bank upstream of
Exploradore Calle Bridge.
Niver Creek
5/25/76

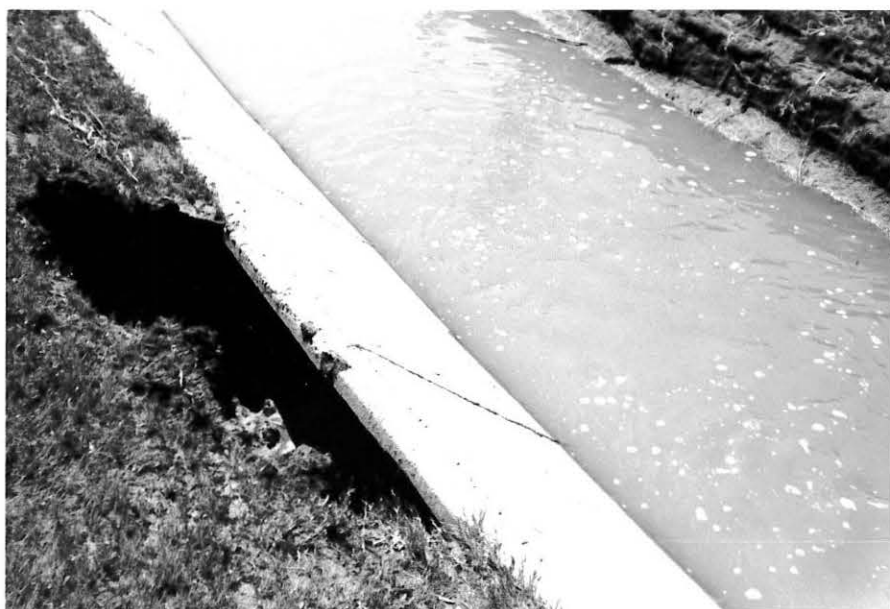
left side of the channel opposite the last one photographed has been undermined. The concrete lining appears to be in good condition although the fill material behind it has been eroded away. No photograph was taken as I was out of film. ^{photo taken later.} (16)

(16) I stopped and photographed the undermined section of concrete channel previously described (Page 3, top of page).

16.
Erosion behind lining
upstream of Exploradore
Calle crossing. *Left bank.*
Niver Creek
5/25/76

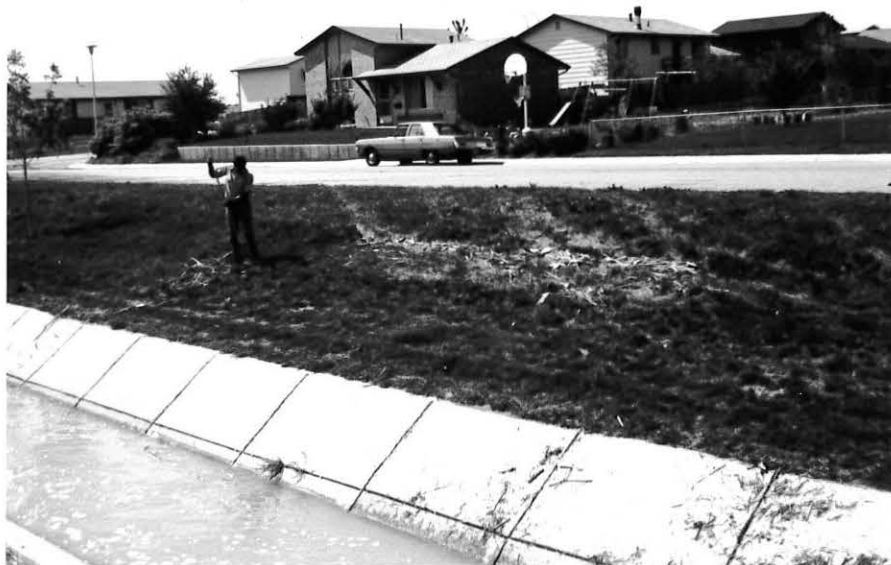
11.
Adams County cleanup near
Exploradore Calle.
Niver Creek
5/25/76

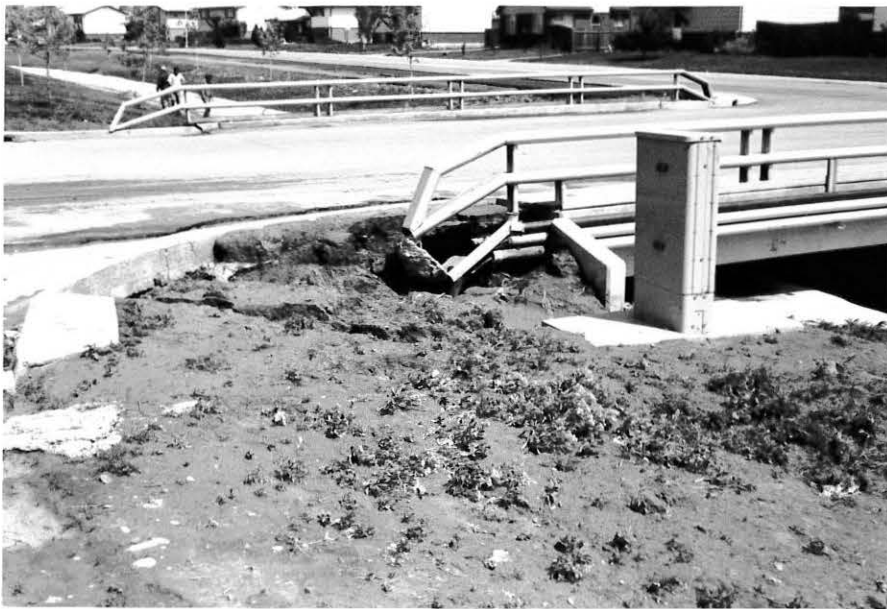
12.

In the reach between the last road crossing and the first road crossing a bikeway has been constructed between the roadway and the left side of the channel. The bikeway is asphalt and appears to be in reasonable shape although it was quite soft to walk on. Some of the fill material ~~which is~~ on the right side of this bikeway between the bikeway and the channel has been eroded and will have to be replaced. ^{The} man from Adams County was raking the accumulated debris into the channel. A portion of the bikeway ~~right~~ at the bridge may have been lost during the flood. Considerable sediment had collected at the intersection of Coronado Parkway and Explorador Calle on the right side of the channel. Both the right and left abutments of this bridge had been eroded on the downstream side (photo taken) (14)

Right abutment (downstream
side) Exploradore Calle
Bridge.
Niver Creek
5/25/76

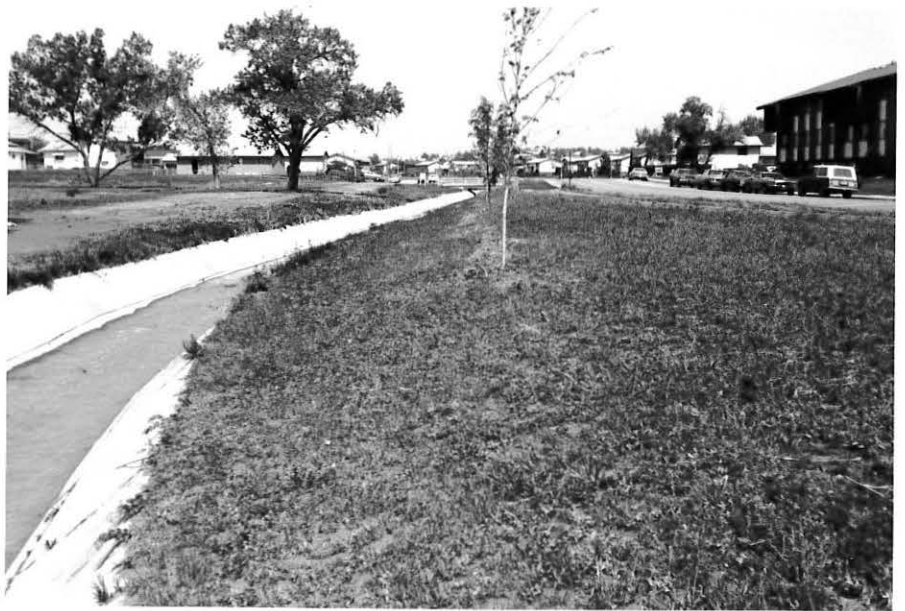
13.

Below this point the concrete lined channel appeared to be in satisfactory condition. (13) A photograph was taken looking upstream at the bridge crossing and Explorador Calle from a considerable distance downstream. The photograph shows debris collected at about 2 feet or so above the top of the concrete channel. It appears that water overflowed at this location into a ~~small~~ park on the right side of the stream. (14) A photograph was taken showing some debris which ~~has~~ collected, and ponded water. Just downstream from this location the concrete lined channel goes over a steep drop and transition structure into a rip rap lined open channel. The structure appeared to be in fine working order and no serious erosion was evident.

Looking upstream at
channel below Exploradore
Calle crossing.
Niver Creek
5/25/76

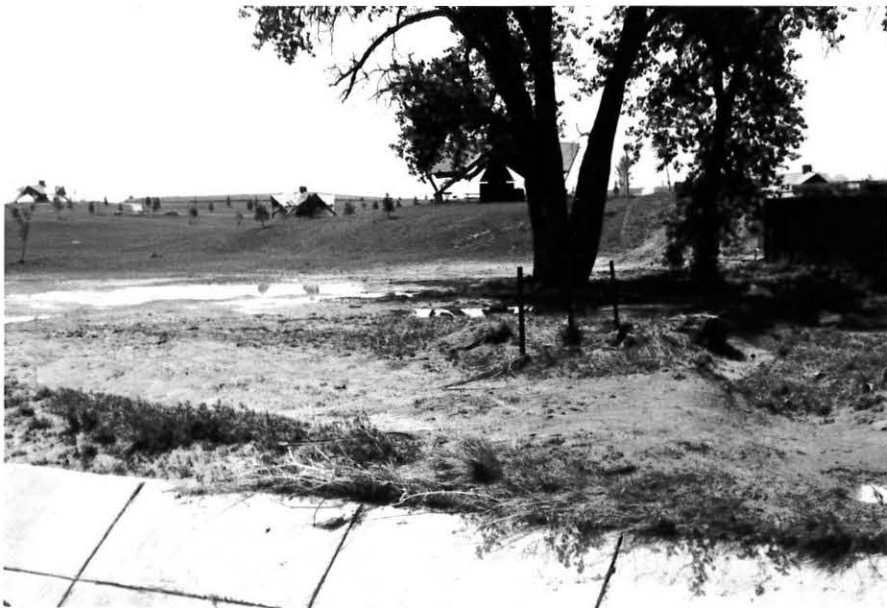
14.

Right overbank at park
below Exploradore Calle.
Niver Creek
5/25/76

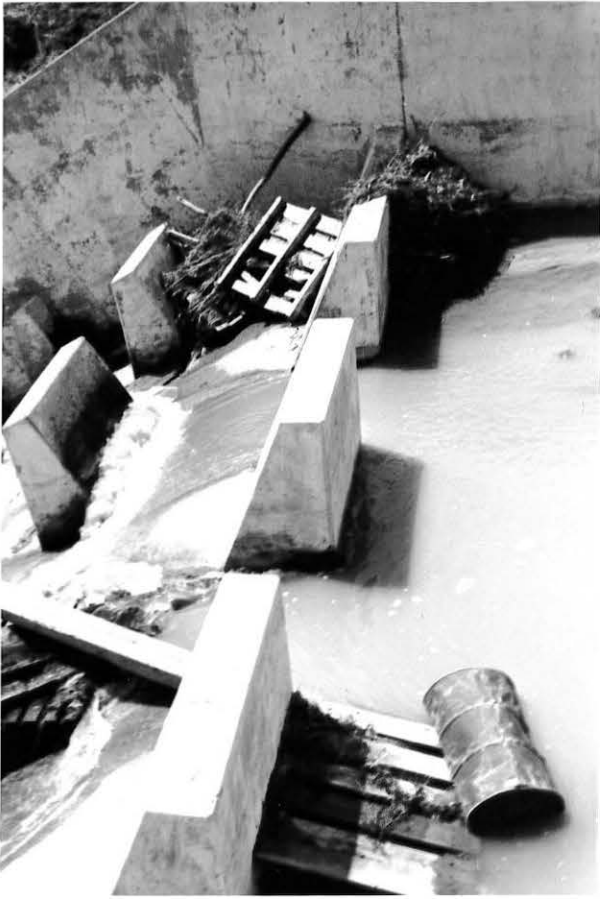
15.
Drop structure at York.
Niver Creek
5/25/76

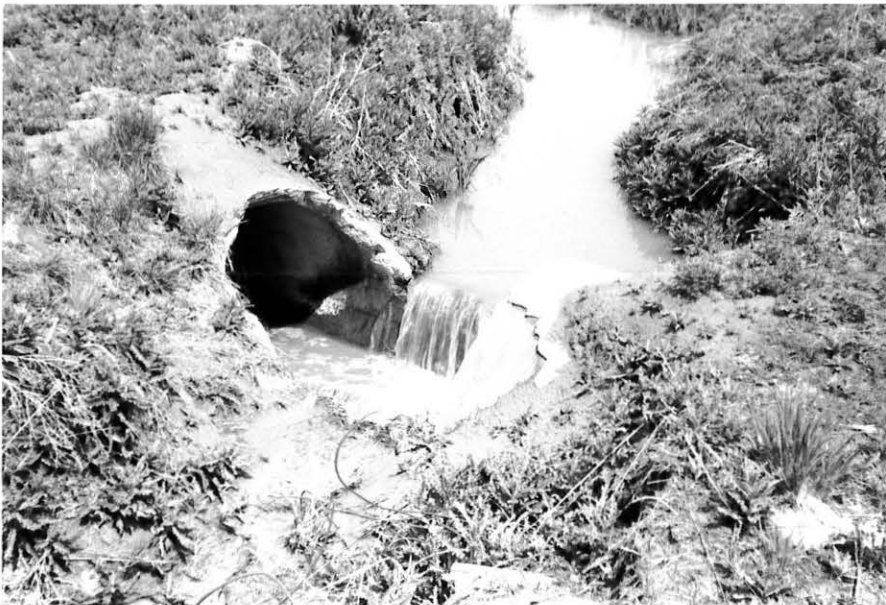
TRIB. "L"
It did not appear that Huron Street had been overtopped by tributary L. (17) I took a photograph at the structure on the upstream side of Huron. (I hope the structure is a storm sewer.) Further upstream of this point water in the tributary flows over what appears to be a sanitary sewer with little or no cover. (18) A photograph was taken. The structure did not seem to be damaged. During the last series of major flood events on this tributary some sanitary sewers had washed out below this location just north of a Drive-in Movie Theatre. I did not visit the site.

17.
Tributary "L" structure
at Huron.
Niver Creek.
5/25/76

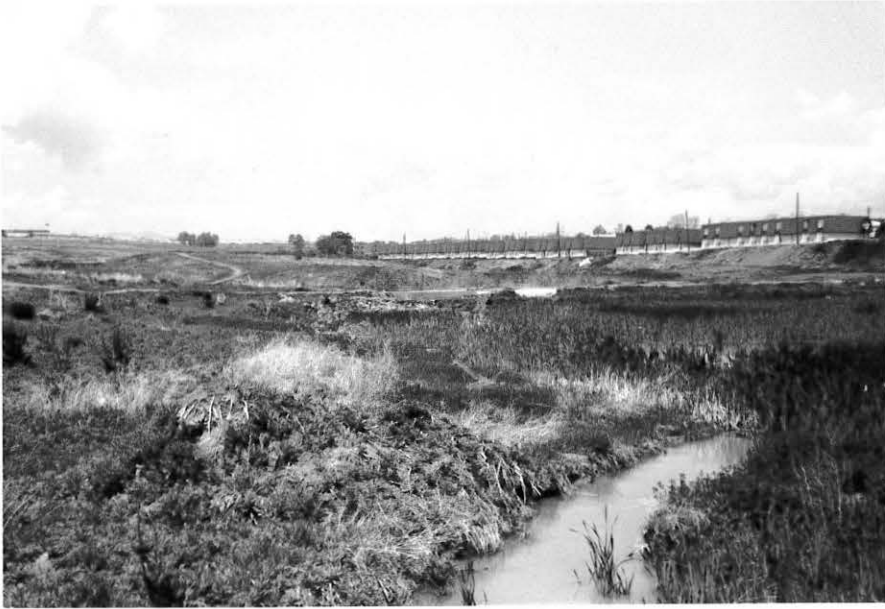
18.
Sanitary sewer crossing
at Tributary "L" upstream
of Huron.
Niver Creek.
5/25/76

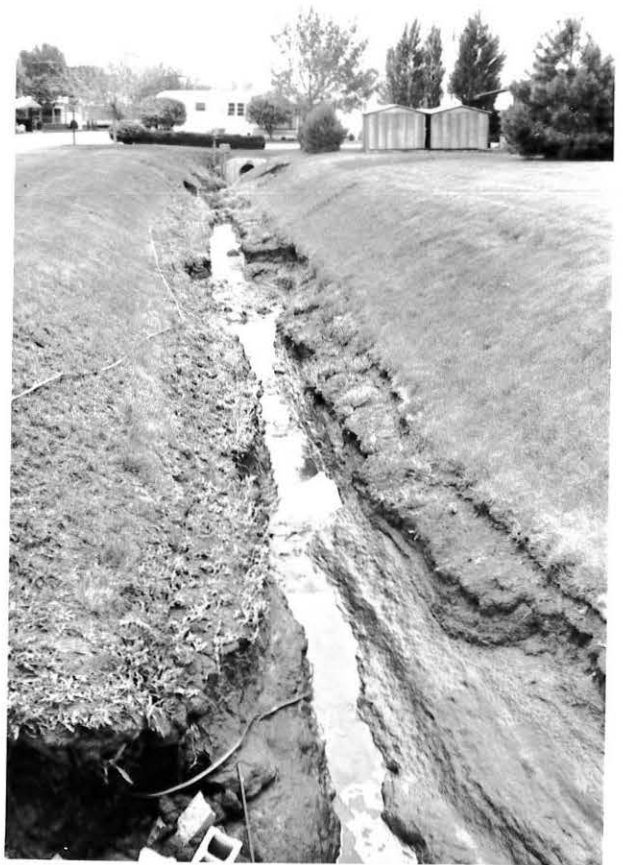
19.
Channel above U.S.G.S. gaging
station in Holiday Hills
Mobile Home Park.
Tributary "M", Niver Creek.
5/25/76

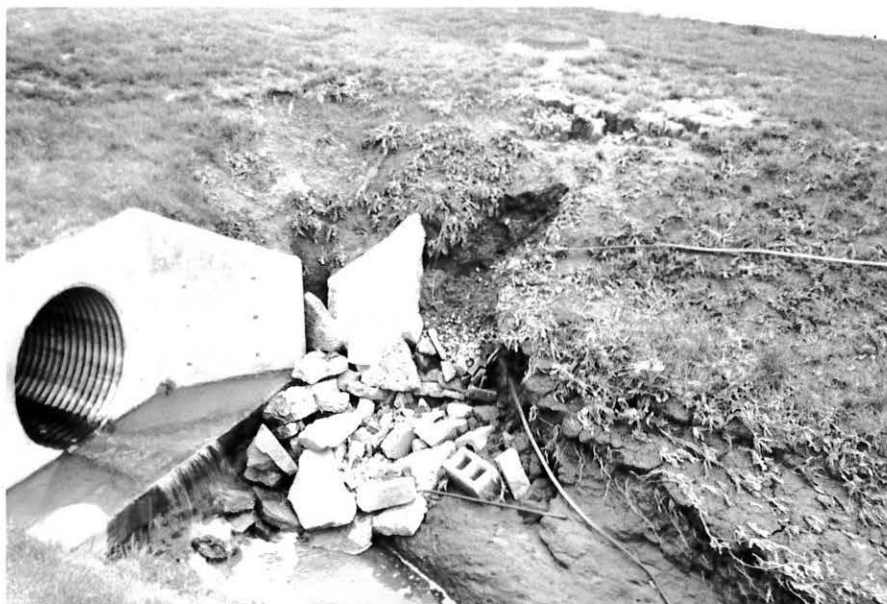
20.
Downstream end culvert
under community building
Holiday Hills Mobile
Home Park.
Tributary "M", Niver Creek
5/25/76

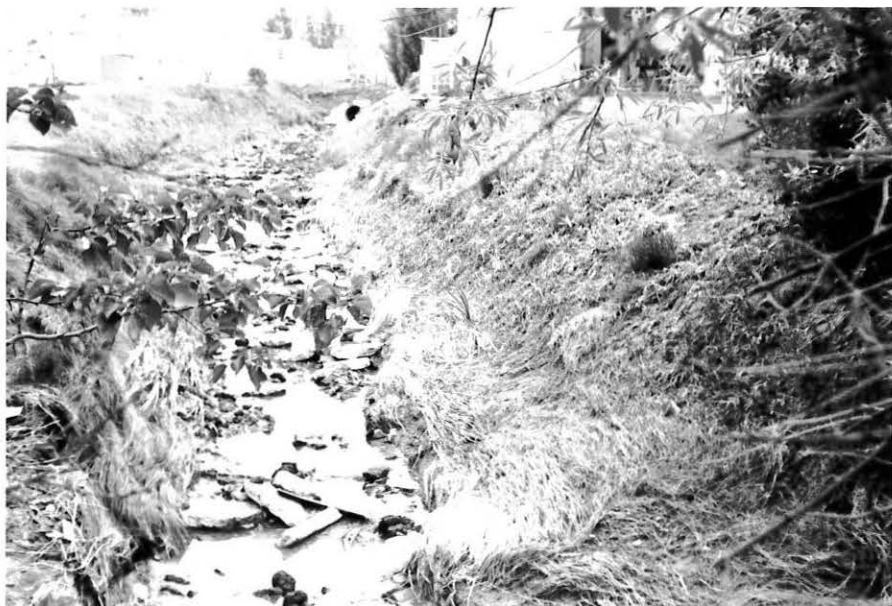
(21) A photograph was taken looking upstream at the channel reach below this point. The channel appears to have flown relatively full recently although no erosion is evident. (22) A photograph was also taken of the upstream end of the culvert under Pecos St. It is in fine order.

21.
Channel downstream of
U.S.G.S. gaging station,
Holiday Hills Mobile
Home Park.
Tributary "M", Niver Creek.
5/25/76

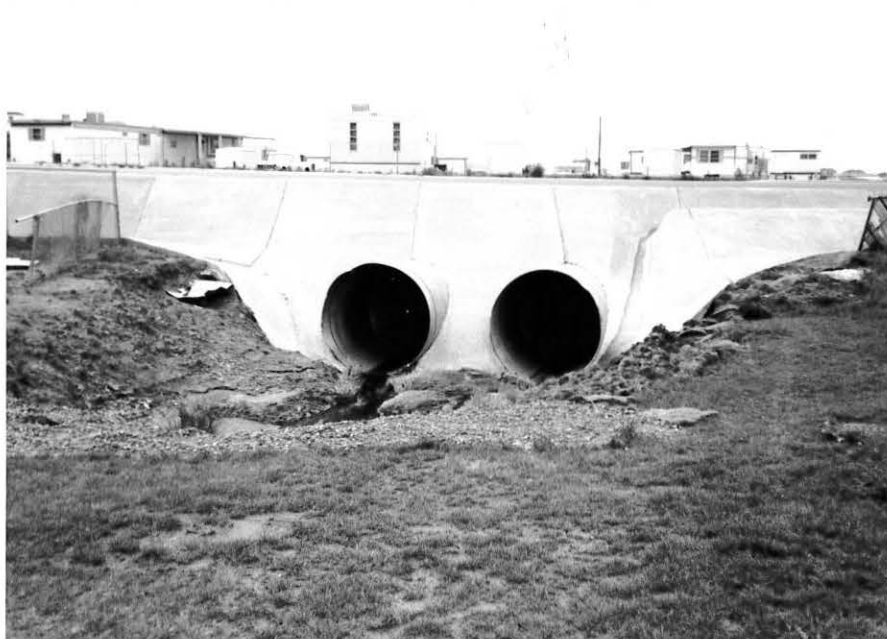
22.
Upstream end, crossing of
Pecos. Tributary "M",
Niver Creek
5/25/76

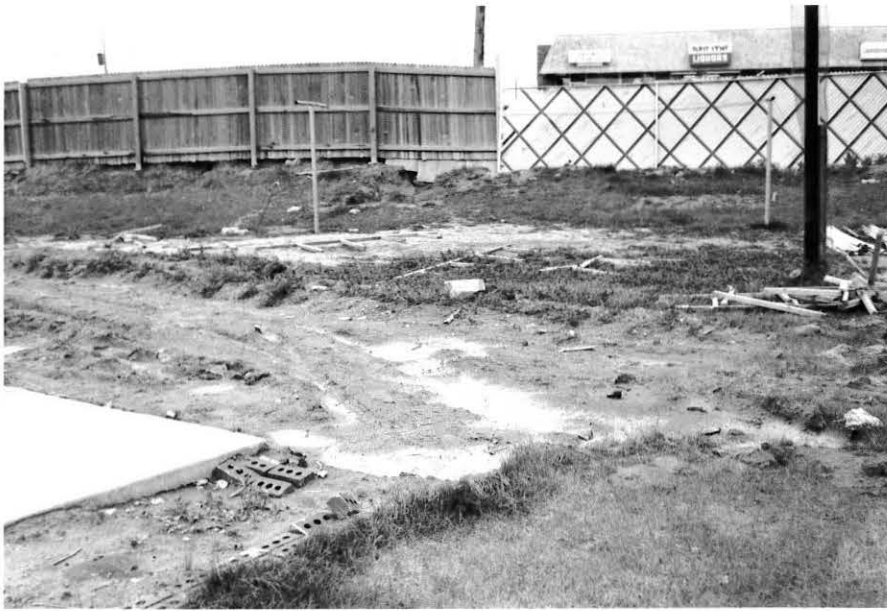
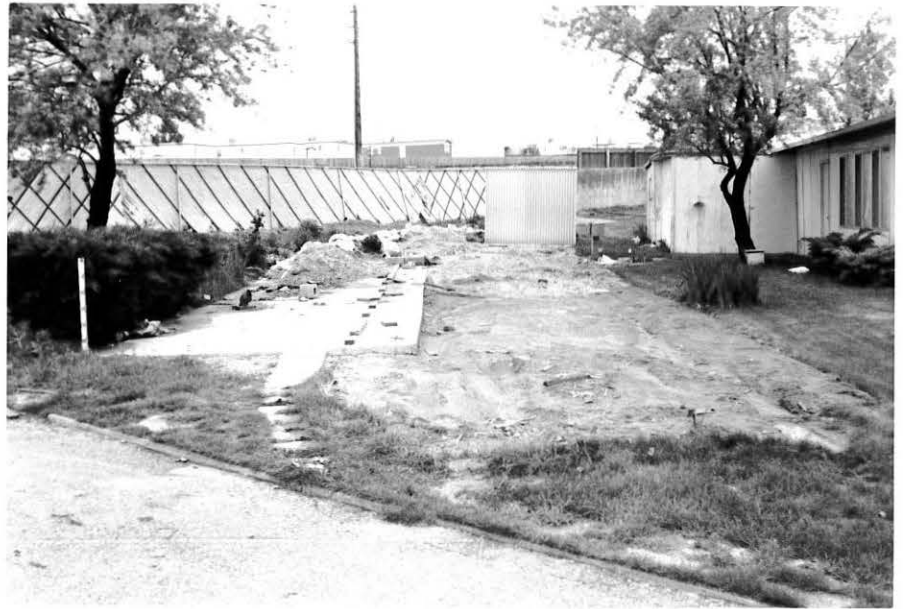
(23, 24) I took two photographs which showed sediment had been deposited. The retaining wall which was destroyed last year was never replaced, however, a temporary chain link fence was installed. (25) A photograph was taken looking west along 92nd Avenue showing the temporary fence, eroded embankment and the sand bags which have been placed. Apparently during the last week the two trailers which occupy the two end sites of this cul-de-sac were removed because of flooding problems. I spoke with the lady who lives near this point who was irate about the whole thing. Within this development no roadway overtopping was observed on tributary M. However, the southeast corner of the development was a problem as it was last year.

23.
Sediment deposited by
overflow from 92nd Avenue.
Holiday Hills Mobile
Home Park.
5/25/76

24.
Sediment deposited by
overflow from 92nd Avenue.
Holiday Hills Mobile
Home Park.
5/25/76

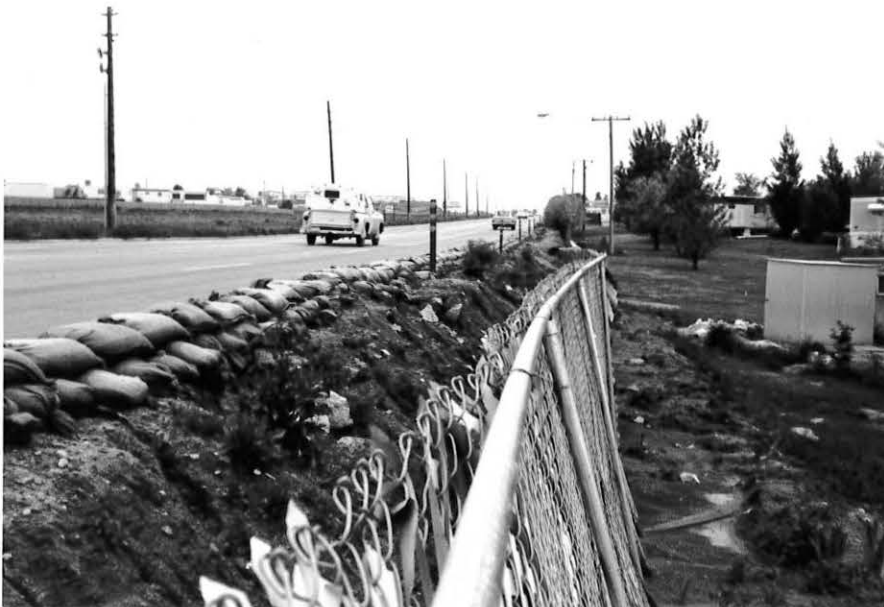
25.
Looking west along 92nd
Avenue at Holiday Hills
Mobile Home Park.
5/25/76

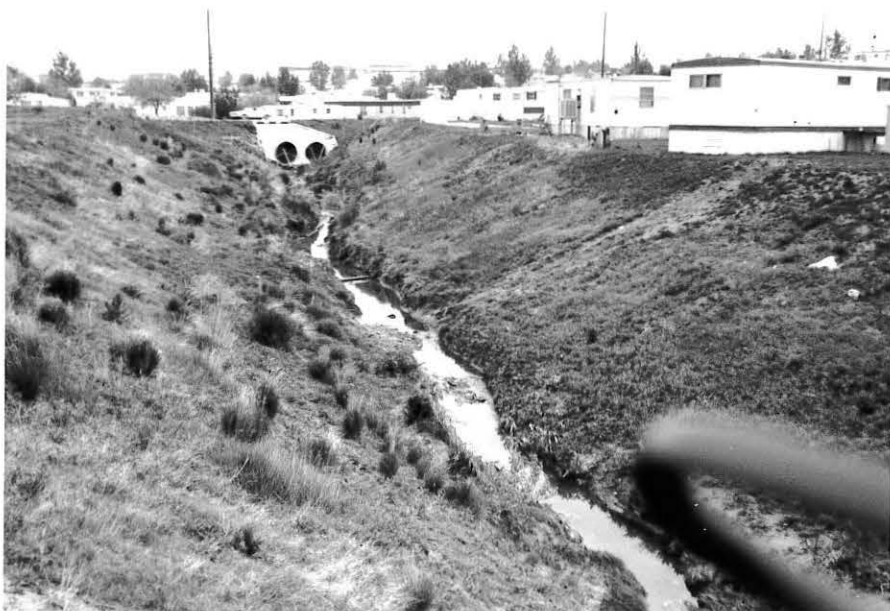
(26) A photograph was taken looking upstream at the channel and the crossing under Pecos Street. (27) Another photograph was taken showing some erosion near a sanitary sewer crossing.

26.
Channel downstream of
Pecos in Valley View
Estates Mobile Home Park.
(Formerly Redwood Estates).
Tributary "M", Niver Creek
5/25/76

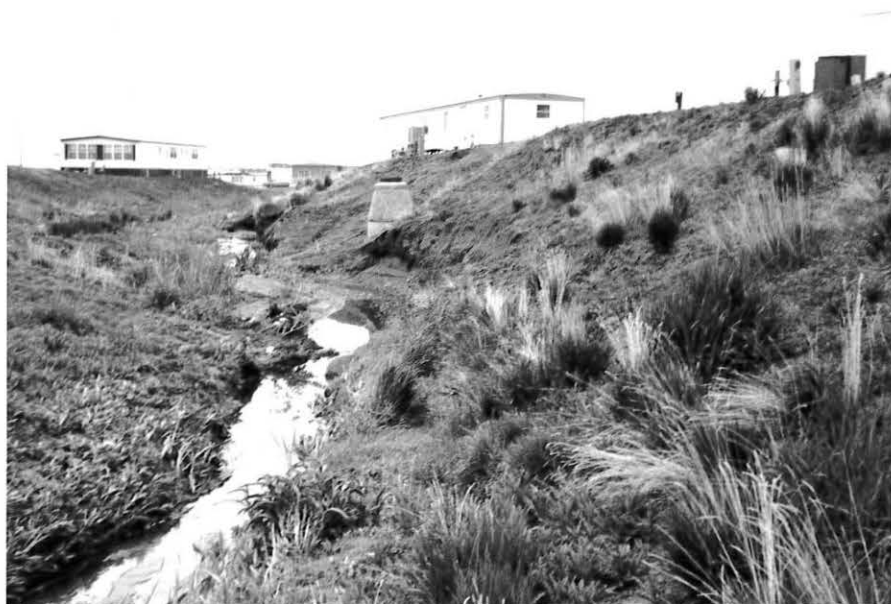
27.
Channel erosion, Tributary
"M", Niver Creek in Valley
View Estates Mobile Home
Park.
5/25/76

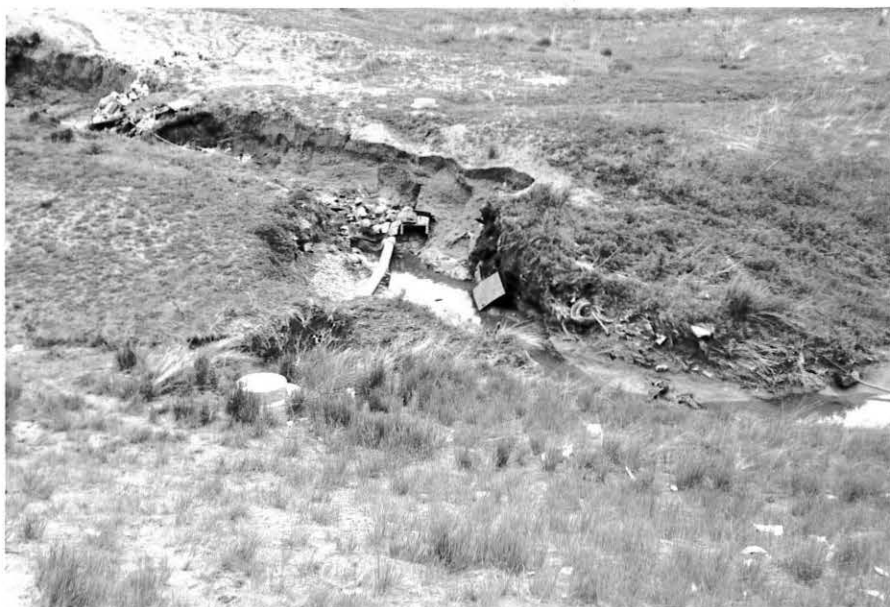
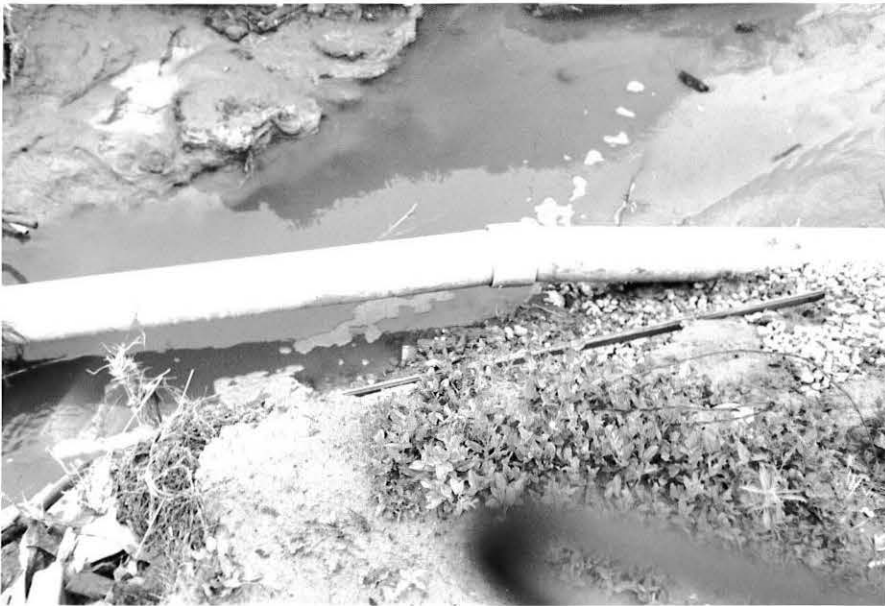
29.

Tributary N passes just north of this mobile home community. The sanitary sewer crossing that Wells Fargo Realty was concerned about was exposed. (28, 29) I took two photographs showing how the sanitary sewer crossing had been undercut and how the alignment was off. Upstream of this point two large diameter pipes had been used to form a drop structure. The left bank ~~had been~~ eroded to the point where these were no longer effective. (30) I took one photograph. The sanitary sewer crossing did not appear to be leaking. Water had been flowing in the grass lined channel immediately adjacent to the north boundary of the mobile home community.

28.
6" sanitary sewer
crossing, Tributary "N",
Niver Creek, north of
Valley View Estates.
5/25/76

6" sanitary sewer crossing,
Tributary "N", Niver Creek,
north of Valley View Estates.
5/25/76

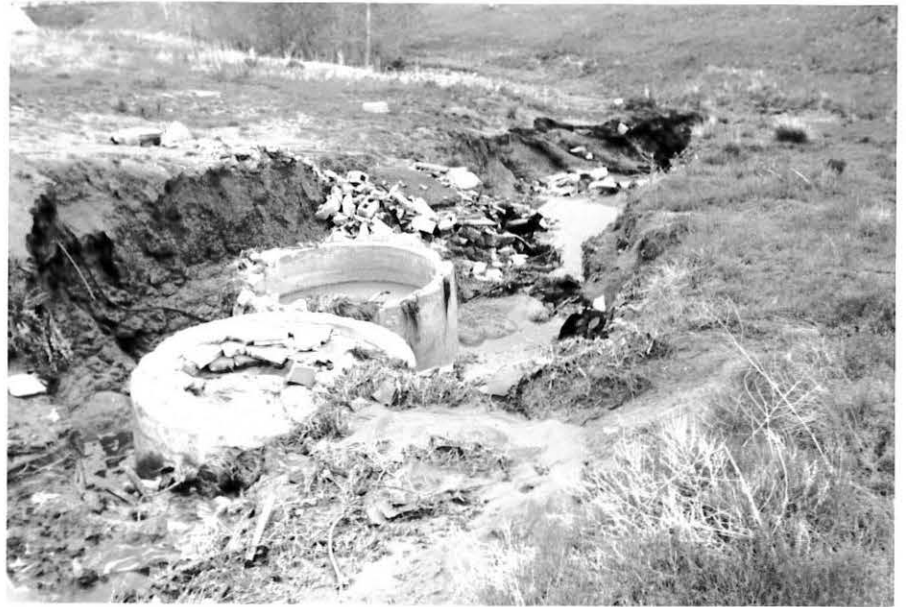
30.
Main channel
upstream of crossing
shown in 28 & 29.
Tributary "N",
Niver Creek
5/25/76

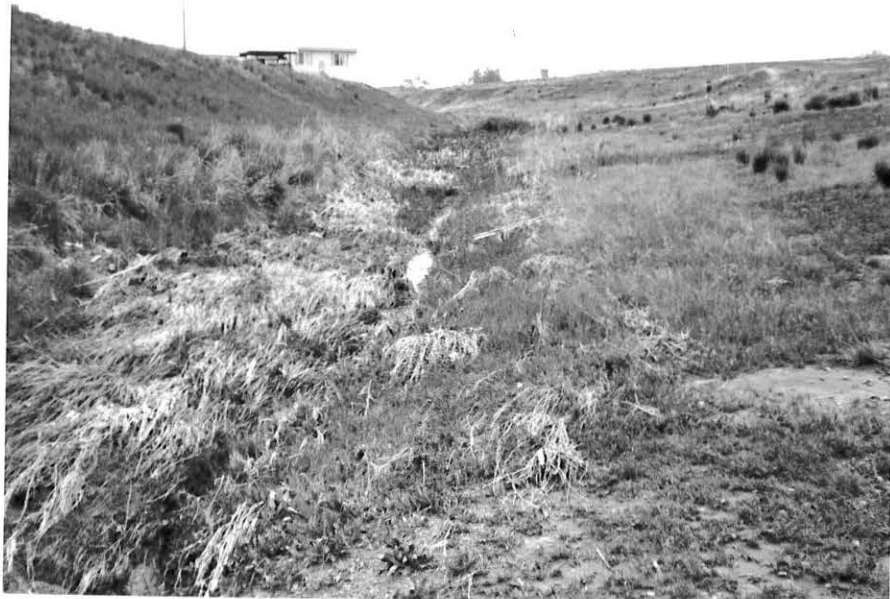
31.

(31) A photograph was taken looking in the upstream direction.

Grassed overflow channel
upstream of sewer
crossing shown in 28.
Tributary "N",
Niver Creek
5/25/76

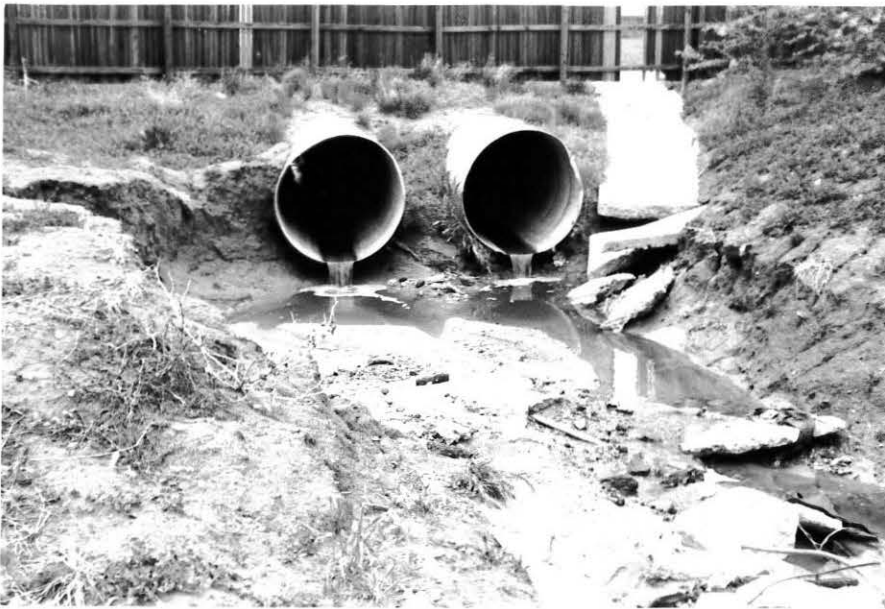
32.

(32) A photograph was taken of the downstream of the culvert for the westerly entrance of Valley View Estates. The photograph shows some erosion on the downstream end of the culverts. The channel for tributary M parallels 92nd Ave downstream of

Downstream end of west
entrance to Valley View
Estates Mobile Home Park.
Tributary "M", Niver Creek.
5/25/76
