# Floods of June 1965 in South Platte River Basin, Colorado

By H. F. MATTHAI

GEOLOGICAL SURVEY WATER-SUPPLY PAPER 1850-B

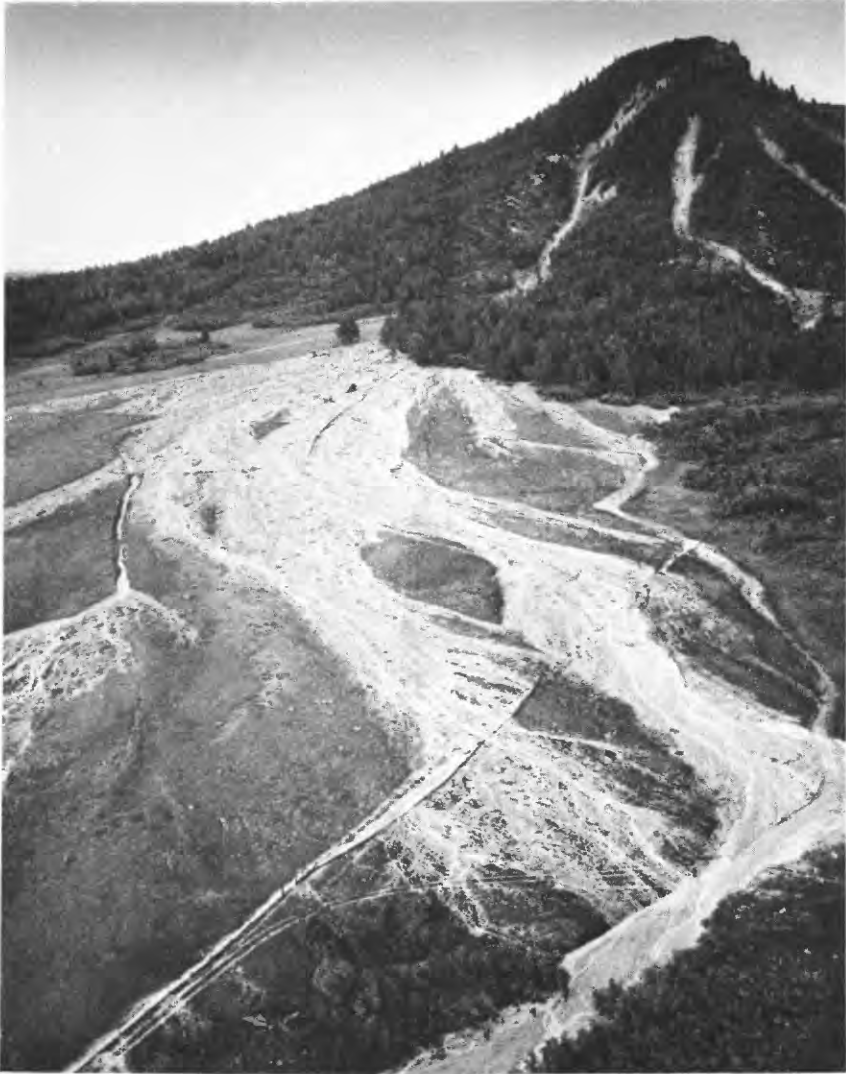
FIGURE 3.—Erosion scars and deposition south of Castle Rock, Colo., June 17, 1965. Denver Post photograph by Lowell Georgia.

The heavy runoff flowing down steep gradients in the Castle Rock area of East and West Plum Creeks scoured the soil down to bedrock in places along the small tributary channels. Where channels were inadequate, the water flowed overland, cut new channels, and deposited sand, gravel, enormous boulders, and other debris on fields and pastures (figs. 3 and 4).

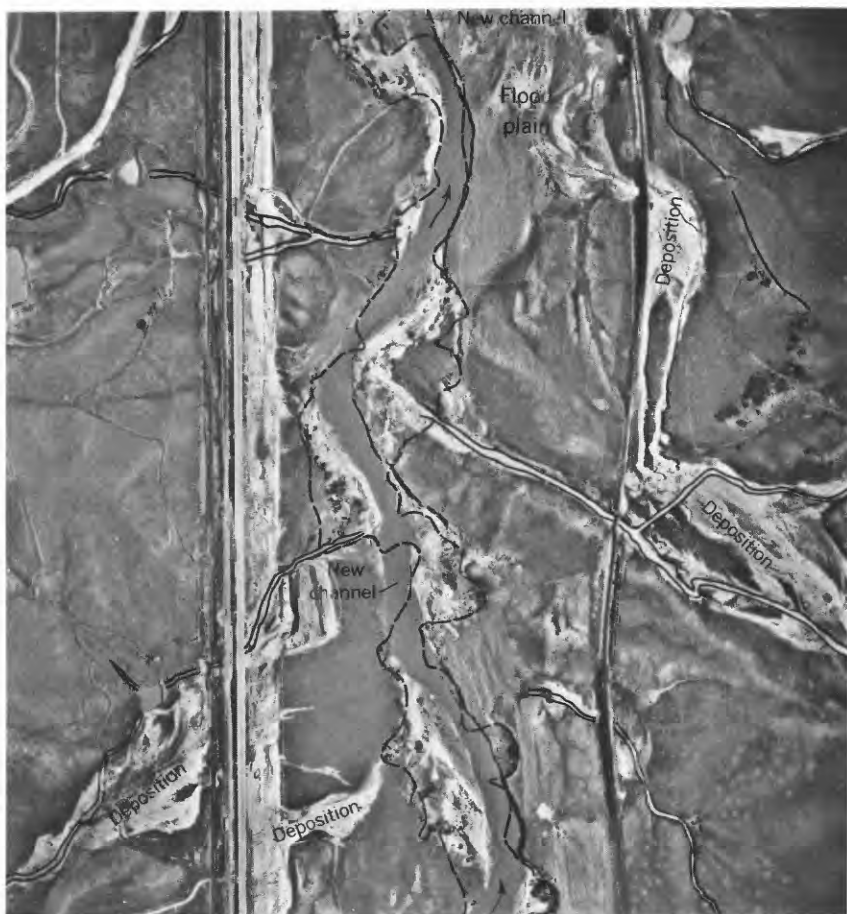
FIGURE 4.—Results of overland flow along East Plum Creek south of Castle Rock, Colo. Photograph by Colorado Army National Guard on June 18, 1965.

In figure 4, the solid lines are tributaries of East Plum Creek as they are depicted in aerial photographs taken in October 1964. The dashed lines are the limits of the meanders of the low-water channel and of trees and brush of moderate density. The light areas in the photograph are deposits of sediment. Note the two major changes in the main channel position and that most of the trees and brush have been washed out.

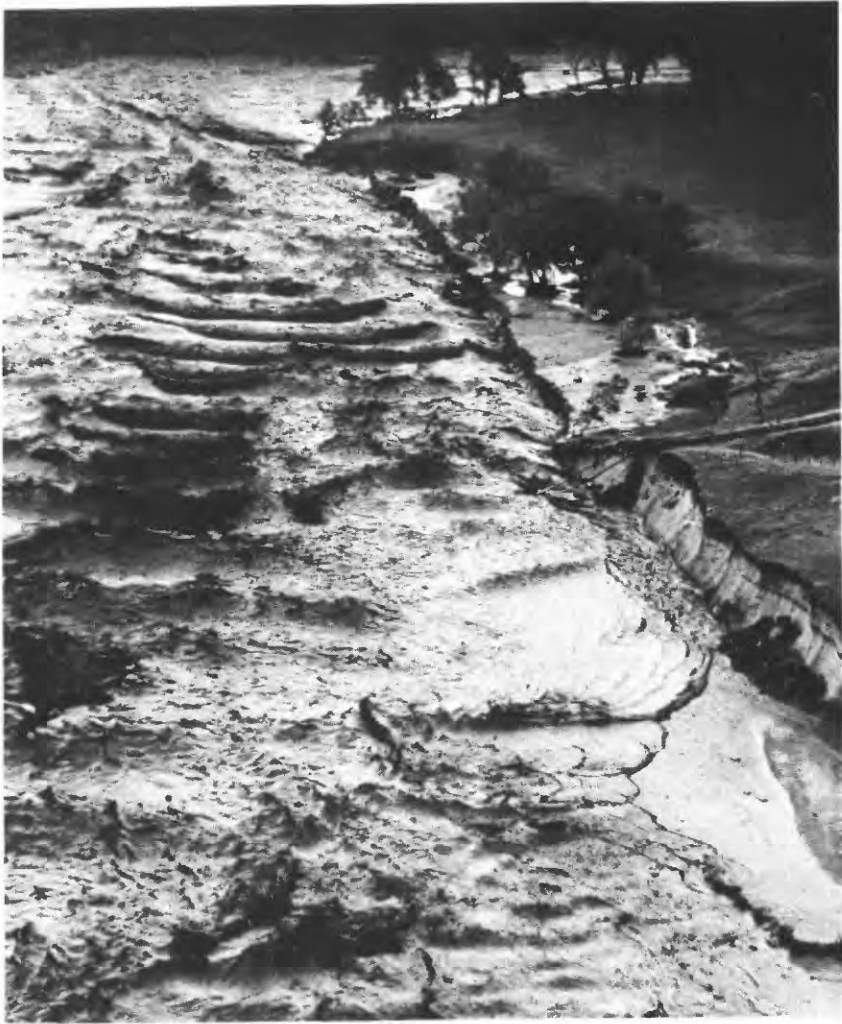
FIGURE 5.—View downstream on East Plum Creek south of Sedalia, Colo., late afternoon of June 16. Denver Post photograph by Lowell Georgia.

The Plum Creek gaging station near Louviers was destroyed, but observations indicated that the flow increased a thousandfold, from about 150 cfs to 154,000 cfs, in less than 3 hours. The recession was also rapid; a measurement of 988 cfs was made by wading at 1200 hours on June 17, only 18 hours from the peak. Streamflow records have been collected on Plum Creek either near Sedalia or near Louviers since 1942, and the maximum discharge prior to June 16, 1965, was 7,700

cfs in August 1945. The peak discharge on June 16, 1965, was 20 times the previous maximum discharge in 23 years.

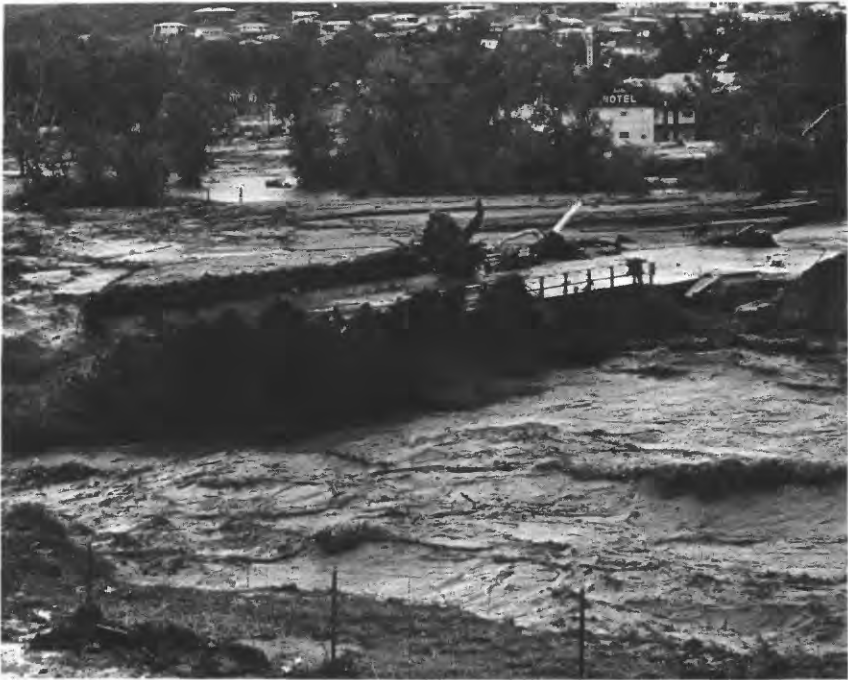
FIGURE 9.—Bridge on approach road from Castle Rock to Interstate Highway 25 destroyed by East Plum Creek. Denver Post photograph by William Peters.

The damage in rural areas in the Plum Creek basin was extensive. The heavy runoff deposited all kinds of debris—from sand to huge boulders and trees—on fields and pastures. Road embankments were severely eroded, and bridges on county, State, and interstate roads were destroyed. (See fig. 9.) Large cut banks, particularly along East

Bridge engineers report that scouring at bridge piers or abutments was not a factor in any bridge failures. The primary causes were the added thrust from the debris piled against the upstream side of the bridge and the increased water pressure against the bridge. The impact of large floating objects was part of the problem at some bridges. Cross sections at bridges before and after the flood showed a net scour of as much as 4 feet in the bed of the channel under bridges supported by closely spaced pile bents and (or) solid piers. At sites where bridges are supported by two or three columns, little or no net scour occurred.

Repairs and replacement of bridges and highways in the State Highway system alone cost \$9 million. The city and county of Denver spent an additional \$914,000 on repair of their streets and bridges.

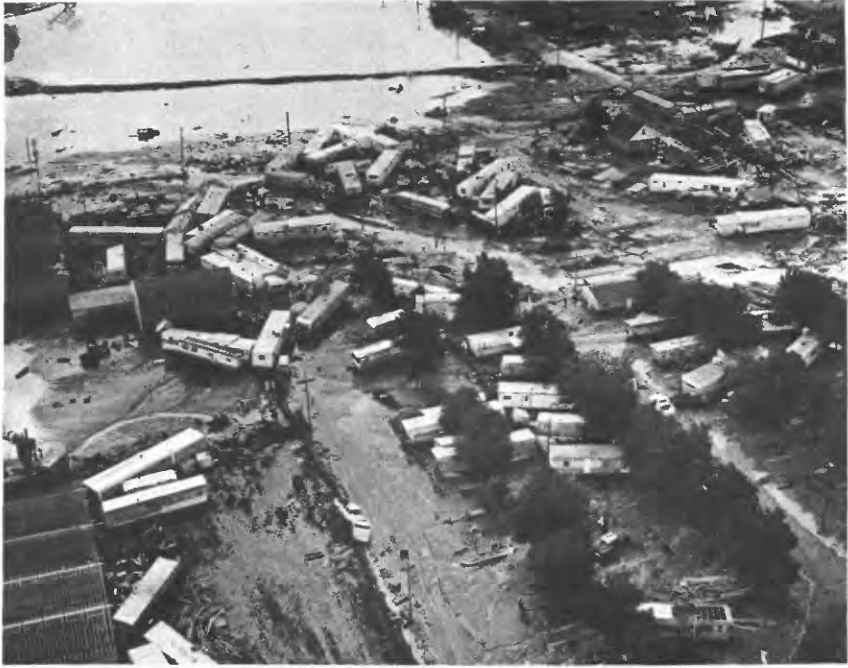
FIGURE 10.—South Platte River near West Bowles Ave., Littleton, Colo., on morning of June 17, 1965. Denver Post photograph by Edward Maker.

The conditions in and near Denver on the morning after the flood can be described in many ways, but the most succinct and appropriate description is that the South Platte River valley was a mess. The city of Denver spent just over \$1 million cleaning up mud and debris in addition to that spent by other municipalities, businesses, and individuals.
