II. THE BOULDER CREEK DRAINAGE BASIN

BOULDER CREEK
EARLY FLOOD WARNING STUDY

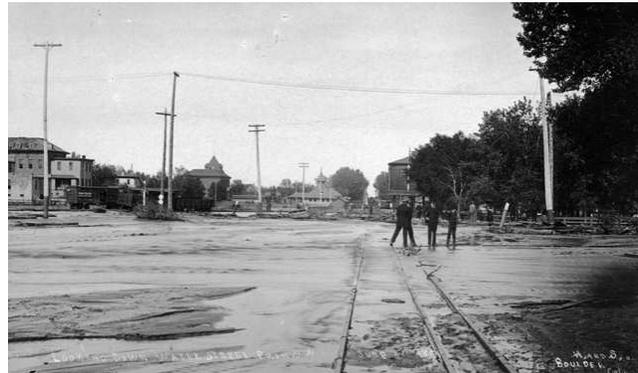
Location: Looking down Water Street from 12th - June 12, 1894
Photo Credit: Denver Public Library

In Boulder, floodwaters covered the entire area between Water Street (now called Canyon Boulevard) and University Hill to depths as great as eight feet. Every bridge in Boulder and a number of residences were swept away. Other types of damage included: commercial establishments, public utilities, railroad property, roads and streets, and irrigation structures. Many people were trapped in their homes and had to be rescued. Only one life was lost; this was due, in part, to the flood's slow onset.

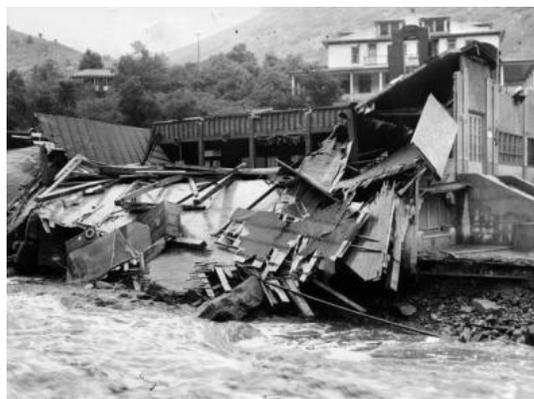
Location: Eldorado Springs dancehall – Sept. 4, 1938
Photo Credit: Denver Public Library

1938, August 31-September 4. This storm produced general rains over all of eastern Colorado. The largest amounts of precipitation occurred in the mountains where more than 6 inches was reported west of Eldorado Springs. Eldorado Springs recorded 4.42 inches of rainfall. Approximately 80 percent of the total precipitation falling in the South Boulder Creek basin fell in the late afternoon and evening of September 2. The resulting flood, with a peak discharge of 7,390 cfs passed through Eldorado Springs at approximately 10 PM on **September 2**. The resort community of Eldorado Springs suffered heavy damage and numerous buildings were destroyed when floodwaters eroded their foundations. The valley from Eldorado Springs to Boulder Creek and down Boulder Creek to St. Vrain Creek was in shambles. This flood is the highest recorded flood on South Boulder Creek.

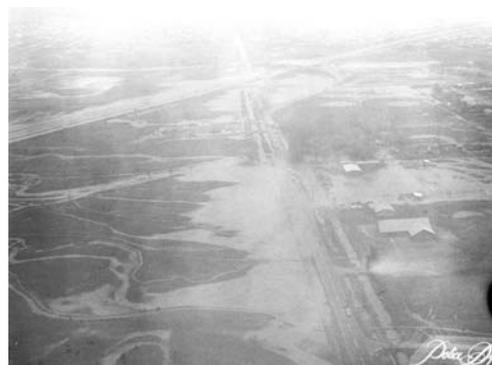
Looking west along South Boulder Road

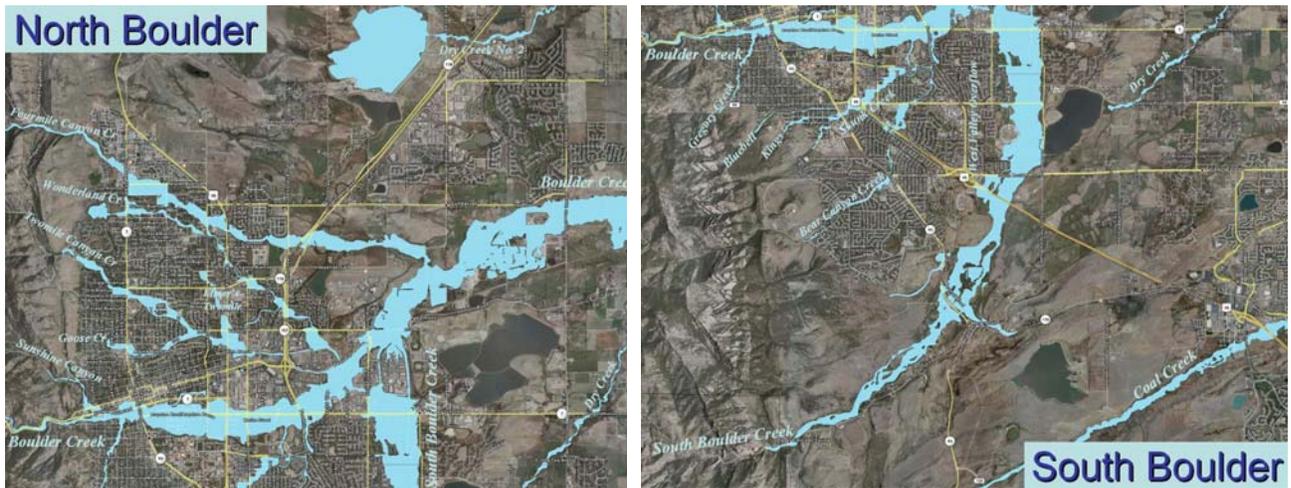
Floodplain mapping for Boulder Creek, South Boulder Creek and other tributary streams may be obtained from a number of Internet sources as well as from the studies listed at the beginning of this section. The aerial photos below show approximate 100-year floodplains for the City of Boulder and surrounding areas. The maps were created from a Google Earth application developed for UDFCD by Leonard Rice Engineers... <http://www.lrcwe-data.com/UDFCD.kml>
