Urban Drainage and Flood Control District

E-19 Surveys

Van Bibber @ HWY 93 Gage

HDR Engineering, Inc.

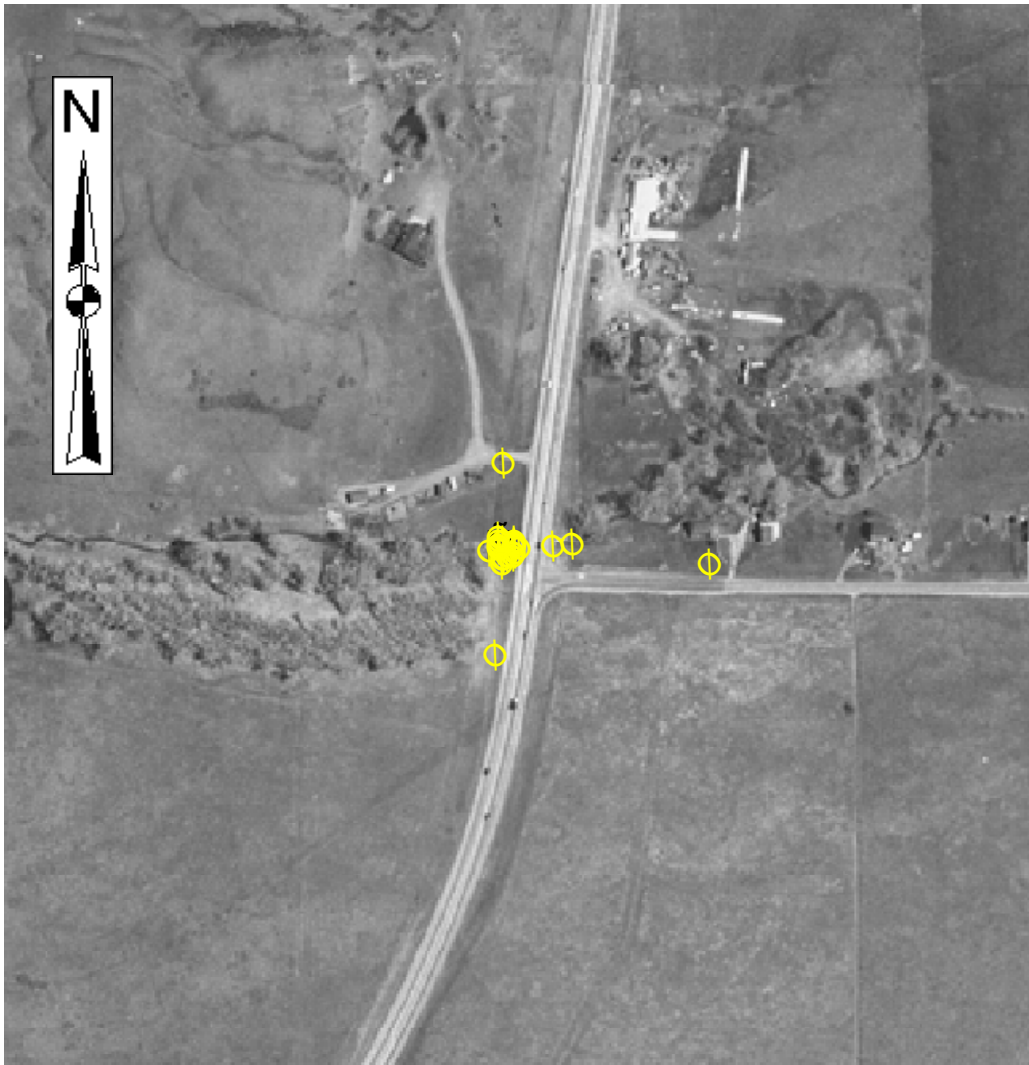
Figure – 2 Surveyed Points

The elevations and locations of any buildings near the gage site were surveyed, along with water surface elevations up and down stream from the gage. In addition, ground elevations were surveyed along a cross section for a possible future rating curve for the site. Figure 2 shows locations of the surveyed points in the vicinity of the gage. The base of the ALERT transmitter was surveyed at an elevation of 100.00 for a temporary benchmark. The flow line elevation is 90.2 feet. The bankfull stage is at 1.3 feet above the flow line. Highway 93 will be overtopped at 13.1 feet above the flow line. Based on the topography of the area, the estimated channel energy slope is 1.6 percent.

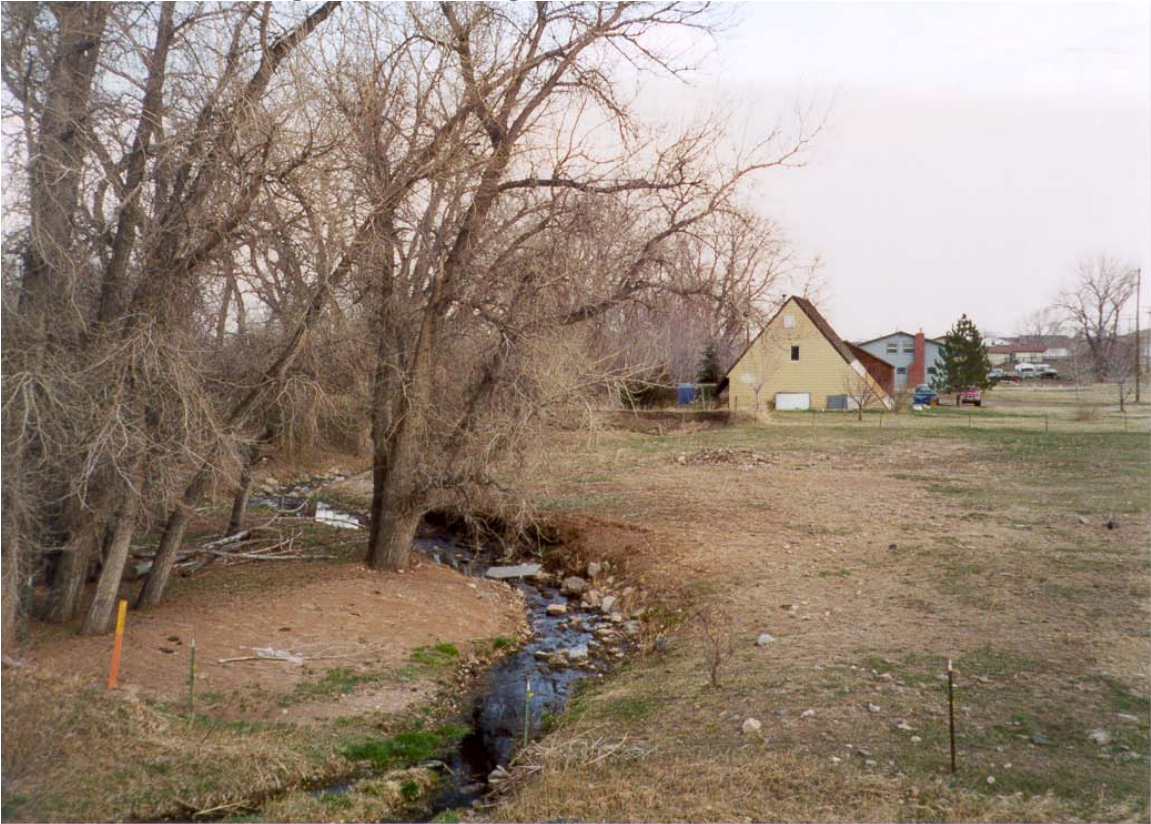
Figure – 3 Looking Downstream after culverts

Several photographs were taken of the site. Figure 3 shows Van Bibber Creek at the gage location looking downstream after the culverts. Figure 4 shows Van Bibber Creek at the gage location looking upstream. Figure 5 is looking downstream through the culverts.

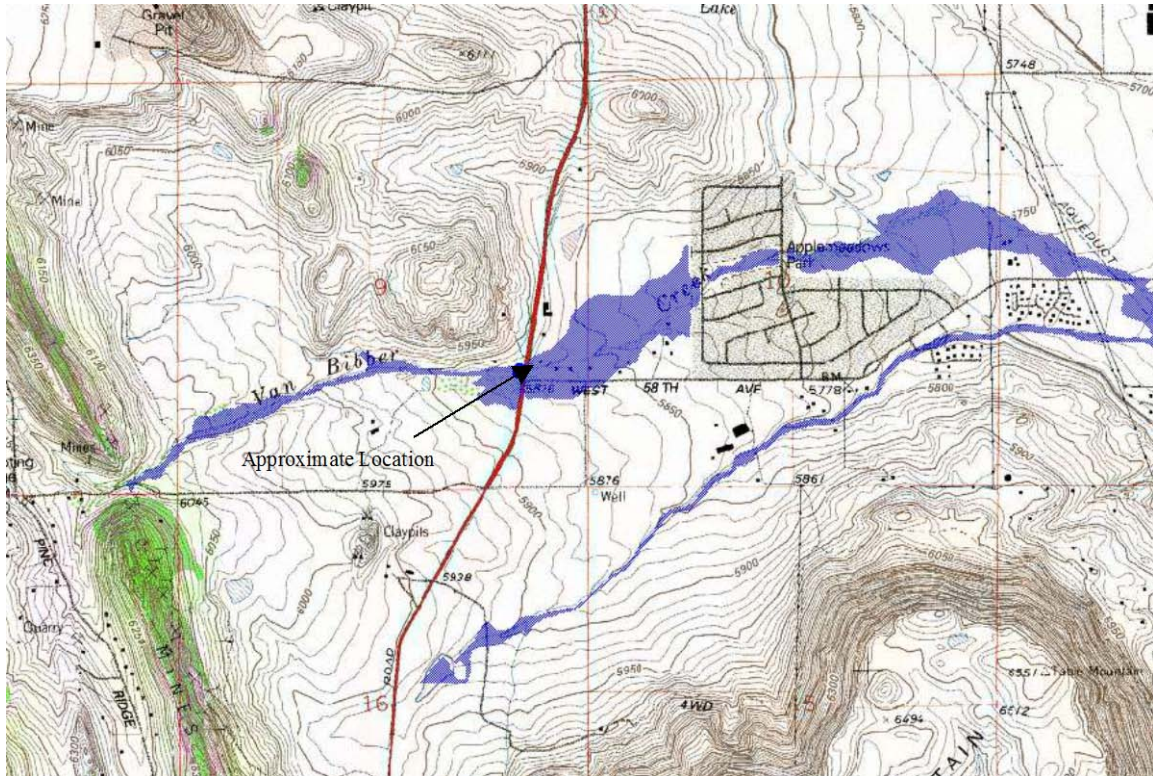
Figure - 6 Approximate 100-Year Flood Boundary As Depicted on District's Annual Flood Hazard Information Brochures

There is limited information available for this gage. The location has been recently converted to a pressure transducer with an ALERT transmitter. Since the gauge installation date in August, 1990, a peak stage of 3.6 feet (corresponding to 560 cfs) was recorded on May 18, 1995. Records of flooding previous to the gauge installation could not be identified during the reconnaissance and library searches. Figure 6 shows the approximate 100-year flood boundary as depicted on district's annual flood hazard information brochures.

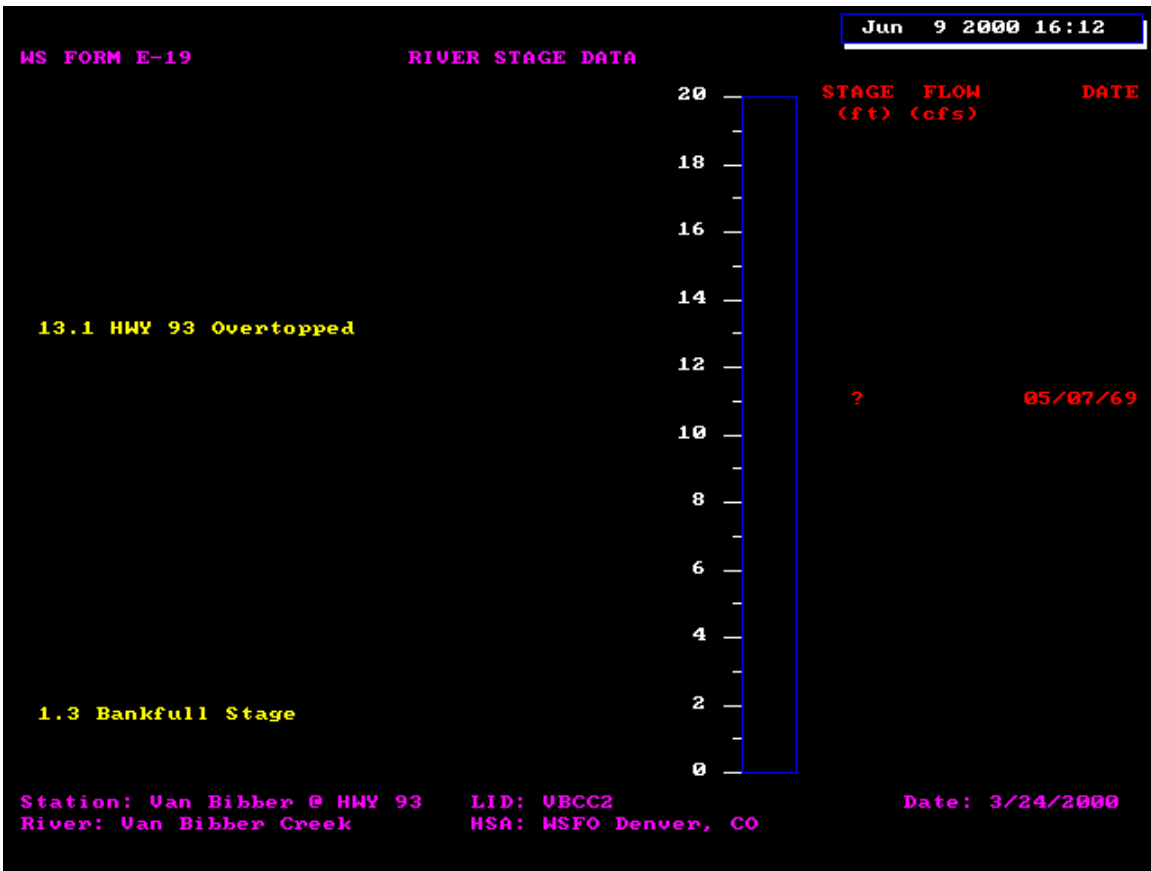
Figure – 7 Graphic Template

The graphics template was created based on the surveyed information, historic records, another information supplied by the Urban Drainage and Flood Control District and the National Weather Service. The graphics template is compatible with the flood warning system and has been created and installed on the District's WebServer. This template is named 333e19.tpt and is located in the appropriate directory in the District's WebServer. Figure 7 shows the graphics template online from the WebServer.
