URBAN DRAINAGE AND FLOOD CONTROL DISTRICT RAIN GAGE SYSTEM AUDIT SITE EVALUATIONS AND DATA ANALYSIS

January 30, 2008

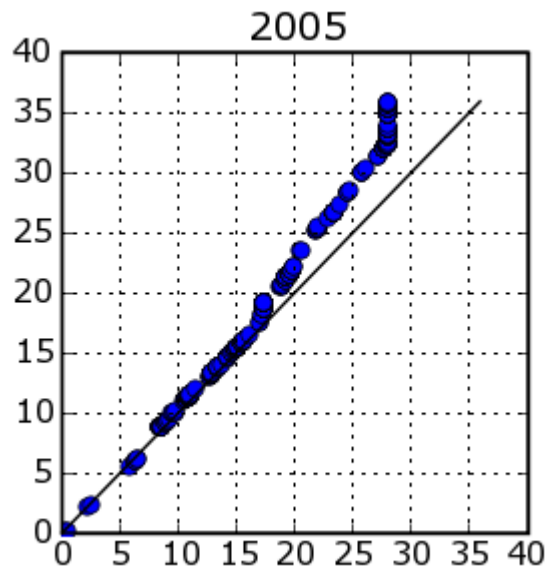
Appendix A is a table of nearest neighbor data for each gage along with pictures and a description of the site. The title on each plot identifies the time period; 2007 for this study. An example plot is shown below.

Figure 2: Example double-mass plot (the units for both axes are inches of accumulation)

Section 4.3 provides insight into methods for interpreting double-mass plots. The general rule of thumb is to give a site a low rating if there are significant changes in the course of the line but this is not a steadfast rule. Significant fluctuations in the slope of the target gage versus average surrounding gage accumulation indicate that the target gage may be faulty.

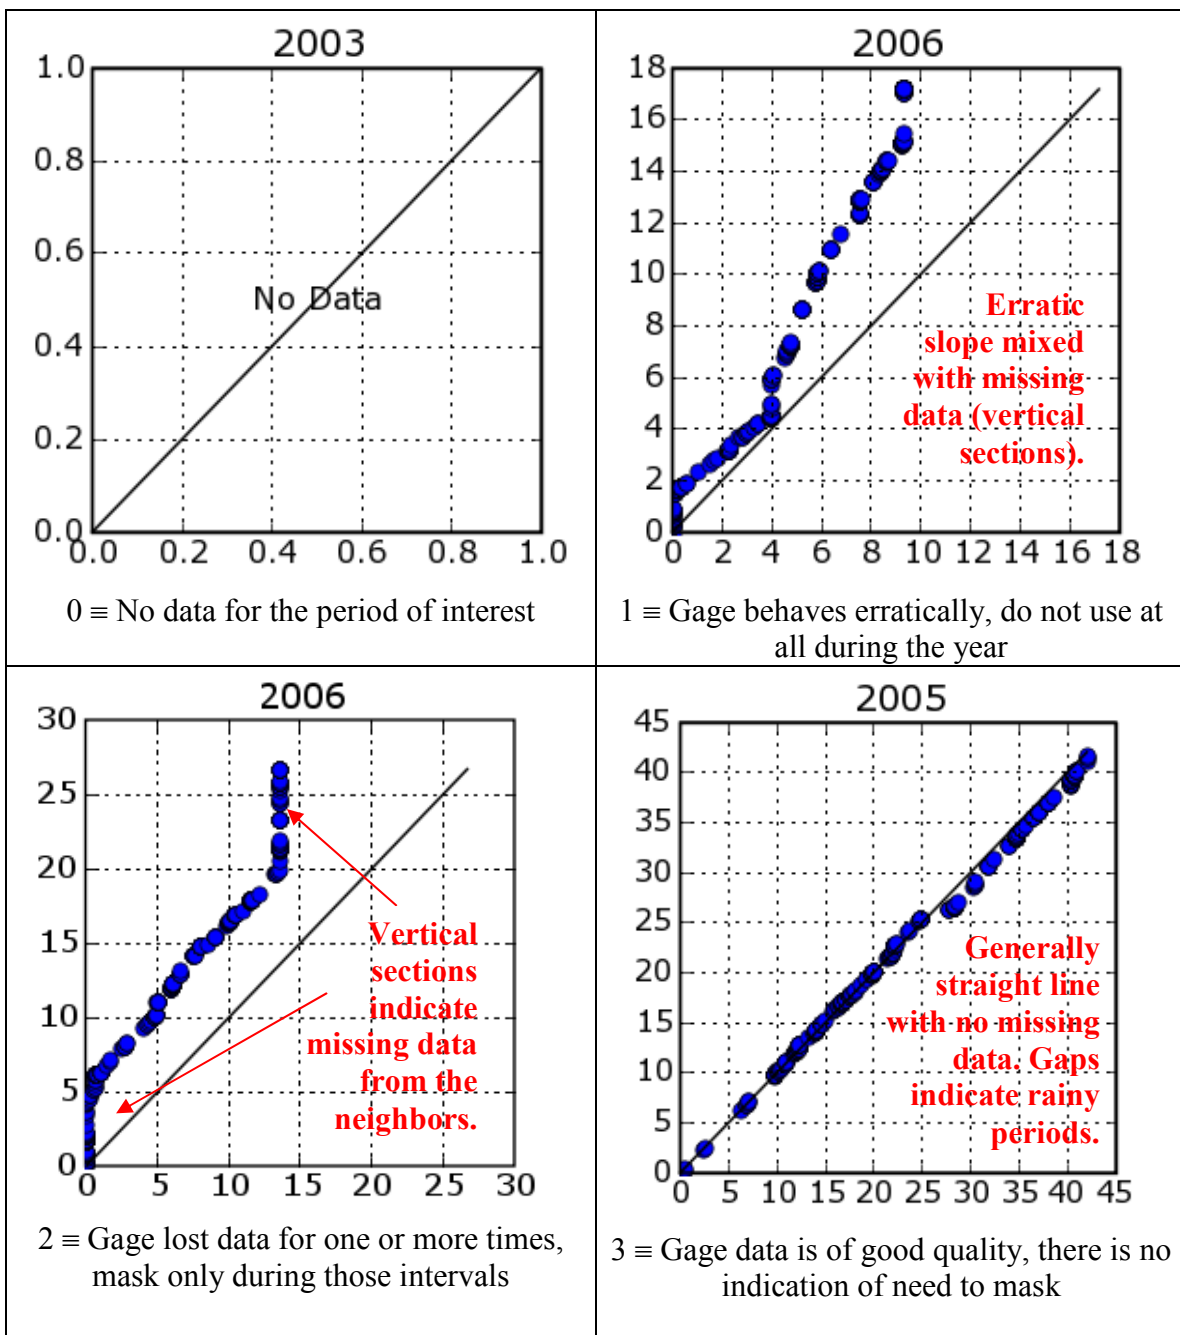
- ◆ 0 ≡ No data for the period of interest
- ◆ 1 ≡ Gage behaves erratically - do not use at all during the year
- ◆ 2 ≡ Gage lost data for one or more times - mask only during those intervals
- ◆ 3 ≡ Gage data is of good quality - there is no indication of need to mask

Examples of double-mass plots that met each of the four evaluation criteria are shown below.

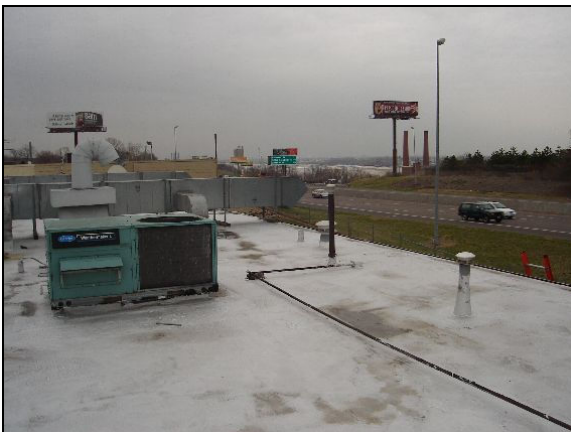
1 ≡ Gage site problems, any information would be completely unreliable
(gage located on top of AC unit)

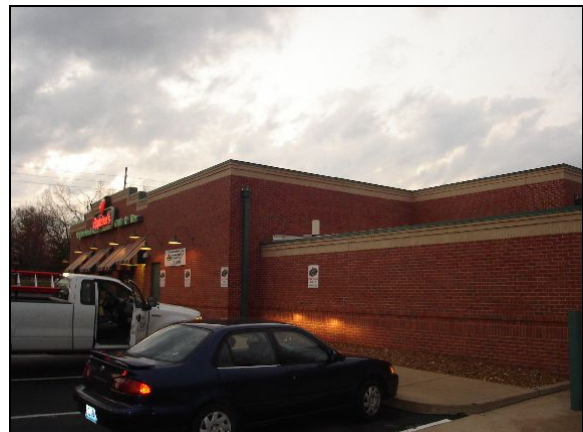
2 ≡ Gage site problems, unlikely that rain catch consistent with actual rainfall
(gage located next to brick wall)

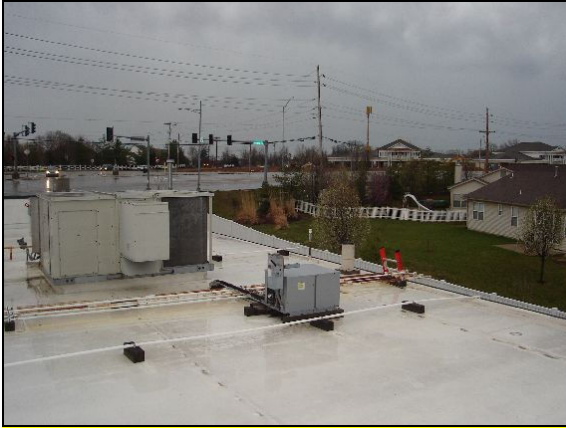
3 \equiv Gage site has problems, each event should be evaluated to determine usefulness for radar rainfall processing (gage located on edge of roof)

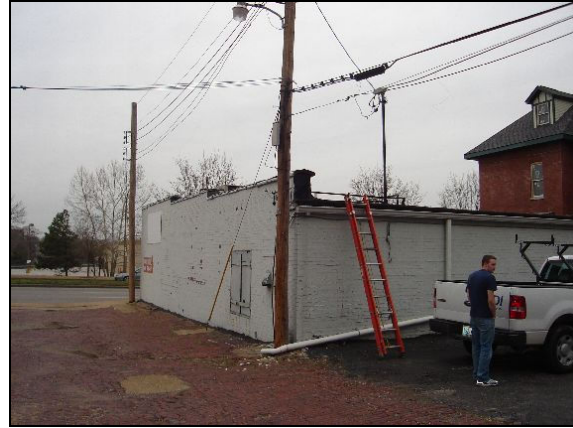
4 \equiv Gage site has some problems, but can generally capture representative rainfall (gage located in center of roof)
