II. THE BOULDER CREEK DRAINAGE BASIN

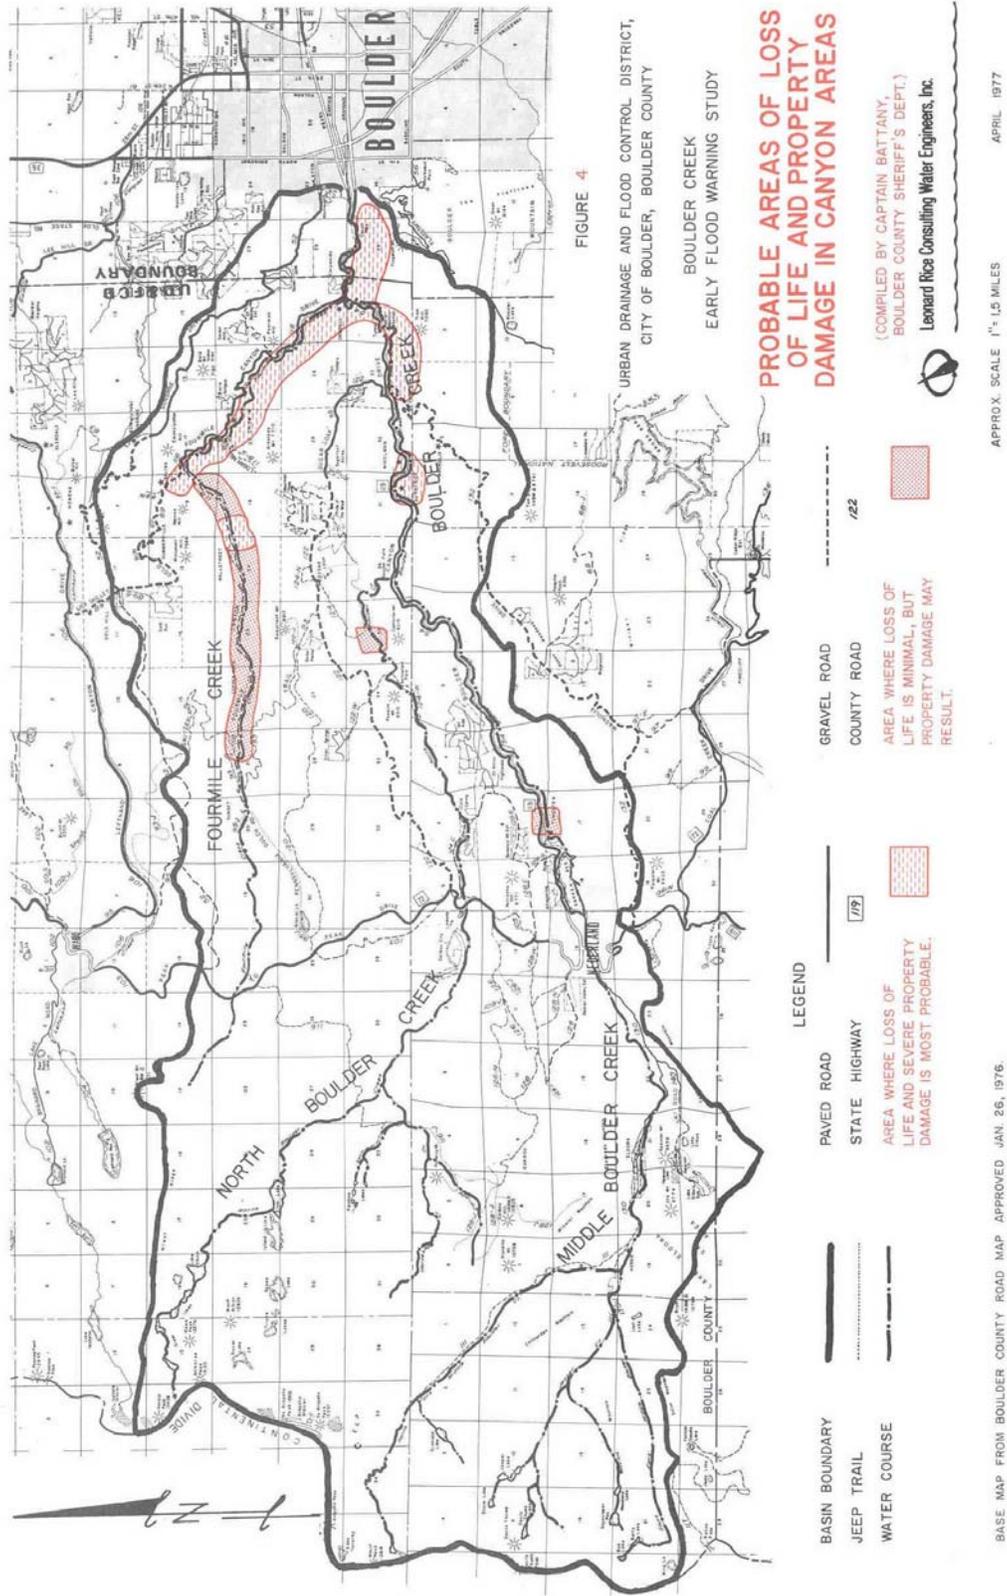
Figure II-4 shows the most probable mountain canyon areas for loss of life and property damage along Fourmile Creek and Boulder Creek.
