UDFCD ALERT Gauging System Maintenance 2017 Annual Report

Kevin Stewart
Urban Drainage and Flood Control District
Denver, Colorado

Prepared By
OneRain Incorporated
1531 Skyway Drive, Unit D
Longmont, Colorado 80504

Report Date: December 22, 2017

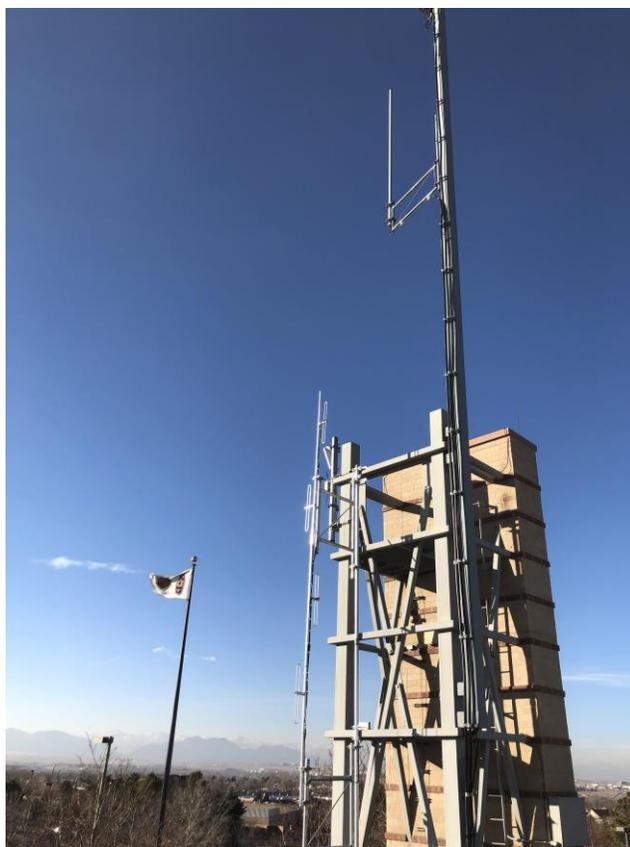
Figure 13: Looking NW

On December 19th, a redundant ALERT2 data receive location was installed at the City of Westminster Public Safety building. Data is received using a DB224 antenna and Blue Water Design B2010 Base Station Receiver/Demodulator (this was UDFCD's spare). Westminster required a minimum visual impact to the north, so the antenna needed to be mounted on the steel structure on the south side of the brickwork. To minimize interference from the steel framework, and maximize reception to the northwest for Lee Hill, it was mounted on standoffs to the south. Pictures show the mounting, and the view to the northwest (Figure 13). The antenna, including feedline and lightning protection, performance was swept with an antenna analyzer and a good match was confirmed.

The cavity filter ordered for the project had not yet arrived at the time of installation, so a spare cavity was retuned and temporarily installed in the radio room.
