Mile High Flood District ALERT Network 2020 End of Year Report

Prepared for: Kevin Stewart Mile Hight Flood District Denver, Colorado

Prepared by: Water & Earth Technologies, Inc. 1225 Red Cedar Circle, Suite A Fort Collins, CO 80524 (970) 225-6080

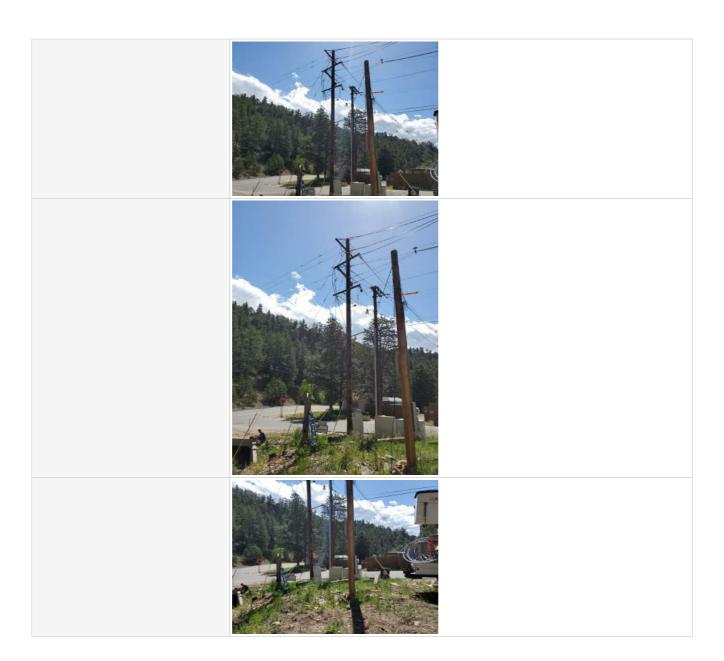
Finishing Comments	
Final Comments	PT reading way too low. Did a 6 point calibration and got an offset of -0.21. Changed from -0.63 New power lines right above and electrical boxes around the standpipe. Most likely what is effecting the transmissions. Decoded data, radio is working great.
Depart Time	10:50 AM (-6 GMT)
Photos
