MHFD ALERT Gauging System Maintenance 2020 Annual Report

Kevin Stewart
Mile High Flood District
Denver, Colorado

Prepared By
OneRain Incorporated
1531 Skyway Drive, Unit D
Longmont, Colorado 80504

Report Date: December 16, 2020

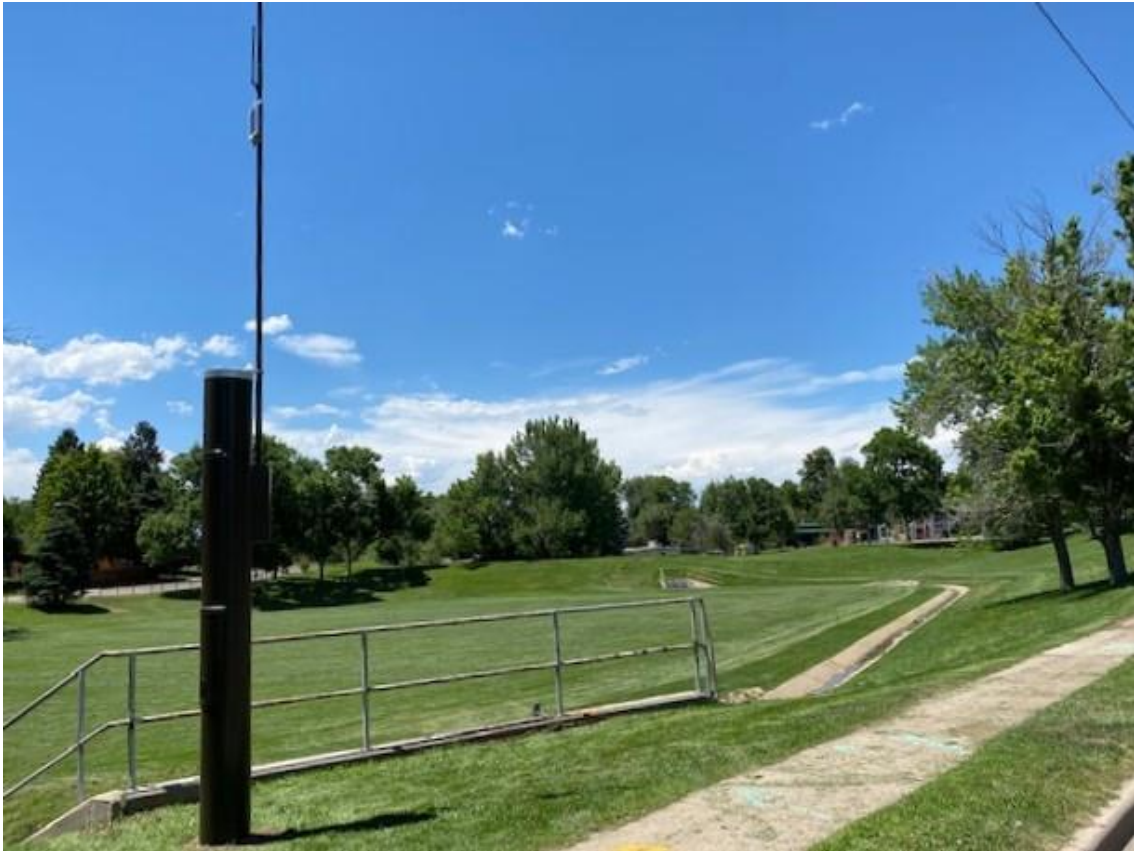
A new ALERT2 stage and rain gauge was installed for the City of Englewood on June 24th. This site was paid for by the City of Englewood but shares the MHFD backbone of repeaters and base stations. Its ALERT2 source address is 10087.

Figure 9: Rotolo Park ALERT2 rain and stage gauge

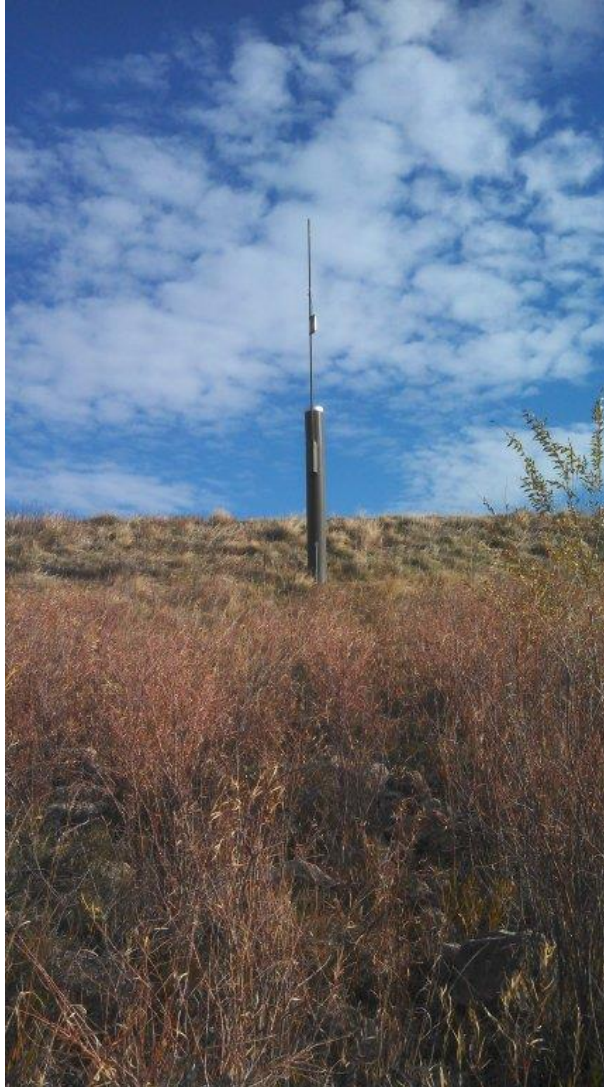
Leyden Reservoir was upgraded to ALERT2 on July 2nd 2020. OneRain installed an HSE 3306-02 transmitter with a GPS antenna. At the request of the MHFD, this site will be operational year-round. Its ALERT2 source address is 10088.

Figure 10: Leyden Reservoir standpipe

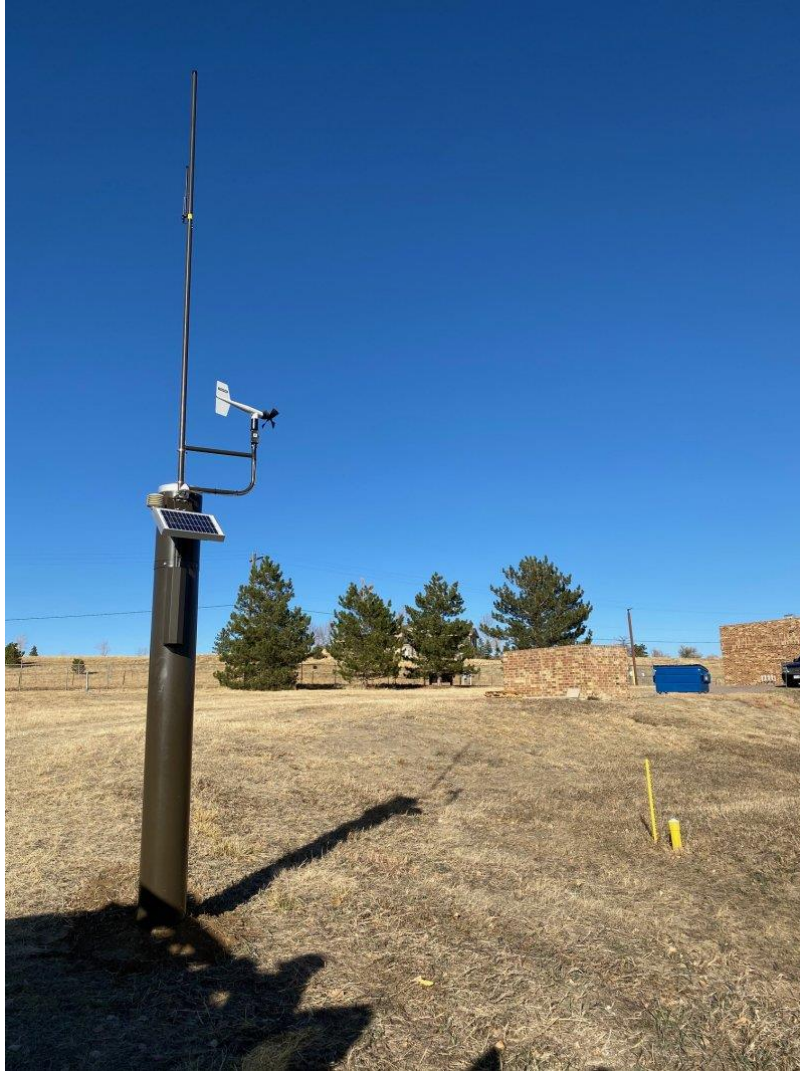
A new ALERT2 weather station was installed for the City of Louisville on November 25th. Like Rotolo Park, this site shares the MHFD backbone and was paid for separately by the City of Louisville. This ALERT2 site reports rain, air temperature, relative humidity, barometric pressure, and wind. Its ALERT2 Source address is 10090

Figure 12: Howard Berry ALERT2 weather station.

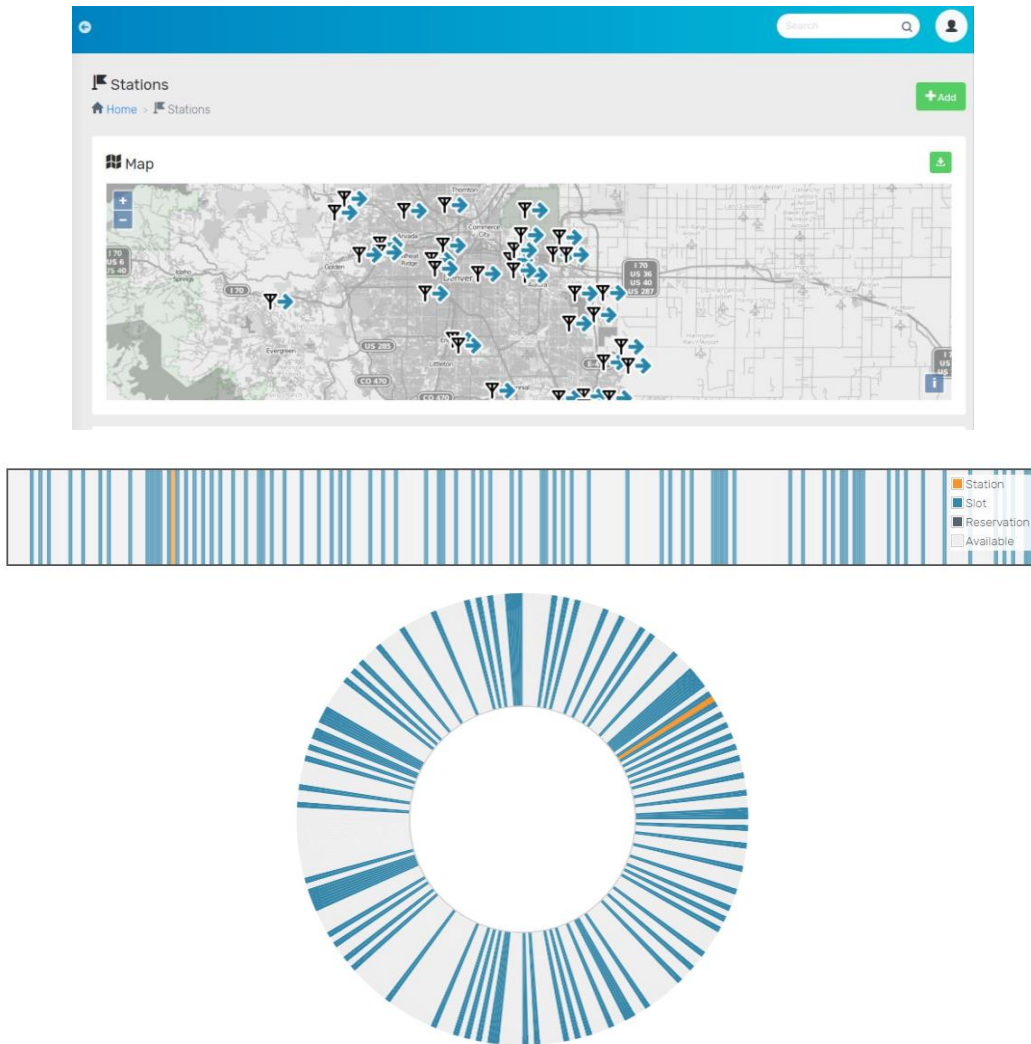
Figure 14: MHFD ALERT2 sites and TDMA timeslots.

Figure 14 was taken from tdma.onerain.com and highlights the ALERT2 sites in Denver (top) and all the slots currently used in the MHFD system (bottom). There are currently 78 ALERT2 sites in total which puts the system at 35% capacity.

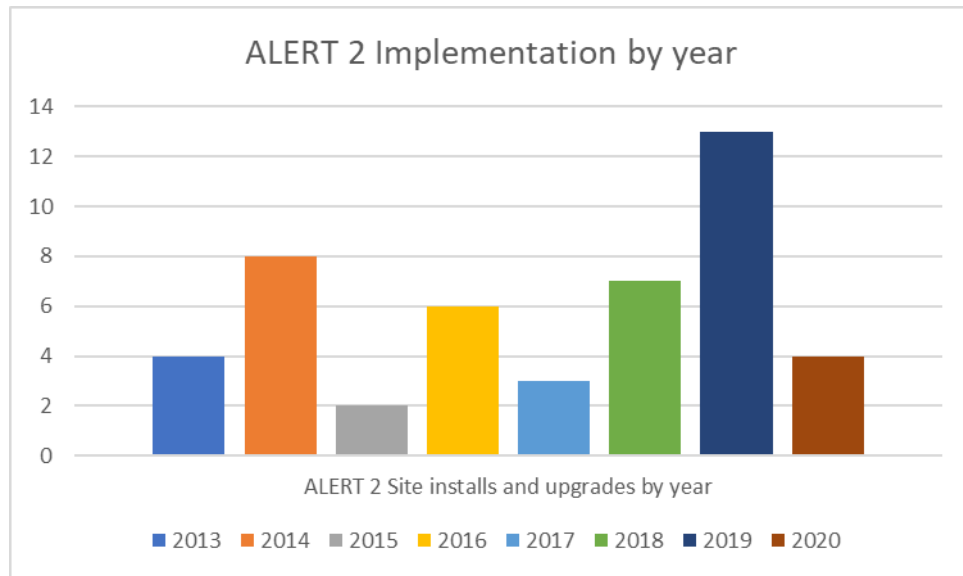
Figure 15: ALERT2 sites added to the MHFD system by year.
