Urban Drainage and Flood Control District

E-19 Survey

Cherry Creek below Bayou Gulch
Alert Station ID: 2850

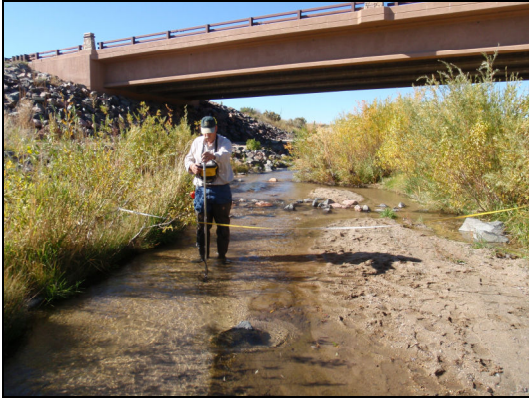
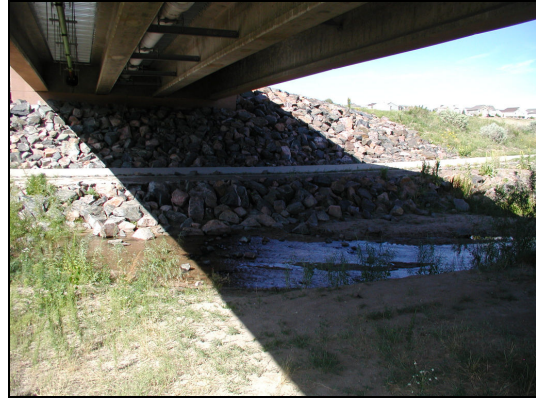
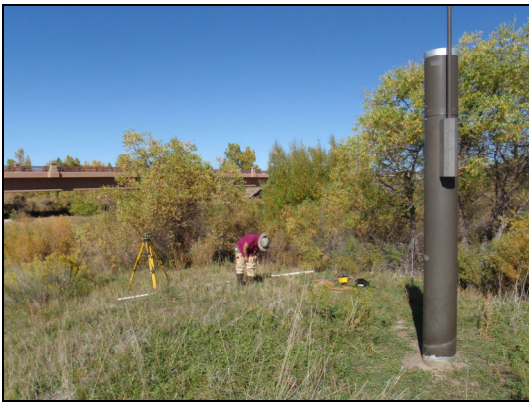
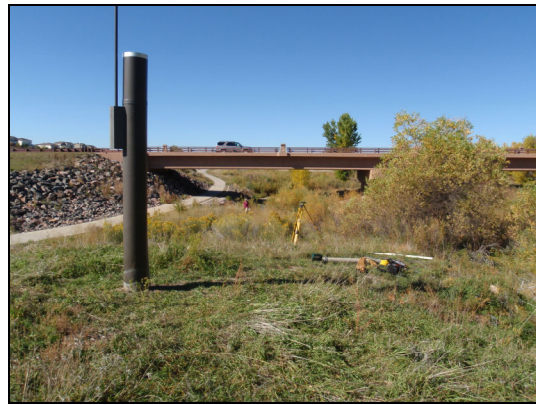
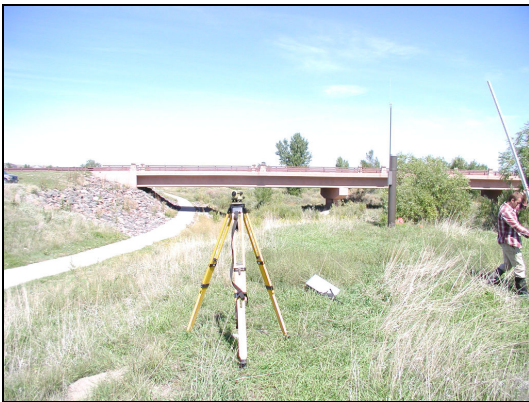
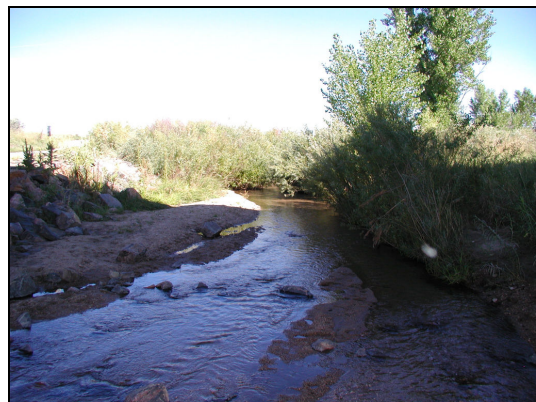
Photos taken during cross section survey and direct flow measurement in August 2008.

The ALERT monitoring station is located several hundred feet upstream of the East Bayou Gulch Road Bridge. The bridge, built in 2002, can safely pass the 100-year discharge with one foot of freeboard. The hydraulic design information associated with the bridge is shown (Table 4) along with a schematic profile drawing of the bridge (Figure 6). Photos showing the bridge and stream taken during the fieldwork to complete the cross section survey are shown in the following pages.

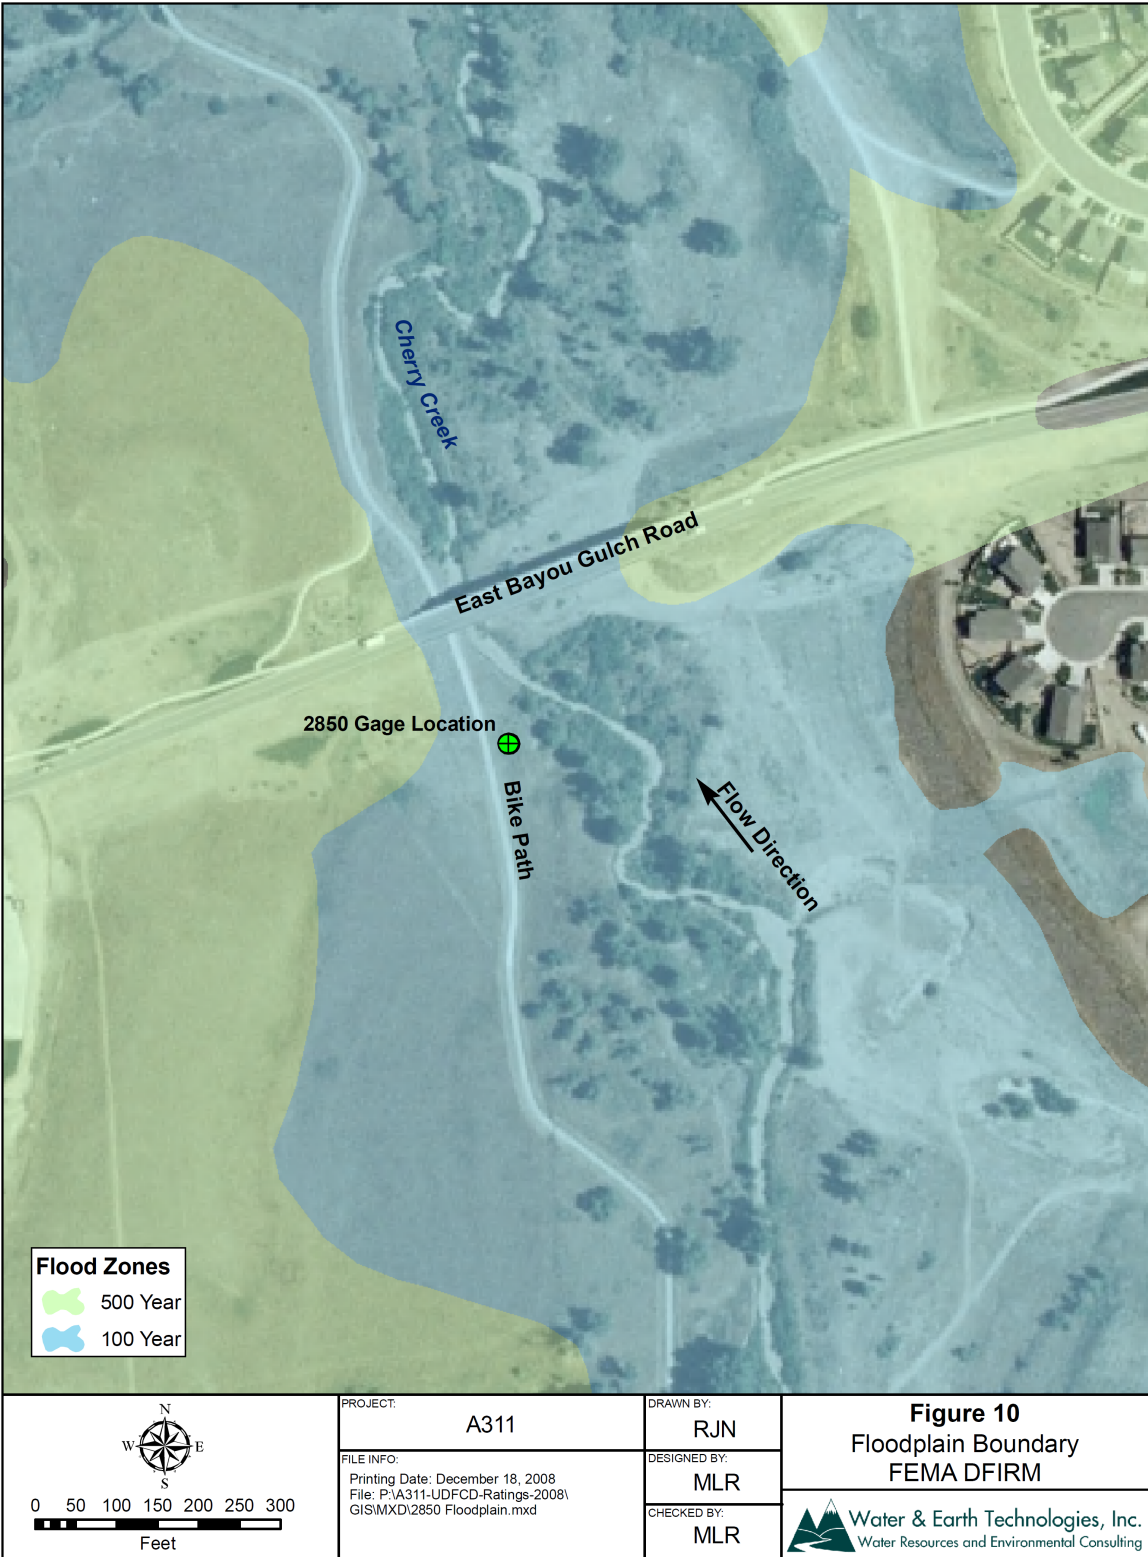
Figure 10. Floodplain Boundaries near the East Bayou Gulch Road Bridge

The Pinery West and Pinery Southwest residential developments are adjacent to Cherry Creek east and west of the gage location. These developments are generally elevated above the 500-year floodplain for Cherry Creek (Figure 10). In terms of flooding, the primary concern is the bike path and the west roadway approach to East Bayou Gulch Road Bridge.
