# Memo

**Date:** February 13, 2006  
**To:** Kevin Stewart, P.E., Chad Kudym  
**From:** Markus Ritsch, P.E.  
**Subject:** January 2006 ALERT Data Analysis

## I. ALERT Data Source

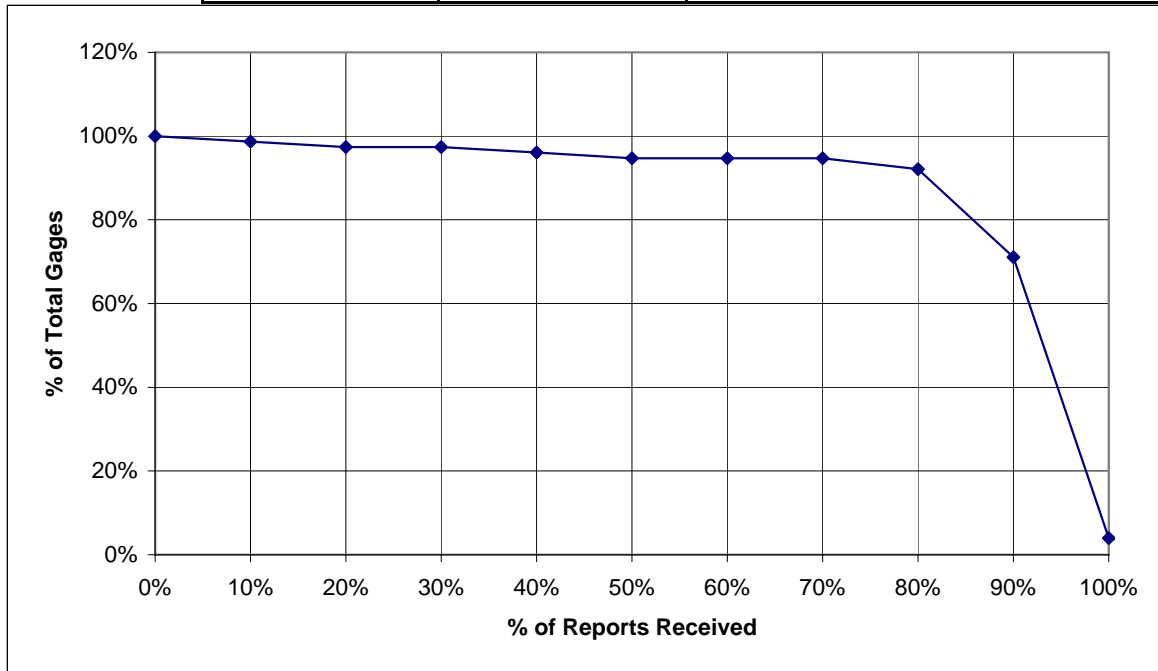
## Rain Timer Performance

total number of gages 76		
% of reports received	frequency	% of gages receiving % or reports or greater
0%	0	100%
10%	1	99%
20%	1	97%
30%	0	97%
40%	1	96%
50%	1	95%
60%	0	95%
70%	0	95%
80%	2	92%
90%	16	71%
100%	51	4%

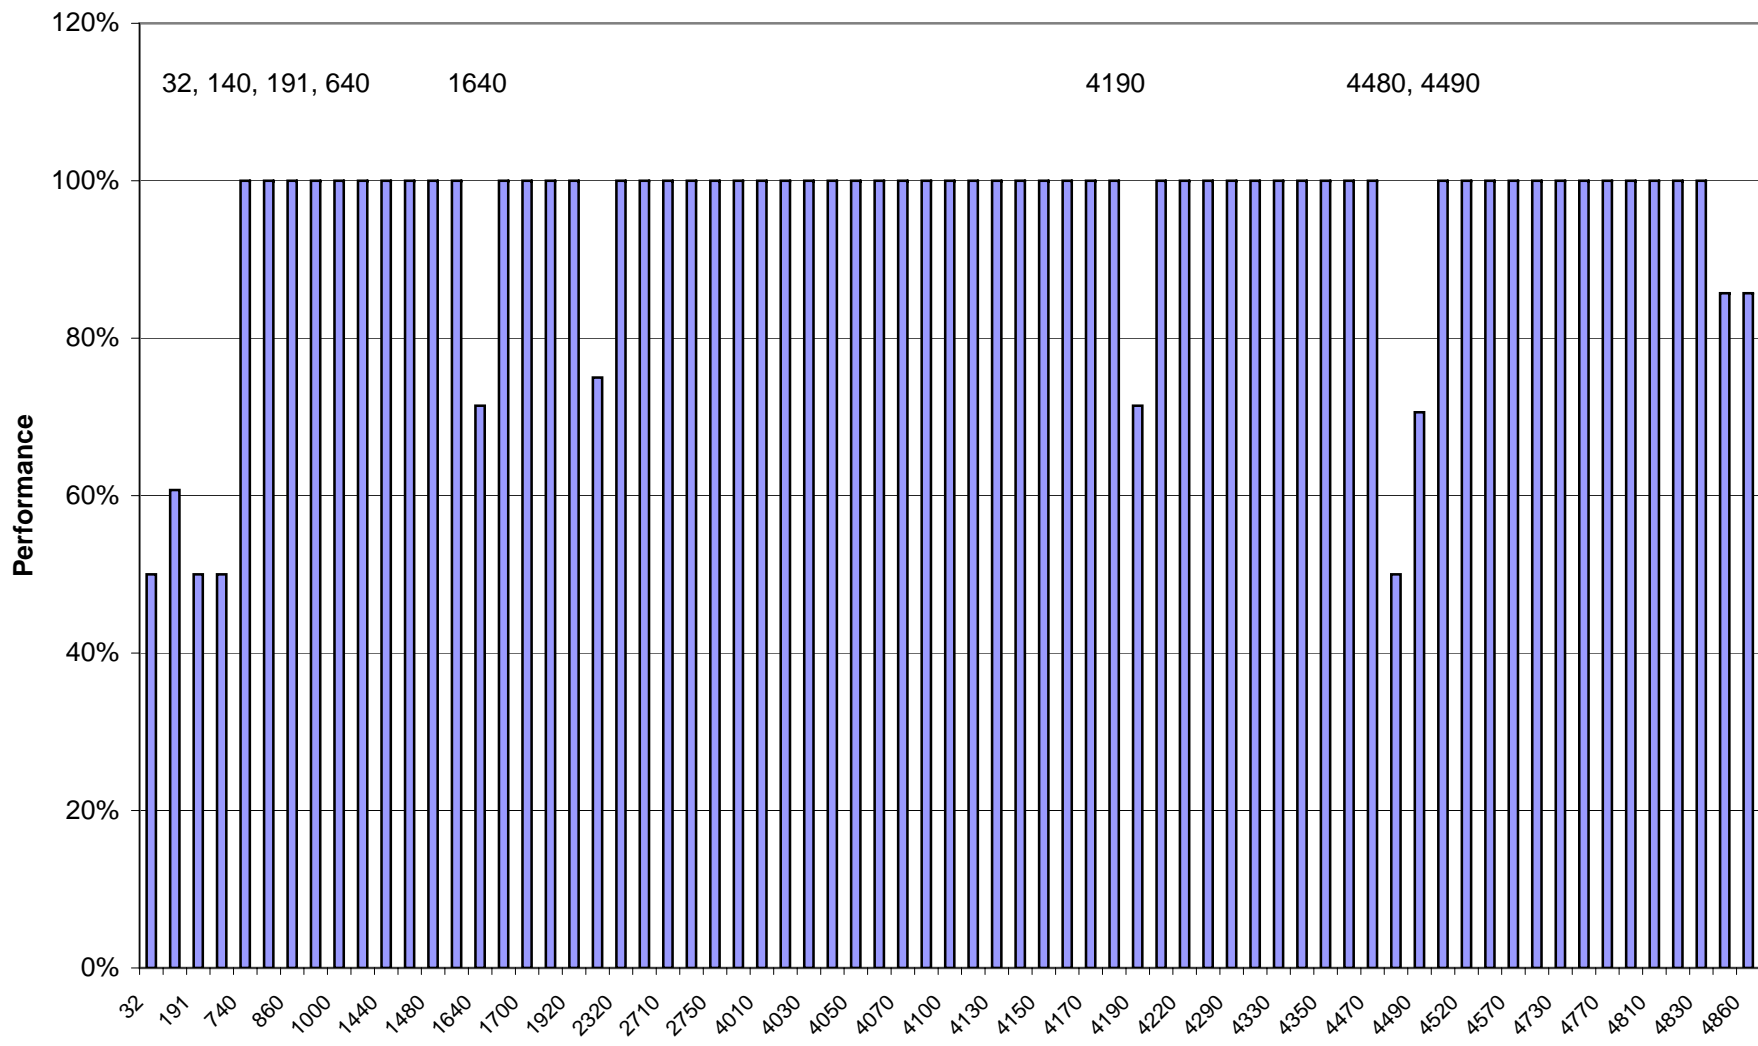
### Rain Event Performance

sensors with performance <75% noted

We recommend further observation of data from these sensors (ID 640, 1640, and 4490) to see if the problems persist into months with more precipitation.
