APPENDIX

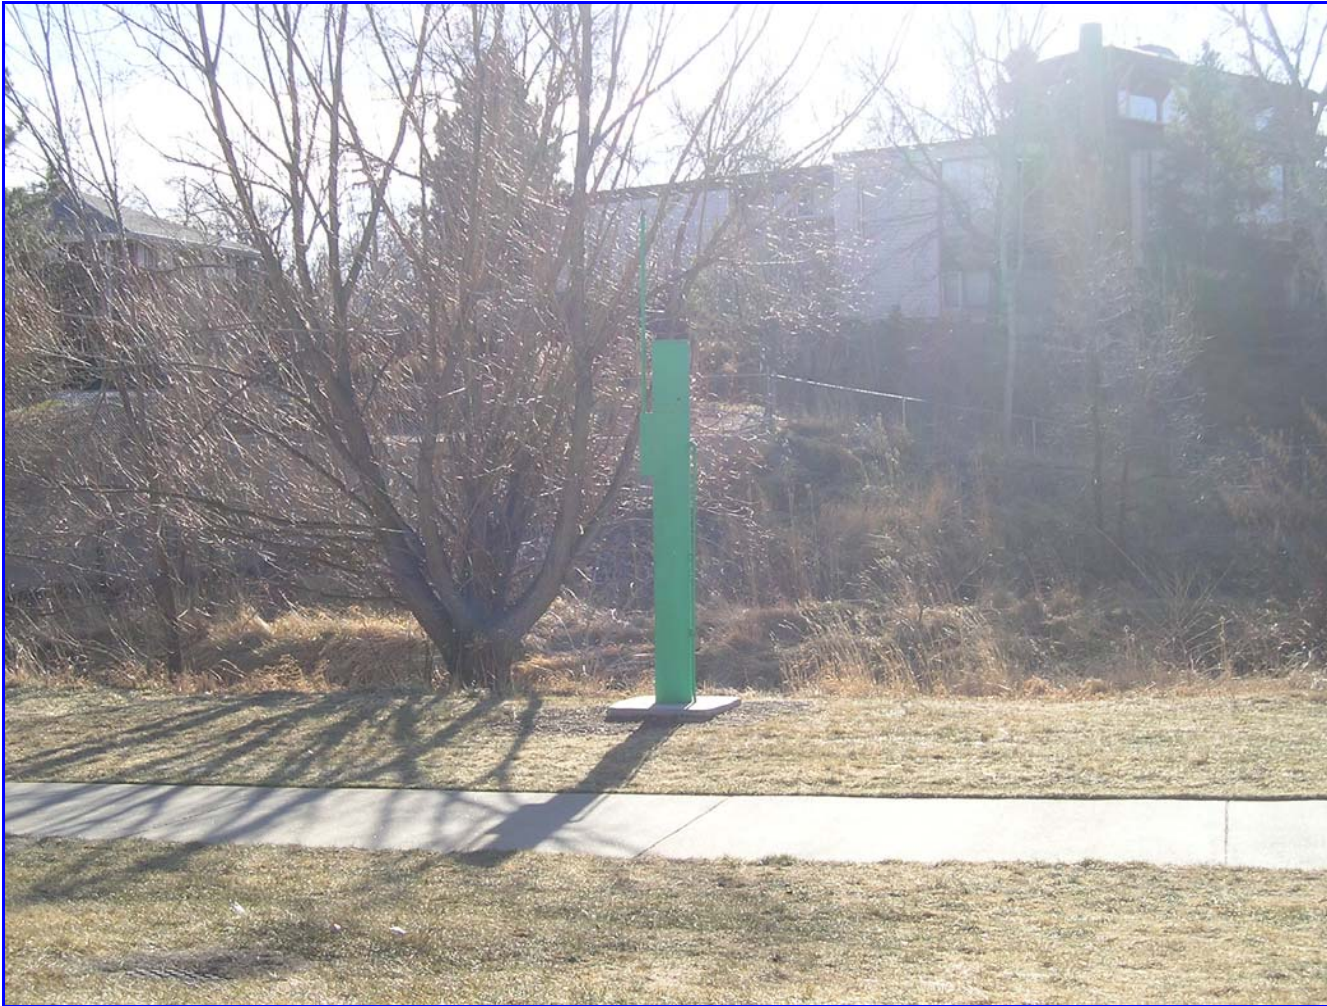
Name	ID	Sensor Type	Date Installed	Latitude	Longitude	Elevation	Gage Height	Anemometer Height	Temperature Sensor Height	Ground type
Car Street	100	P, S	5/30/88	39:48:17 N	-105:05:27 W	5322'	9'2"	N/A	N/A	Grass

Comments: Gage obstruction due to tree to the southeast.

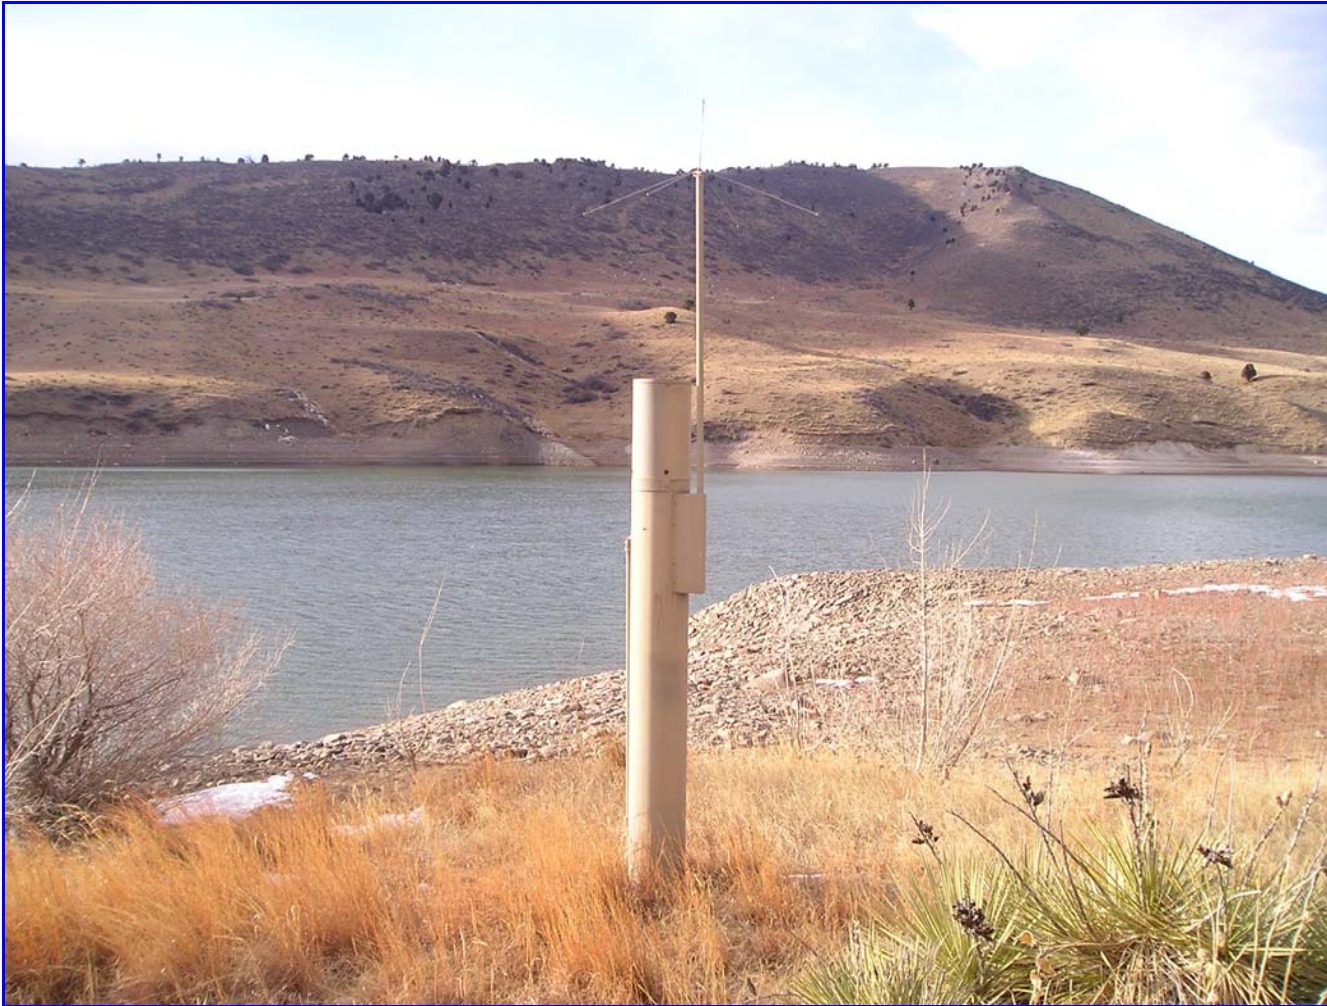
Name	ID	Sensor Type	Date Installed	Latitude	Longitude	Elevation	Gage Height	Anemometer Height	Temperature Sensor Height	Ground type
Ralston Reservoir	110	P, S	9/23/88	39:49:22 N	-105:14:46 W	6033'	9'2"	N/A	N/A	Scrub grass

Comments: Gage located about 25 feet from reservoir. Locked gate. Need permission from Denver water to access.

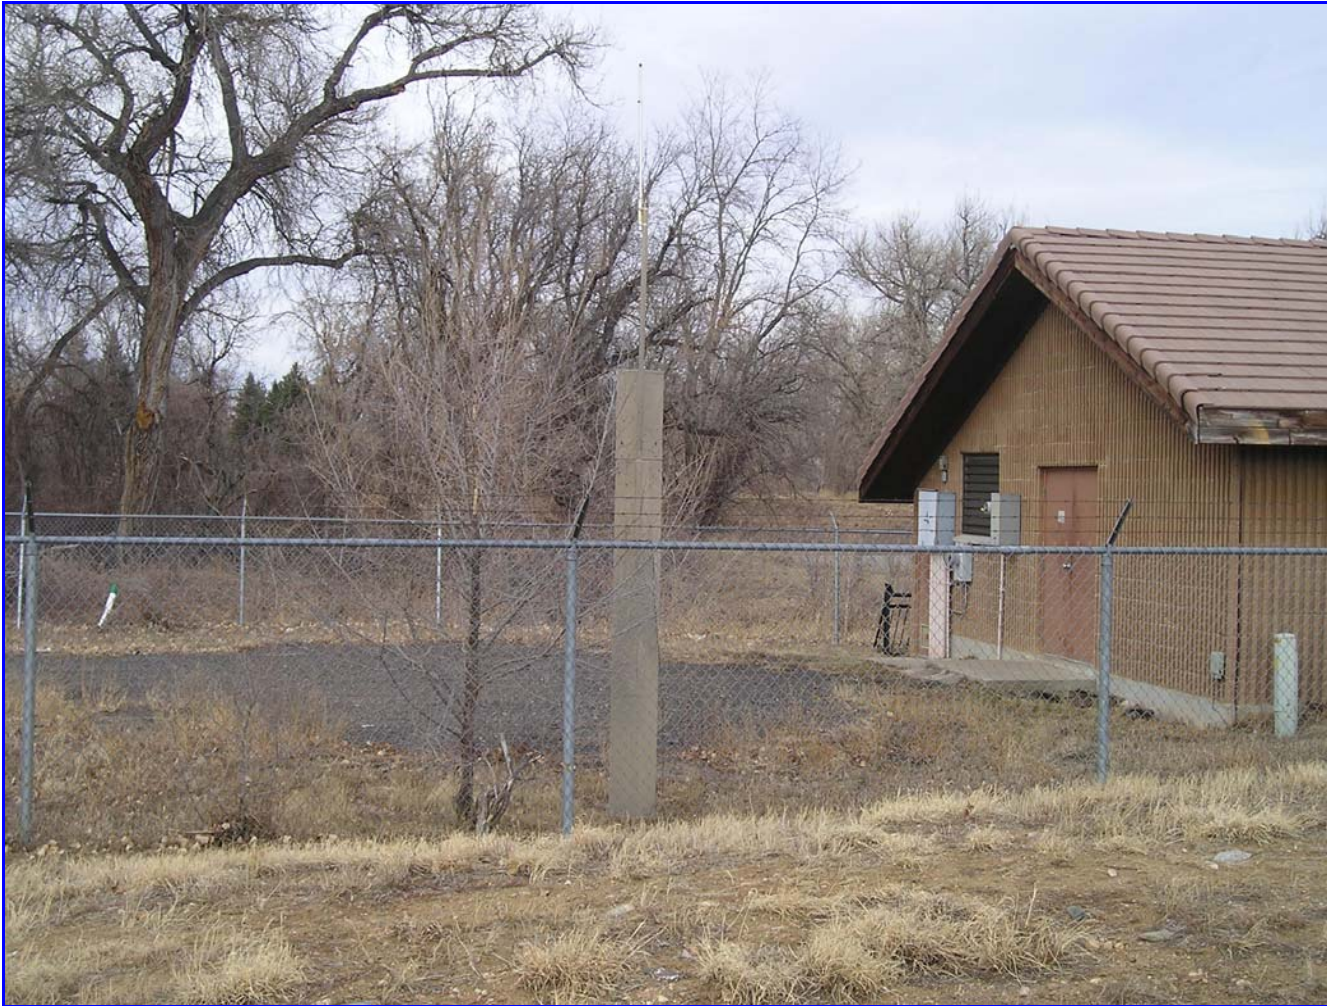
Name	ID	Sensor Type	Date Installed	Latitude	Longitude	Elevation	Gage Height	Anemometer Height	Temperature Sensor Height	Ground type
West Woods	120	P, S	8/21/89	39:49:12 N	-105:10:24 W	5590'	9'5"	N/A	N/A	Scrub grass

Comments: Locked gate. Gage located about 4' from gate. West Woods golf course.

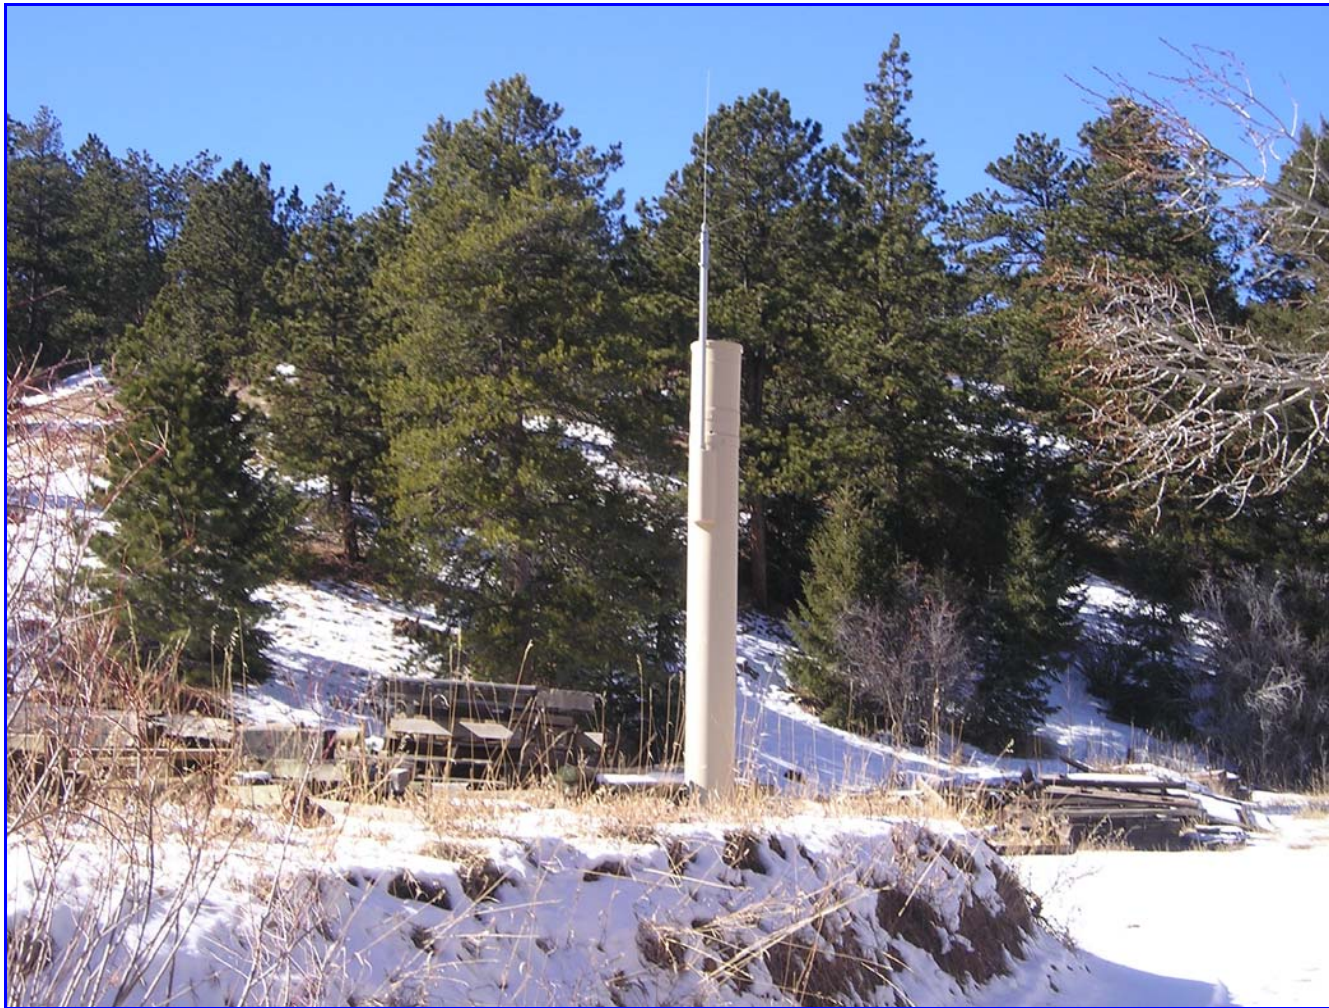
Name	ID	Sensor Type	Date Installed	Latitude	Longitude	Elevation	Gage Height	Anemometer Height	Temperature Sensor Height	Ground type
Blue Mountain	140	Wx/R	04/25/91	39:52:12N	105:17:48W	8050'	9'11"	11'3"	10'4"	Scrub grass

Comments: Pine trees ~20' to the southwest, and west. Moisture sensor ~25 to West, 2.5' off the ground

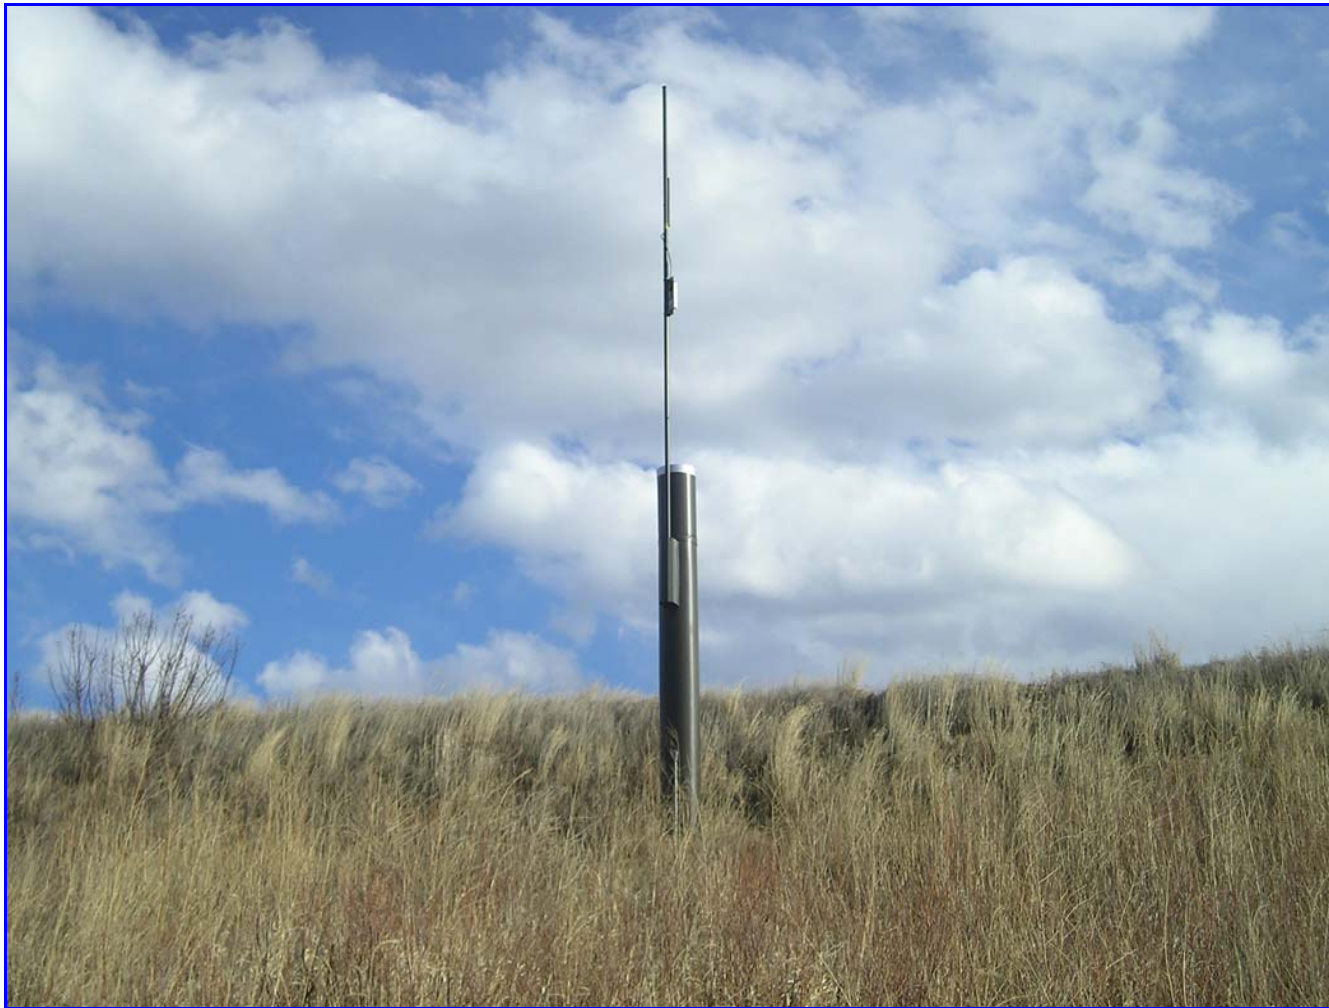
Name	ID	Sensor Type	Date Installed	Latitude	Longitude	Elevation	Gage Height	Anemometer Height	Temperature Sensor Height	Ground type
Knott Creek	150	P	04/09/91	39:51:08 N	105:21:58 W	7815'	9'4"	N/A	N/A	Scrub grass

Comments: Locked gate at trailhead. Located about 0.50 miles above trailhead.

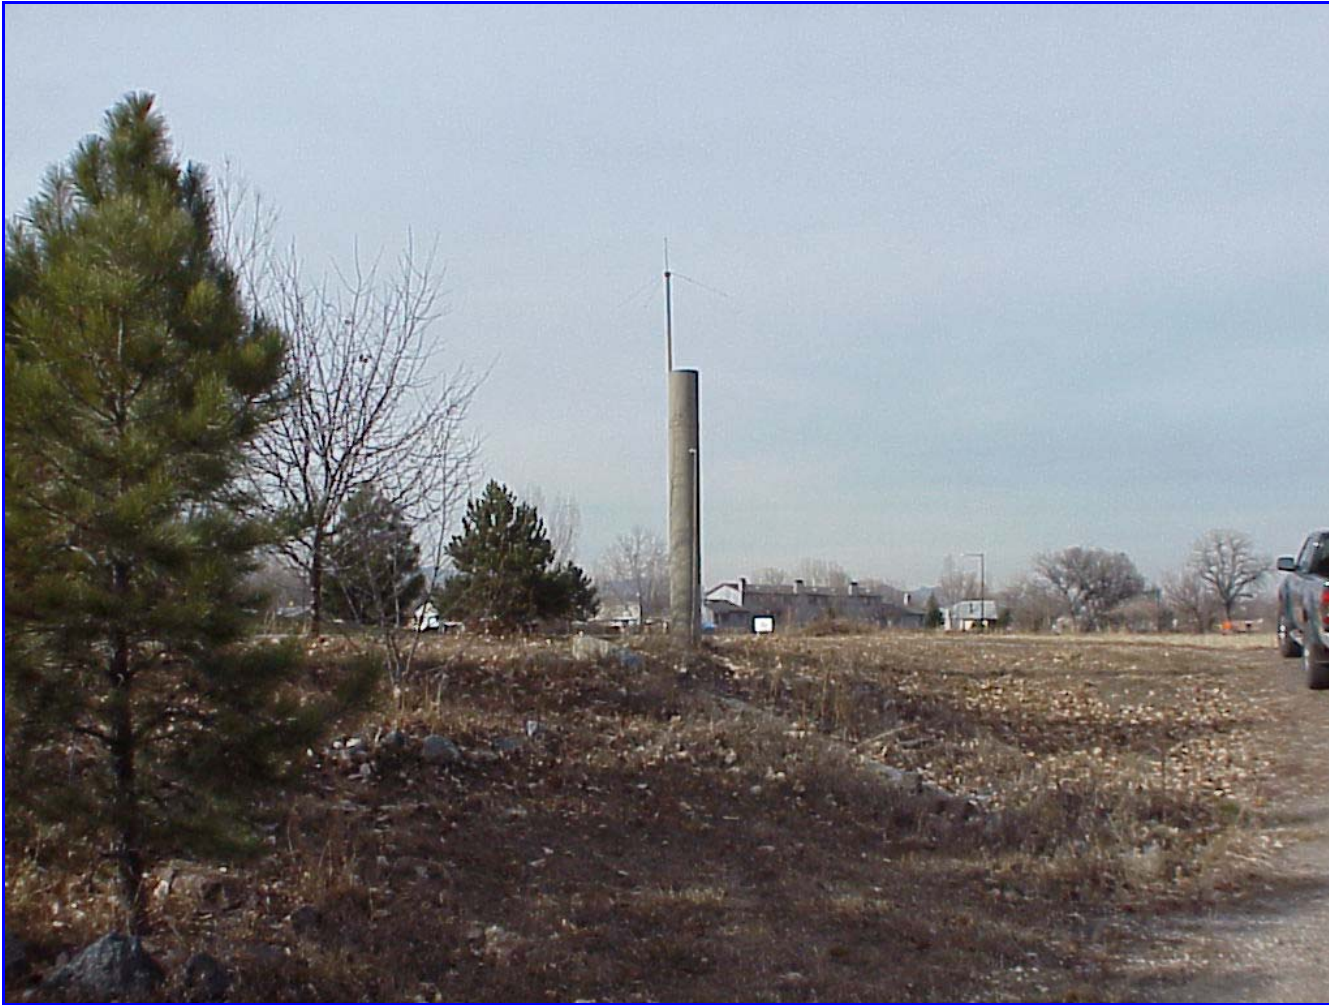
Name	ID	Sensor Type	Date Installed	Latitude	Longitude	Elevation	Gage Height	Anemometer Height	Temperature Sensor Height	Ground type
Leyden Reservoir	200	P, S	05/30/88	39:50:24 N	105:10:02 W	5603'	9'8"	N/A	N/A	Scrub grass

Comments: Gage located on a 45-degree incline. Locked gate on access road.

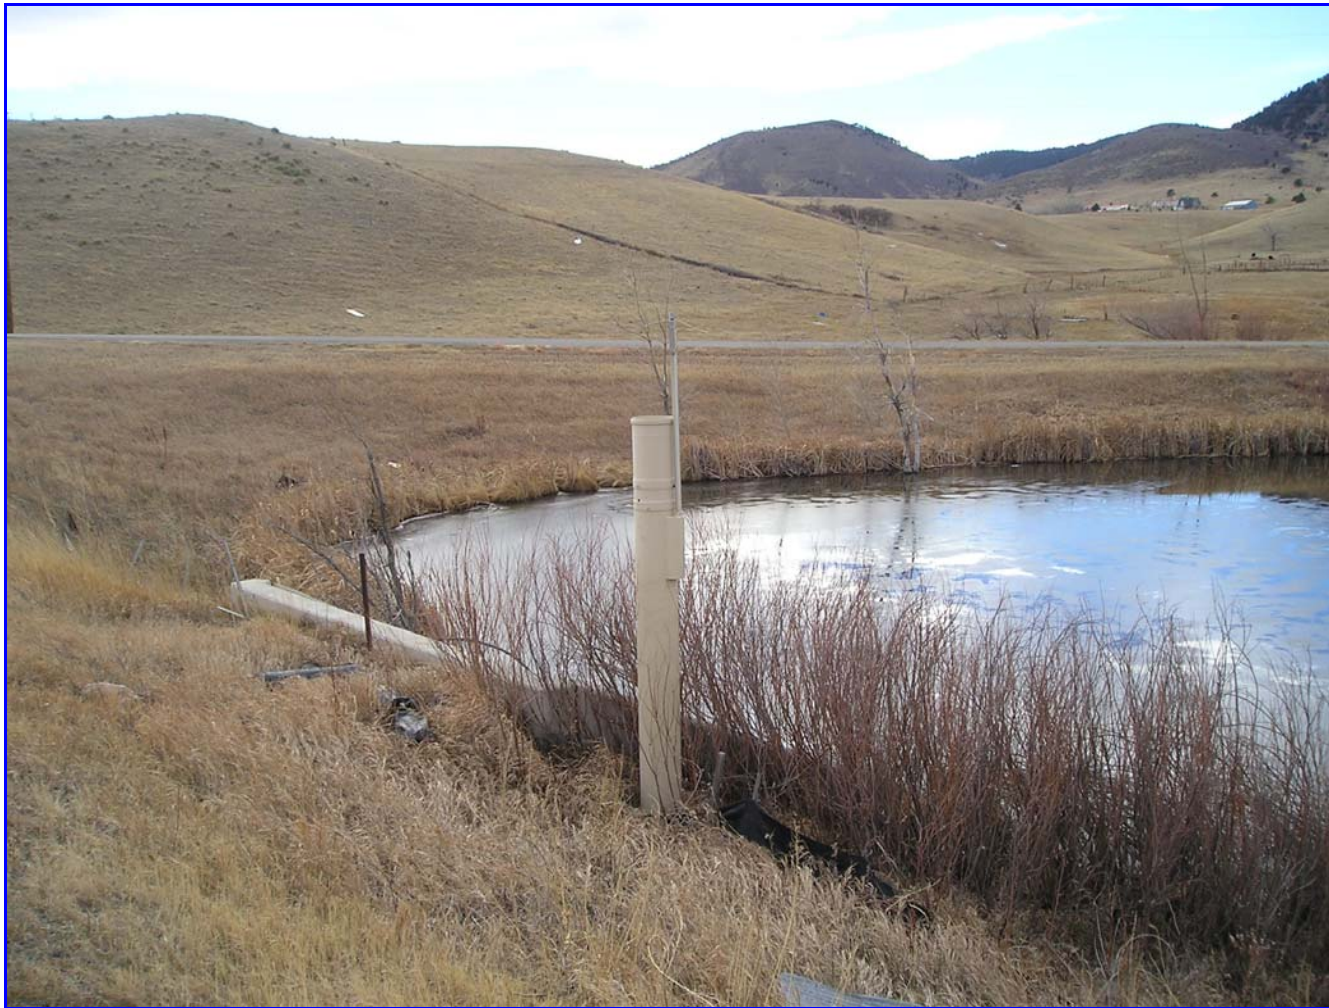
Name	ID	Sensor Type	Date Installed	Latitude	Longitude	Elevation	Gage Height	Anemometer Height	Temperature Sensor Height	Ground type
Leyden Confluence	210	P, S	08/02/89	39:49:21 N	105:07:22 W	5430'	9'8"	N/A	N/A	Grass

Comments: Two story house ~35' to the west.

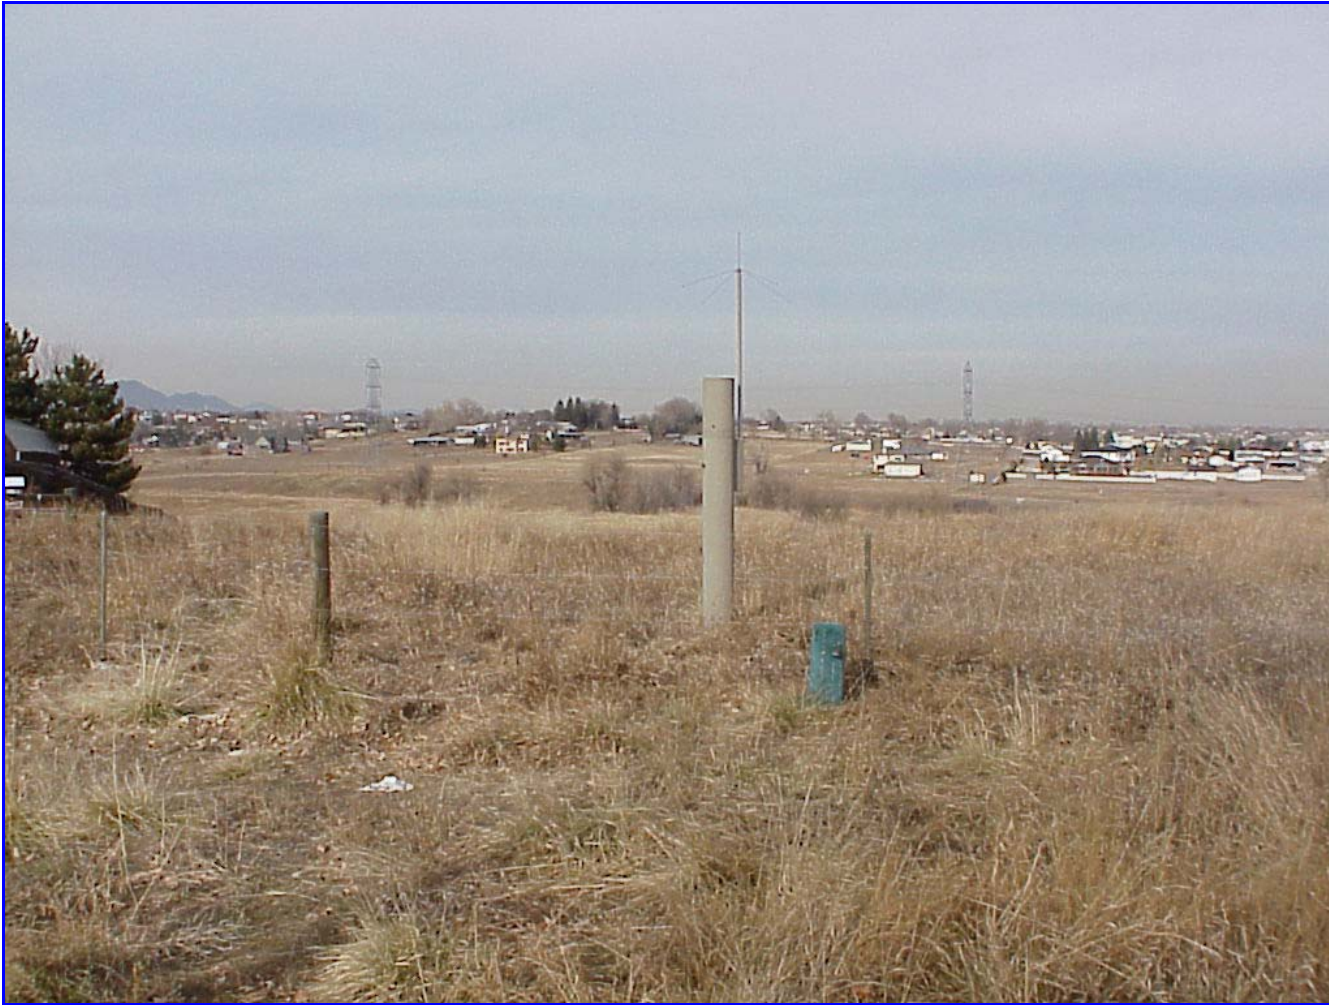
Name	ID	Sensor Type	Date Installed	Latitude	Longitude	Elevation	Gage Height	Anemometer Height	Temperature Sensor Height	Ground type
Upper Leyden	220	P	08/14/90	39:50:40 N	105:14:02 W	6000'	9'6"	N/A	N/A	Scrub grass

Comments: Gage visible from Hwy. 93. Pond ~ 10' to west.

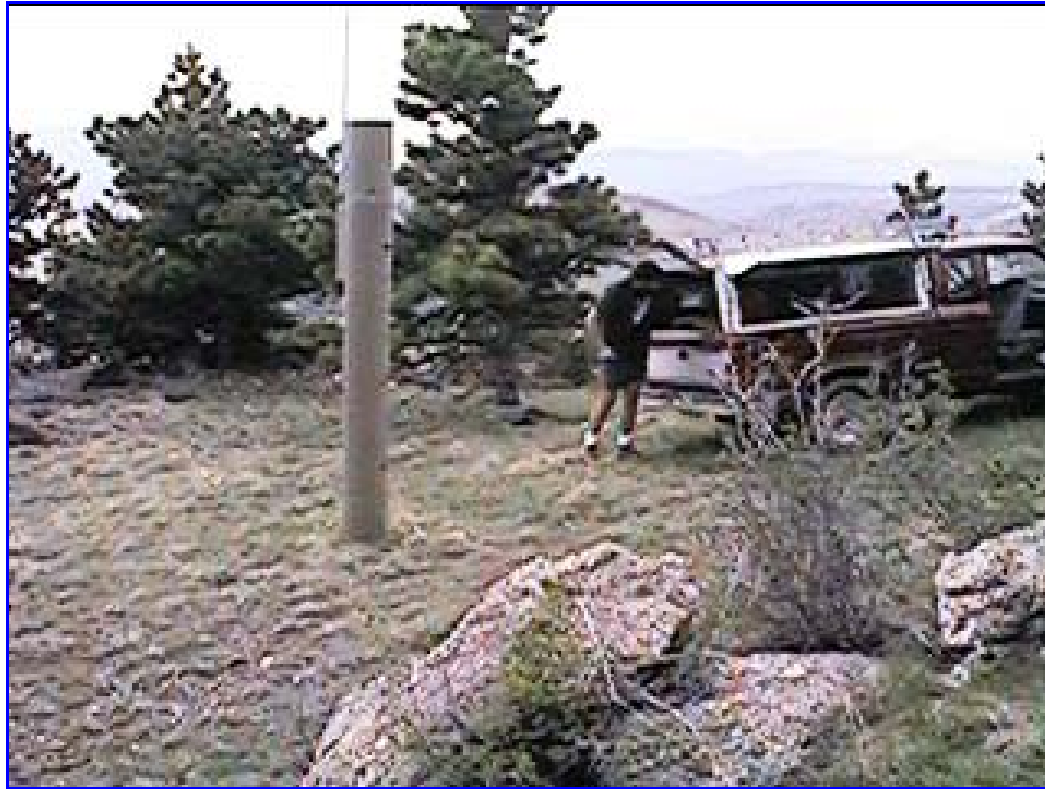
Name	ID	Sensor Type	Date Installed	Latitude	Longitude	Elevation	Gage Height	Anemometer Height	Temperature Sensor Height	Ground type
Guy Hill Ranch	310	P	05/30/88	39:47:48 N	105:19:51 W	8320	10'2"	N/A	N/A	Grass

Comments: Located off of a private road, Guy Hill Ranch Rd.

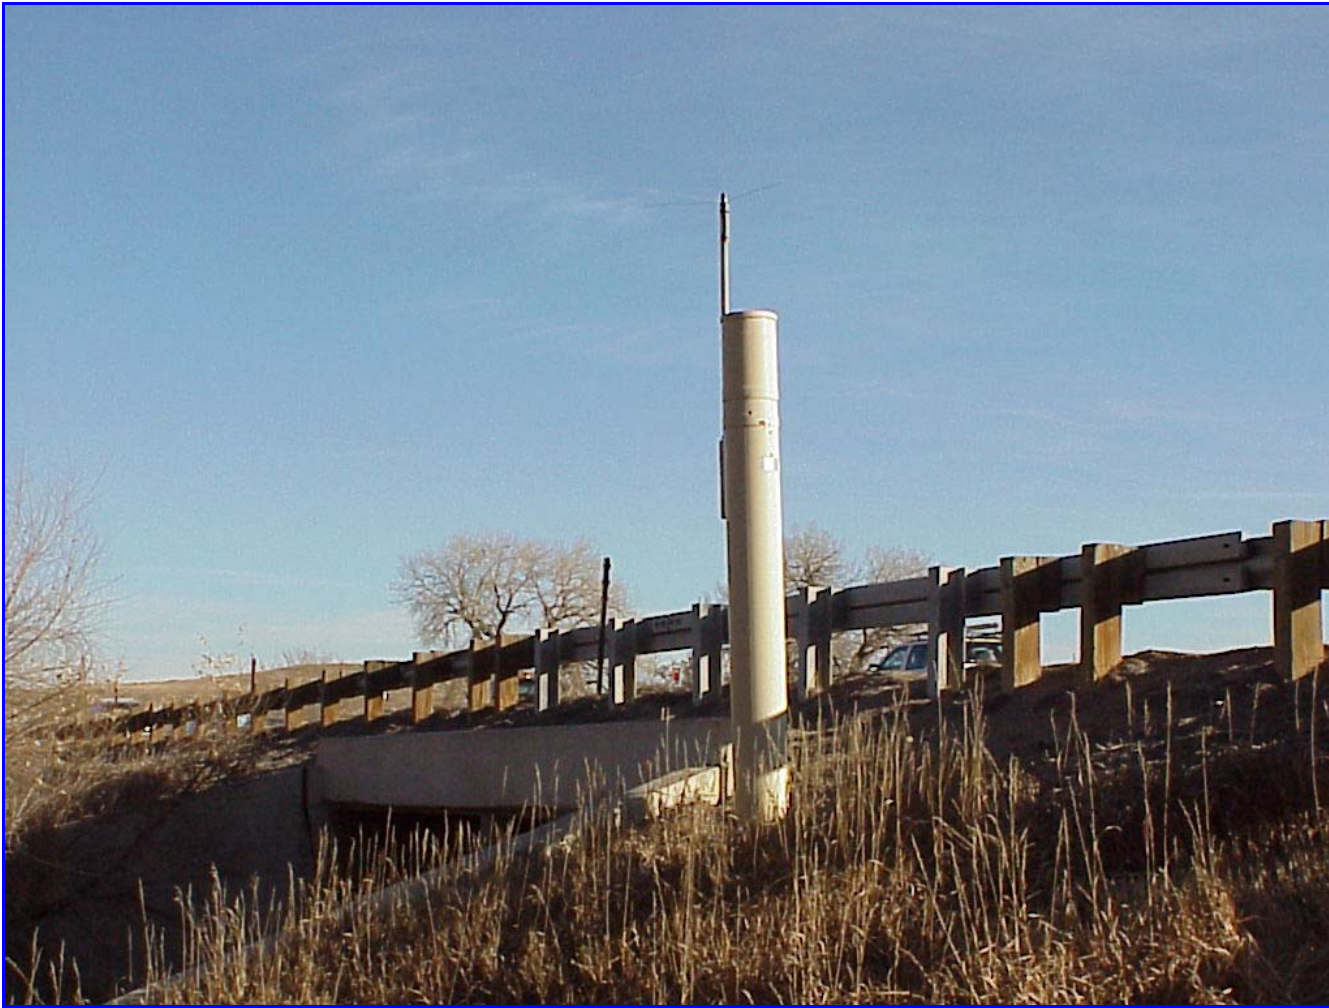
Name	ID	Sensor Type	Date Installed	Latitude	Longitude	Elevation	Gage Height	Anemometer Height	Temperature Sensor Height	Ground type
Sports Complex	320	P, S	07/03/89	39:48:06 N	105:07:04 W	5420'	9'1"	N/A	N/A	Grass, flat

Comments: Trees ~ 60' to the east and ~75' to the southeast.

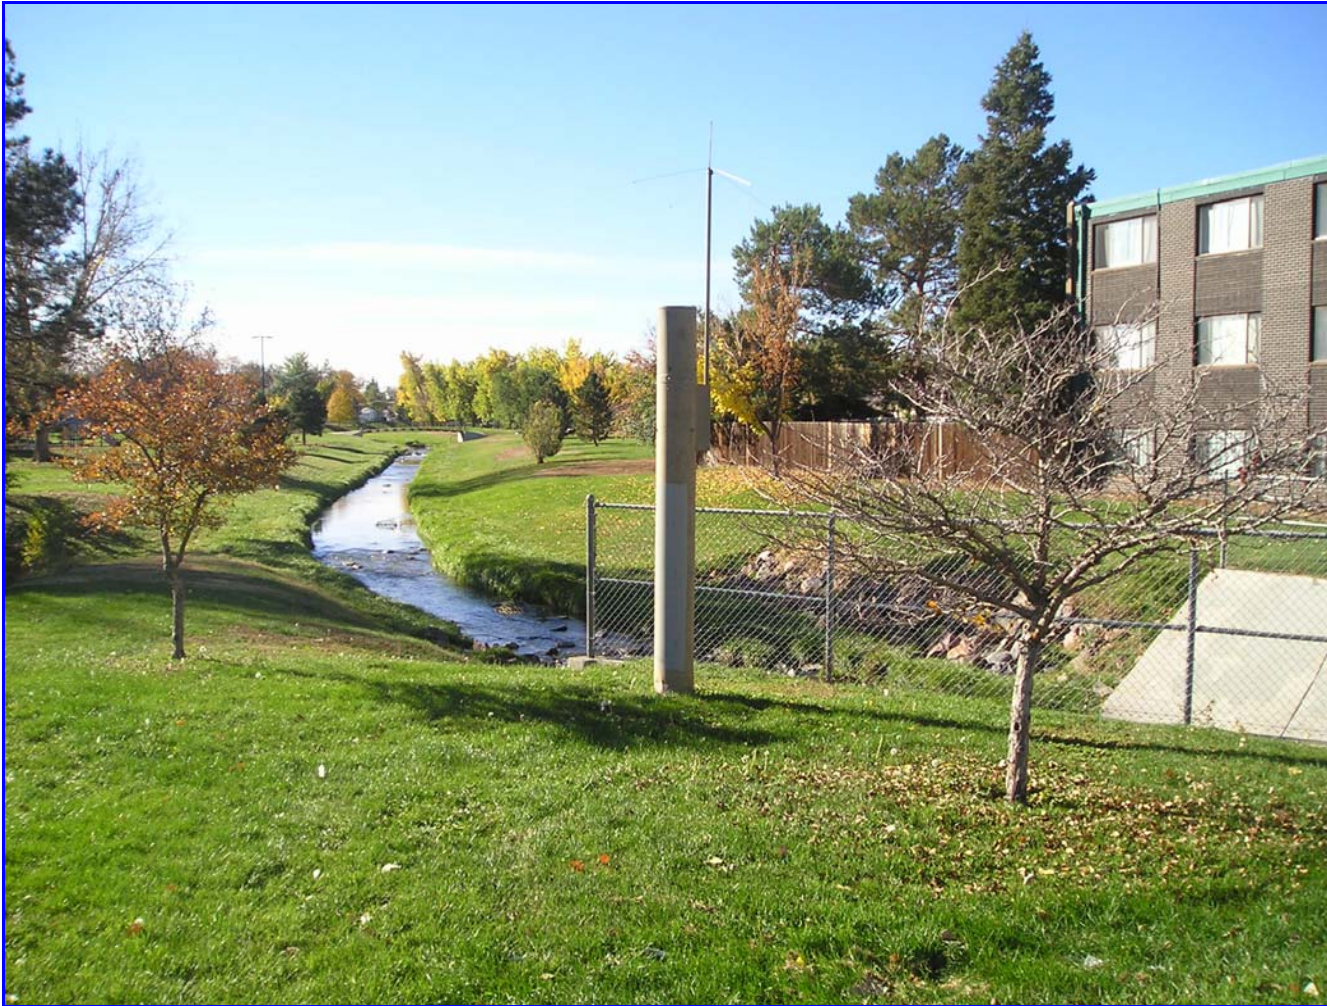
Name	ID	Sensor Type	Date Installed	Latitude	Longitude	Elevation	Gage Height	Anemometer Height	Temperature Sensor Height	Ground type
Montview Park	400	P, S	06/09/88	39:44:50 N	104:52:47 W	5303'	9'10"	N/A	N/A	Grass

Comments: Located ~ 15' from creek.

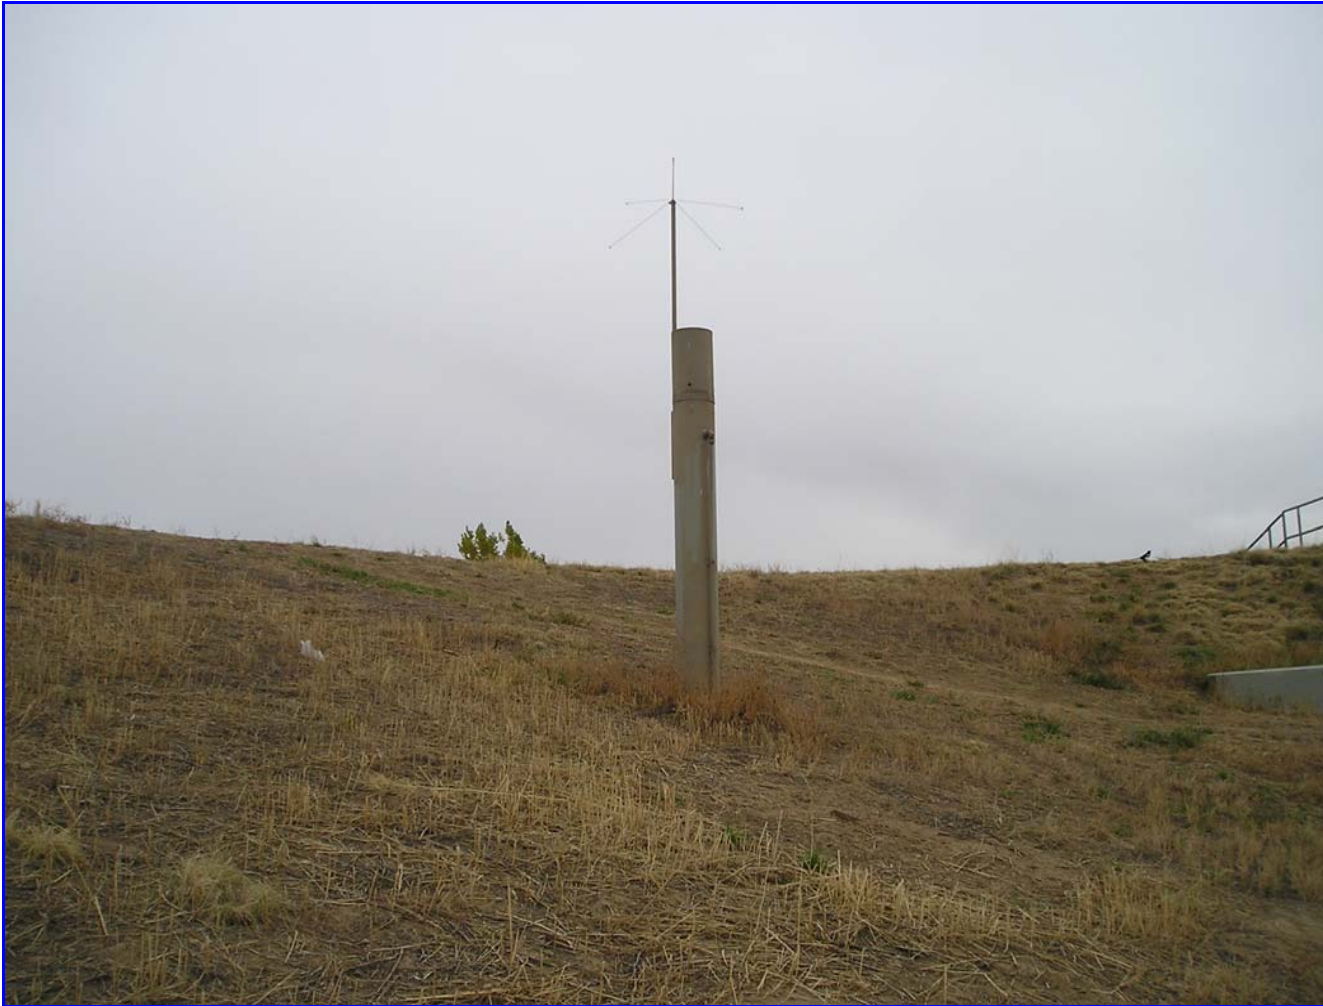
Name	ID	Sensor Type	Date Installed	Latitude	Longitude	Elevation	Gage Height	Anemometer Height	Temperature Sensor Height	Ground type
Kelly Dam	410	P, S	09/22/88	39:43:57 N	104:53:19 W	5344'	8'10"	N/A	N/A	Scrub grass

Comments: Located ~ 15' from creek. 35-degree incline.

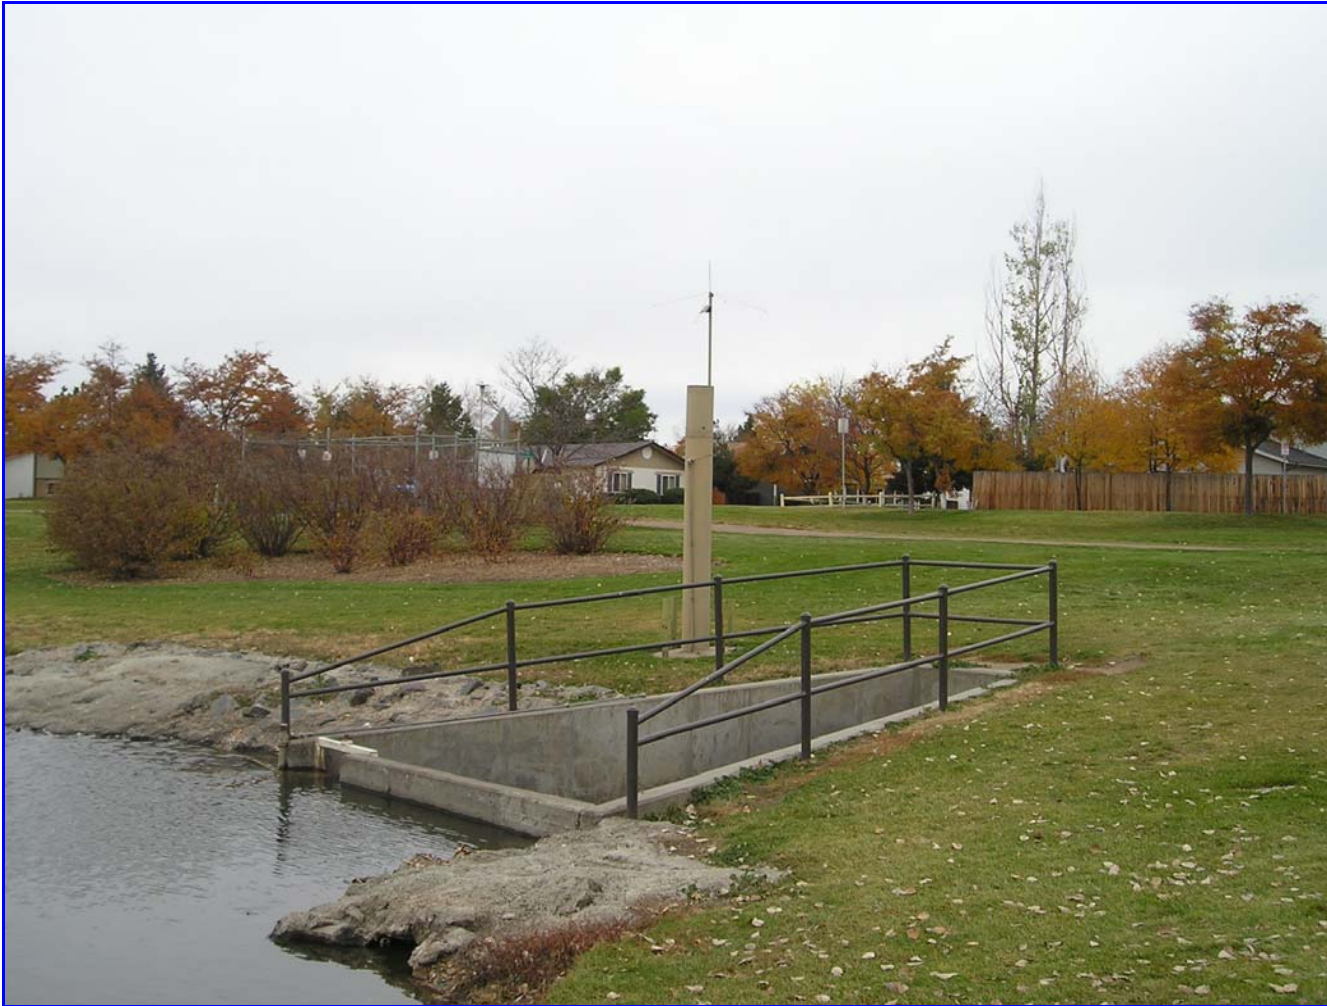
Name	ID	Sensor Type	Date Installed	Latitude	Longitude	Elevation	Gage Height	Anemometer Height	Temperature Sensor Height	Ground type
Utah Park	430	P, S	05/21/88	39:41:07 N	104:50:37 W	5536'	10'4"	N/A	N/A	Grass

Comments: Pond ~ 15' to north.

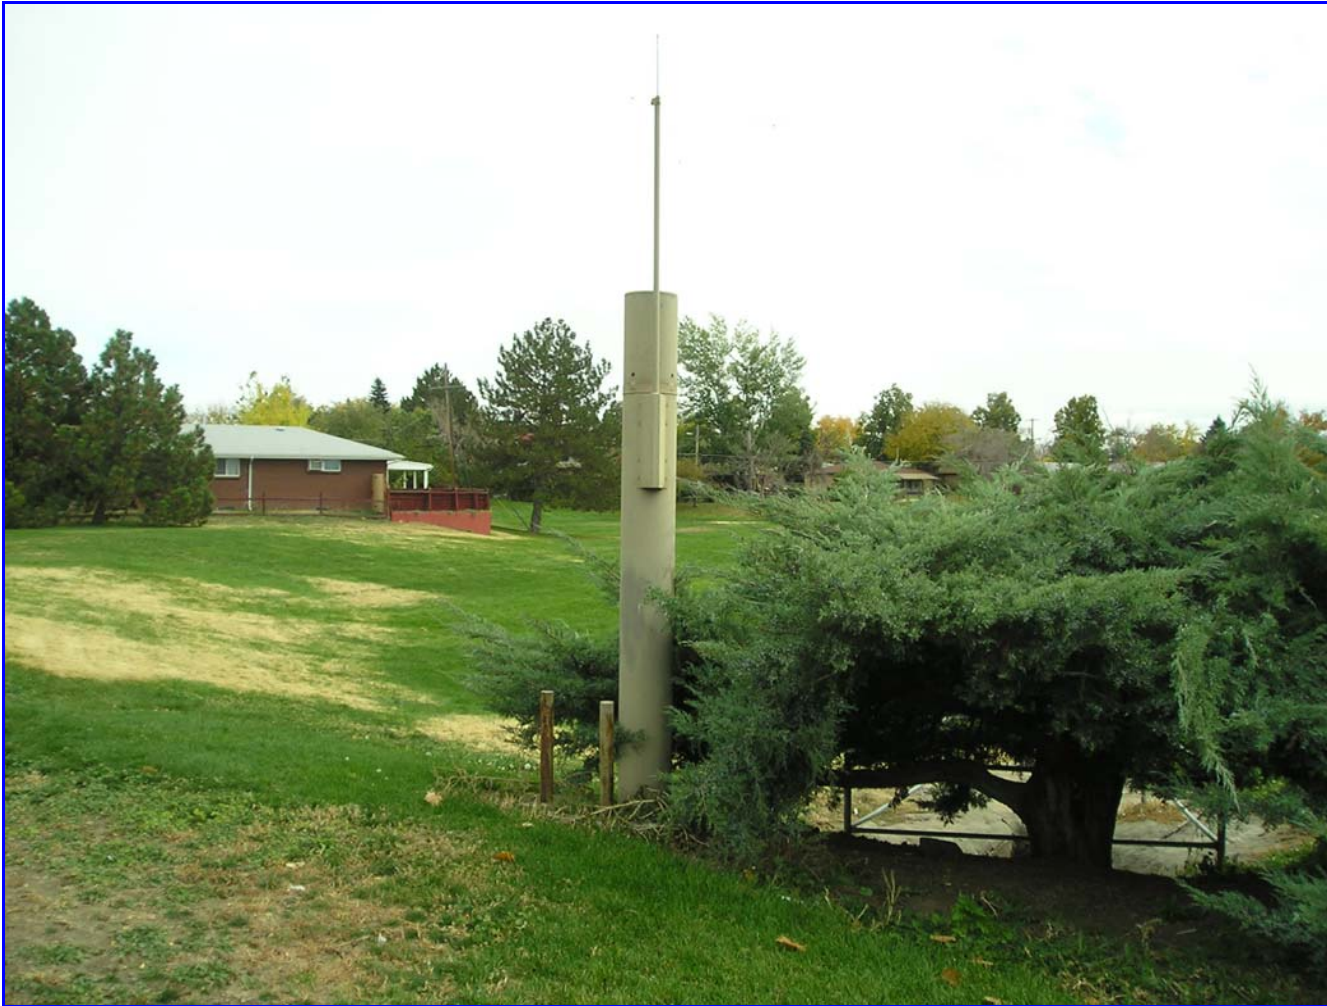
Name	ID	Sensor Type	Date Installed	Latitude	Longitude	Elevation	Gage Height	Anemometer Height	Temperature Sensor Height	Ground type
Havana Park	500	P, S	05/26/88	39:43:59 N	104:51:51 W	5375'	10'2"	N/A	N/A	Grass

Comments: Gage ~ 20 feet from road.

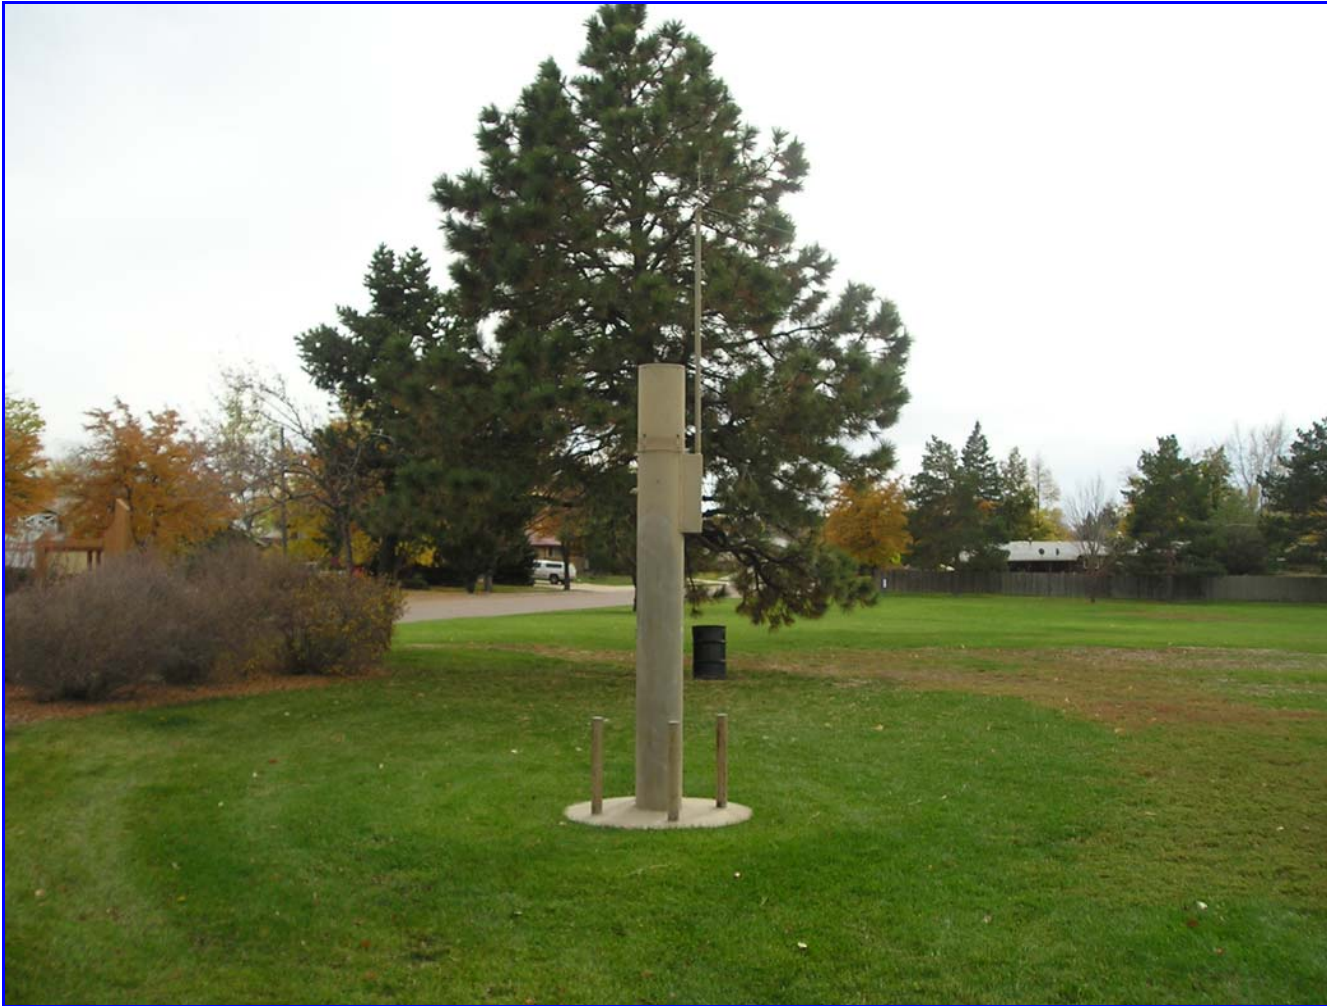
Name	ID	Sensor Type	Date Installed	Latitude	Longitude	Elevation	Gage Height	Anemometer Height	Temperature Sensor Height	Ground type
Virginia Court	510	P	05/21/88	39:42:24 N	104:50:19 W	5550'	9'6"	N/A	N/A	Grass

Comments: 30 foot tree ~ 30 feet to the southeast.

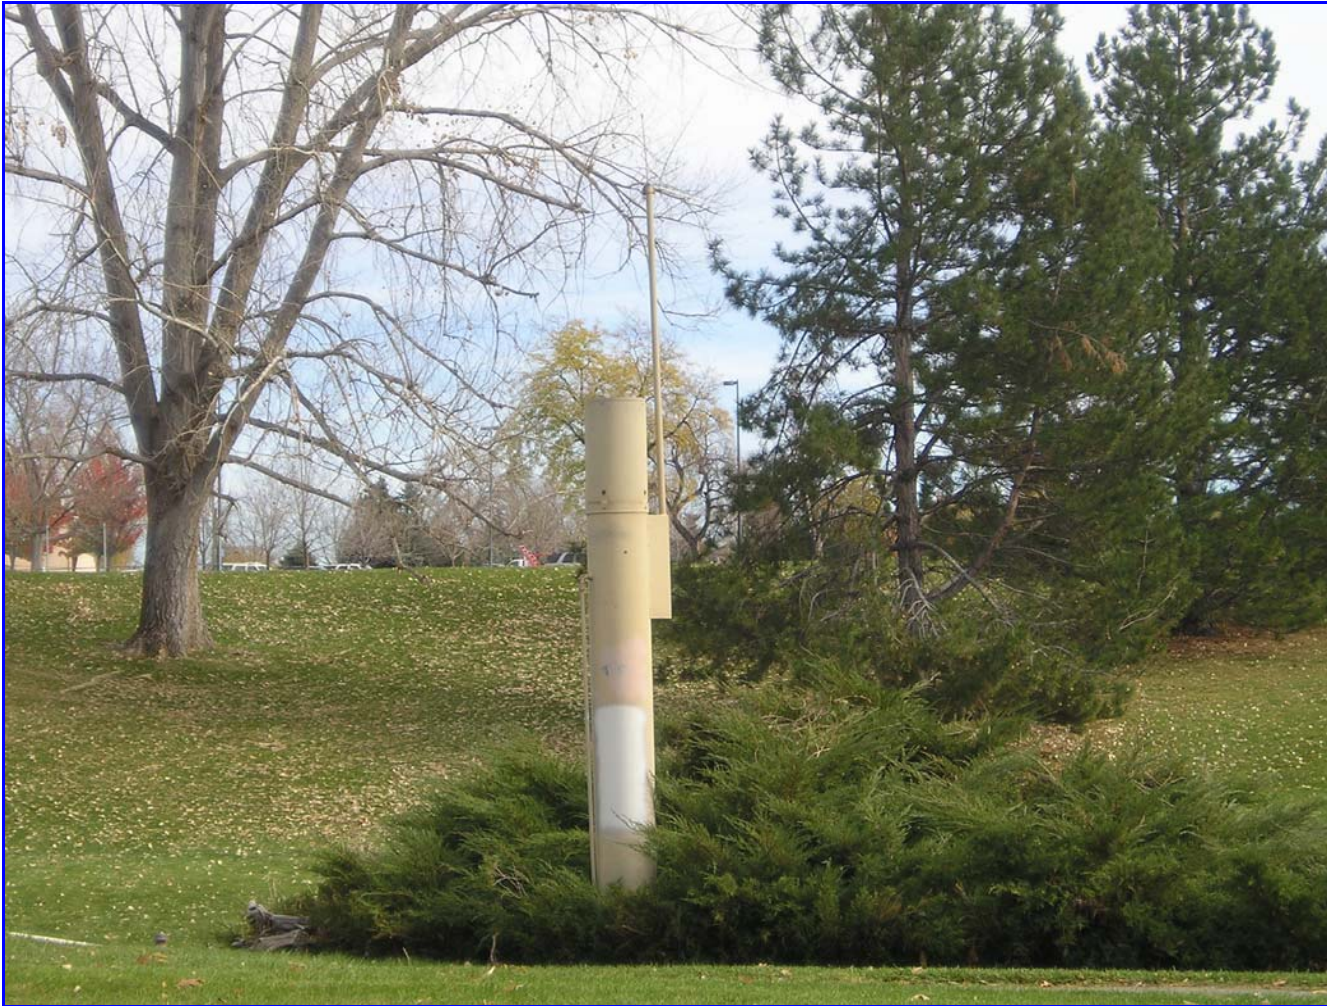
Name	ID	Sensor Type	Date Installed	Latitude	Longitude	Elevation	Gage Height	Anemometer Height	Temperature Sensor Height	Ground type
Harvard Gulch Park	600	P, S	07/25/89	39:40:20 N	104:58:56 W	5315'	8'10"	N/A	N/A	Grass

Comments: Gage located ~ 15 feet from road. Creek ~ 9 feet to the east.
