APPENDIX

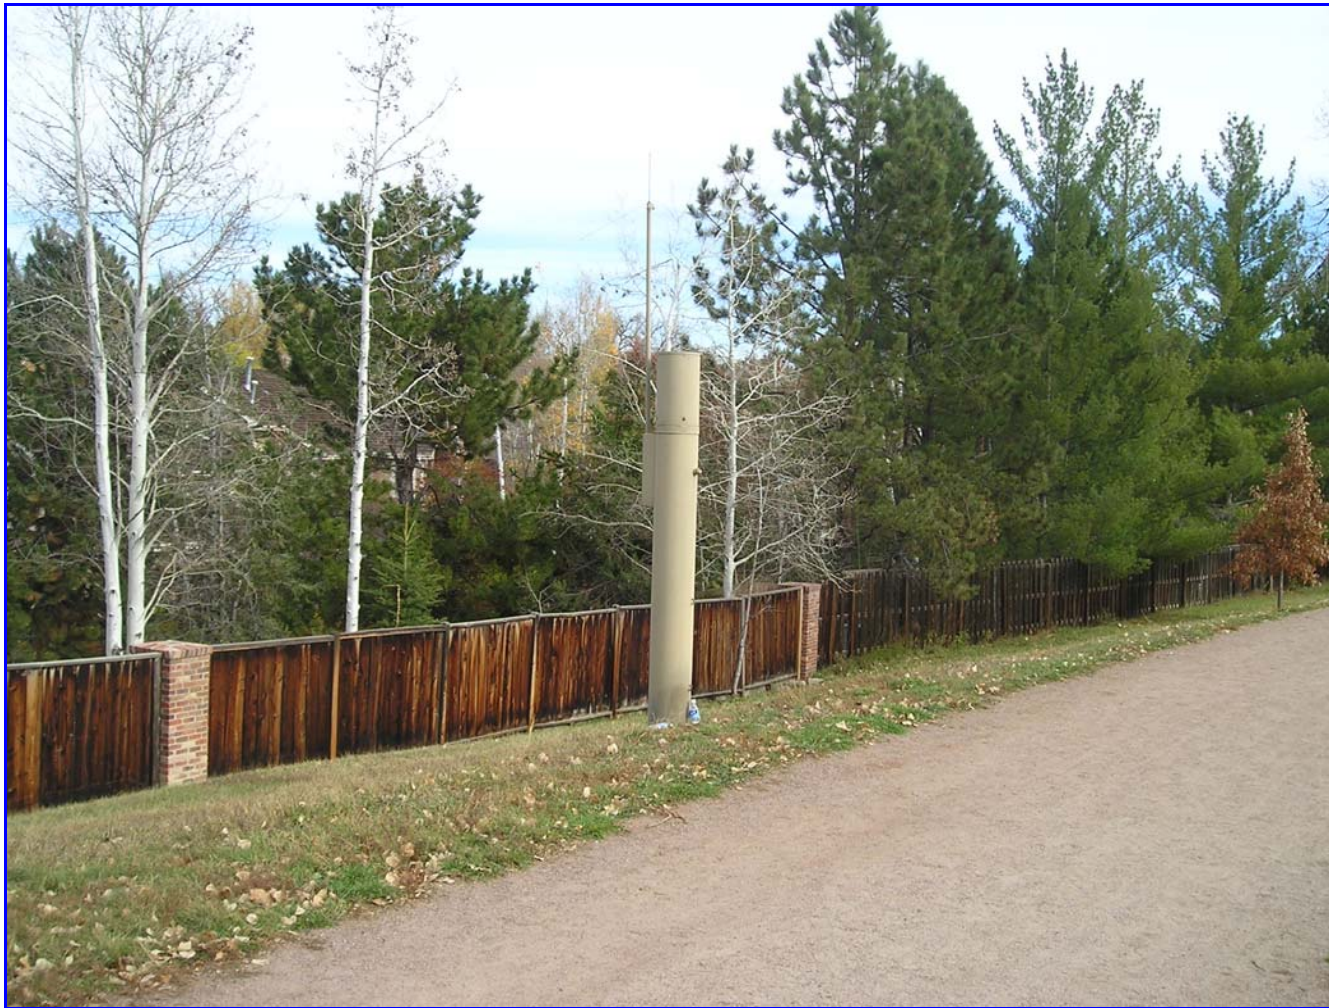
Name	ID	Sensor Type	Date Installed	Latitude	Longitude	Elevation	Gage Height	Anemometer Height	Temperature Sensor Height	Ground type
Harvard Gulch @ Jackson	610	P, S	07/25/89	39:40:09 N	104:56:33 W	5410'	9'11"	N/A	N/A	Grass

Comments: Gage located ~ 20 feet from Creek.

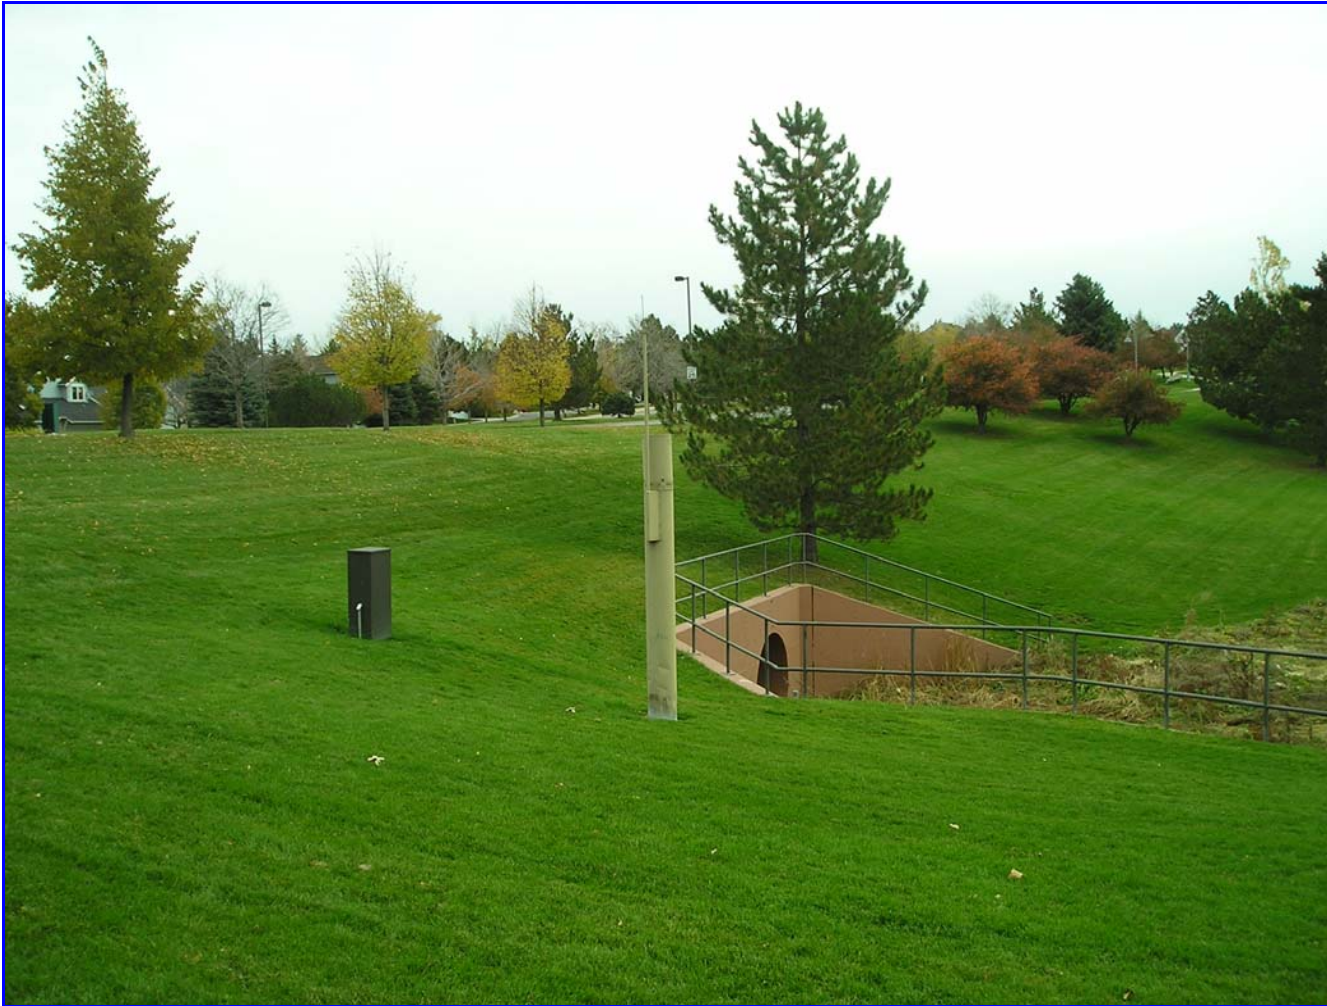
Name	ID	Sensor Type	Date Installed	Latitude	Longitude	Elevation	Gage Height	Anemometer Height	Temperature Sensor Height	Ground type
Temple Pond	630	P, S	05/29/87	39:37:55 N	104:53:28 W	5575'	9'8"	N/A	N/A	Grass

Comments: Gage located ~ 20 feet from a detention pond.

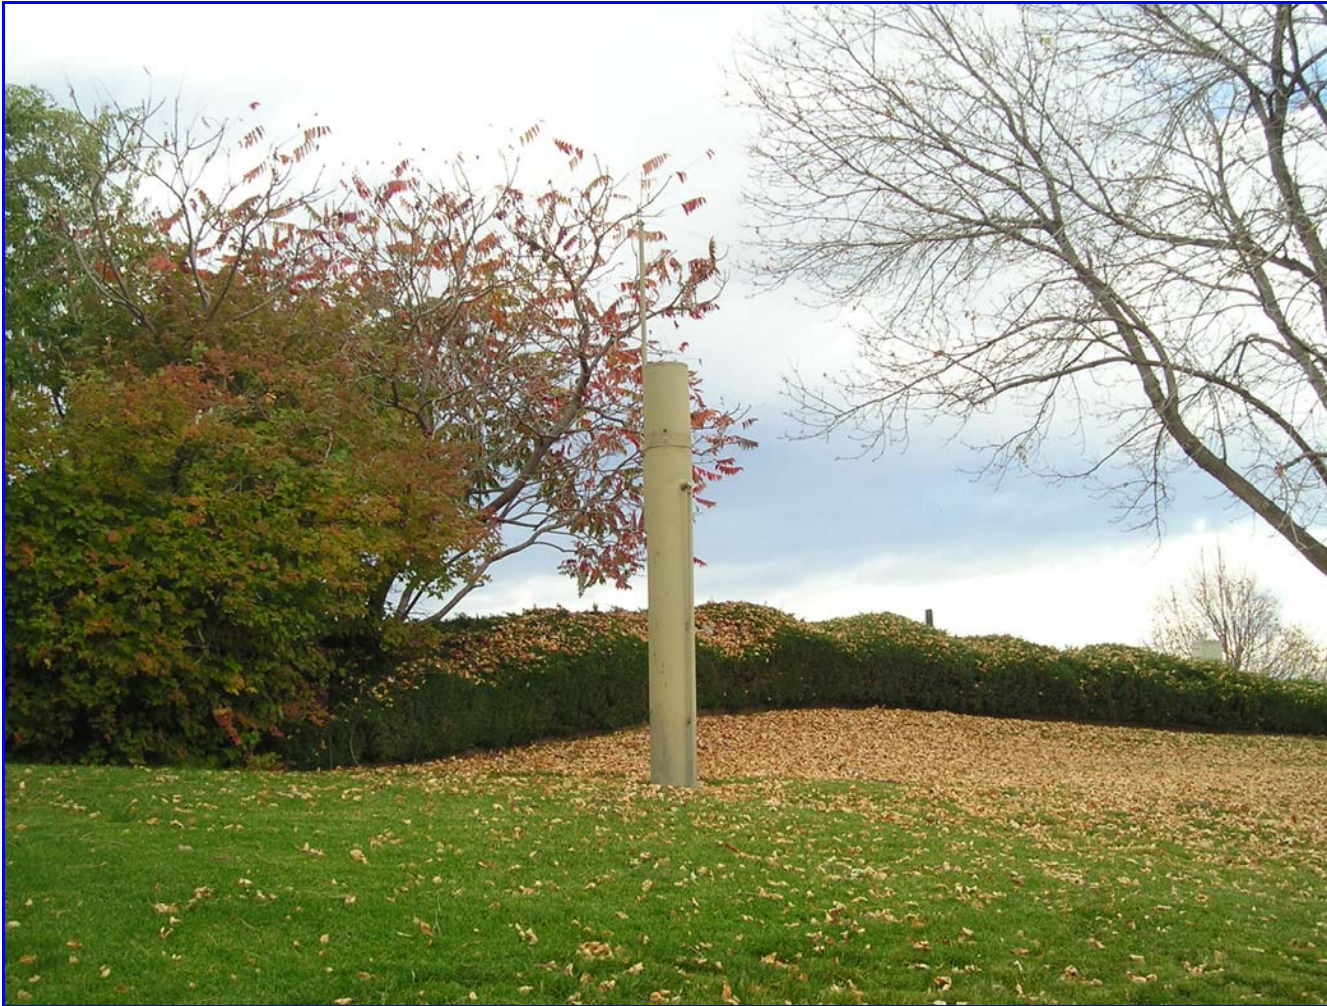
Name	ID	Sensor Type	Date Installed	Latitude	Longitude	Elevation	Gage Height	Anemometer Height	Temperature Sensor Height	Ground type
Goldsmith @ Eastman	640	P, S	09/06/89	39:39:22 N	104:54:08 W	5480'	9'2"	N/A	N/A	Grass

Comments: Gage obstructions due to tree to the north and south of gage. Obstructions will increase as trees grow.

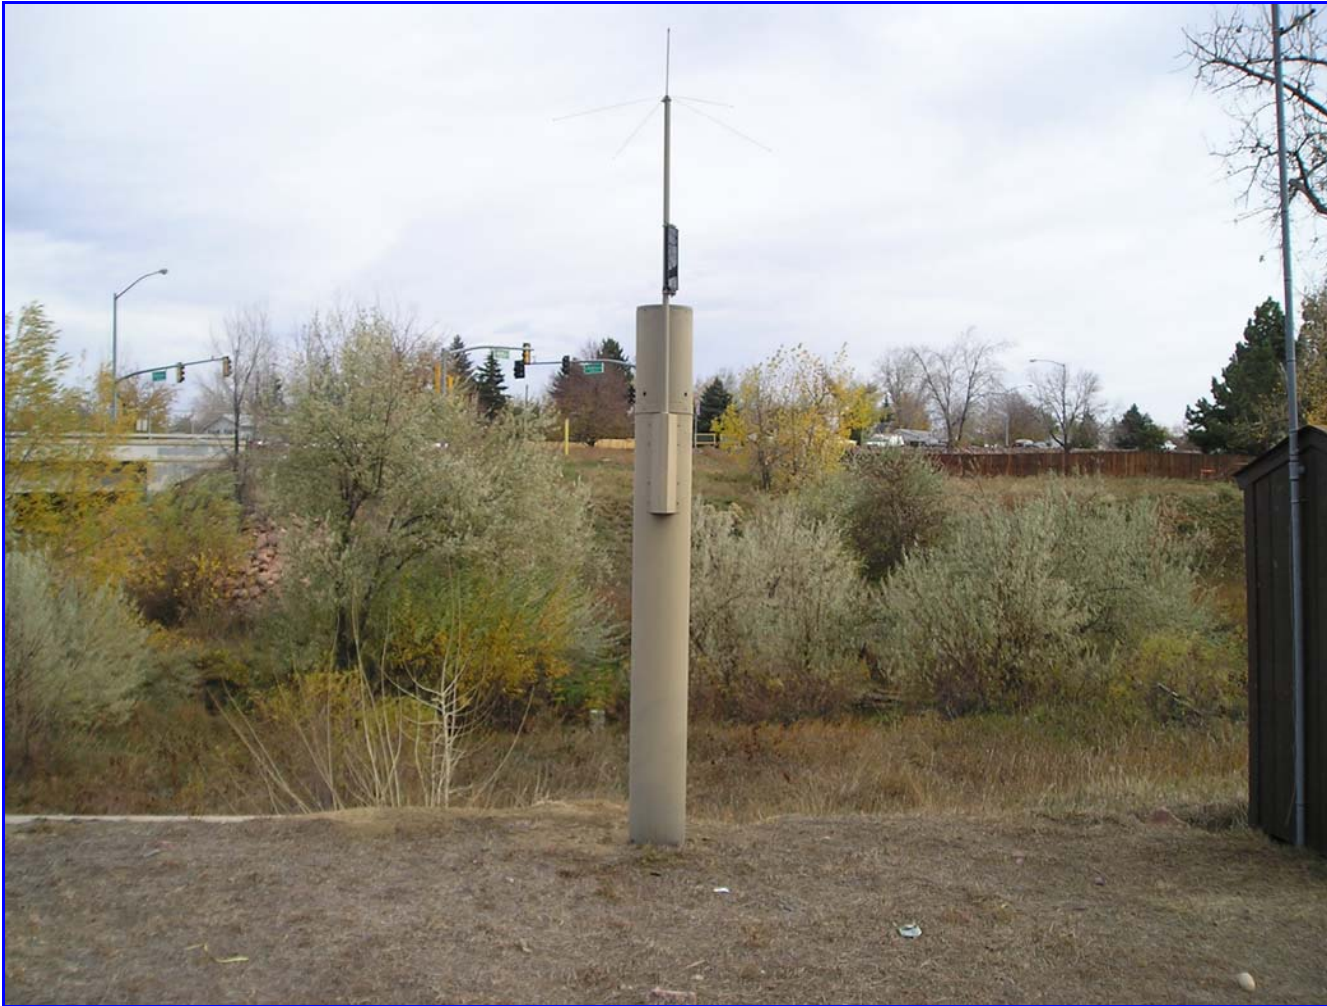
Name	ID	Sensor Type	Date Installed	Latitude	Longitude	Elevation	Gage Height	Anemometer Height	Temperature Sensor Height	Ground type
Toll Gate @ 6th	700	P, S	11/07/89	39:43:30 N	104:49:06 W	5400'	9'2"	N/A	N/A	Scrub grass

Comments: Gage located ~ 40 feet from creek. 7 foot tall shed ~ 9 feet to south.

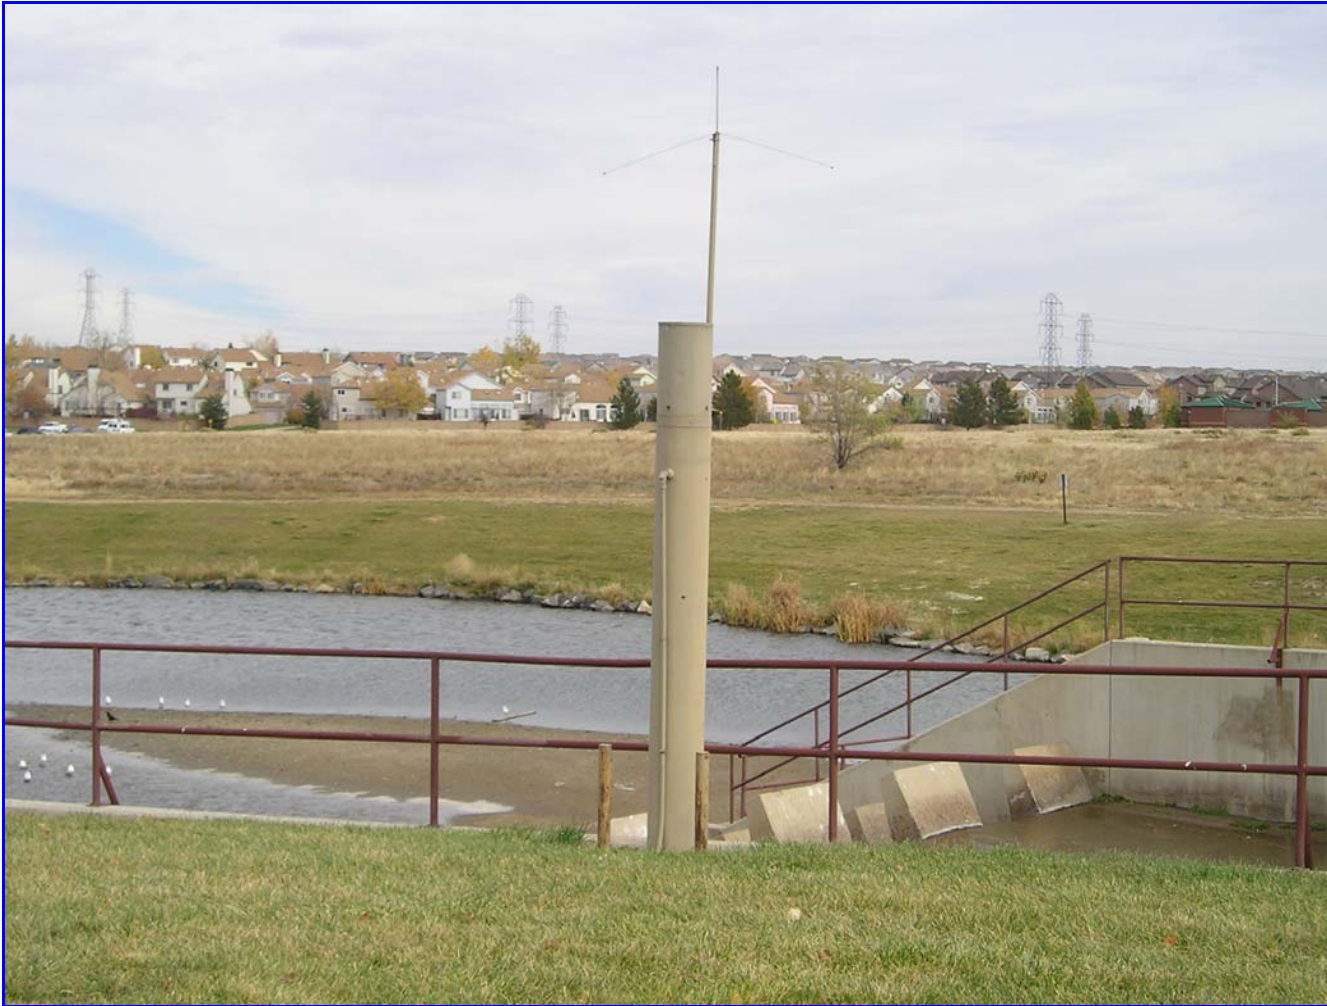
Name	ID	Sensor Type	Date Installed	Latitude	Longitude	Elevation	Gage Height	Anemometer Height	Temperature Sensor Height	Ground type
Confluence Pond	720	P, S2	07/25/89	39:40:01 N	104:46:37 W	5570'	9'8"	N/A	N/A	Grass

Comments: Gage located ~ 15 feet from drop structure.

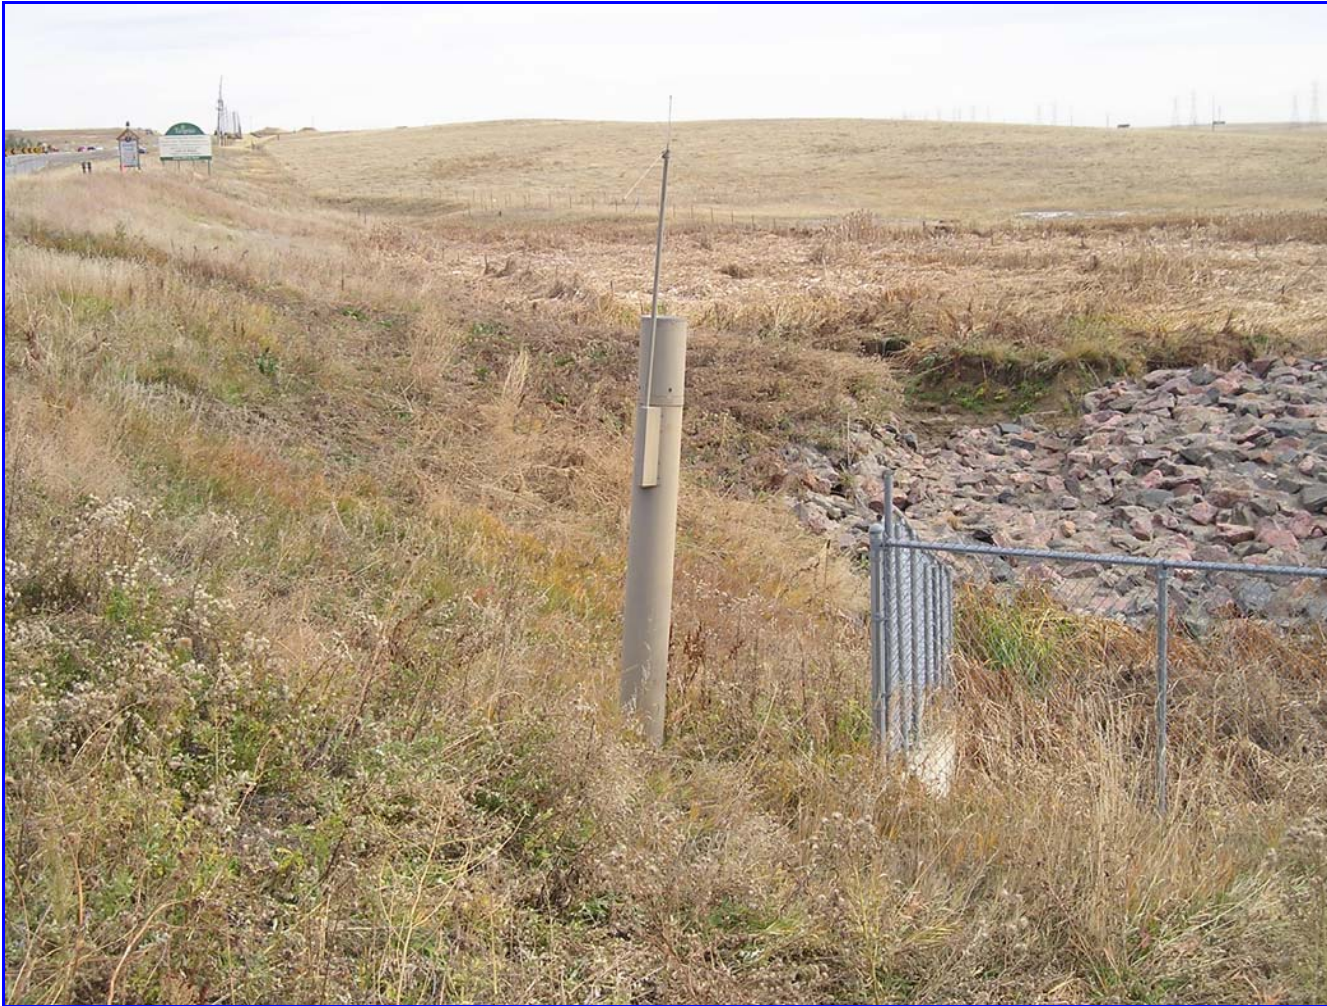
Name	ID	Sensor Type	Date Installed	Latitude	Longitude	Elevation	Gage Height	Anemometer Height	Temperature Sensor Height	Ground type
No Name @ Quincy	730	P, S	08/13/90	39:38:18 N	104:44:55 W	5710'	9'8"	N/A	N/A	Grass

Comments: Gage located ~ 12 feet from creek. Gage tilted ~ 15 degrees to south.

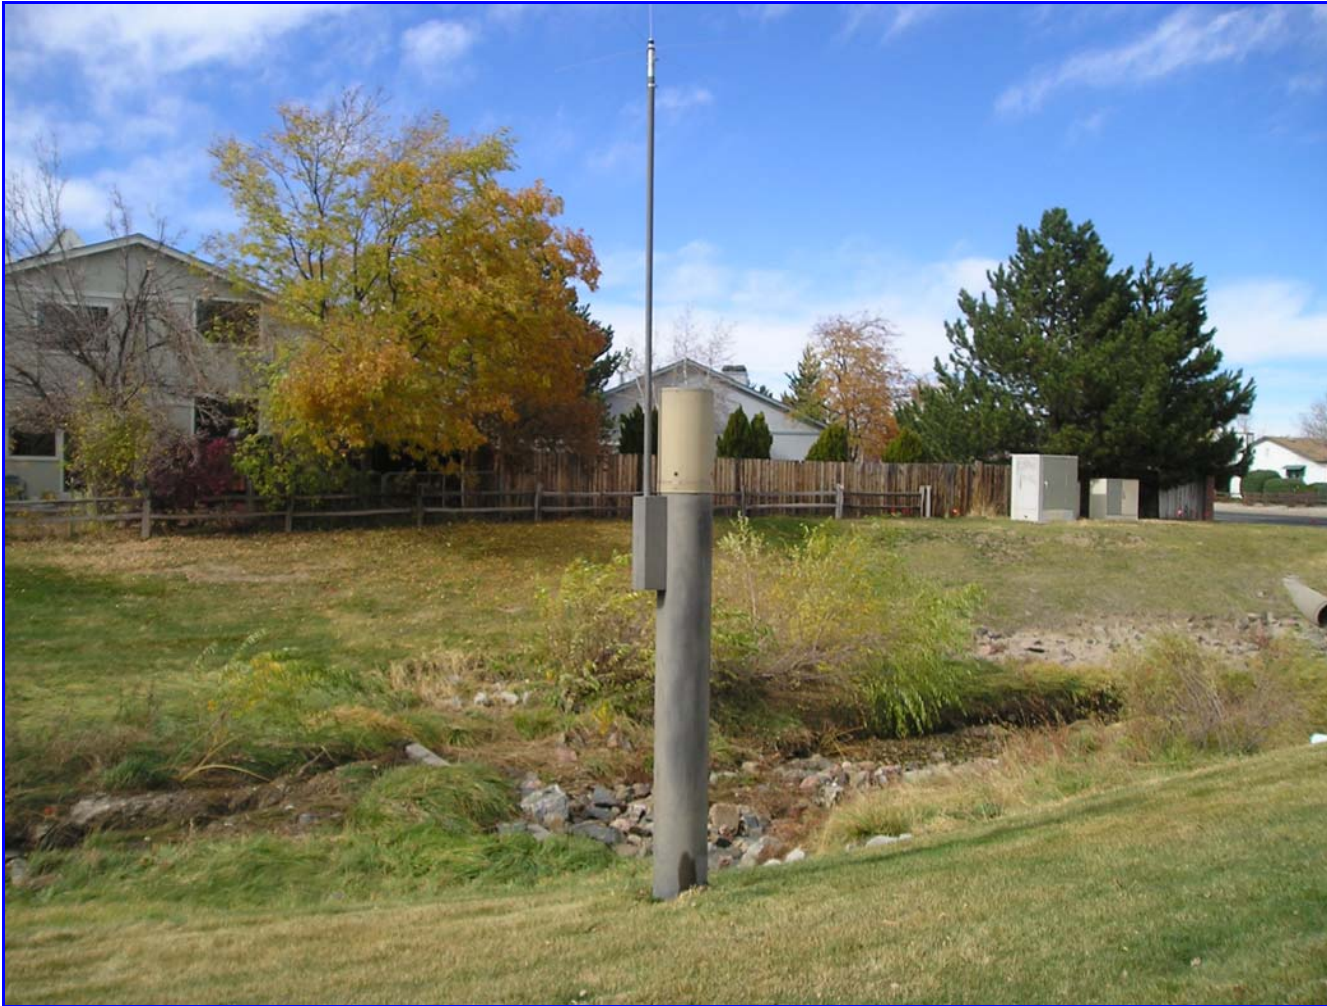
Name	ID	Sensor Type	Date Installed	Latitude	Longitude	Elevation	Gage Height	Anemometer Height	Temperature Sensor Height	Ground type
Mission Viejo Park	760	P	08/03/89	39:38:55 N	104:47:47 W	5660'	9'1"	N/A	N/A	Grass

Comments: Gage located ~ 10 feet from creek.

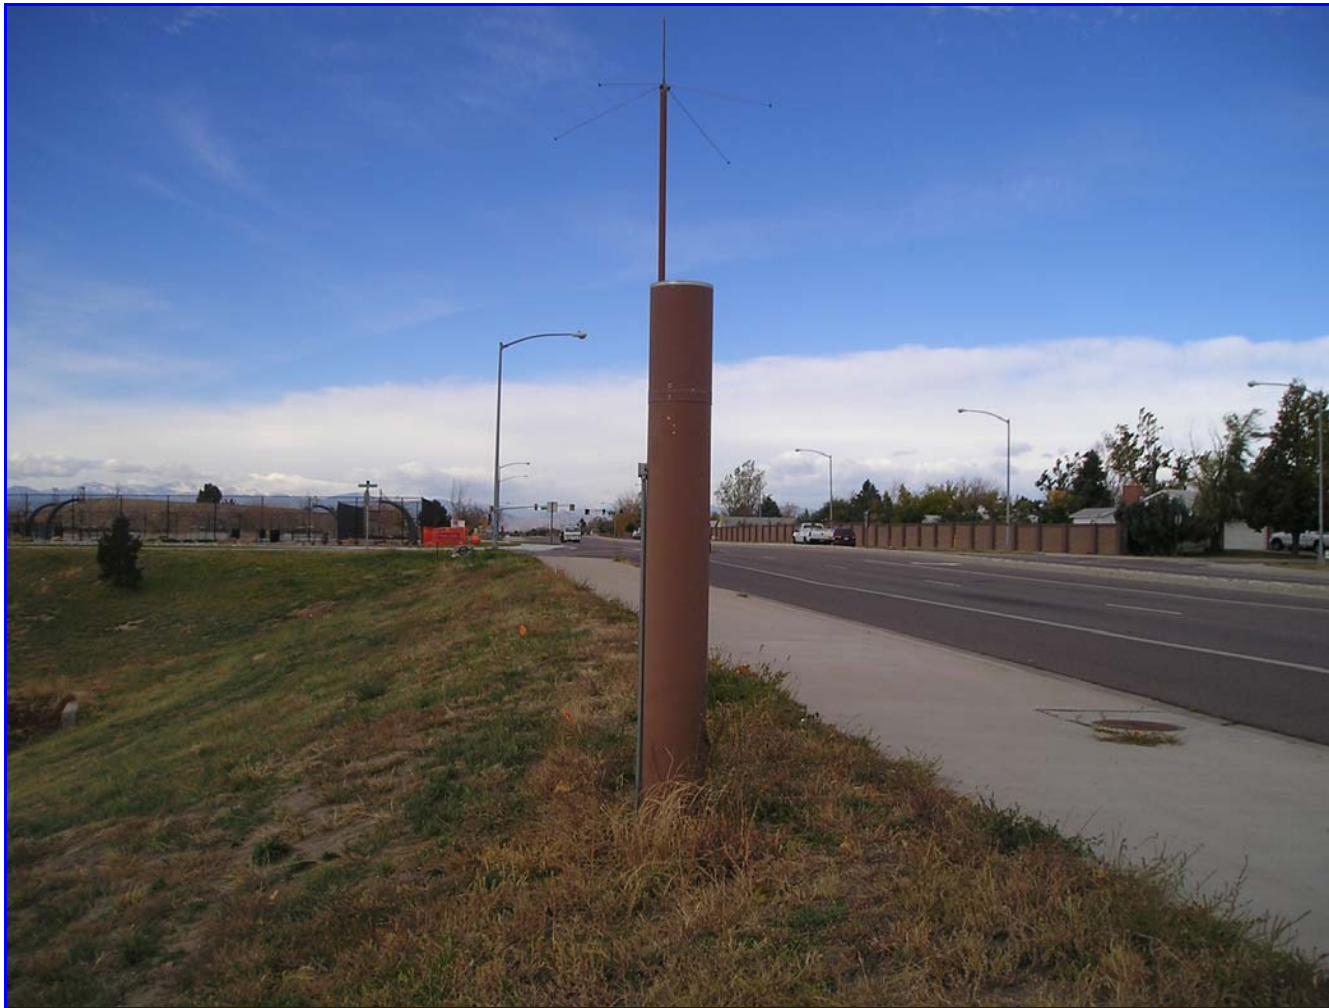
Name	ID	Sensor Type	Date Installed	Latitude	Longitude	Elevation	Gage Height	Anemometer Height	Temperature Sensor Height	Ground type
Sable Ditch @ 18th	800	P, S	08/02/89	39:44:43 N	104:48:35 W	5430'	9'4"	N/A	N/A	Grass

Comments: Gage located ~ 5 feet from canal and ~ 20 feet from road.

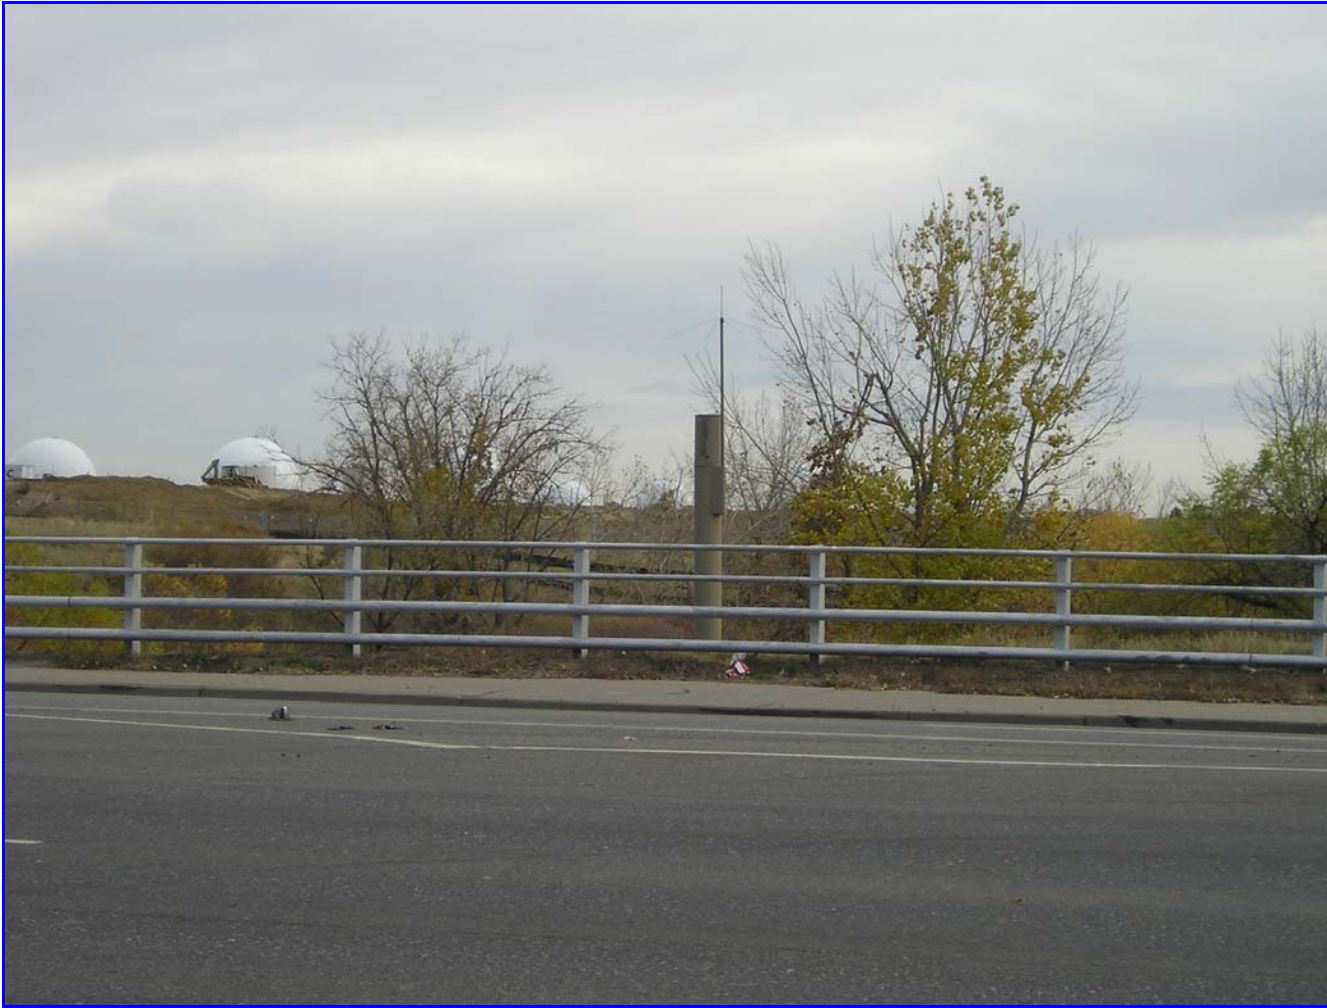
Name	ID	Sensor Type	Date Installed	Latitude	Longitude	Elevation	Gage Height	Anemometer Height	Temperature Sensor Height	Ground type
Granby Ditch @ 6th	810	P, S	08/03/89	39:43:31 N	104:47:48 W	5455'	8'2"	N/A	N/A	Grass

Comments: Gage located ~ 12 feet from road. Detention pond ~ 30 feet to the south.

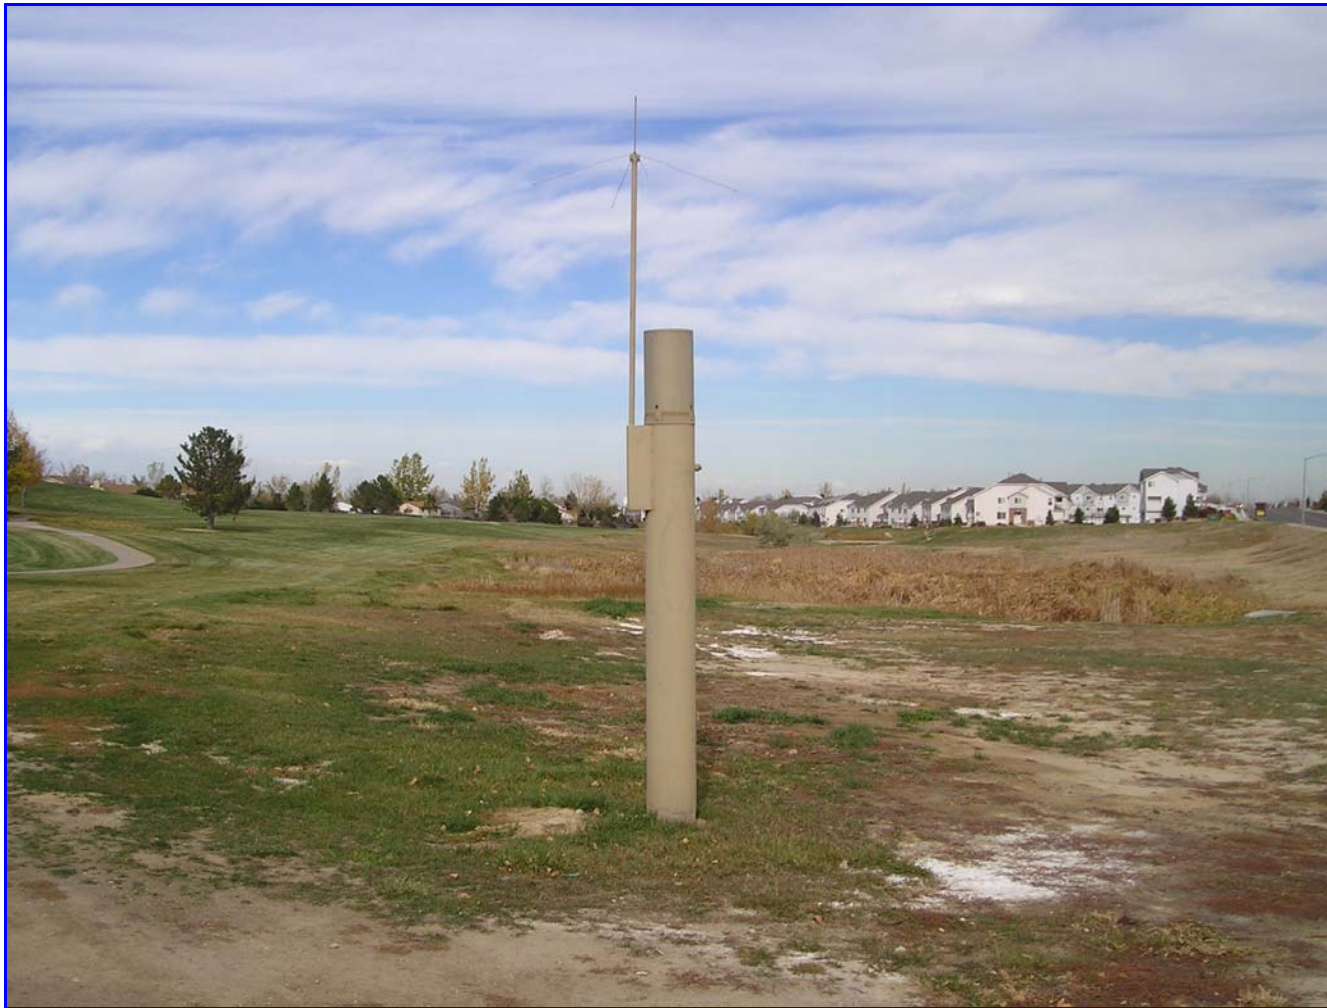
Name	ID	Sensor Type	Date Installed	Latitude	Longitude	Elevation	Gage Height	Anemometer Height	Temperature Sensor Height	Ground type
East Toll Gate @ Buckley	820	P, S	08/03/89	39:42:41 N	104:47:28 W	5460'	9'6"	N/A	N/A	Scrub grass

Comments: Gage located ~ 8 feet from road. Creek ~ 9 feet to the east.

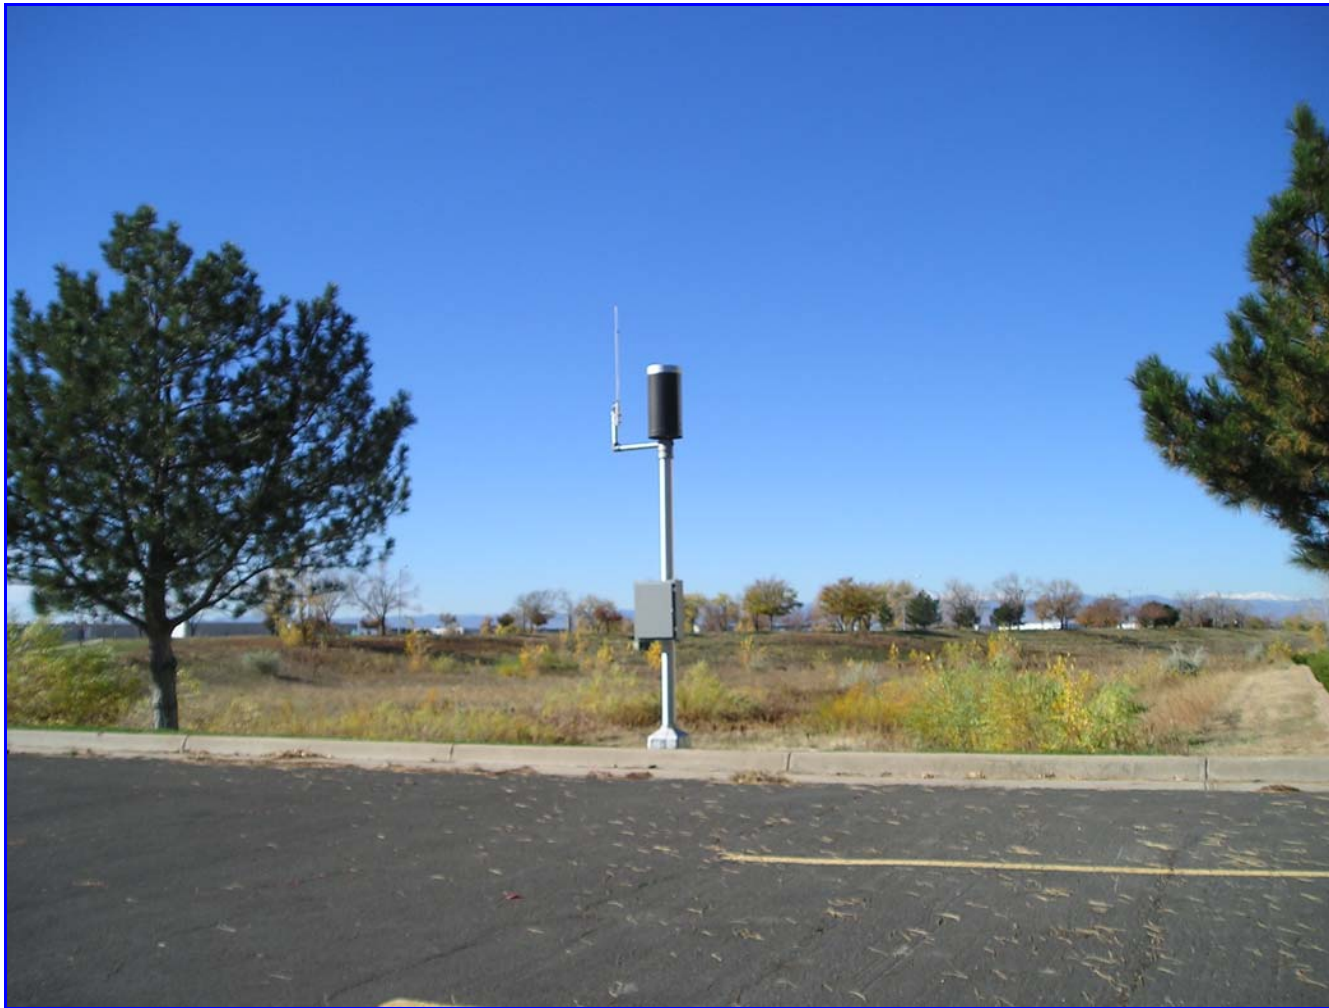
Name	ID	Sensor Type	Date Installed	Latitude	Longitude	Elevation	Gage Height	Anemometer Height	Temperature Sensor Height	Ground type
Side Creek Park	830	P	08/03/89	39:41:01 N	104:45:47 W	5600'	9'4"	N/A	N/A	Scrub grass

Comments: Gage located ~25 feet from road.

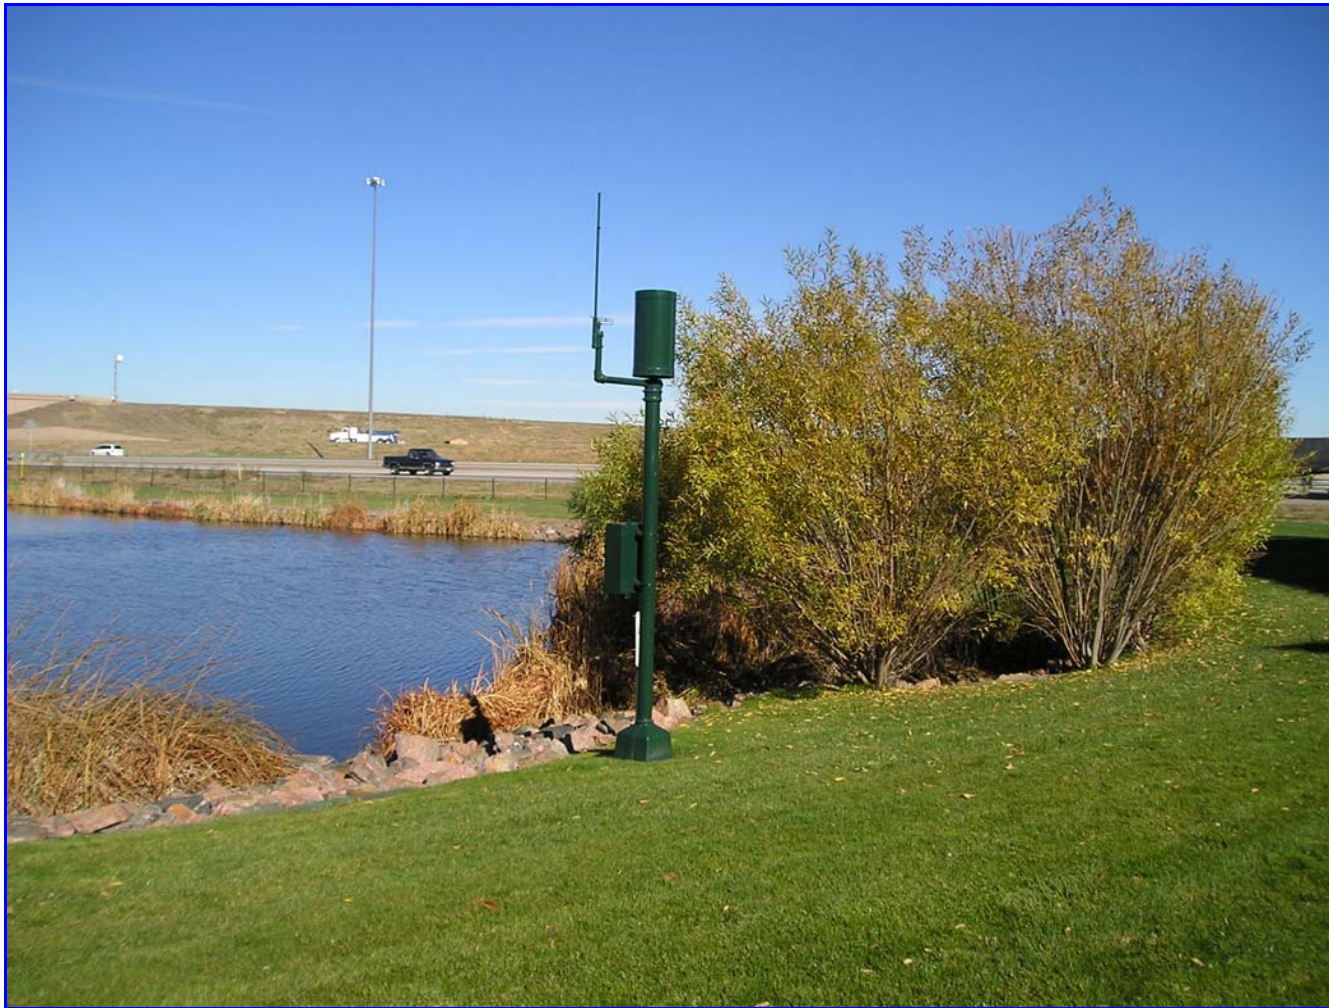
Name	ID	Sensor Type	Date Installed	Latitude	Longitude	Elevation	Gage Height	Anemometer Height	Temperature Sensor Height	Ground type
Aurora Fire Station 12	840	P	03/30/04	39:45:43 N	104:45:41 W	5433'	9'2"	N/A	N/A	Dirt

Comments: Gage located ~5 feet from fire station parking lot.

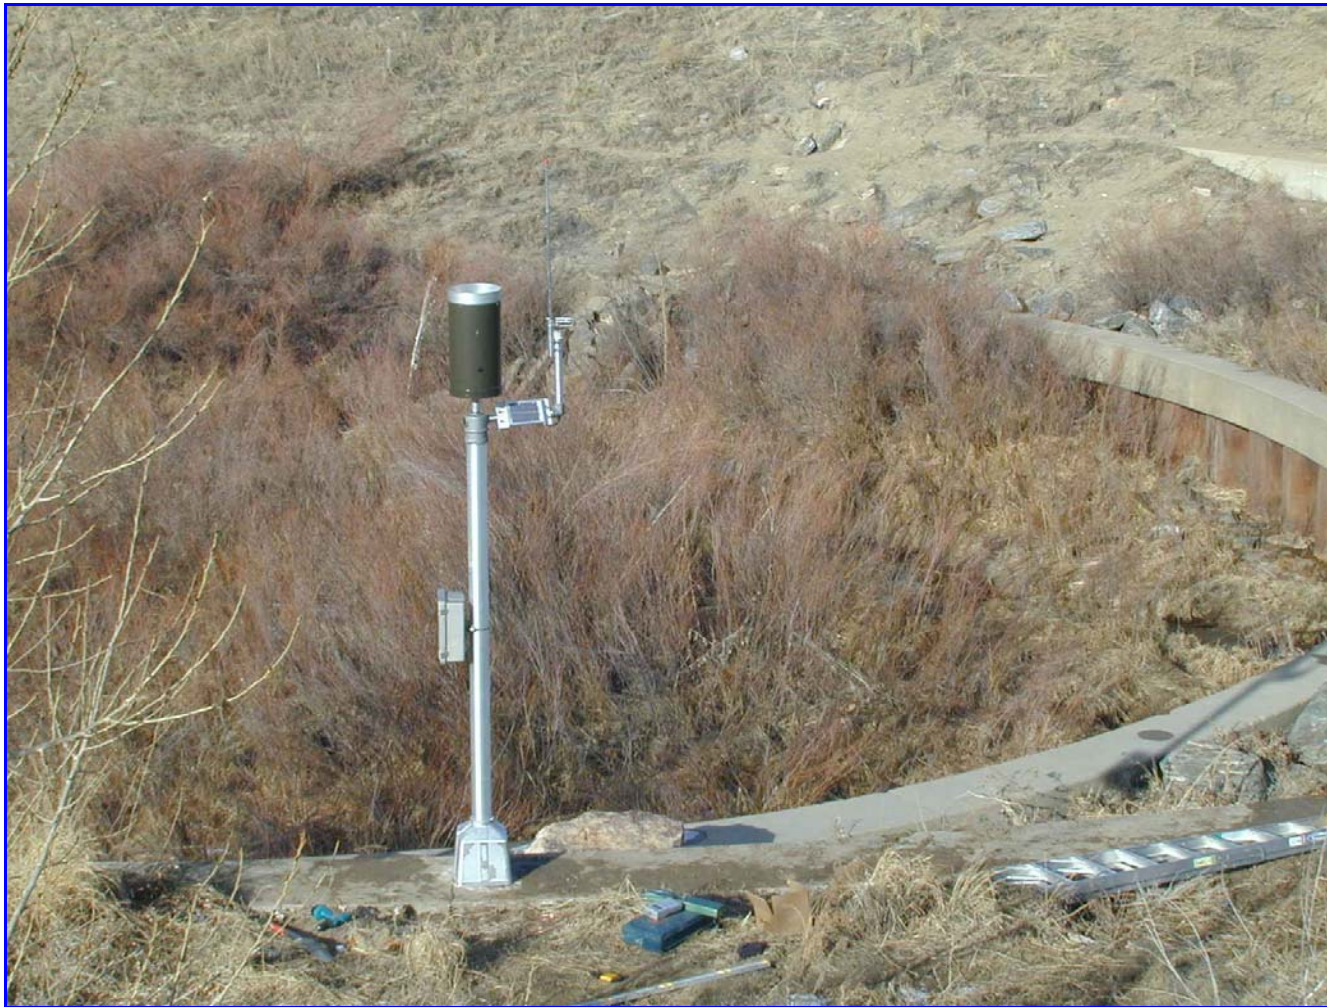
Name	ID	Sensor Type	Date Installed	Latitude	Longitude	Elevation	Gage Height	Anemometer Height	Temperature Sensor Height	Ground type
Flying J Truck Stop	850	P, S	03/30/04	39:45:57 N	104:47:34 W	5387'	9'2"	N/A	N/A	Grass

Comments: Obstruction will occur due to tree to the N when tree grows ~5 feet in the vertical. Gage located ~ 15 feet from pond.

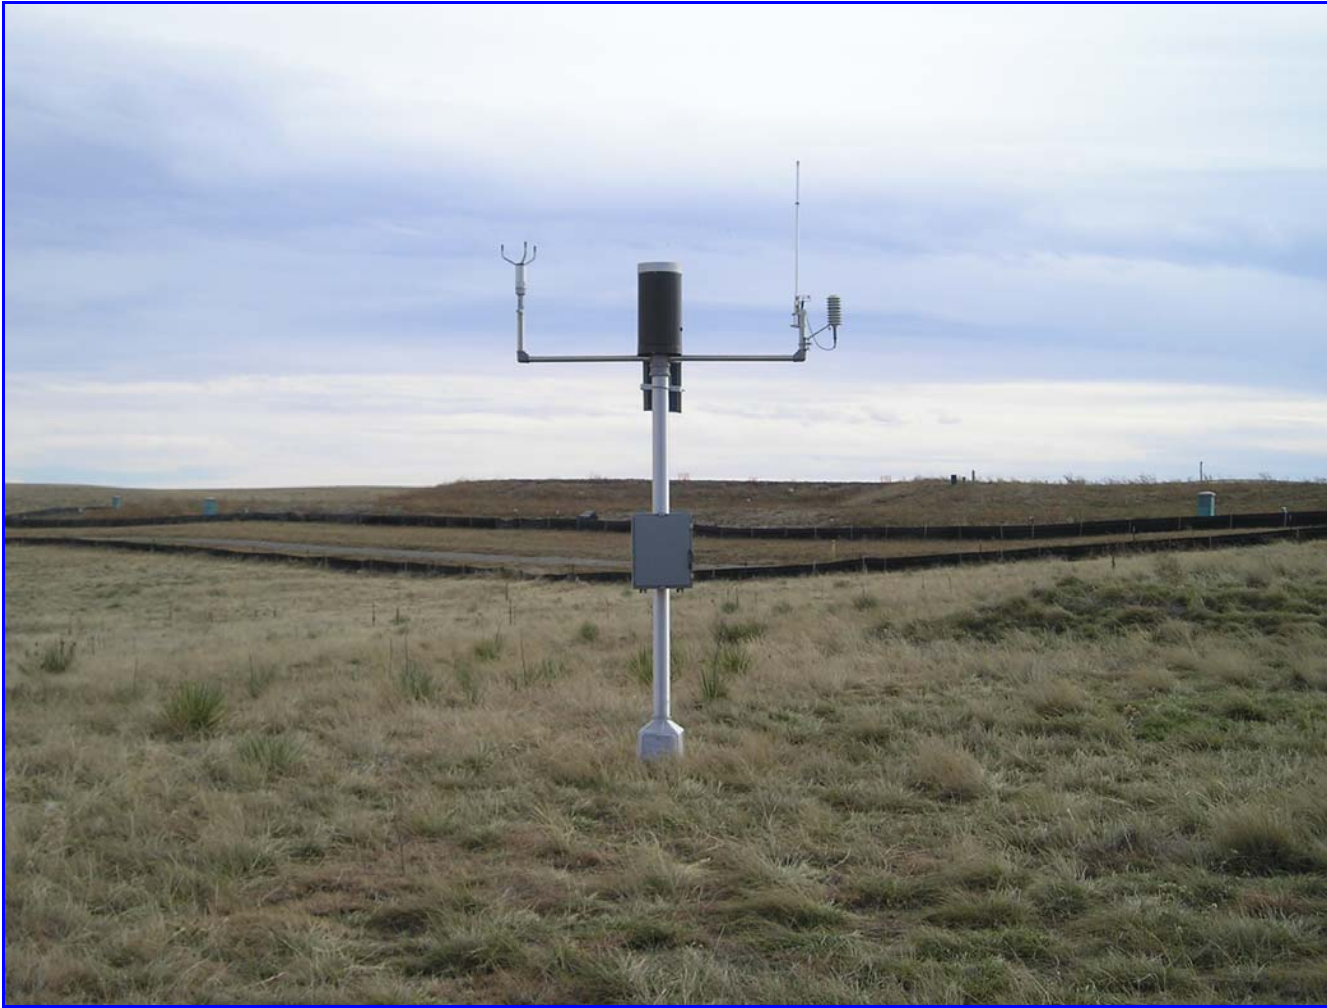
Name	ID	Sensor Type	Date Installed	Latitude	Longitude	Elevation	Gage Height	Anemometer Height	Temperature Sensor Height	Ground type
Murphy Creek Golf Course	870	P, S	03/30/04	39:41:07 N	104:42:37 W	5614'	10'11"	N/A	N/A	Scrub grass

Comments: Gage located ~ 15 feet from creek and ~ 20 feet from road.

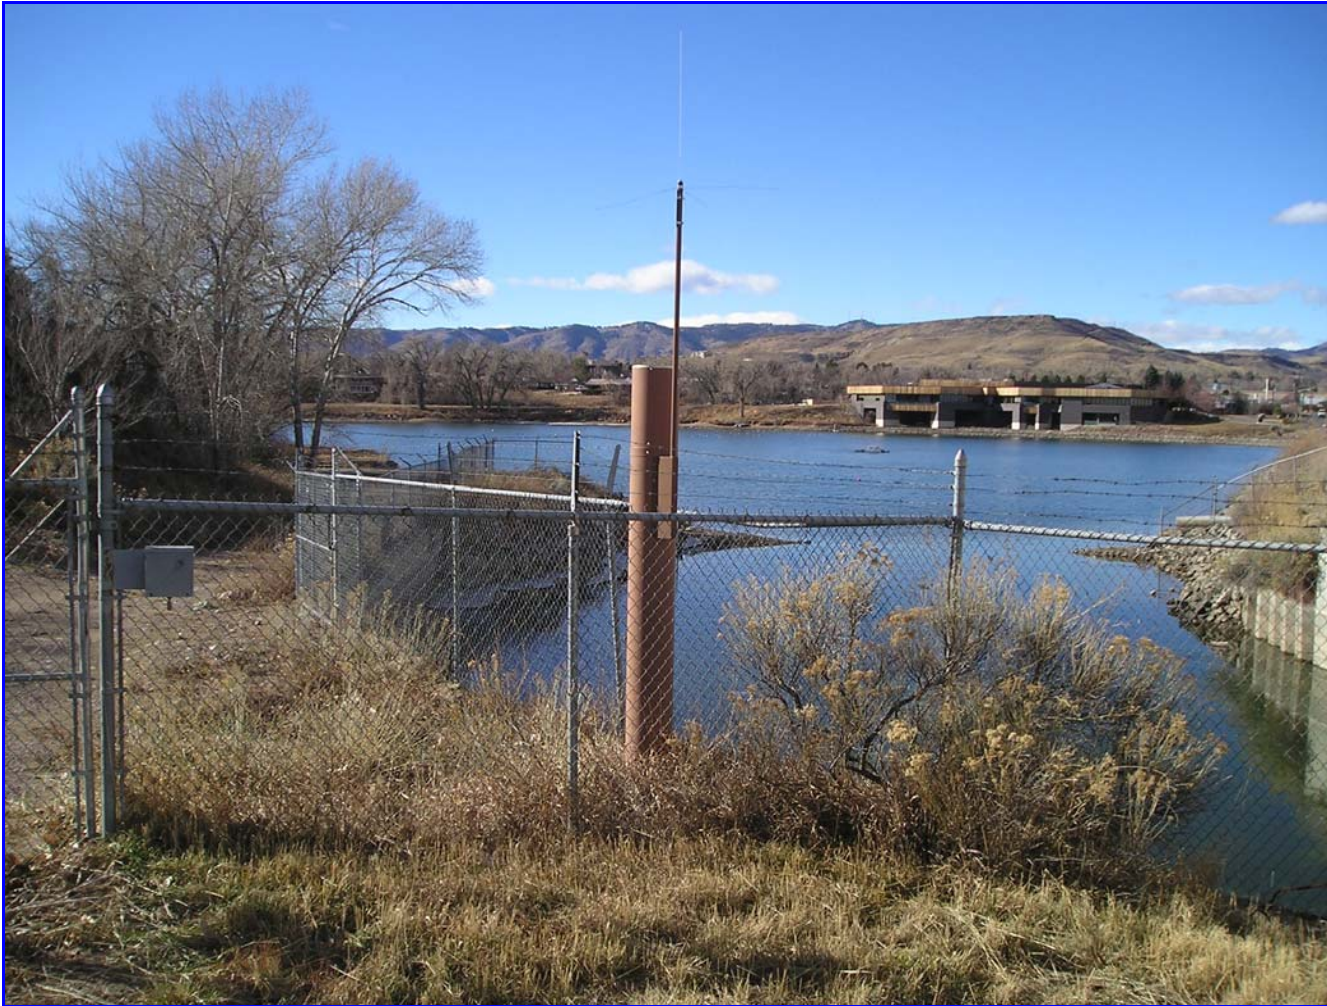
Name	ID	Sensor Type	Date Installed	Latitude	Longitude	Elevation	Gage Height	Anemometer Height	Temperature Sensor Height	Ground type
Maple Grove Reservoir	1000	P, S	06/02/85	39:45:20 N	105:08:12 W	5519'	9'8"	N/A	N/A	Scrub grass

Comments: Locked gate. Gage located about 5' from gate and ~ 8 feet from reservoir.

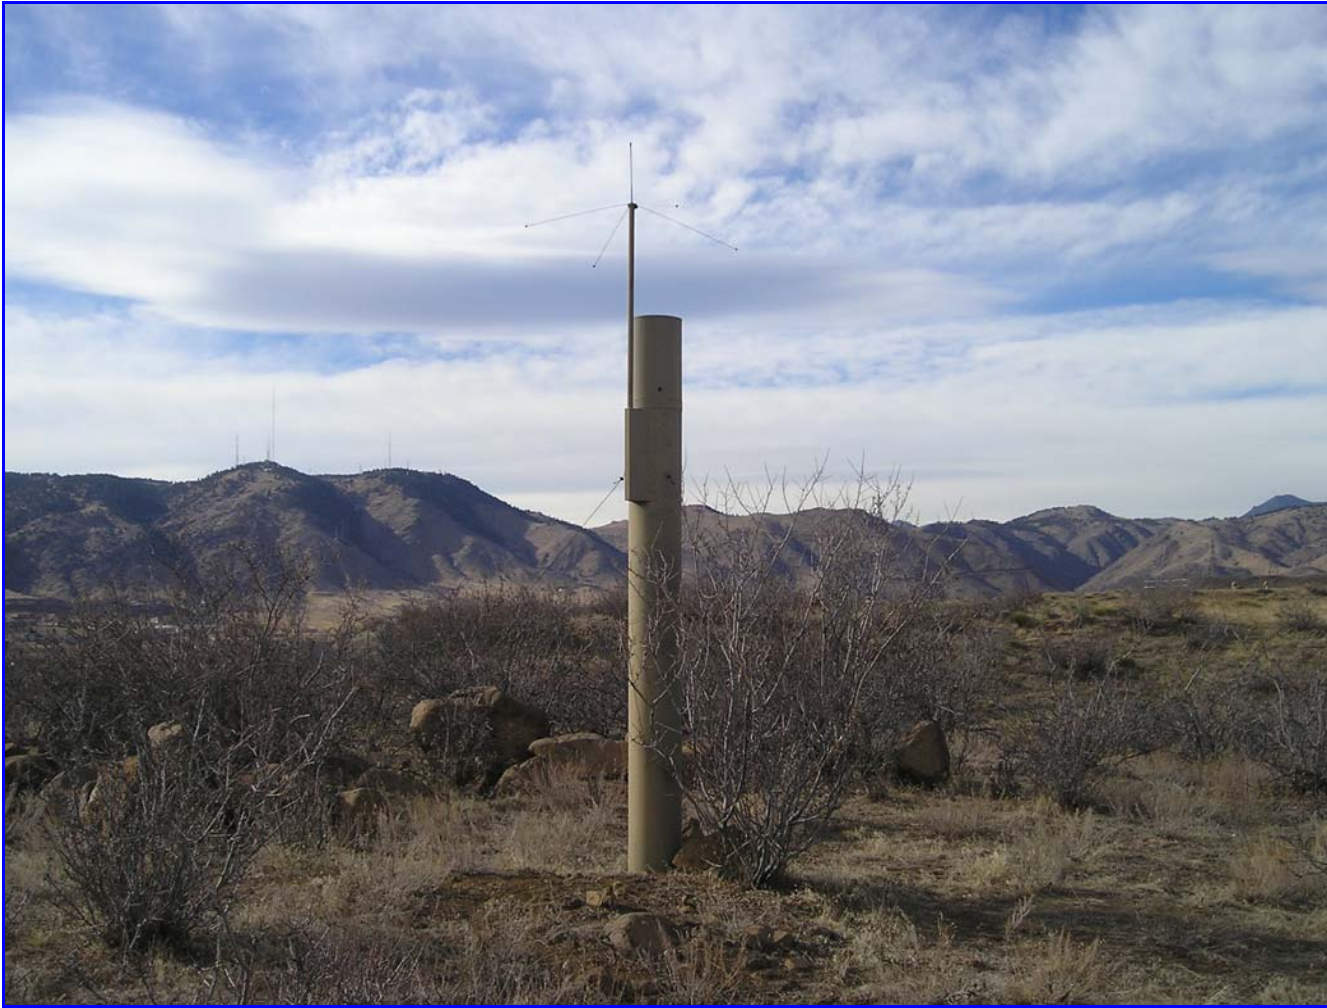
Name	ID	Sensor Type	Date Installed	Latitude	Longitude	Elevation	Gage Height	Anemometer Height	Temperature Sensor Height	Ground type
Denver West	1010	P	05/30/02	39:43:54 N	105:09:08 W	5805'	10'2"	N/A	N/A	Scrub grass

Comments: Locked gate. Gage located about 20' from gate.
