APPENDIX

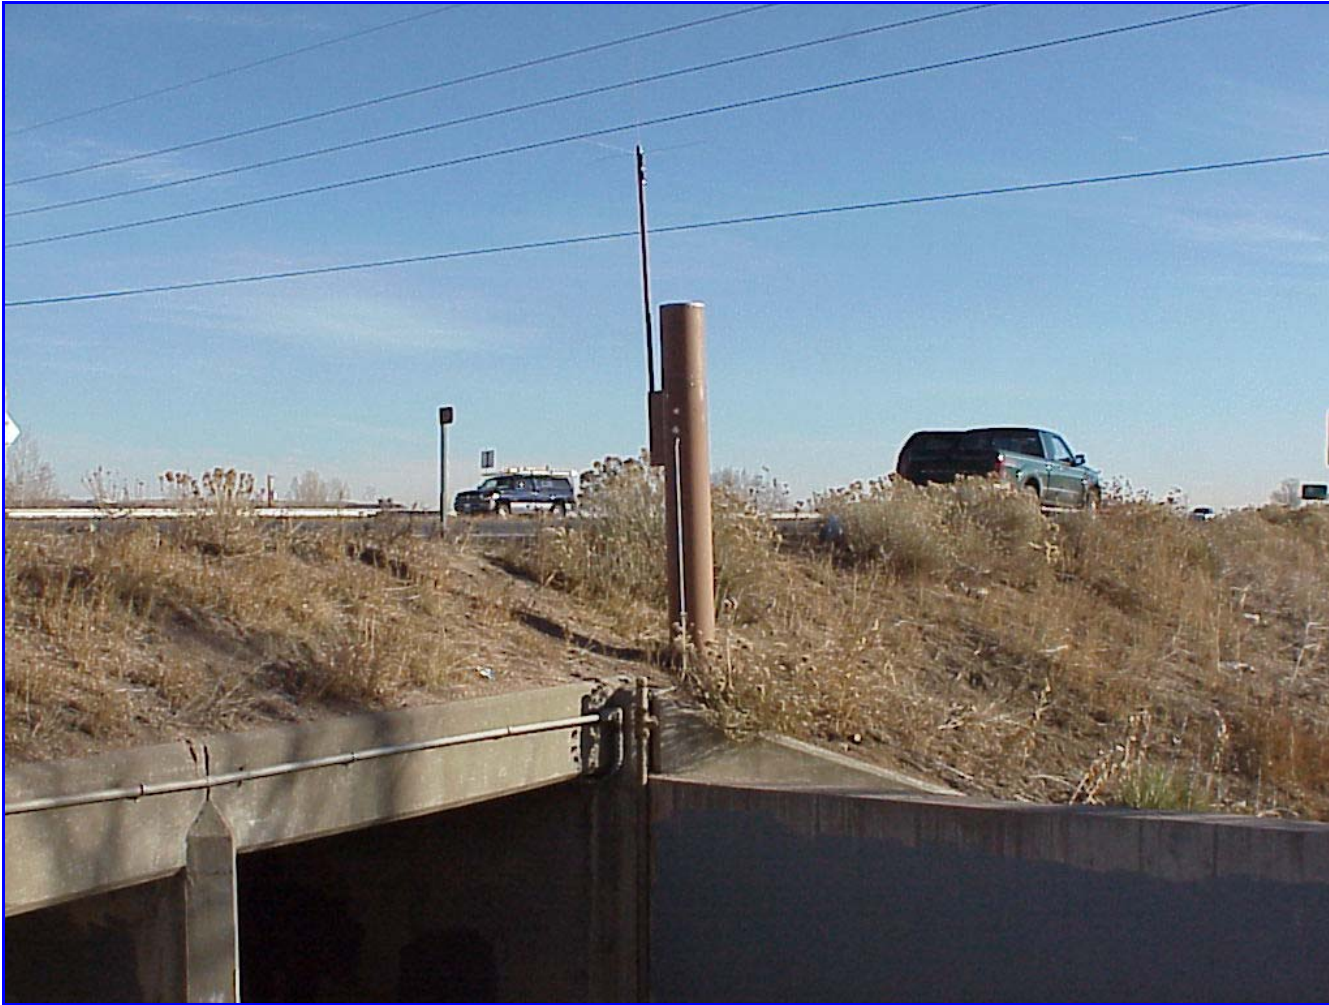
Name	ID	Sensor Type	Date Installed	Latitude	Longitude	Elevation	Gage Height	Anemometer Height	Temperature Sensor Height	Ground type
NREL/South Table Mountain	1030	P	04/01/85	39:44:26 N	105:10:34 W	6000'	10'1"	N/A	N/A	Scrub grass

Comments: Gage located on a Mesa to the north of NREL. NREL security assistance needed to access gage.

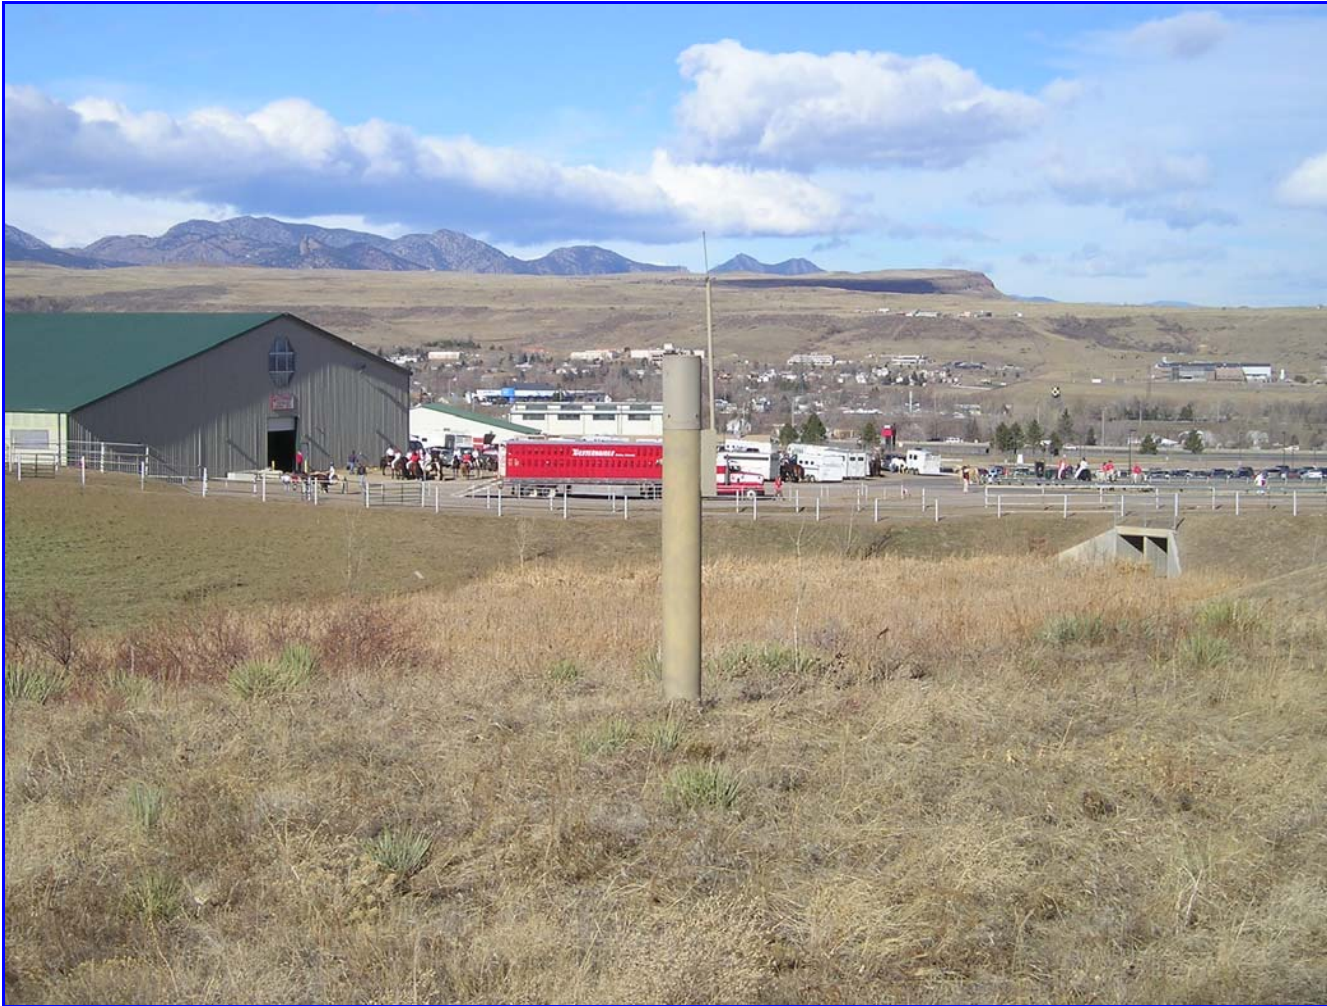
Name	ID	Sensor Type	Date Installed	Latitude	Longitude	Elevation	Gage Height	Anemometer Height	Temperature Sensor Height	Ground type
Jeffco Fairgrounds	1050	P	04/01/85	39:43:14 N	105:10:04 W	5920'	9'6"	N/A	N/A	Scrub grass

Comments: Gage located ~ 30 feet from road.

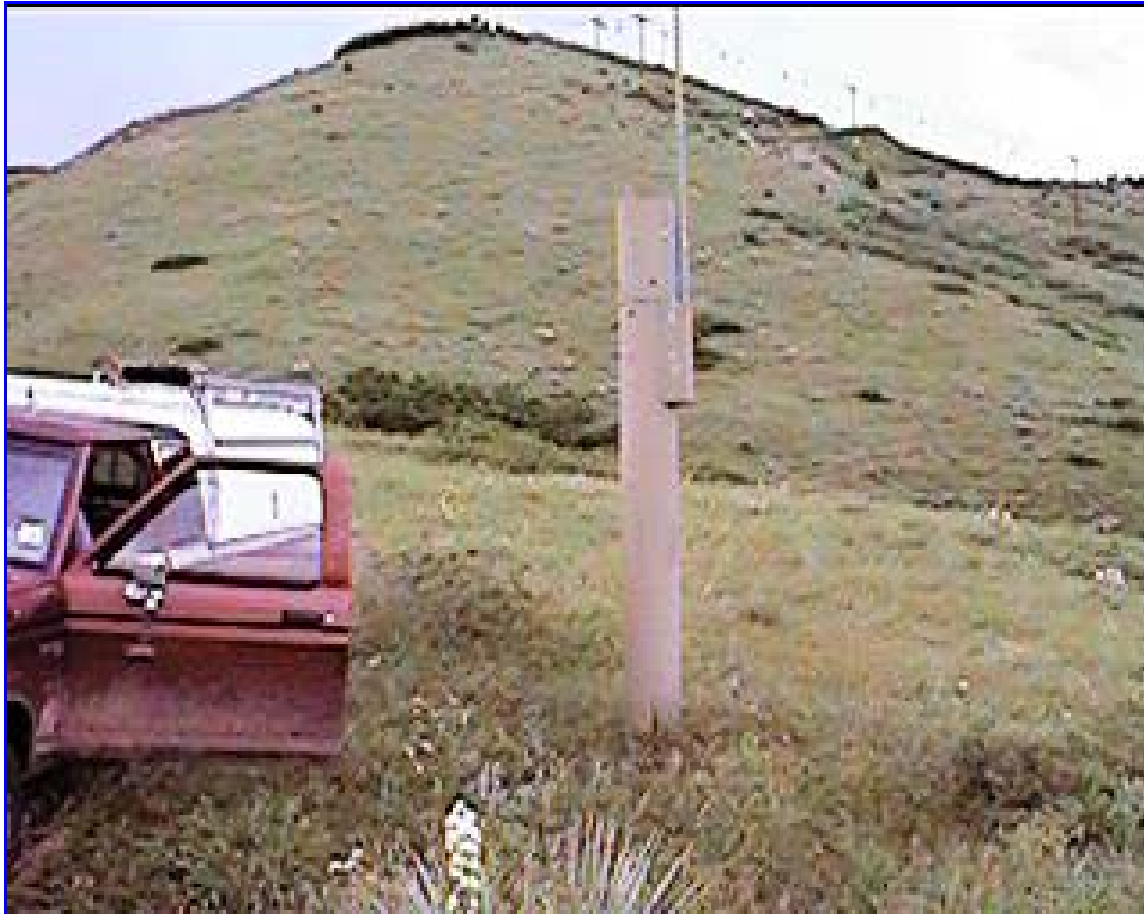
Name	ID	Sensor Type	Date Installed	Latitude	Longitude	Elevation	Gage Height	Anemometer Height	Temperature Sensor Height	Ground type
Heritage Square	1060	P	04/01/85	39:42:36 N	105:12:44 W	6420'	9'9"	N/A	N/A	Scrub grass

Comments: Gage located Apex Mine property, which is a secured area.

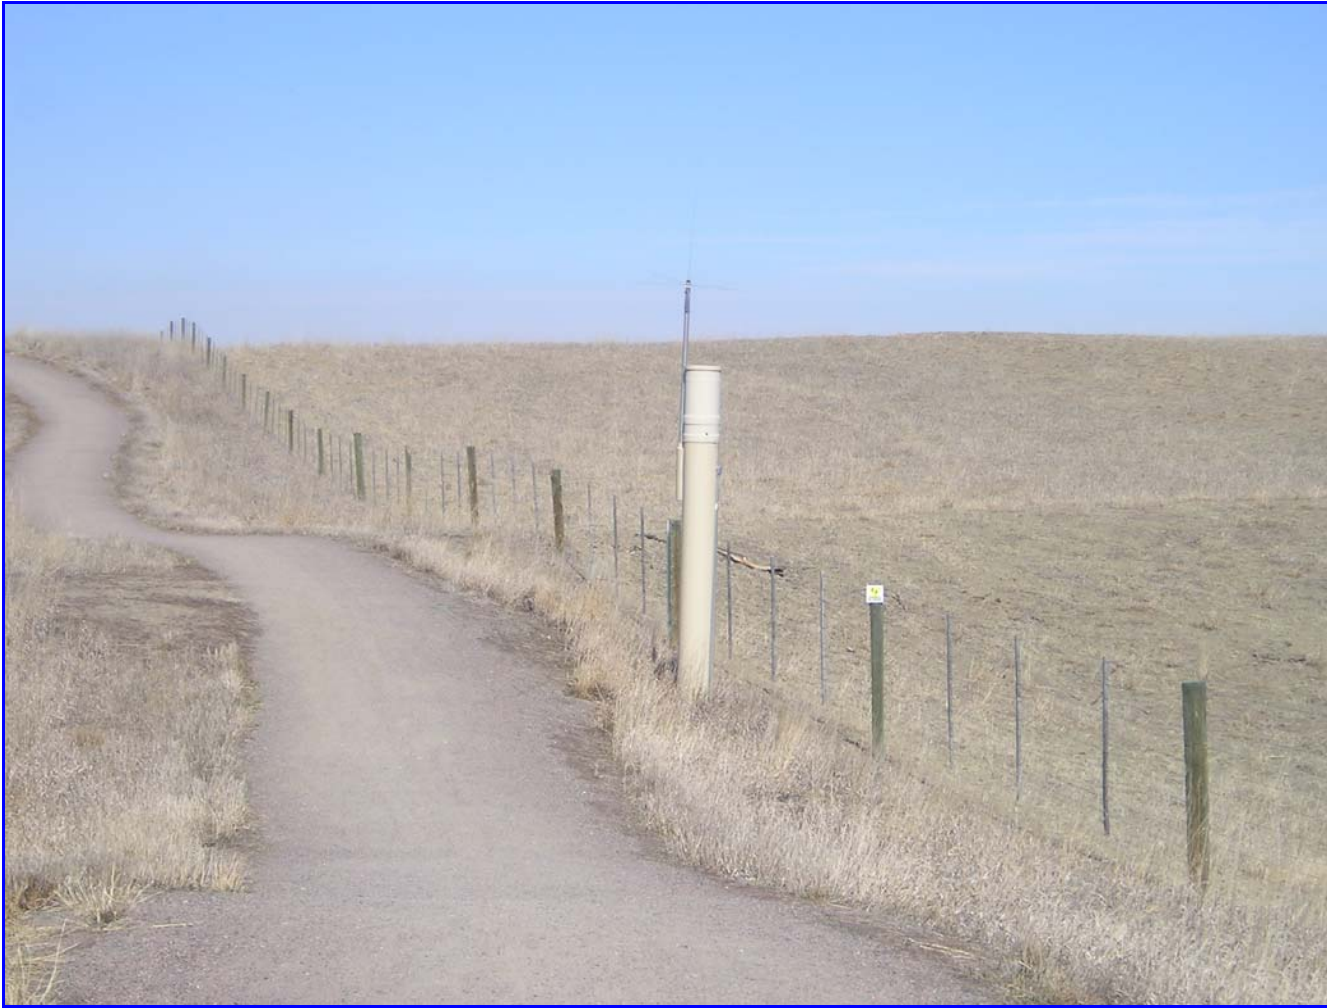
Name	ID	Sensor Type	Date Installed	Latitude	Longitude	Elevation	Gage Height	Anemometer Height	Temperature Sensor Height	Ground type
Louisville Dwy D	1100	P, S	05/06/88	39:58:23 N	105:09:22 W	5464'	7'10"	N/A	N/A	Grass

Comments: Gage located on a 30-degree incline.

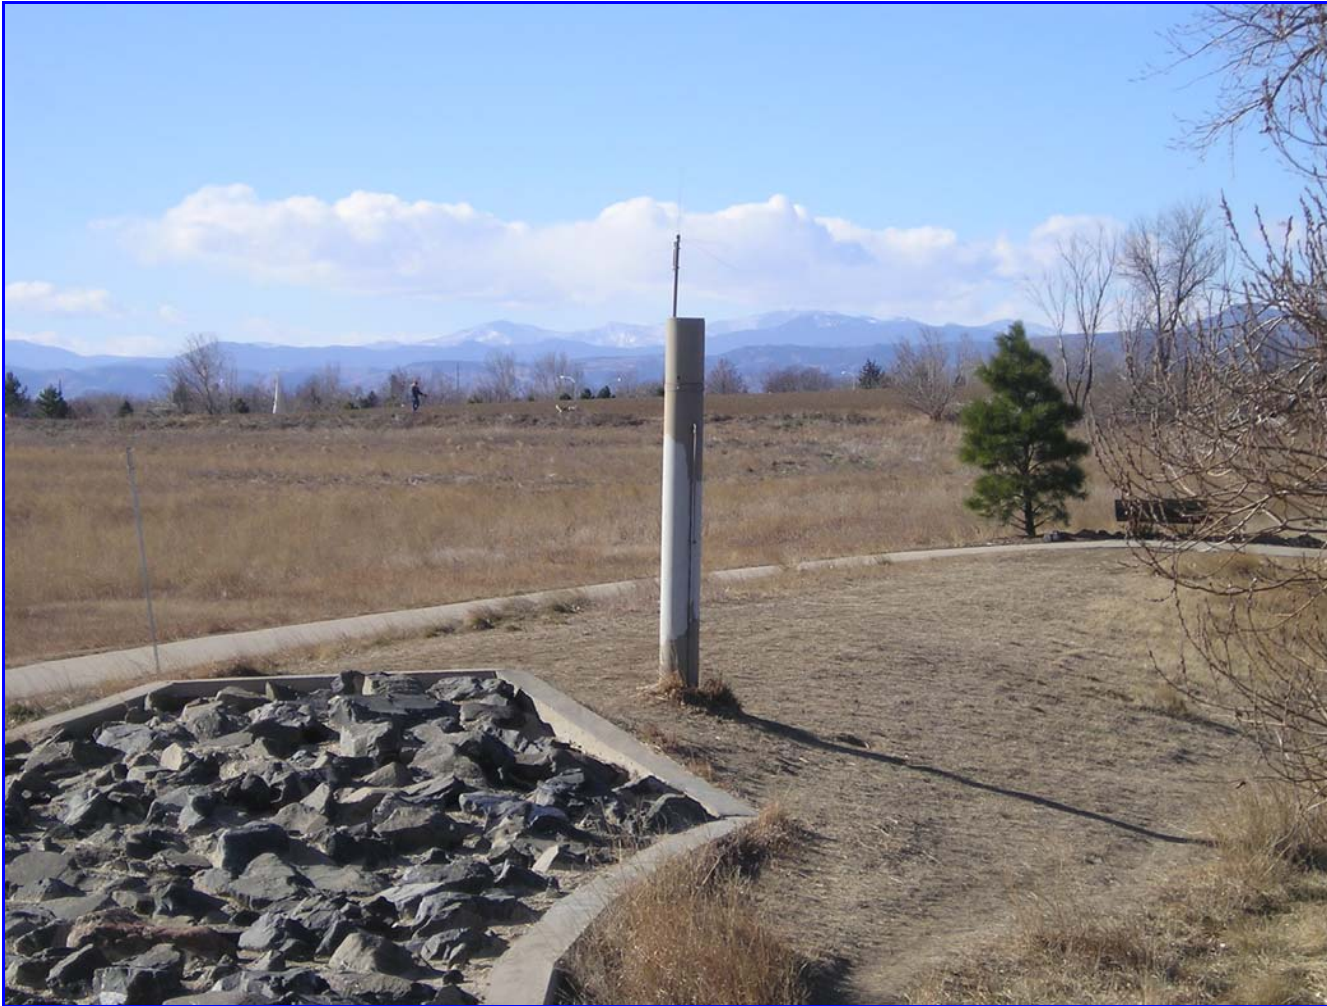
Name	ID	Sensor Type	Date Installed	Latitude	Longitude	Elevation	Gage Height	Anemometer Height	Temperature Sensor Height	Ground type
Broomfield Basin	1200	P, S	03/23/89	39:55:40 N	105:03:52 W	5350'	9'8"	N/A	N/A	Scrub grass

Comments: Gage located ~ 35 feet from a pond.

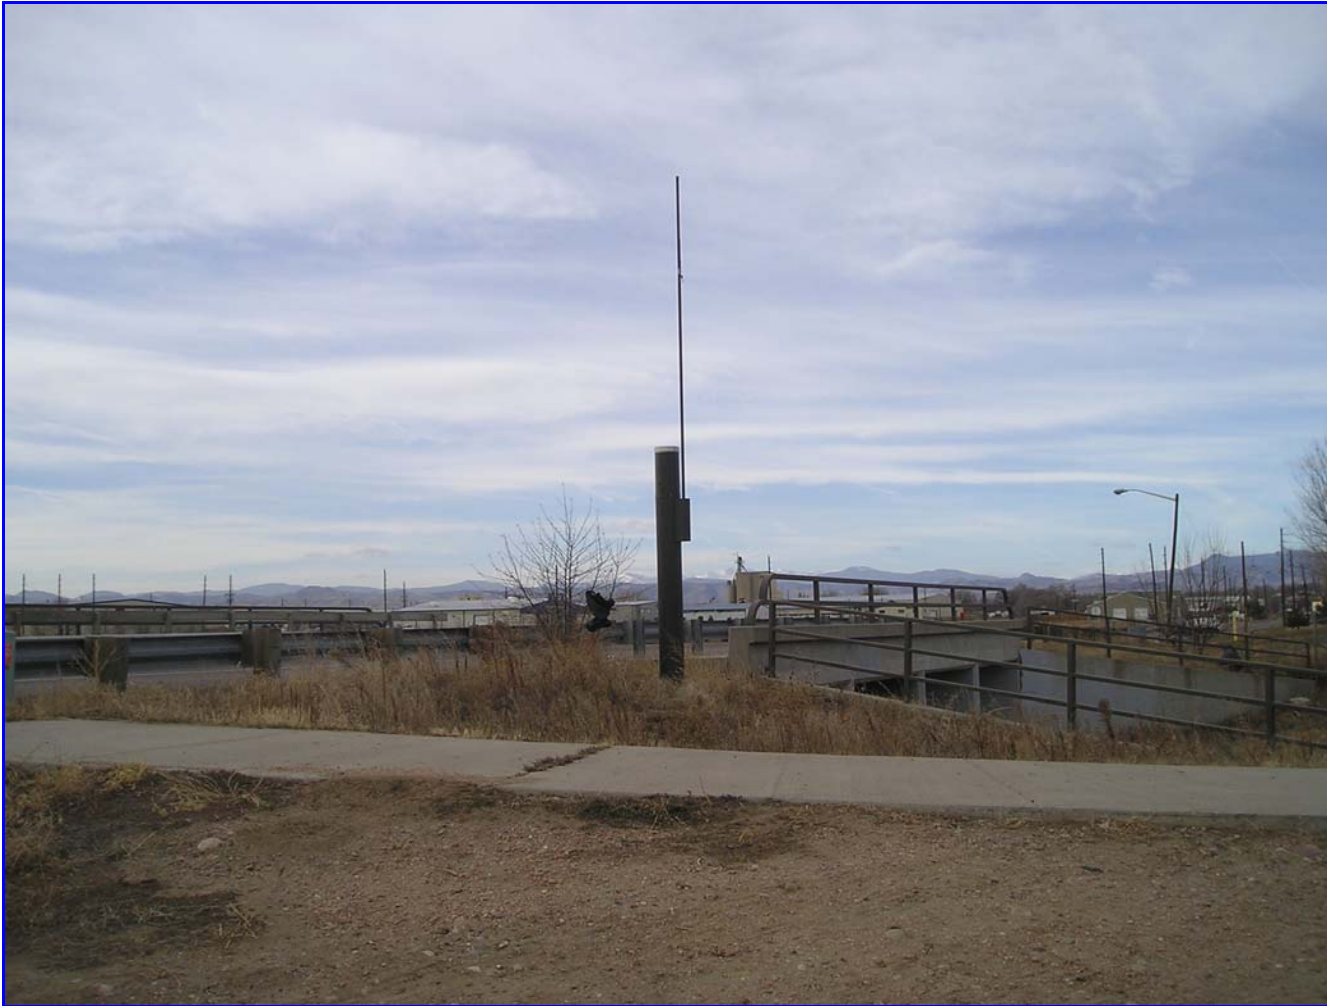
Name	ID	Sensor Type	Date Installed	Latitude	Longitude	Elevation	Gage Height	Anemometer Height	Temperature Sensor Height	Ground type
Little Dry @ 64th	1310	P, S	08/29/01	39:48:47 N	105:00:50 W	5204'	9'8"	N/A	N/A	Scrub grass

Comments: Gage located ~ 9 feet from road and ~ 15 feet from creek.

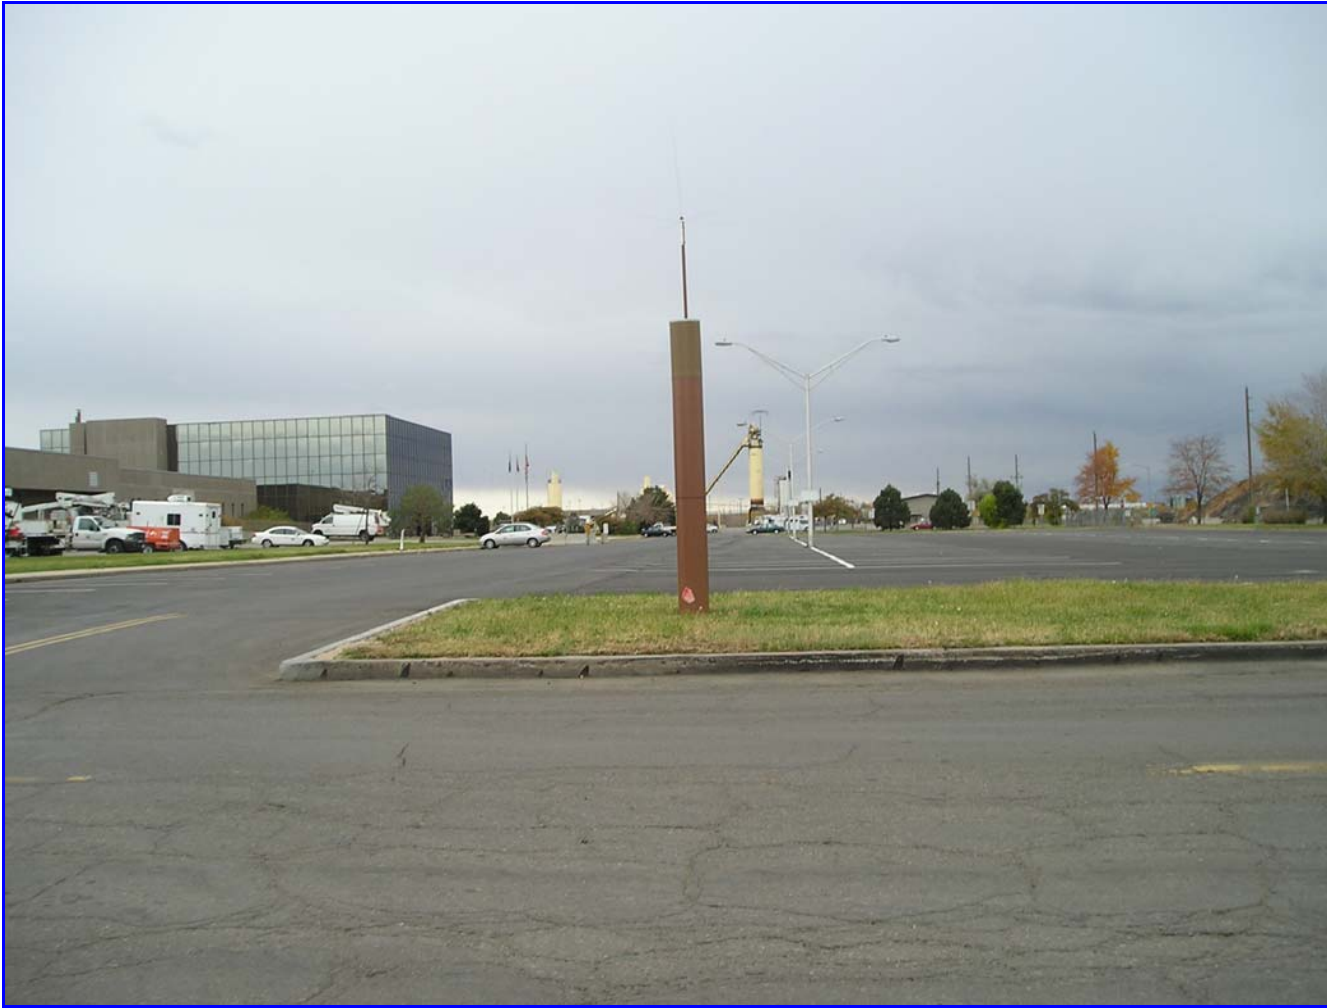
Name	ID	Sensor Type	Date Installed	Latitude	Longitude	Elevation	Gage Height	Anemometer Height	Temperature Sensor Height	Ground type
SPR @ 3 rd Avenue	1320	P, S	01/28/03	39:43:18 N	105:00:37 W	5210'	9'8"	N/A	N/A	Grass

Comments: Gage located ~ 5 feet from river. Obstruction will occur due to tree to the south when tree grows ~5 feet in the vertical. Locked gate after business hours.

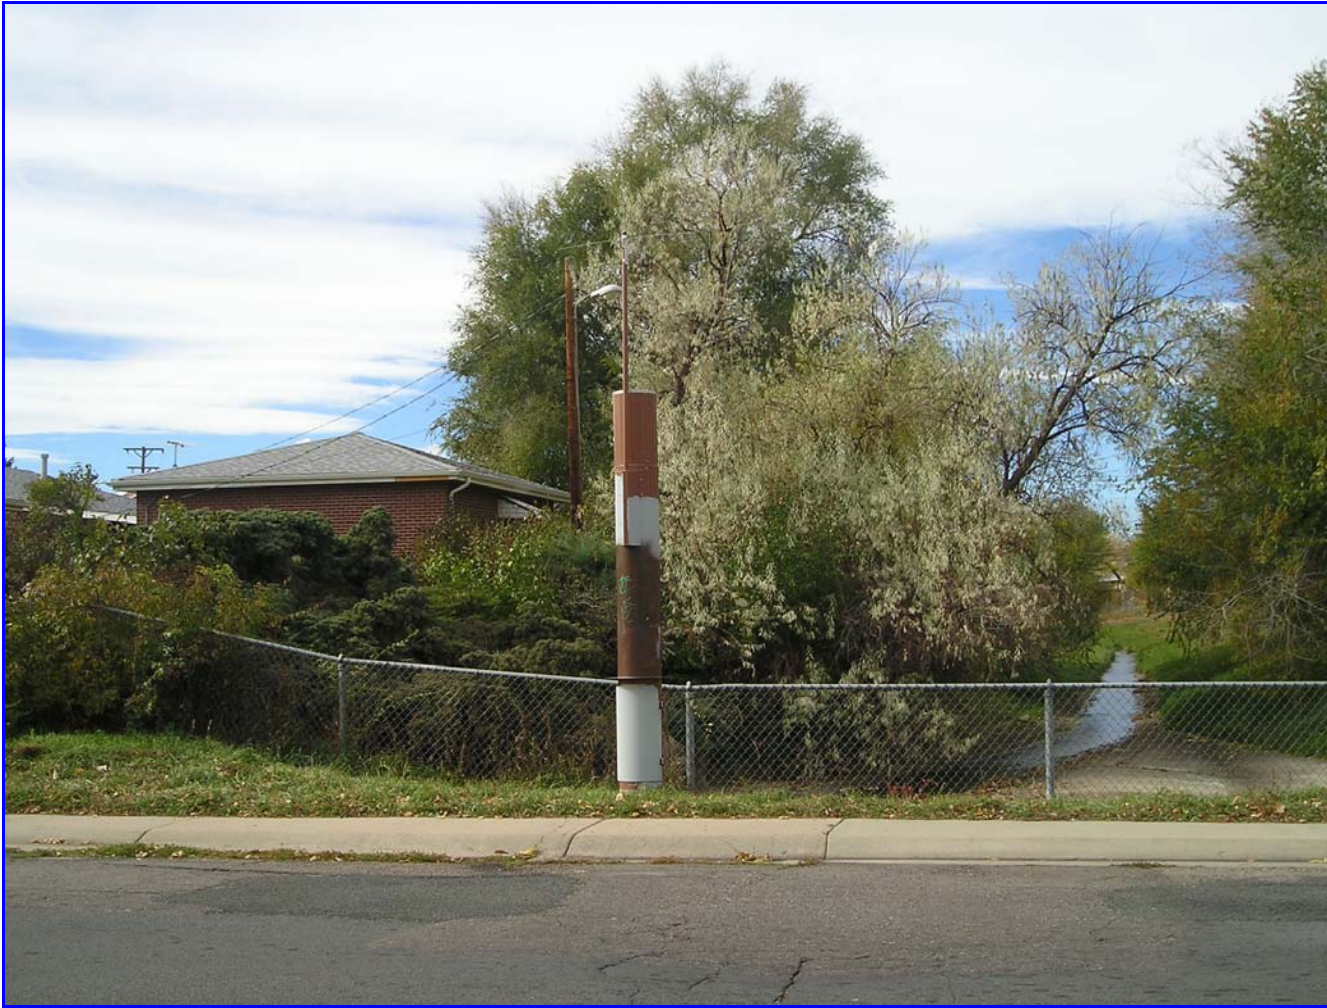
Name	ID	Sensor Type	Date Installed	Latitude	Longitude	Elevation	Gage Height	Anemometer Height	Temperature Sensor Height	Ground type
Roslyn	1330	P	01/17/03	39:47:50 N	104:54:04 W	5220'	9'1"	N/A	N/A	Grass

Comments: Locked gate after business hours.

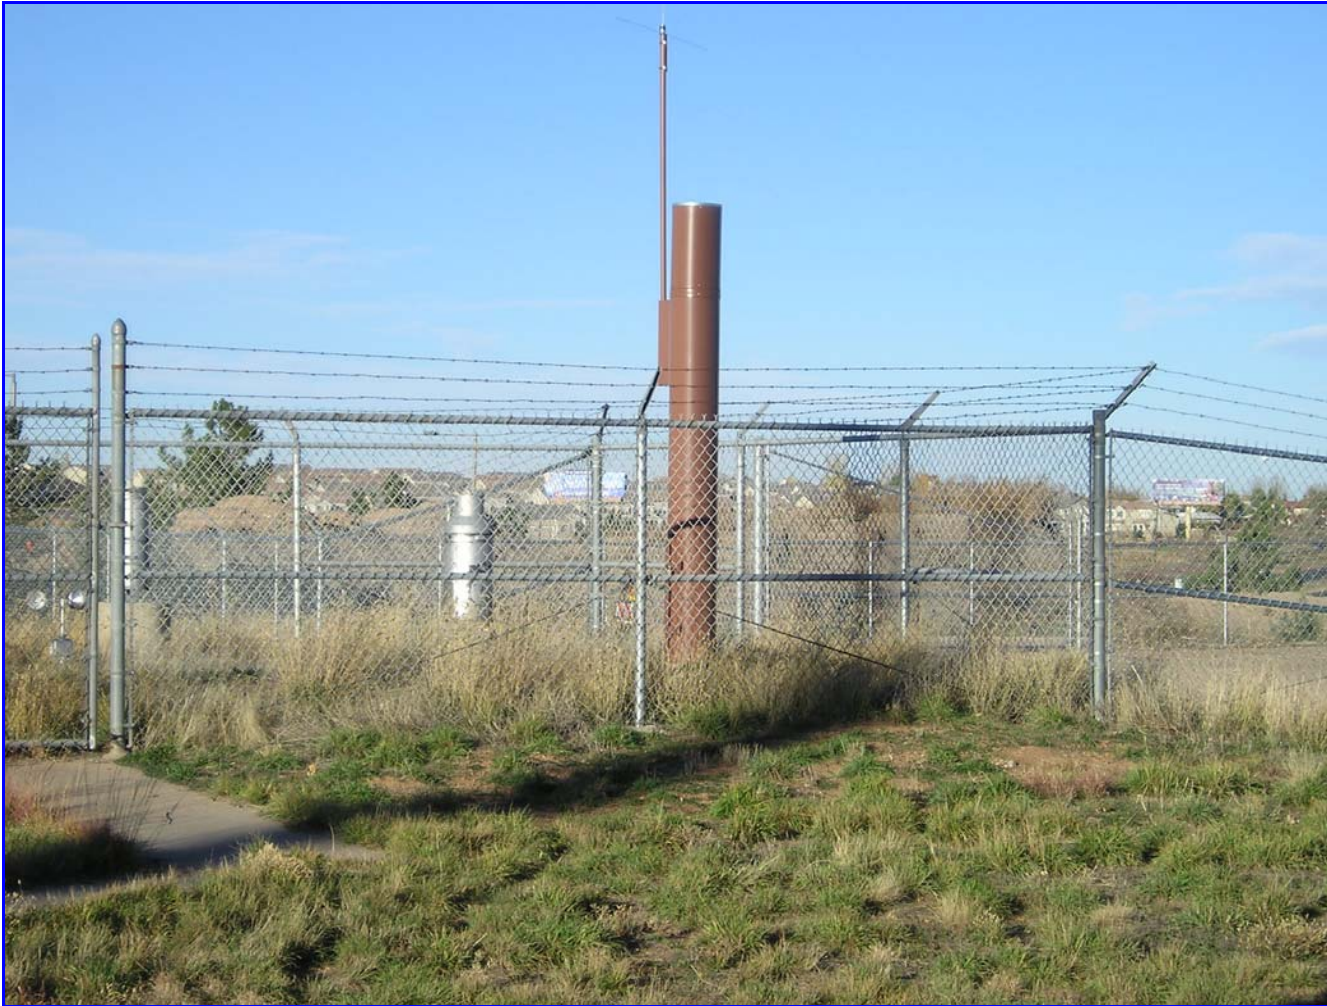
Name	ID	Sensor Type	Date Installed	Latitude	Longitude	Elevation	Gage Height	Anemometer Height	Temperature Sensor Height	Ground type
Chatfield COE	1350	P	03/06/03	39:33:23 N	105:04:44 W	5545'	9'10"	N/A	N/A	Scrub grass

Comments: Locked gate after business hours. Security access needed. Located in locked fenced enclosure.

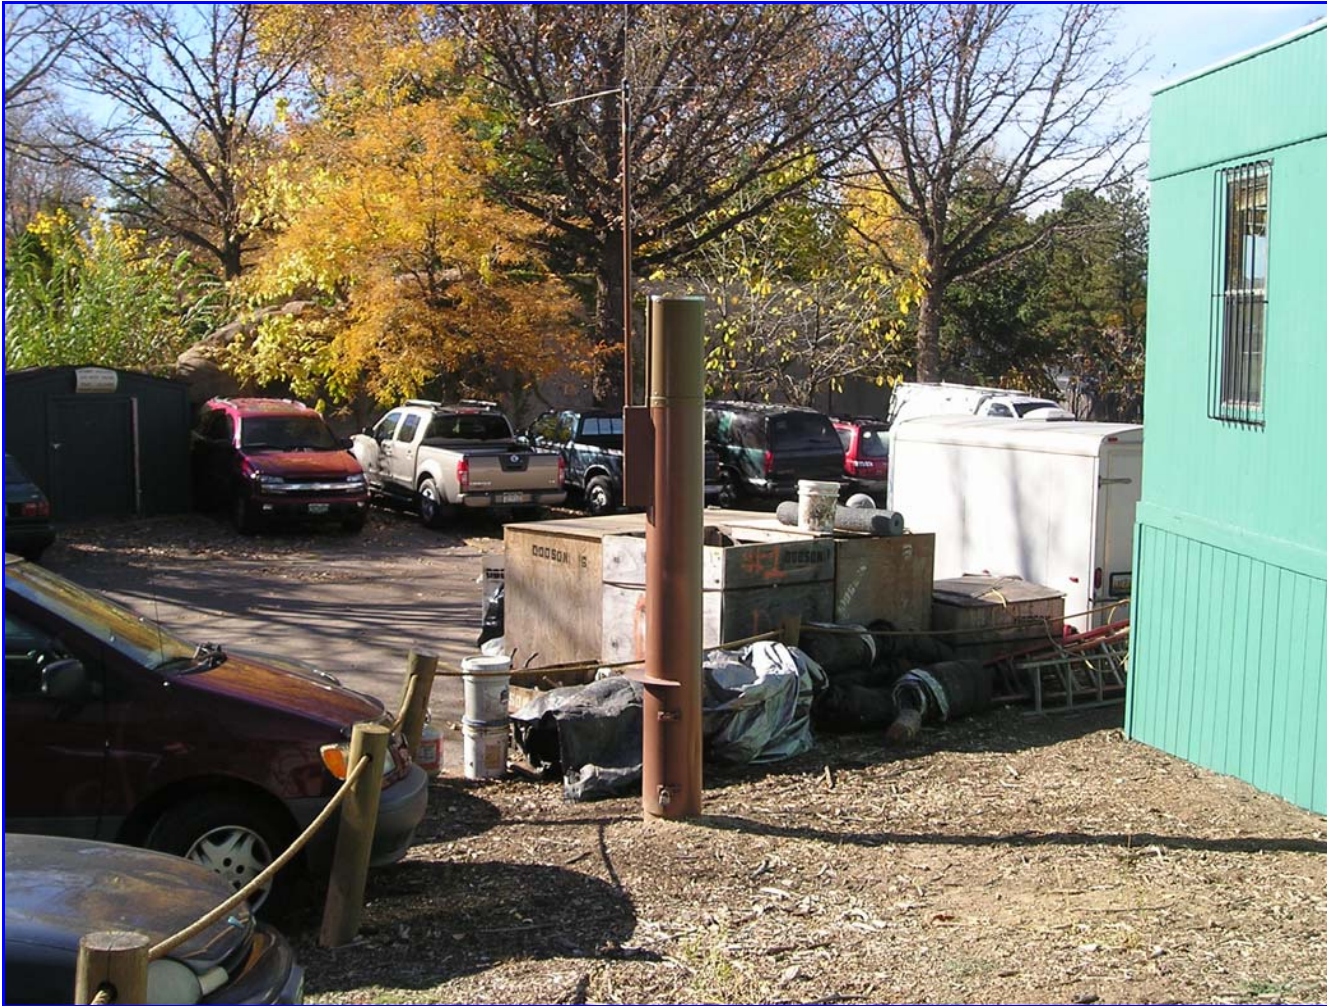
Name	ID	Sensor Type	Date Installed	Latitude	Longitude	Elevation	Gage Height	Anemometer Height	Temperature Sensor Height	Ground type
Denver Zoo	1360	P	01/17/03	39:45:03 N	104:57:14 W	5265'	9'10"	N/A	N/A	Dirt

Comments: Locked gate. Security access needed. Obstruction will occur due to tree to the north when tree grows ~10 feet in the vertical

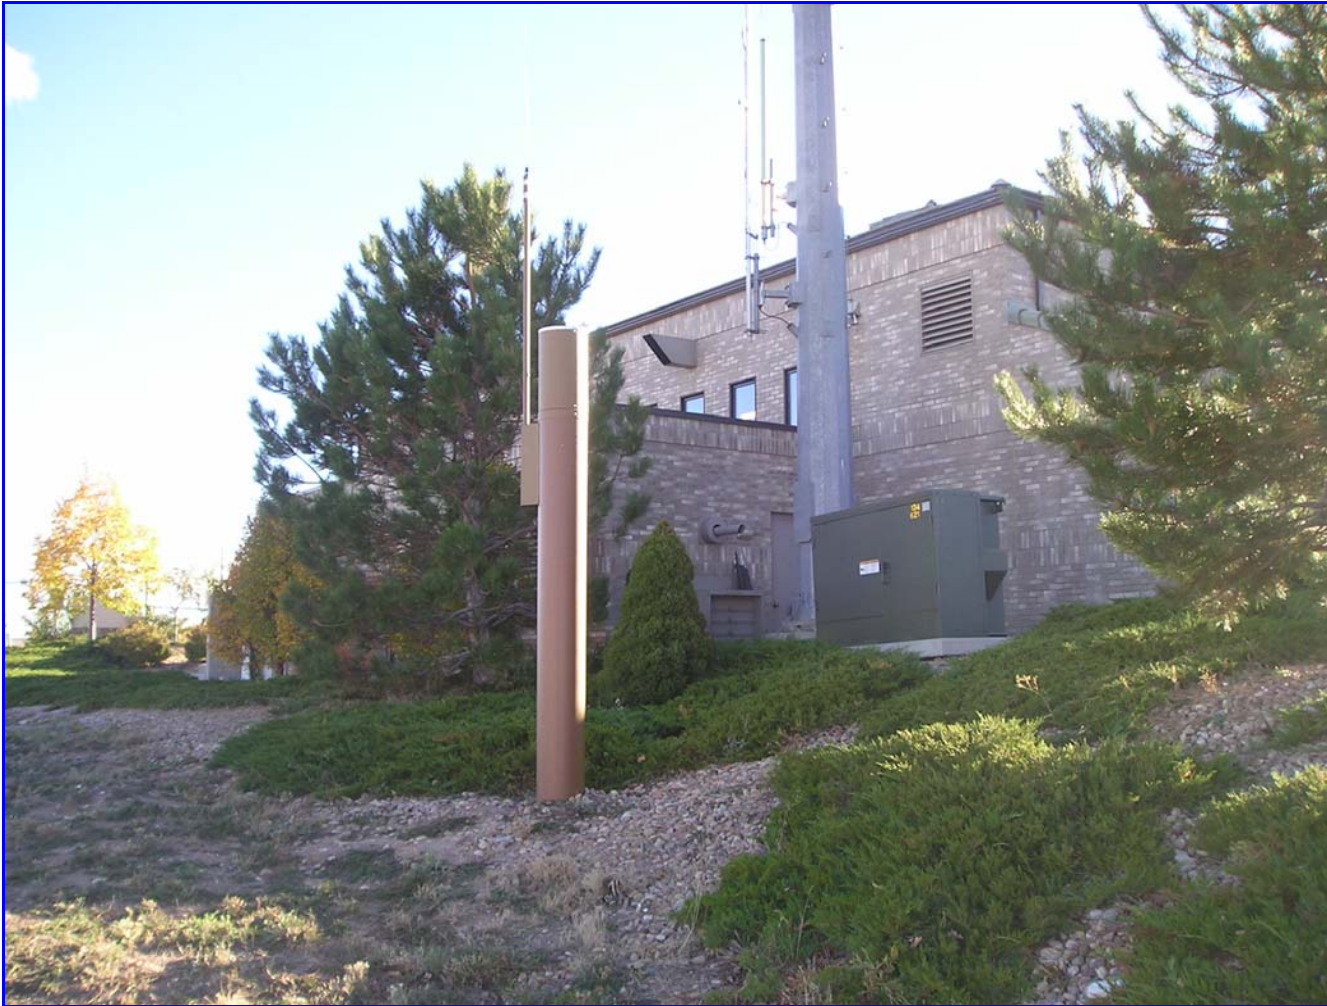
Name	ID	Sensor Type	Date Installed	Latitude	Longitude	Elevation	Gage Height	Anemometer Height	Temperature Sensor Height	Ground type
West Metro Fire	1370	P	02/26/04	39:34:52 N	105:08:16 W	5853'	9'2"	N/A	N/A	Gravel

Comments: Two story building ~ 30 feet to west.

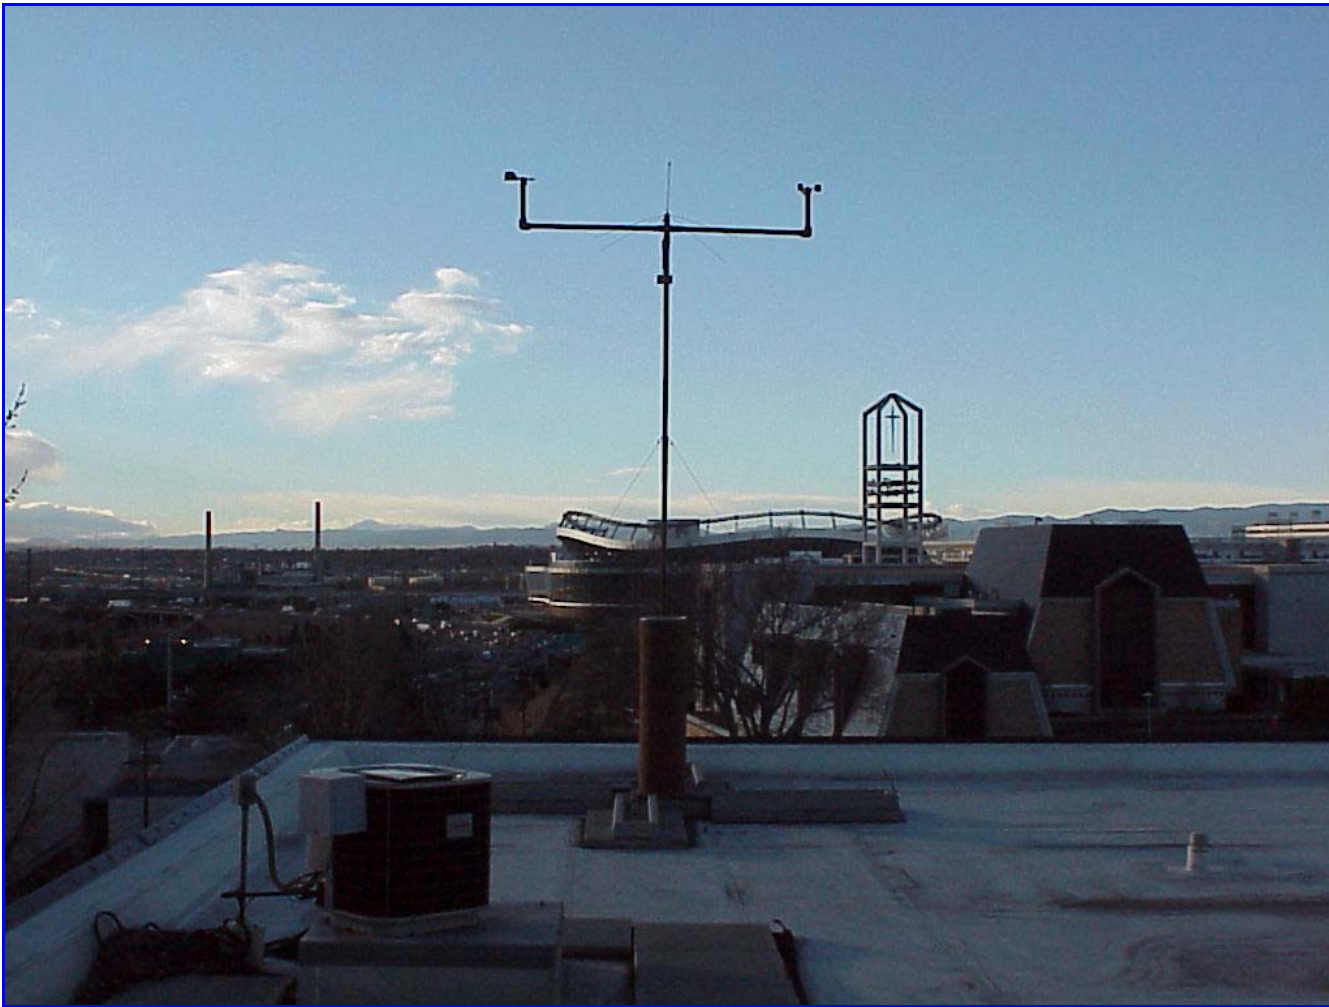
Name	ID	Sensor Type	Date Installed	Latitude	Longitude	Elevation	Gage Height	Anemometer Height	Temperature Sensor Height	Ground type
Upper Sloan Detention	1400	P, S	05/30/87	39:45:13 N	105:04:45 W	5431'	8'11"	N/A	N/A	Scrub grass

Comments: Gage located on a 45-degree incline.

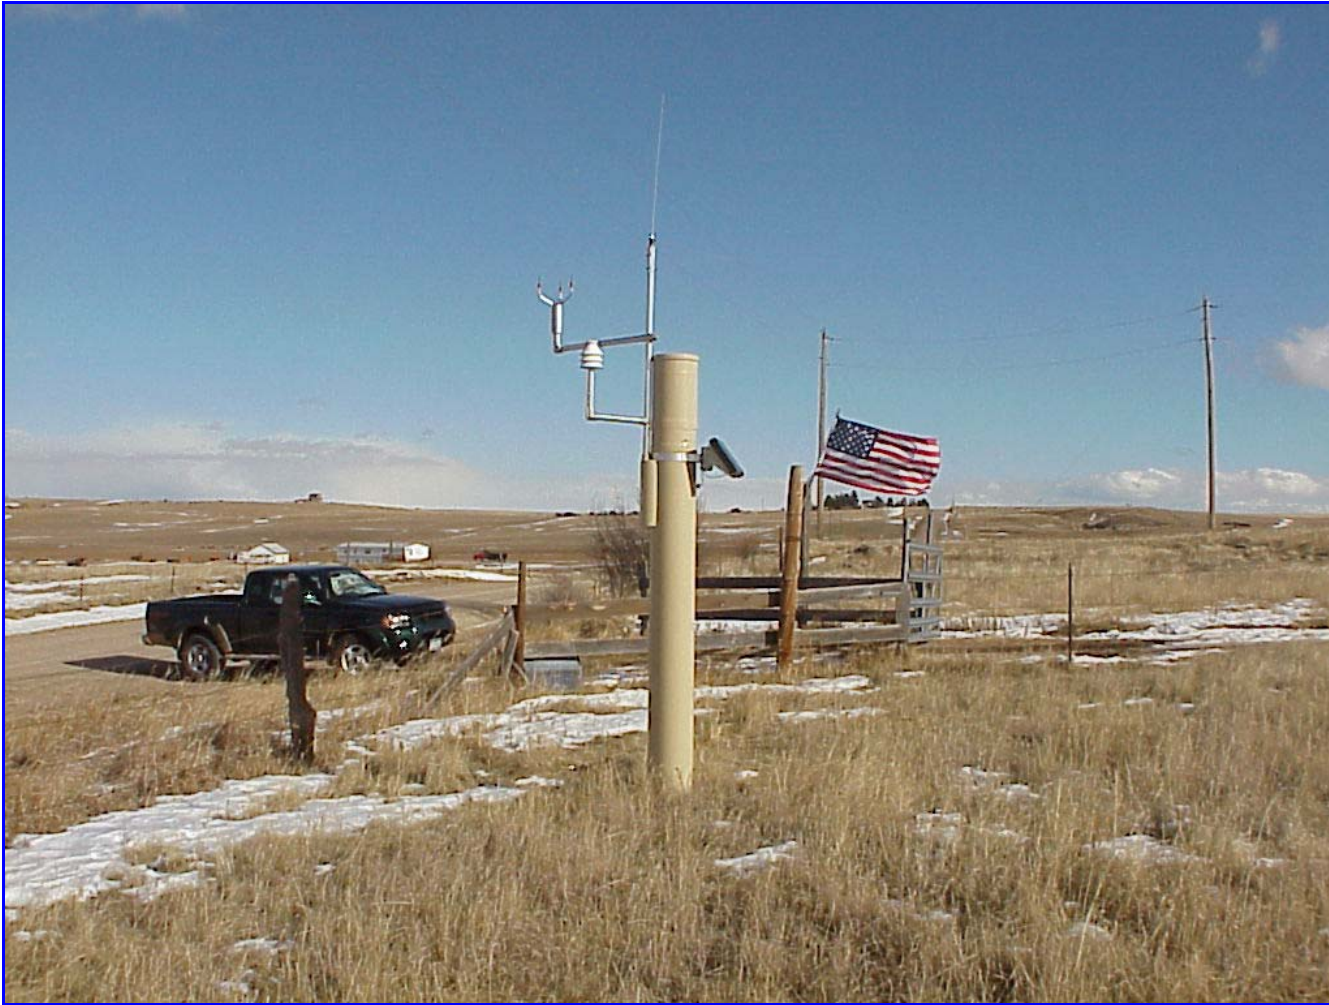
Name	ID	Sensor Type	Date Installed	Latitude	Longitude	Elevation	Gage Height	Anemometer Height	Temperature Sensor Height	Ground type
Elbert	1440	Wx	06/18/99	39:14:43 N	104:35:20 W	6850'	7'8"	8'3"	7'8"	Scrub grass

Comments: Sonic anemometer. Gage located on private residence.

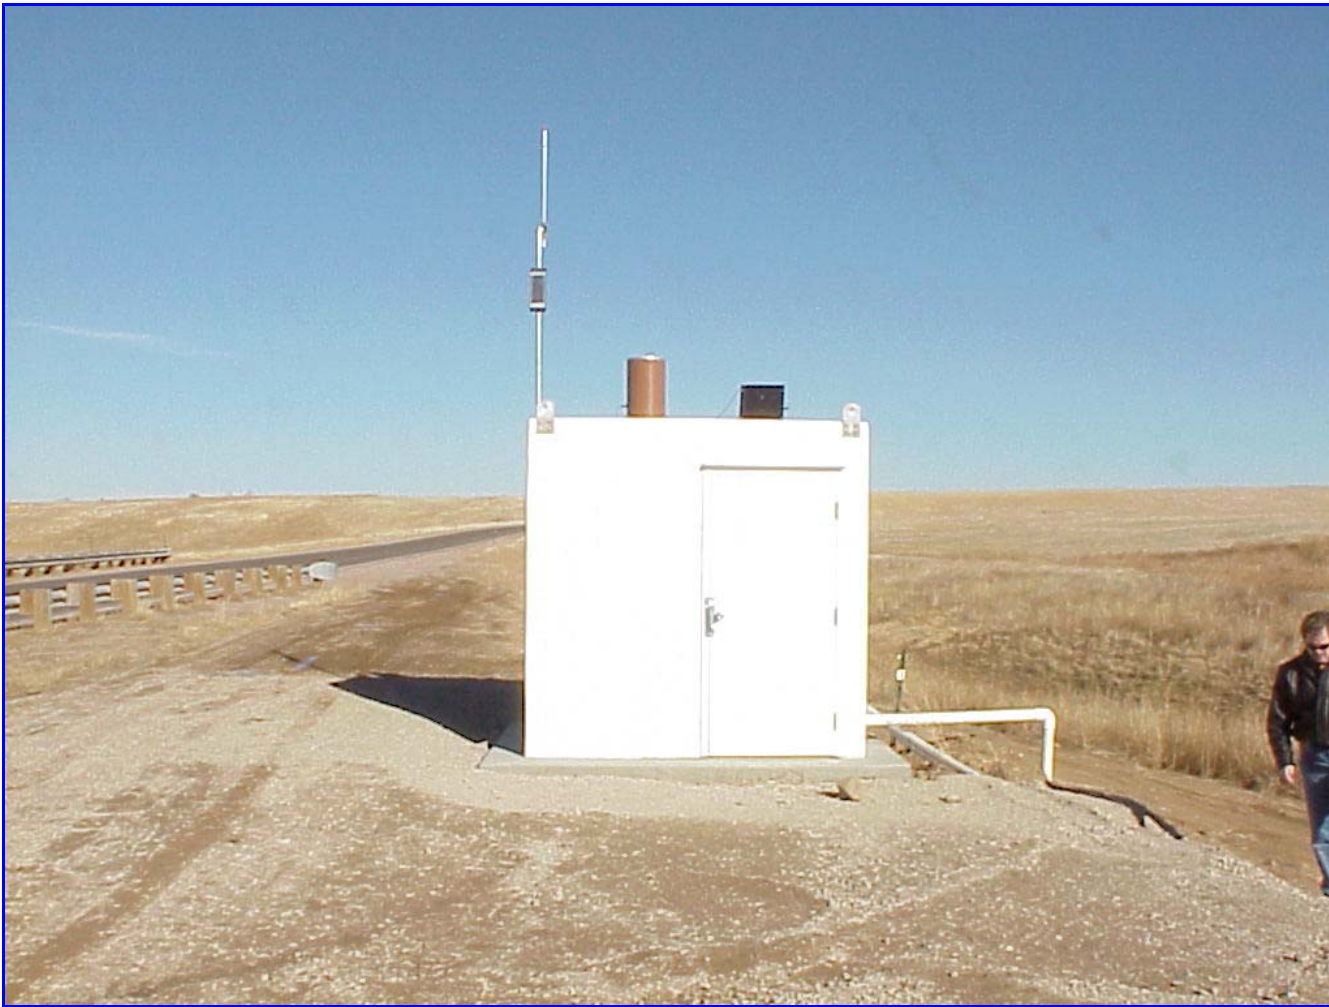
Name	ID	Sensor Type	Date Installed	Latitude	Longitude	Elevation	Gage Height	Anemometer Height	Temperature Sensor Height	Ground type
Third Creek @ DIA	1480	P, S	11/19/01	39:53:24 N	104:43:48 W	5186'	~10'	N/A	N/A	Concrete

Comments: Asphalt road 25' to the west. Third creek, box culvert 20' to southeast.

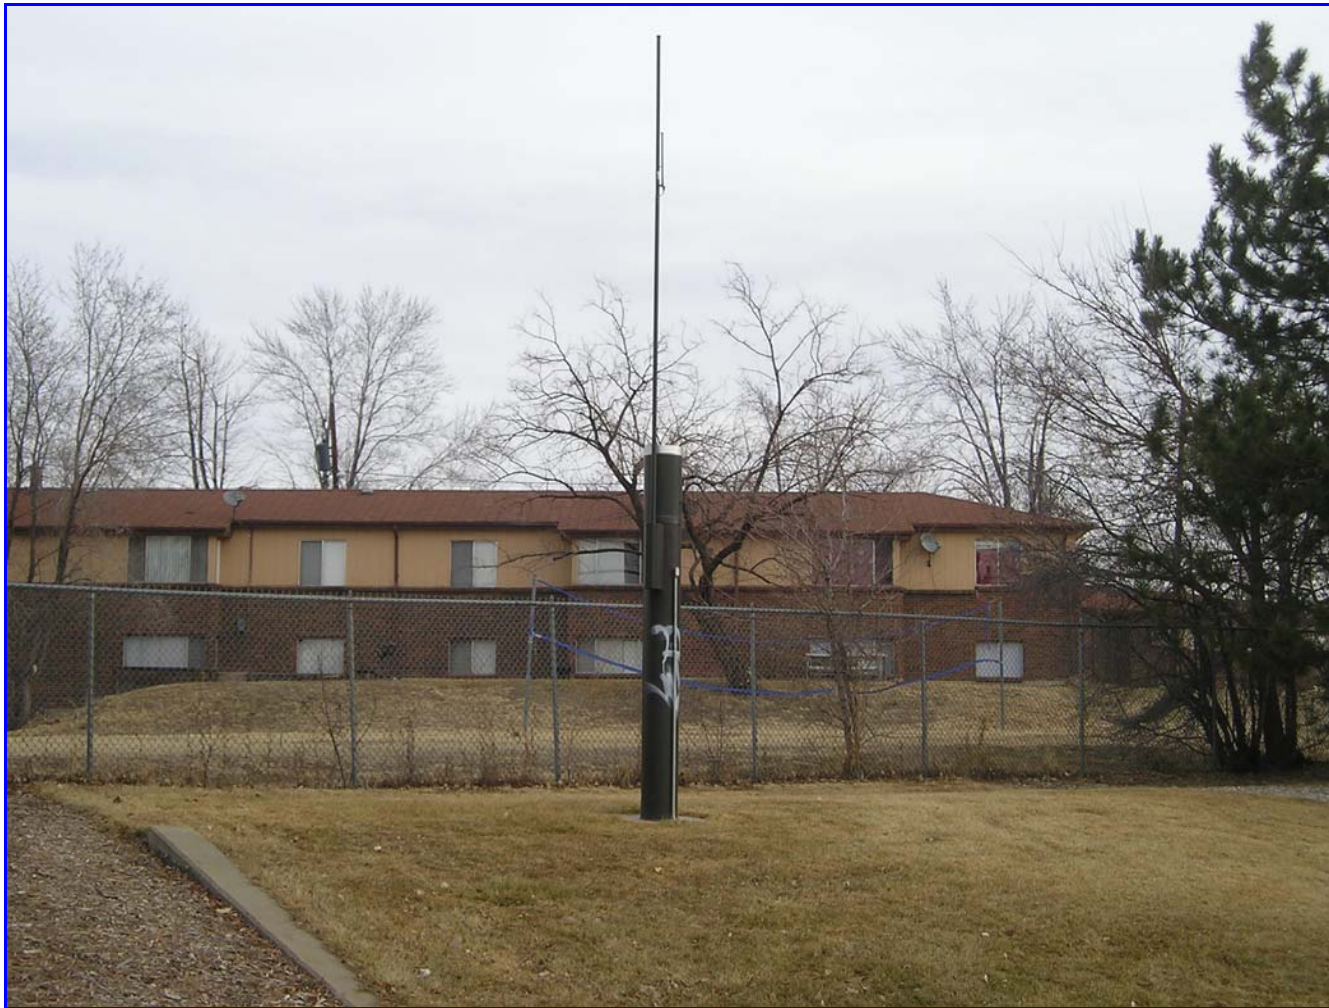
Name	ID	Sensor Type	Date Installed	Latitude	Longitude	Elevation	Gage Height	Anemometer Height	Temperature Sensor Height	Ground type
Powers Park	1500	P, S	04/22/02	39:36:58 N	104:59:50 W	5410'	9'7"	N/A	N/A	Grass

Comments: Graffiti on gage. 35' tree ~ 30 ' to east.

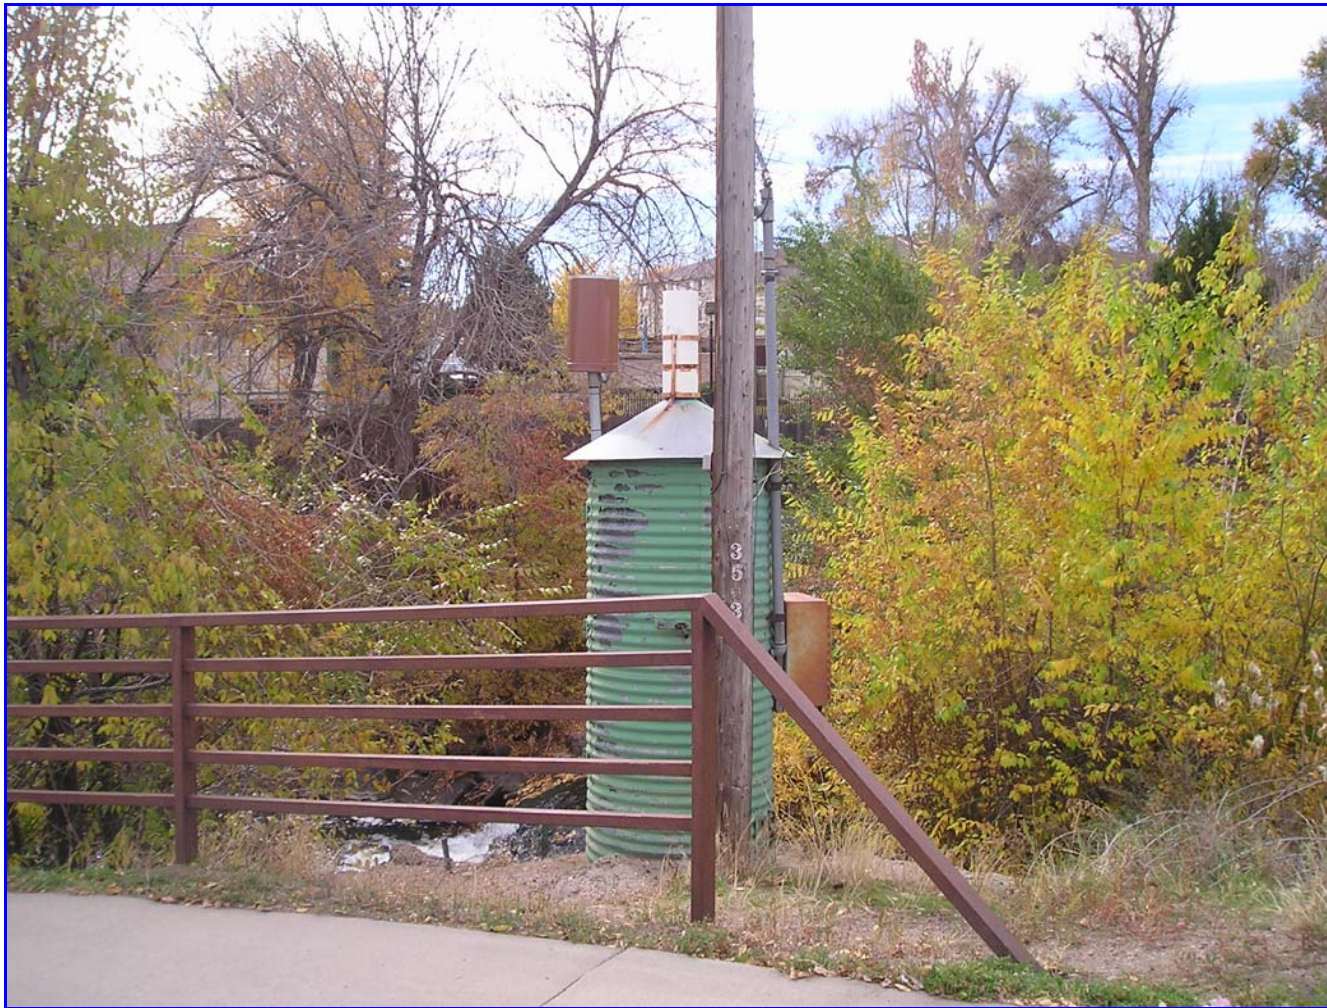
Name	ID	Sensor Type	Date Installed	Latitude	Longitude	Elevation	Gage Height	Anemometer Height	Temperature Sensor Height	Ground type
Bear Creek @ Lowell	1530	P, S	10/16/02	39:39:08 N	105:01:58 W	5310'	10'6"	N/A	N/A	N/A

Comments: Obstruction due to tree to the east of gage
