APPENDIX

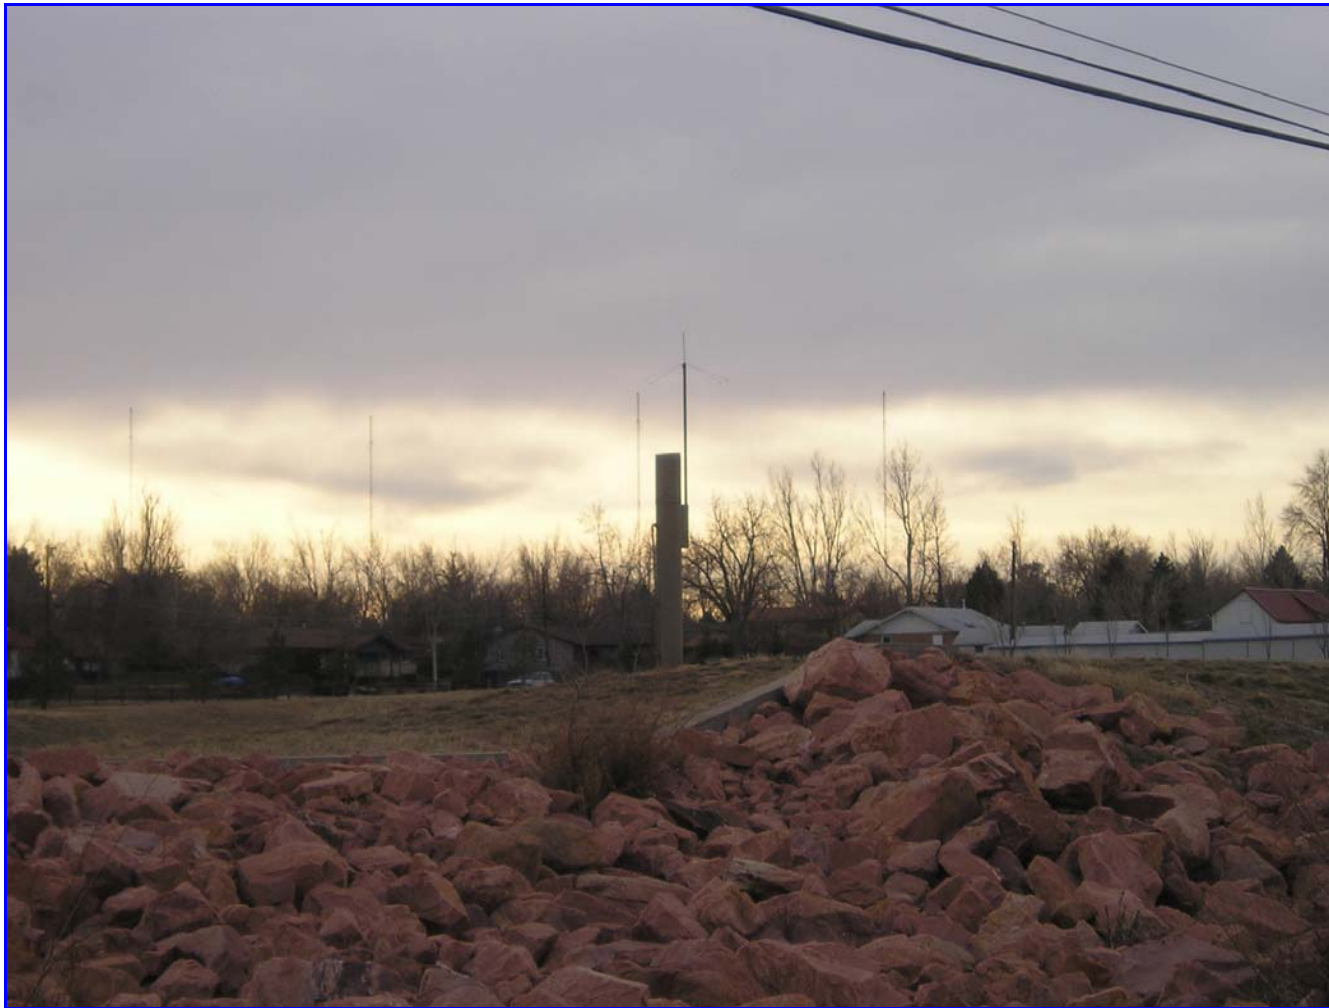
Name	ID	Sensor Type	Date Installed	Latitude	Longitude	Elevation	Gage Height	Anemometer Height	Temperature Sensor Height	Ground type
Englewood Dam	1600	P, S	06/11/87	39:35:23 N	104:55:05 W	5570'	9'8"	N/A	N/A	Scrub grass

Comments: Gage on 40-degree incline.

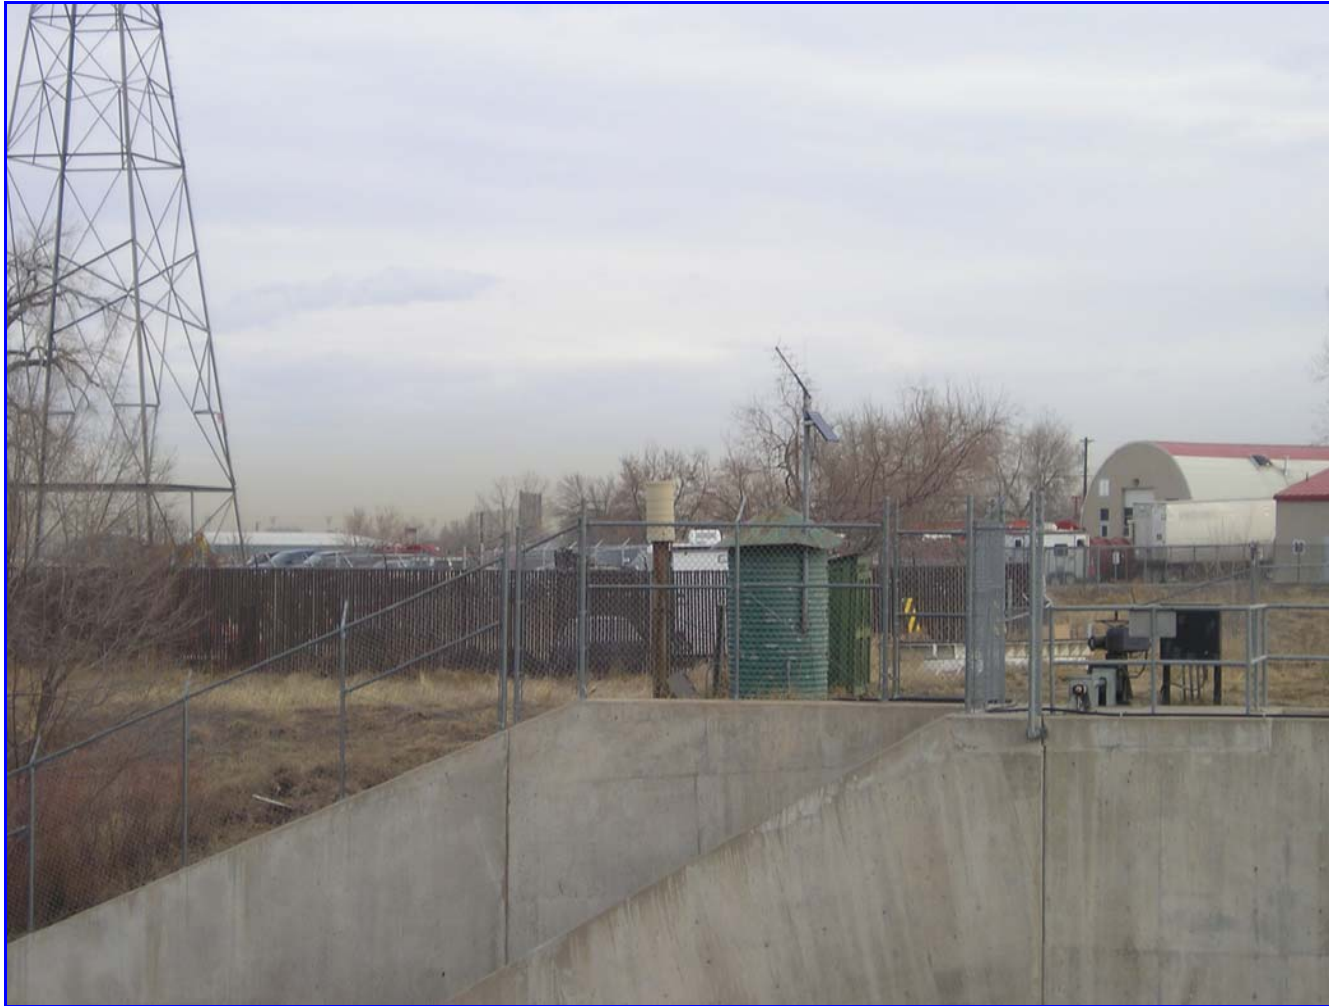
Name	ID	Sensor Type	Date Installed	Latitude	Longitude	Elevation	Gage Height	Anemometer Height	Temperature Sensor Height	Ground type
Slaughterhouse Gulch	1620	P, S	03/23/89	39:36:31 N	104:59:10 W	5470'	9'3"	N/A	N/A	Grass

Comments: Gage located ~ 12 feet from detention pond.

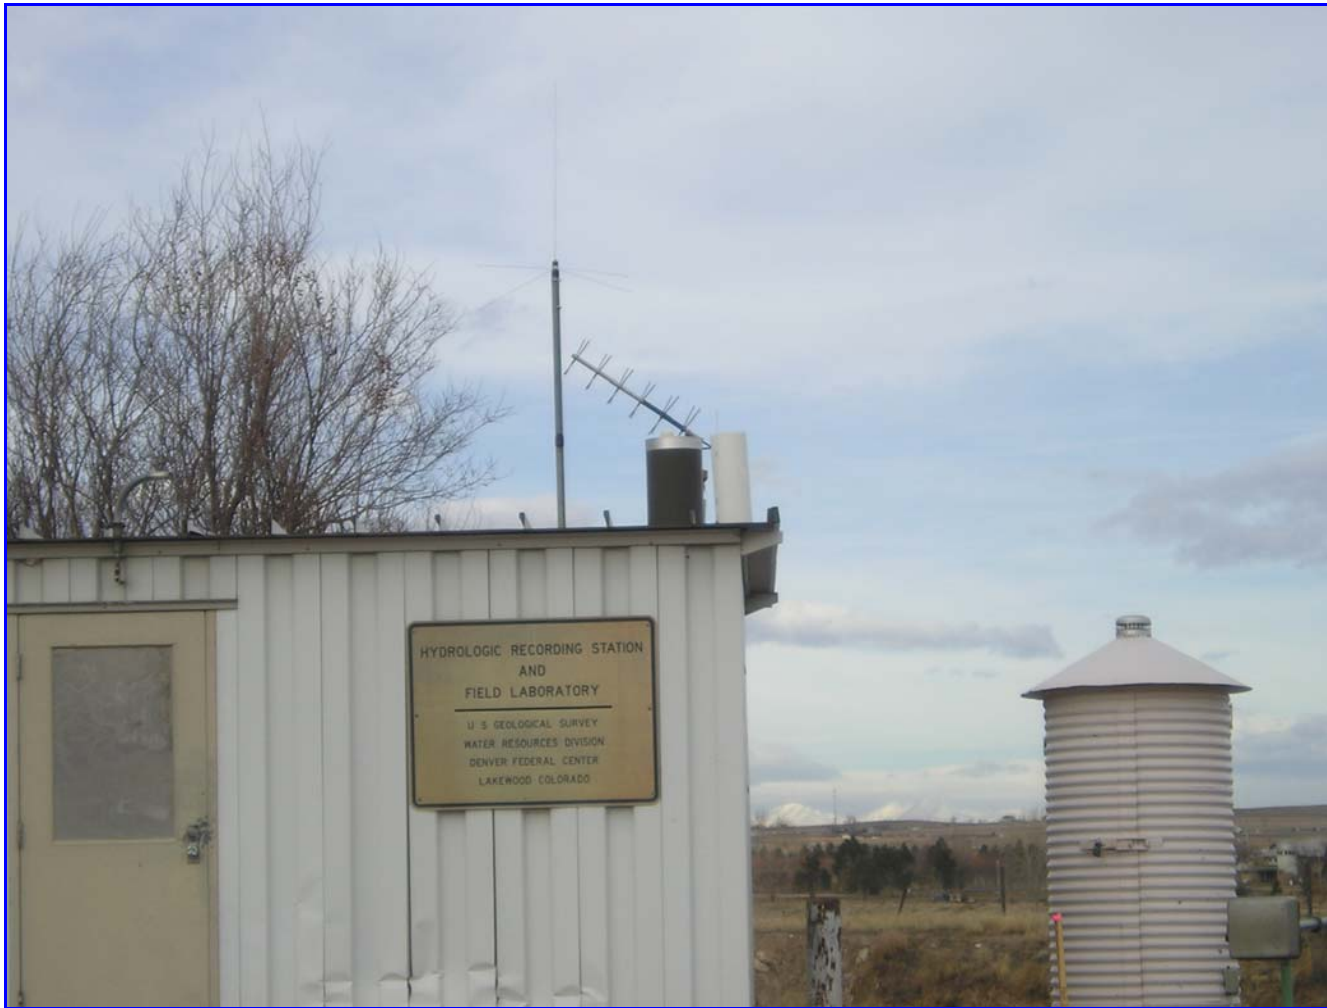
Name	ID	Sensor Type	Date Installed	Latitude	Longitude	Elevation	Gage Height	Anemometer Height	Temperature Sensor Height	Ground type
SPR @ Union	1640	P, S	05/21/98	39:37:57 N	105:00:52 W	5290'	7'6"	N/A	N/A	Concrete

Comments: Locked gate on access road.

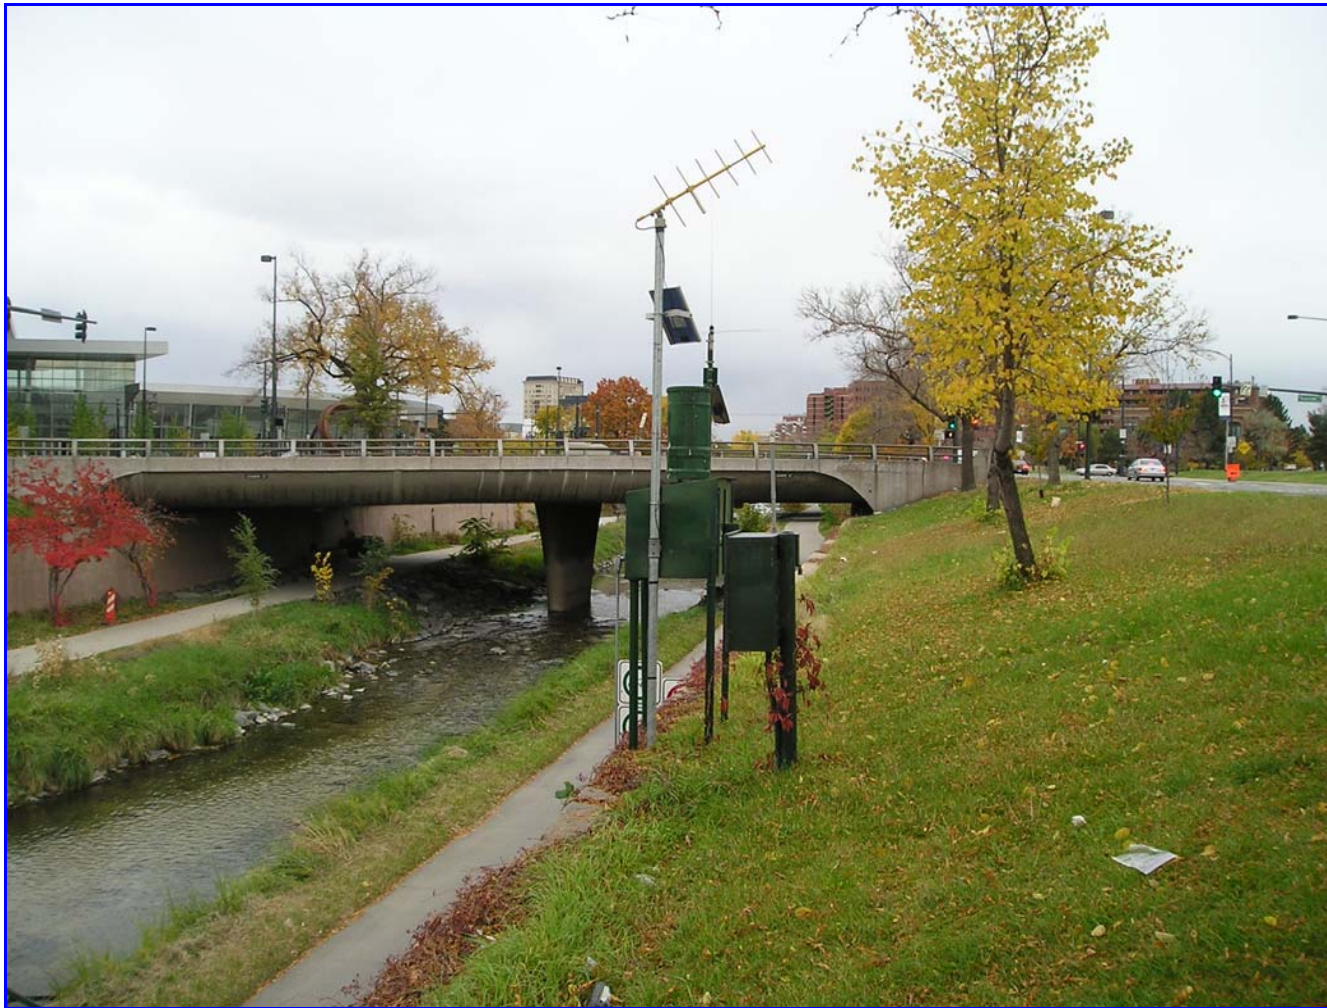
Name	ID	Sensor Type	Date Installed	Latitude	Longitude	Elevation	Gage Height	Anemometer Height	Temperature Sensor Height	Ground type
SPR @ Henderson	1660	P, S	04/17/98	39:55:19 N	104:52:00 W	5003'	12'2"	N/A	N/A	Metal

Comments: Gage located ~ 20 feet from river.

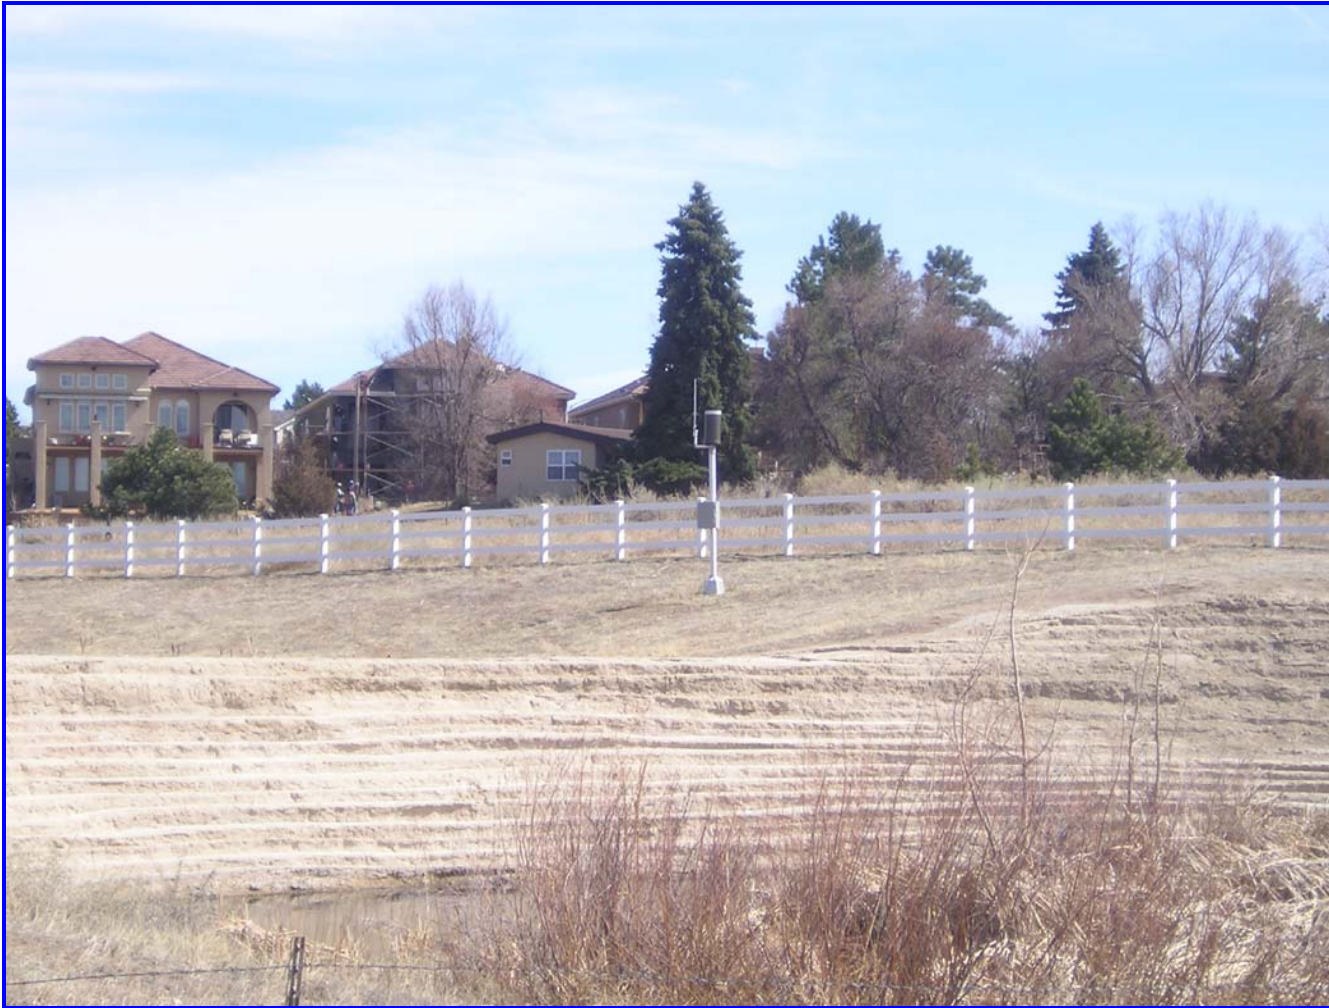
Name	ID	Sensor Type	Date Installed	Latitude	Longitude	Elevation	Gage Height	Anemometer Height	Temperature Sensor Height	Ground type
Cherry Creek @ Champa	1700	P, S	05/14/98	39:44:32 N	104:59:58 W	5190'	7'4"	N/A	N/A	Wood

Comments: Obstruction due to Solar panels NW and E of gage opening. Obstruction will occur due to tree to the SW when tree grows ~5 feet in the vertical

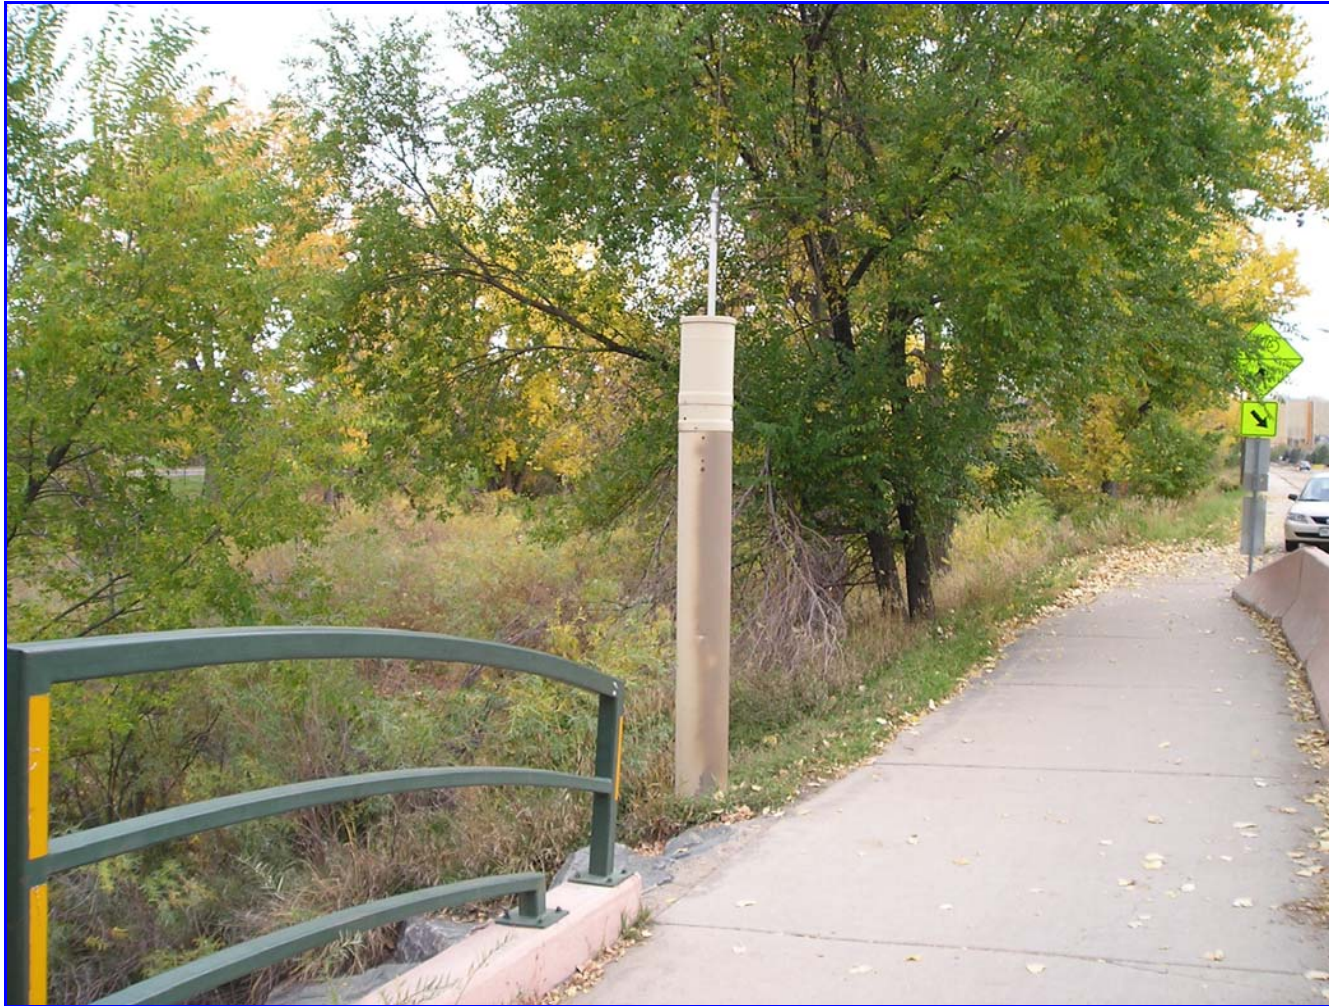
Name	ID	Sensor Type	Date Installed	Latitude	Longitude	Elevation	Gage Height	Anemometer Height	Temperature Sensor Height	Ground type
Shop Creek	1710	P	03/30/04	39:37:50 N	104:49:42 W	5608'	10'8"	N/A	N/A	Grass

Comments: Pond ~ 25' to north. Gage on 30-degree incline.

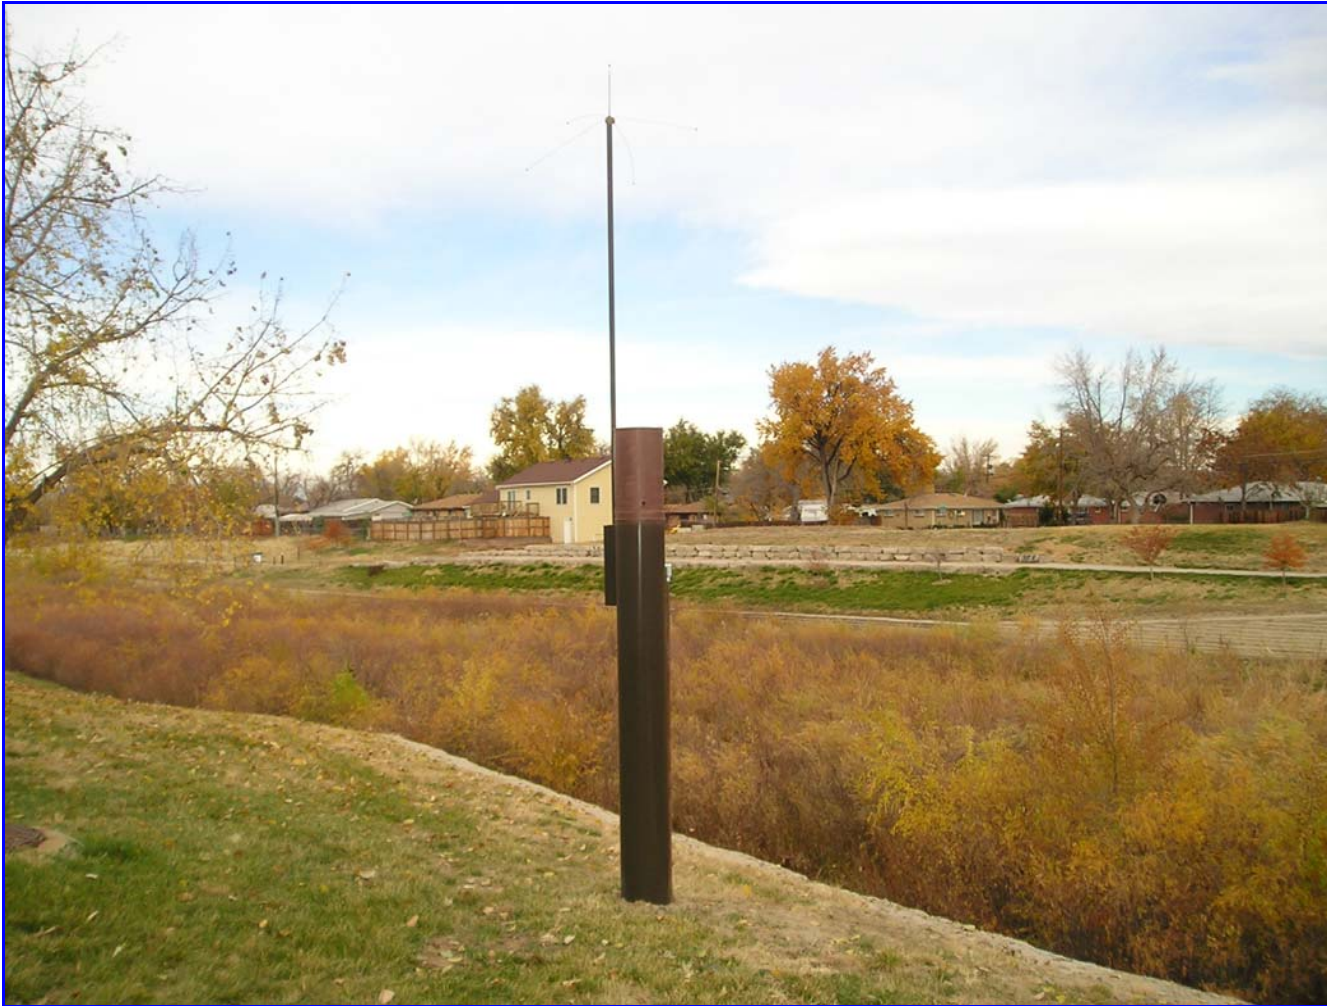
Name	ID	Sensor Type	Date Installed	Latitude	Longitude	Elevation	Gage Height	Anemometer Height	Temperature Sensor Height	Ground type
Cherry Creek @ Steele	1720	P, S	04/08/91	39:42:47 N	104:56:57 W	5310'	8'10"	N/A	N/A	Grass

Comments: Obstruction due to tree to the SE of gage. Obstruction will increase as tree grows.

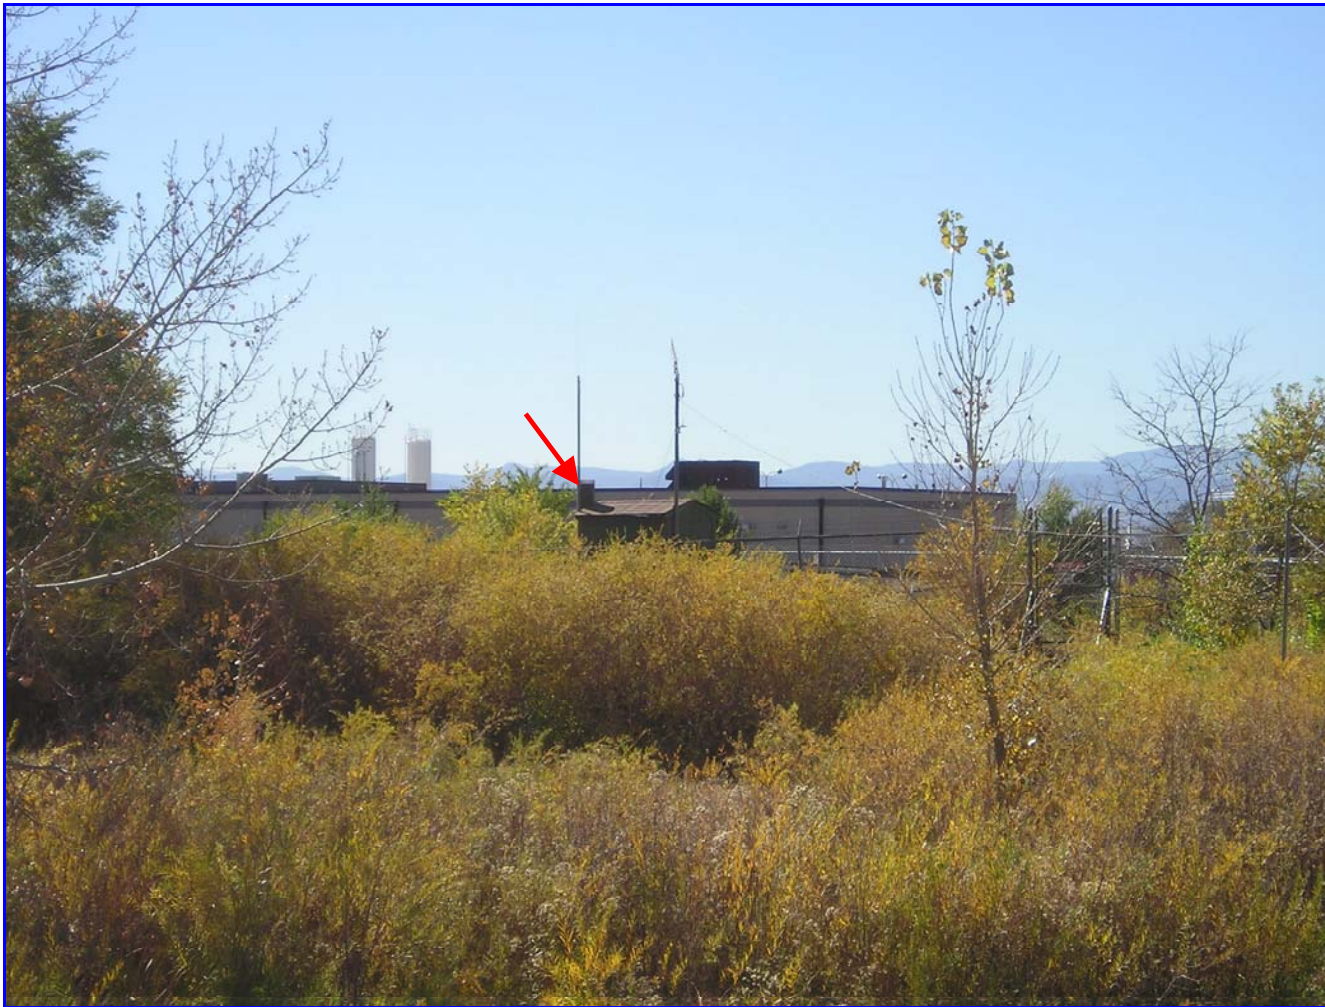
Name	ID	Sensor Type	Date Installed	Latitude	Longitude	Elevation	Gage Height	Anemometer Height	Temperature Sensor Height	Ground type
Sand Creek Park	1800	P, S	03/24/89	39:45:23 N	104:49:52 W	5330'	9'6"	N/A	N/A	Grass

Comments: Gage located ~ 15 feet from creek.

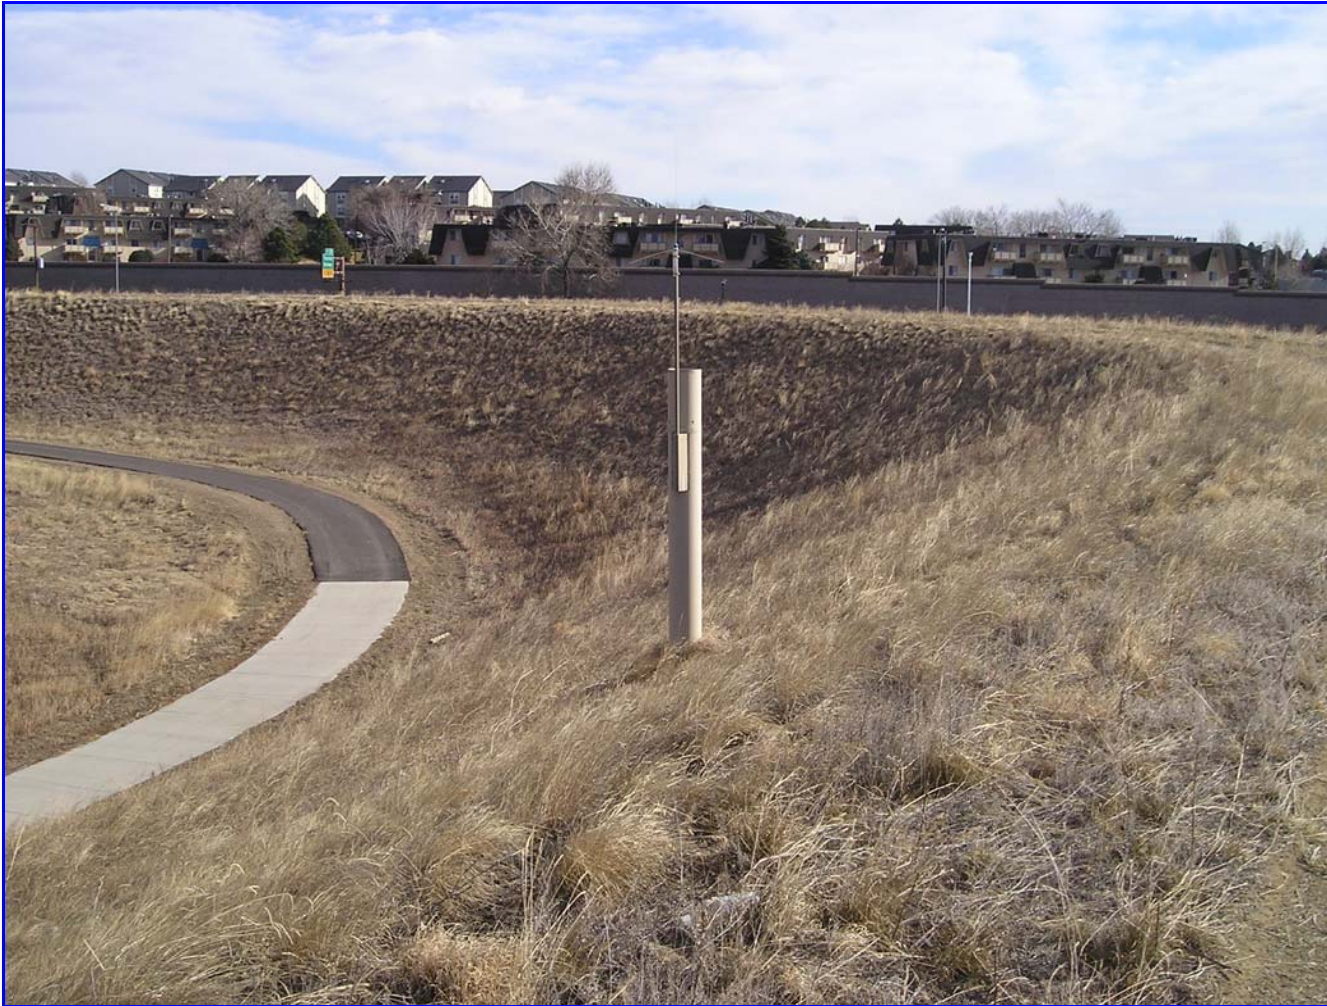
Name	ID	Sensor Type	Date Installed	Latitude	Longitude	Elevation	Gage Height	Anemometer Height	Temperature Sensor Height	Ground type
Sand Creek @ Mouth	1810	P, S	05/11/90	39:48:39 N	104:57:03 W	5120'	9'6"	N/A	N/A	Metal

Comments: Obstruction will occur due to tree to the NE when tree grows ~5 feet in the vertical. Gage located ~ 15 feet from creek.

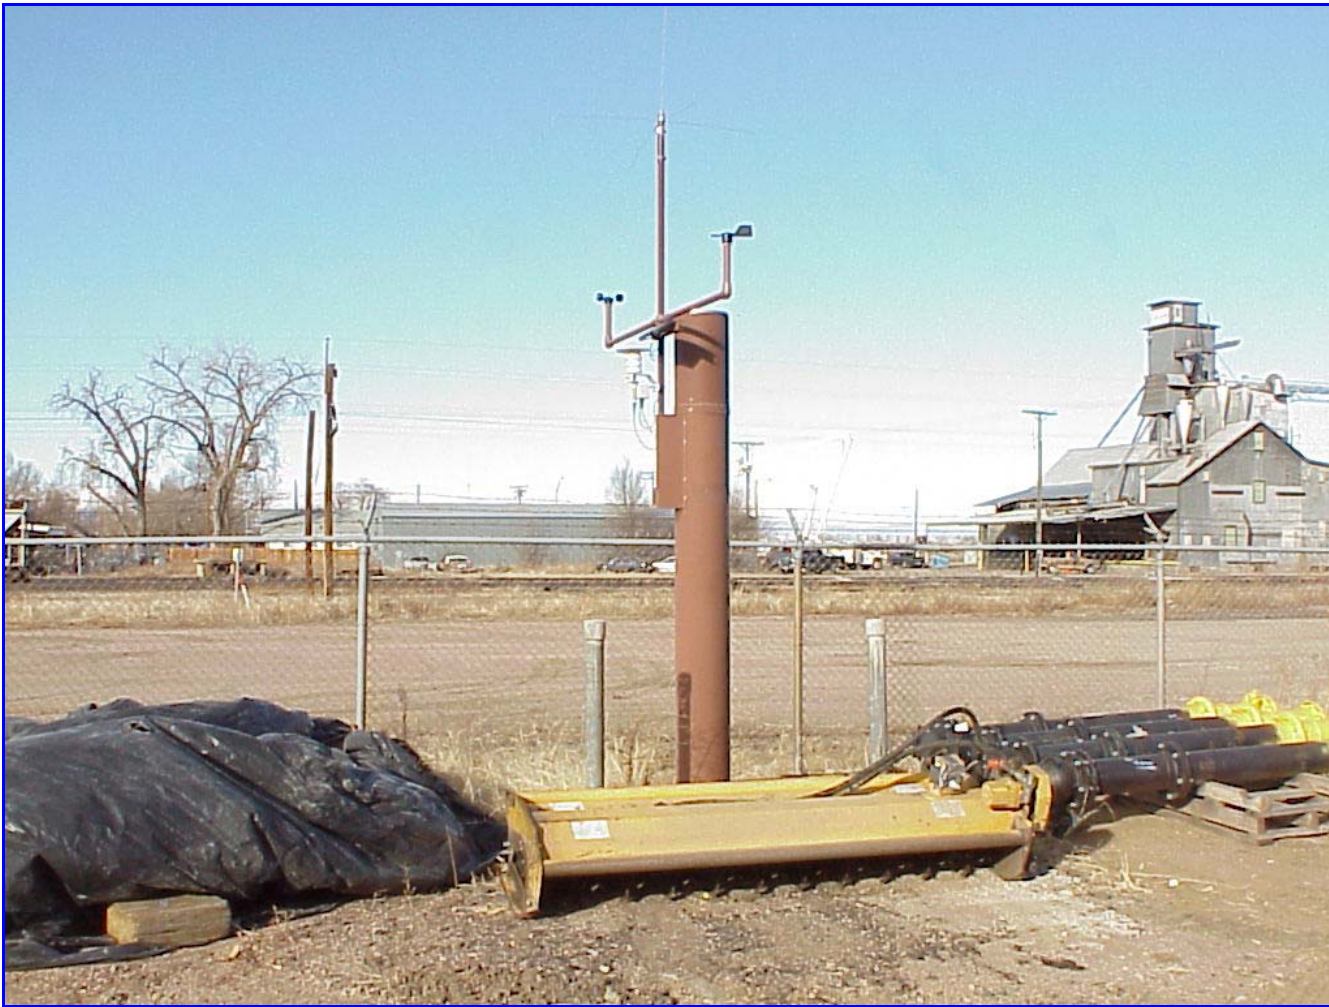
Name	ID	Sensor Type	Date Installed	Latitude	Longitude	Elevation	Gage Height	Anemometer Height	Temperature Sensor Height	Ground type
Niver Detention	1900	P, S	05/30/87	39:51:26 N	104:59:18 W	5236'	9'3"	N/A	N/A	Scrub grass

Comments: Gage located on a 35-degree incline.

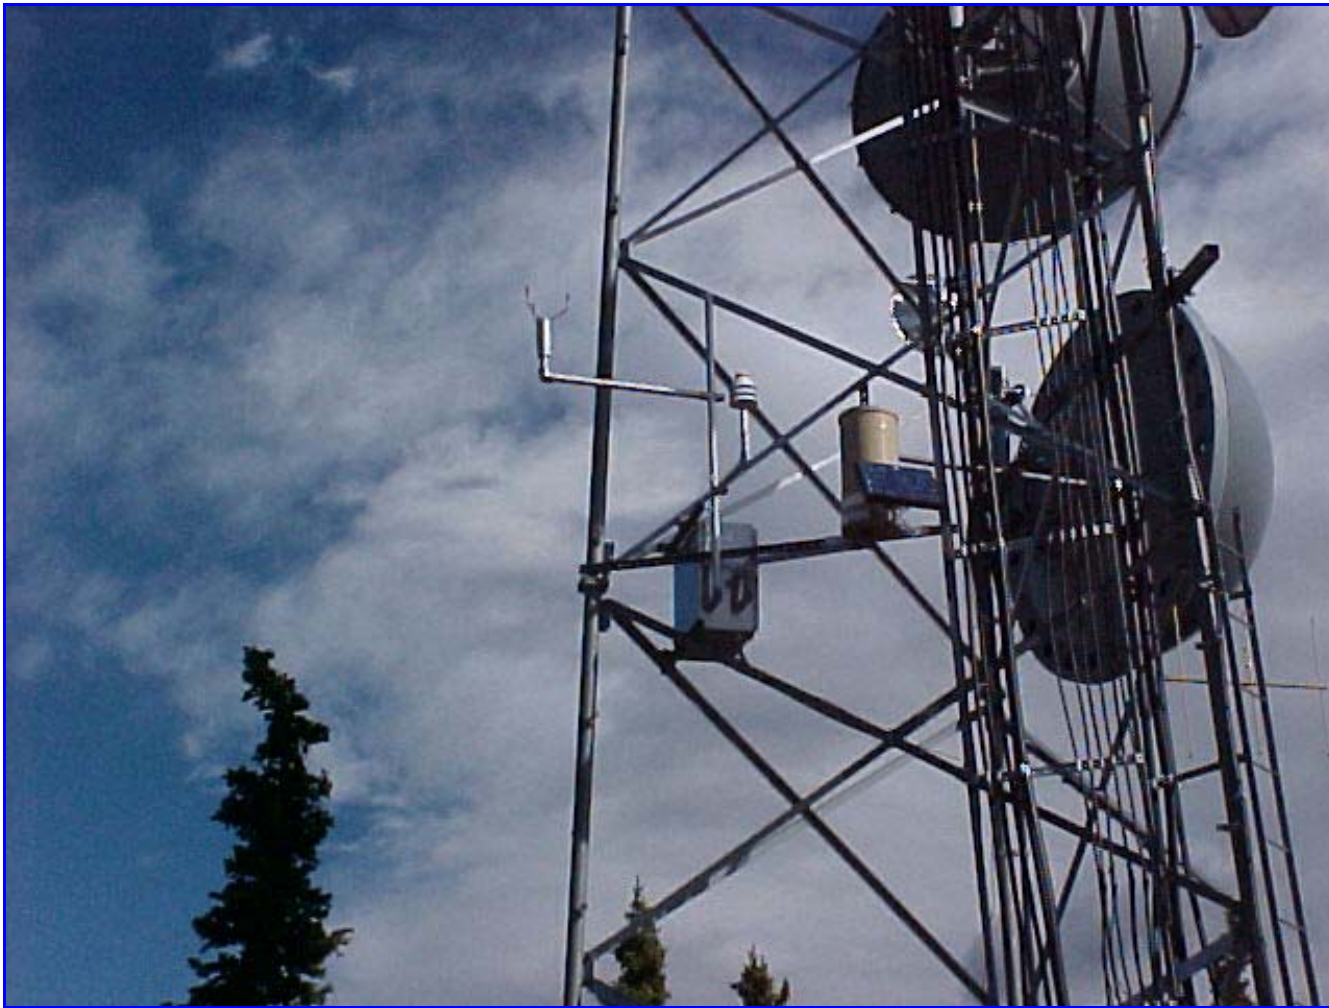
Name	ID	Sensor Type	Date Installed	Latitude	Longitude	Elevation	Gage Height	Anemometer Height	Temperature Sensor Height	Ground type
Brighton	1920	Wx	08/26/98	39:59:36 N	104:49:02 W	4975'	9'3"	9'5"	8'0"	Gravel

Comments: Black tarp 2.5 to the south. Metal machinery 1' to east. Metal piping 3' to north. Black water tank 20' to north 7' off the ground.

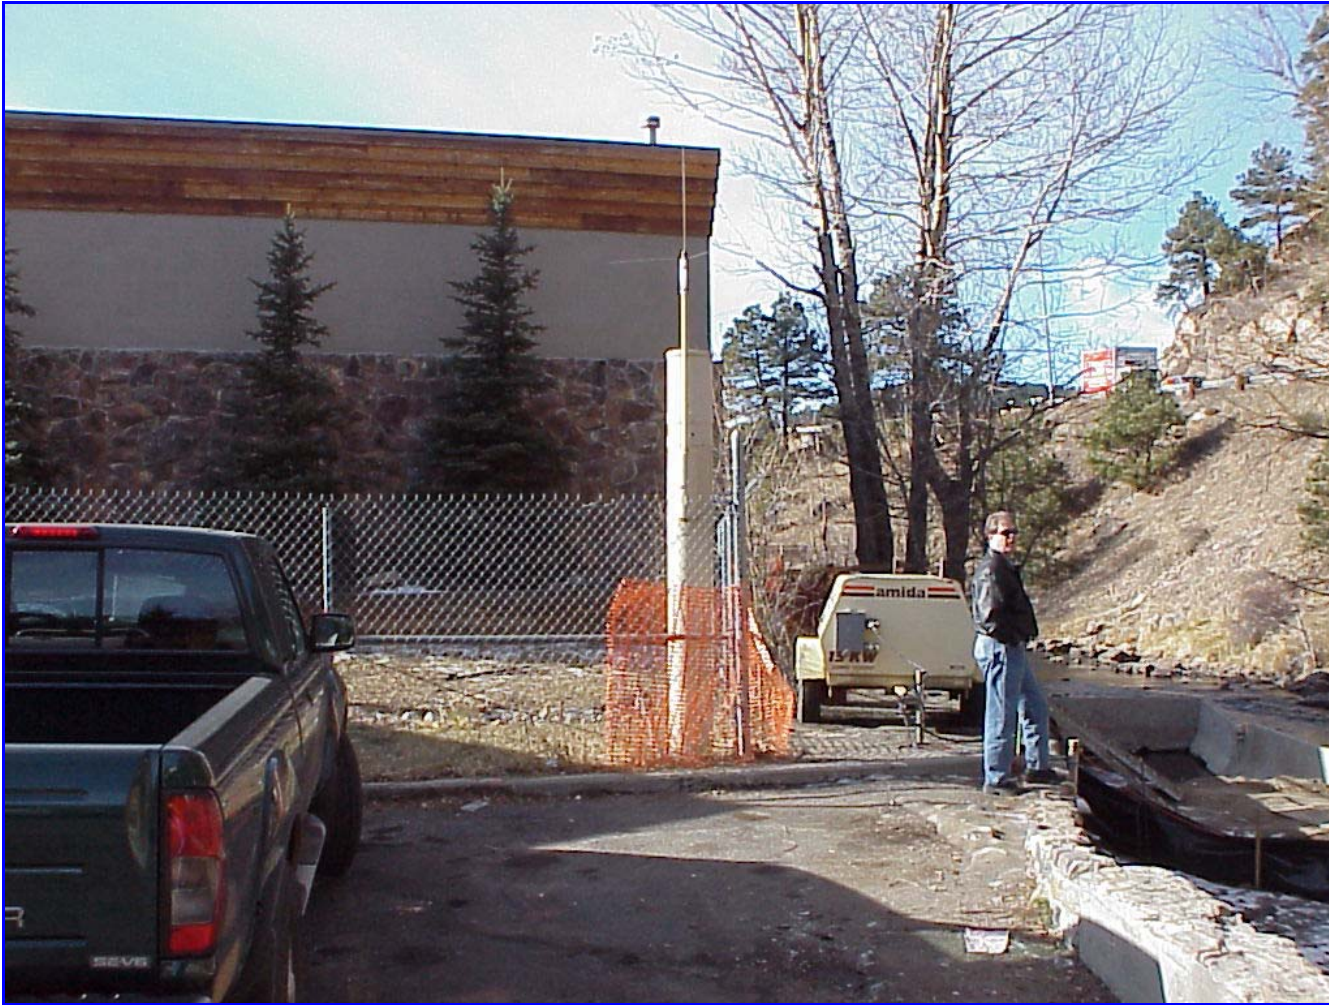
Name	ID	Sensor Type	Date Installed	Latitude	Longitude	Elevation	Gage Height	Anemometer Height	Temperature Sensor Height	Ground type
Hiwan Golf Club	2210	Wx	04/09/91	39:40:20 N	105:20:49 W	7650'	9'3"	10'4"	9'2"	Scrub grass

Comments: Pine trees ~30' to the northwest. Irrigation around gage.

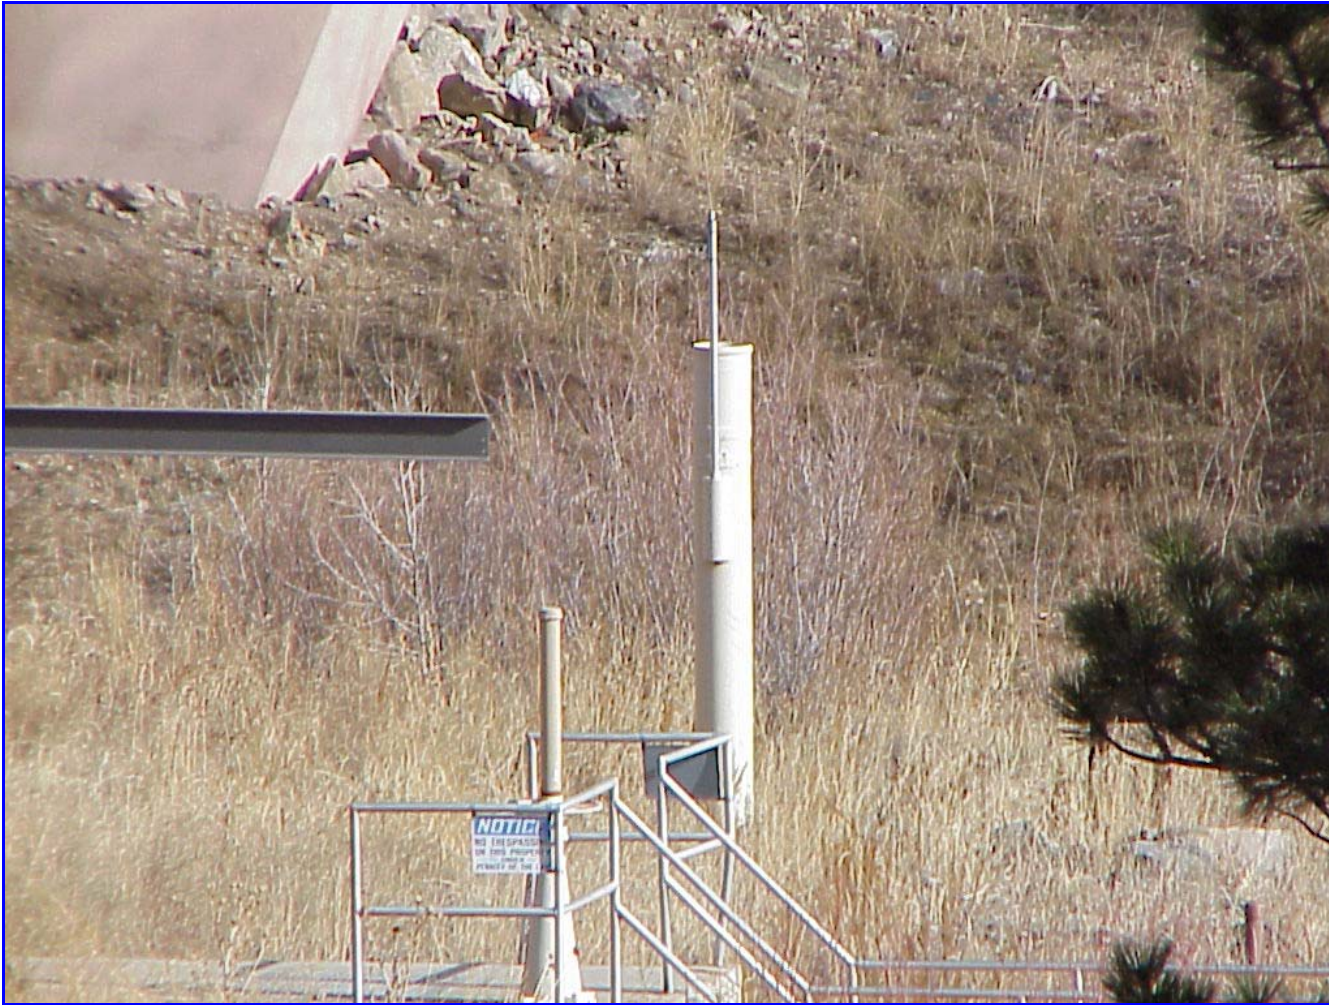
Name	ID	Sensor Type	Date Installed	Latitude	Longitude	Elevation	Gage Height	Anemometer Height	Temperature Sensor Height	Ground type
Bear Creek below Cub Creek	2230	P, S	04/09/91	39:37:56 N	105:19:16 W	7020'	9'7"	N/A	N/A	Grass

Comments: Stream gage ~ 8' from gage. Pines trees ~25' to West. Two story buildings 27' to west. 40' tall tree ~30' to northwest.

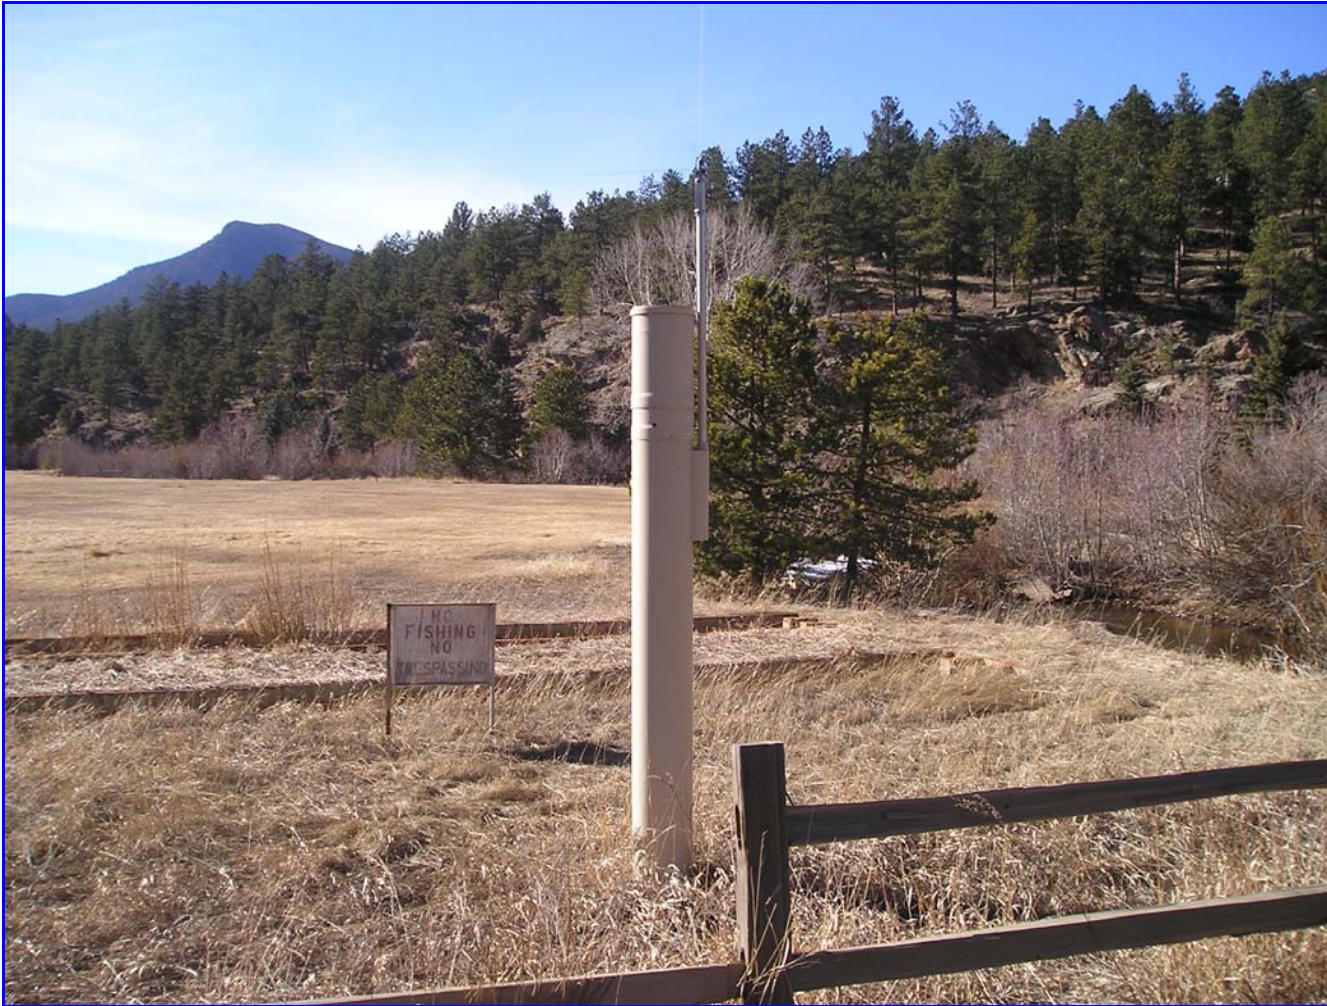
Name	ID	Sensor Type	Date Installed	Latitude	Longitude	Elevation	Gage Height	Anemometer Height	Temperature Sensor Height	Ground type
Cold Spring Gulch Confluence	2240	P, S	04/25/91	39:39:58 N	105:16:31 W	6655'	10'2" (estimated)	N/A	N/A	N/A

Comments: 50' bridge ~ 130' to the northwest.

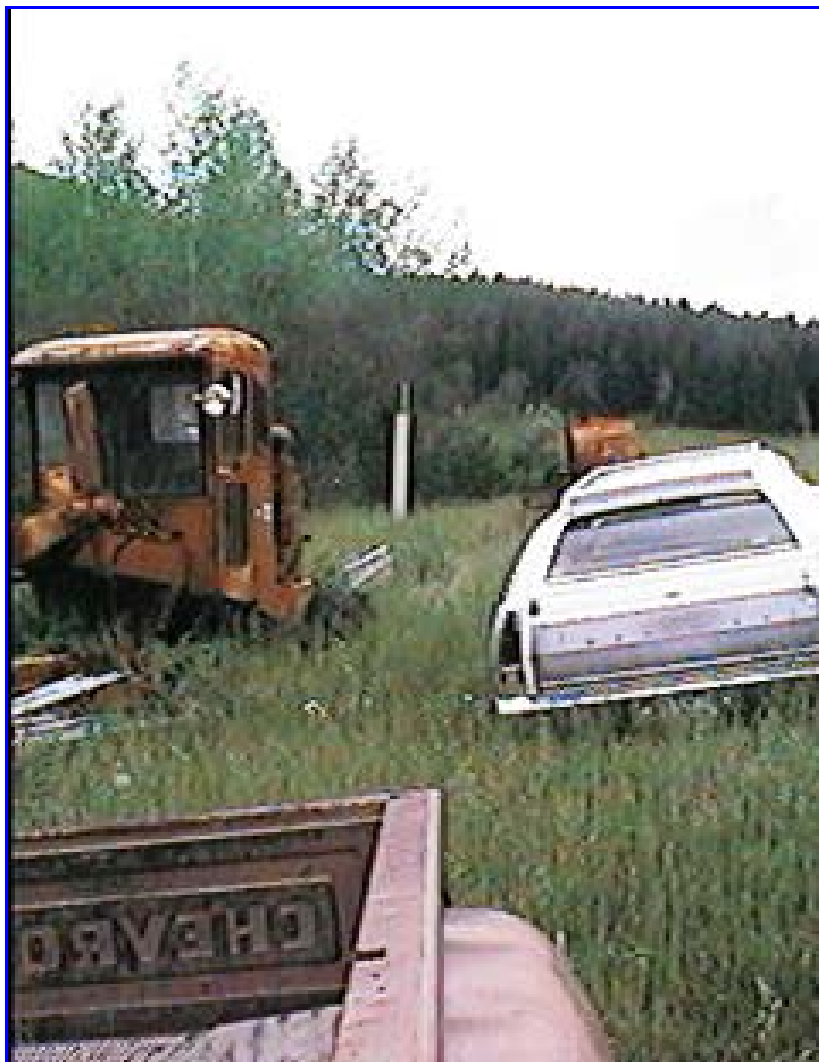
Name	ID	Sensor Type	Date Installed	Latitude	Longitude	Elevation	Gage Height	Anemometer Height	Temperature Sensor Height	Ground type
Rosedale	2250	P, S	05/07/92	39:38:17 N	105:22:50 W	7310'	9'10"	N/A	N/A	Scrub grass

Comments: Creek ~ 25 feet to north.

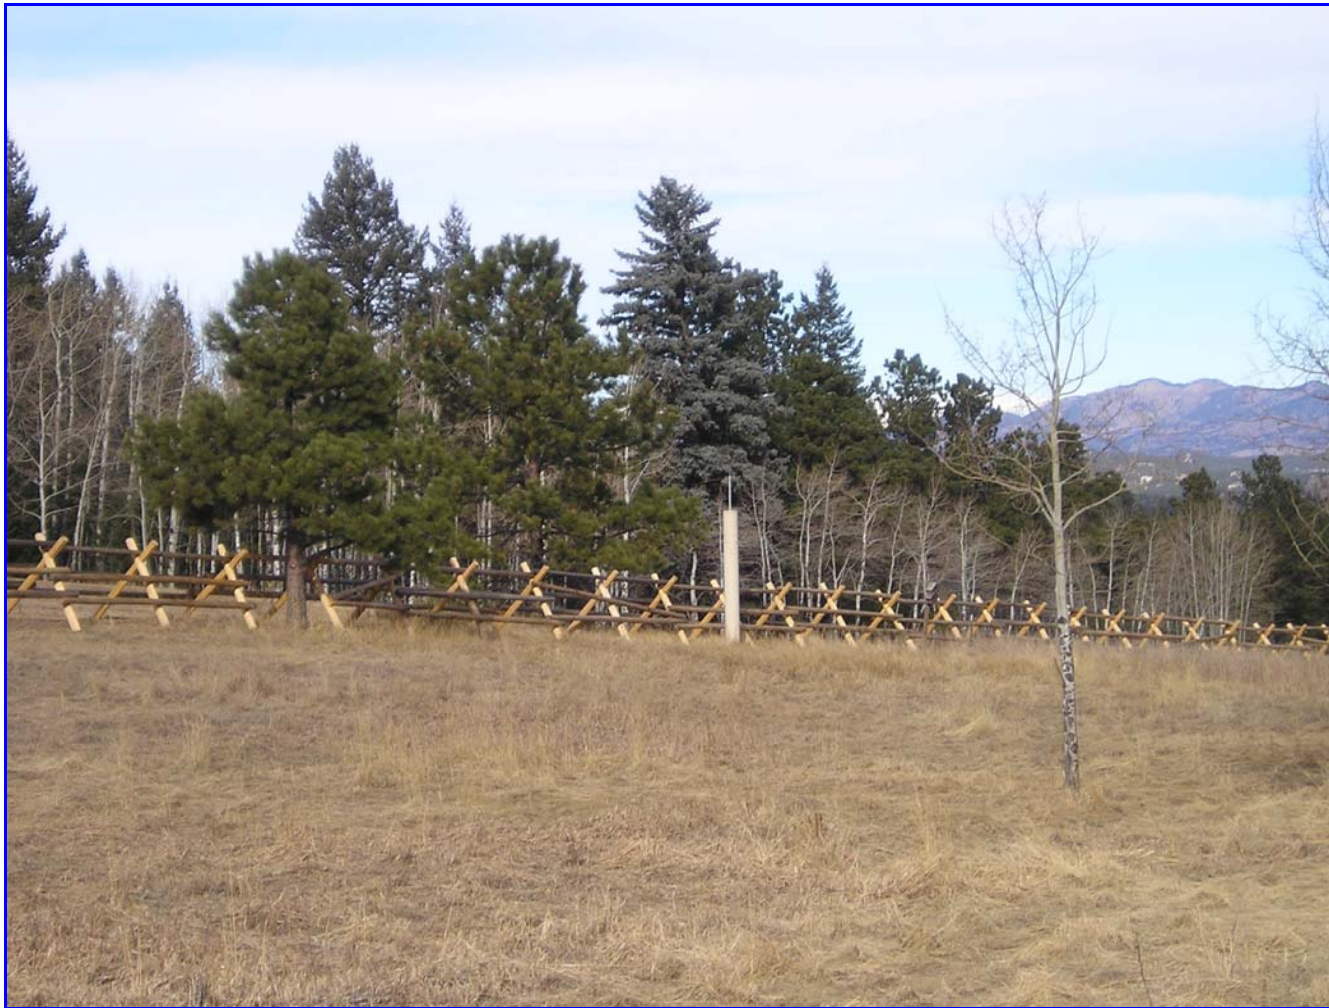
Name	ID	Sensor Type	Date Installed	Latitude	Longitude	Elevation	Gage Height	Anemometer Height	Temperature Sensor Height	Ground type
Cub Creek below Blue Creek	2270	P, S	05/12/92	39:35:34 N	105:20:38 W	7560'	10'3"	N/A	N/A	Scrub grass

Comments: Gage obstruction due to large trees to the north. Damage to lower portion of gage, dent.
