APPENDIX

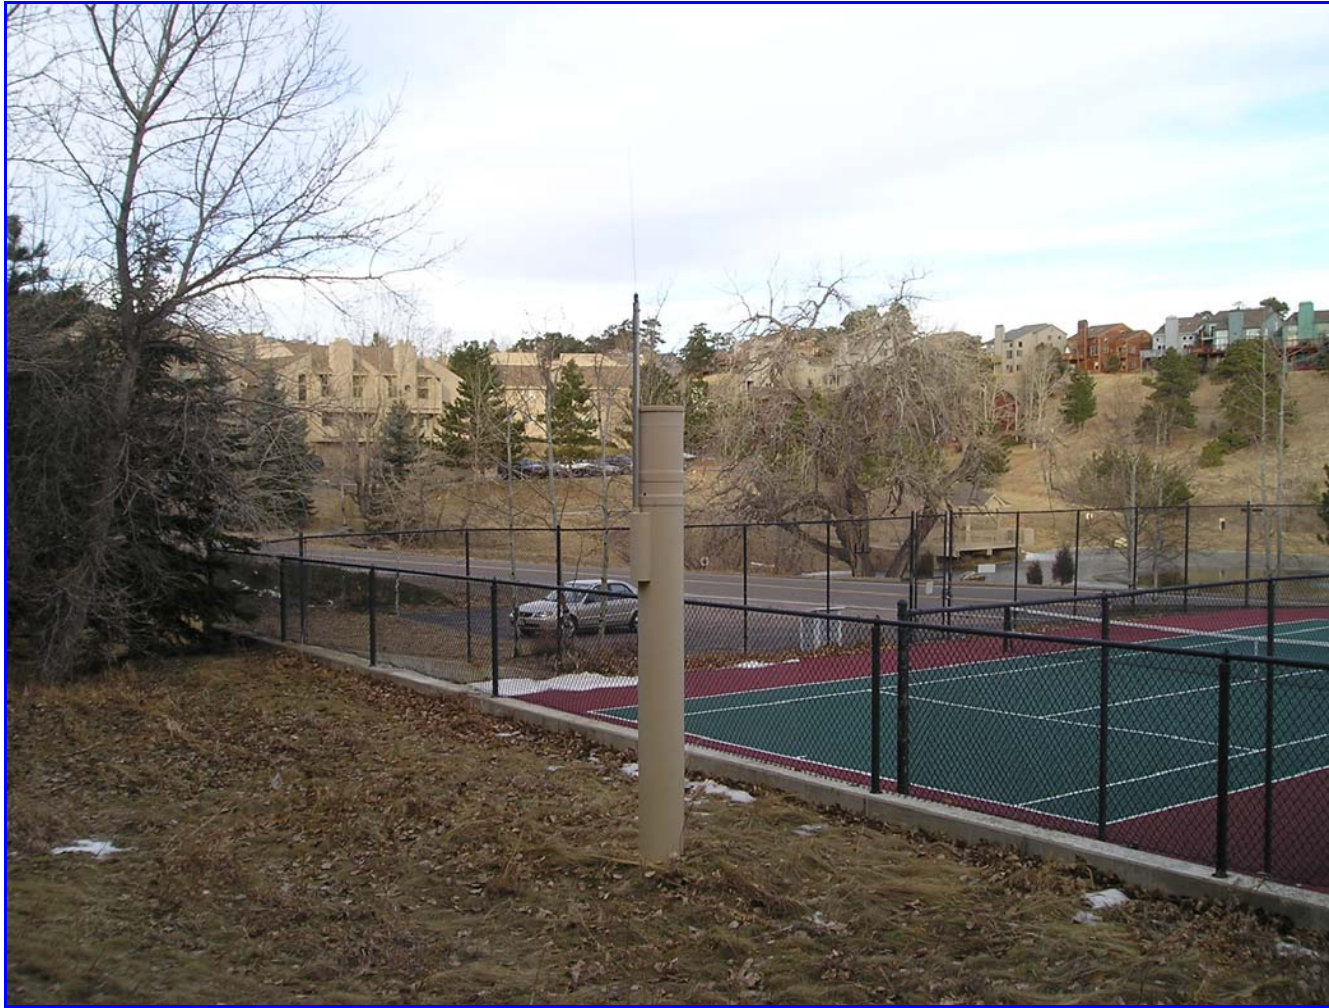
Name	ID	Sensor Type	Date Installed	Latitude	Longitude	Elevation	Gage Height	Anemometer Height	Temperature Sensor Height	Ground type
Kinney Peak	2280	P	11/20/93	39:36:04 N	105:17:46 W	7700'	9'6"	N/A	N/A	Grass

Comments: Gage located on private property. No vehicle access.

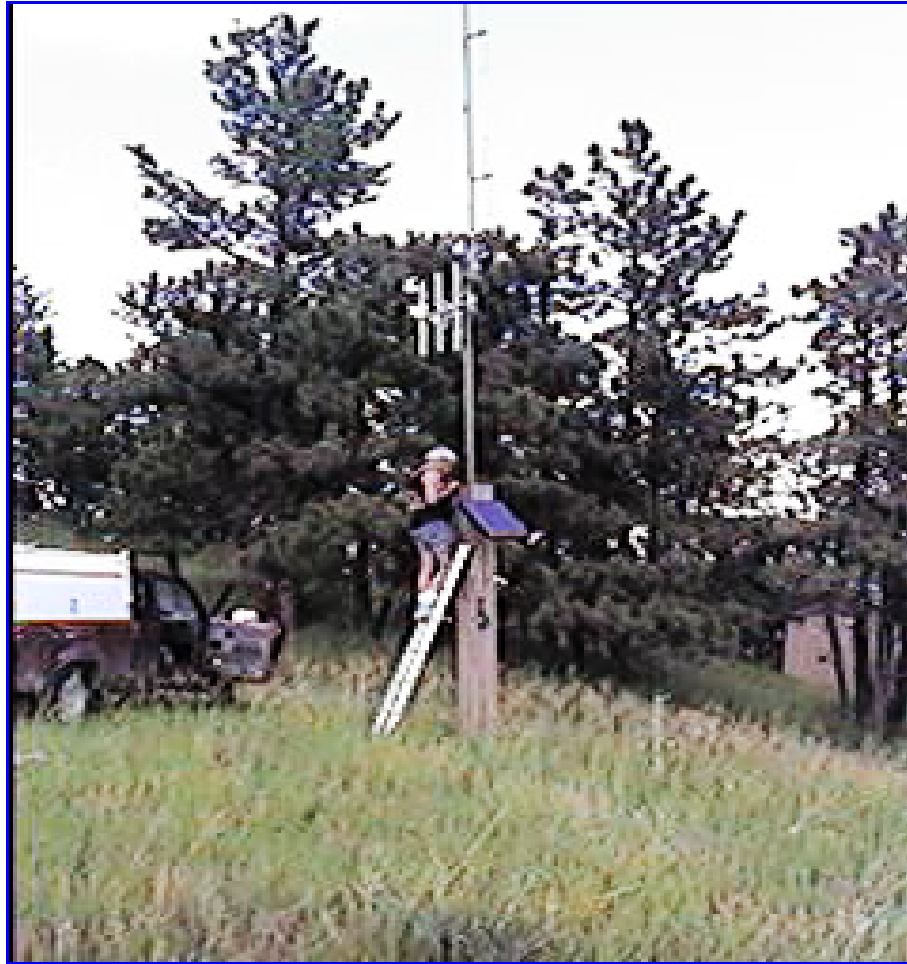
Name	ID	Sensor Type	Date Installed	Latitude	Longitude	Elevation	Gage Height	Anemometer Height	Temperature Sensor Height	Ground type
Genesee Village	2310	P	04/09/91	39:42:07 N	105:15:50 W	7360'	9'10'	N/A	N/A	Grass

Comments: Obstruction will occur due to tree to the south when tree grows ~5 feet in the vertical

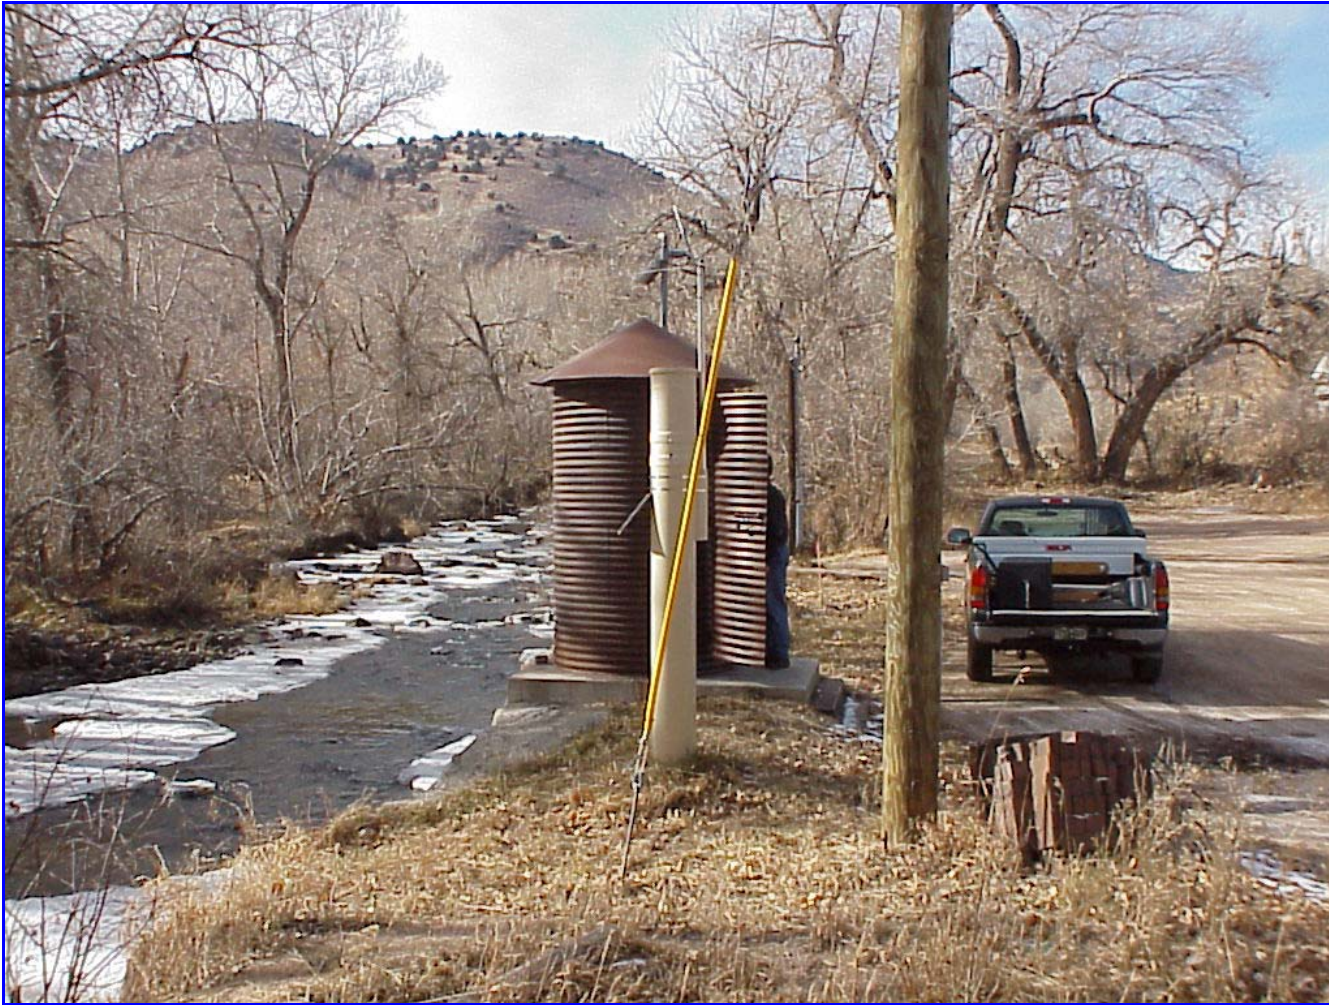
Name	ID	Sensor Type	Date Installed	Latitude	Longitude	Elevation	Gage Height	Anemometer Height	Temperature Sensor Height	Ground type
Choke Cherry Reservoir	2320	R, P	04/23/92	39:41:46 N	105:16:29 W	7850'	10'3"	N/A	N/A	Grass

Comments: Locked gate. Need security access.

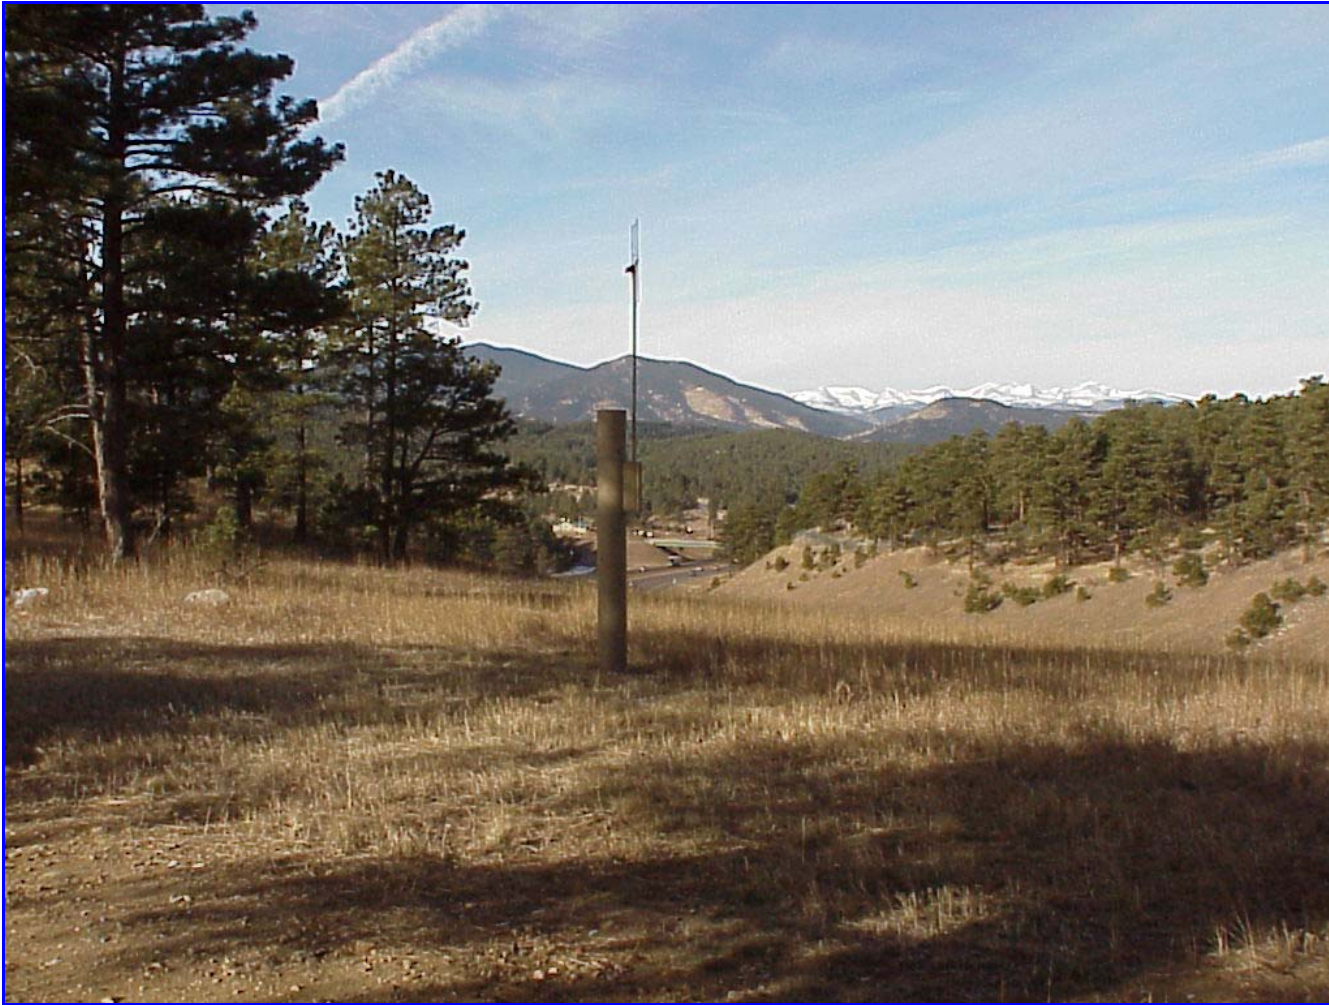
Name	ID	Sensor Type	Date Installed	Latitude	Longitude	Elevation	Gage Height	Anemometer Height	Temperature Sensor Height	Ground type
Bear Creek @ Morrison	2330	P, S	11/22/93	39:39:11 N	105:11:43 W	5790'	6'8"	N/A	N/A	Scrub grass

Comments: USGS Stream gage housing 4'-11' to the west. Creek ~ 7' to south.

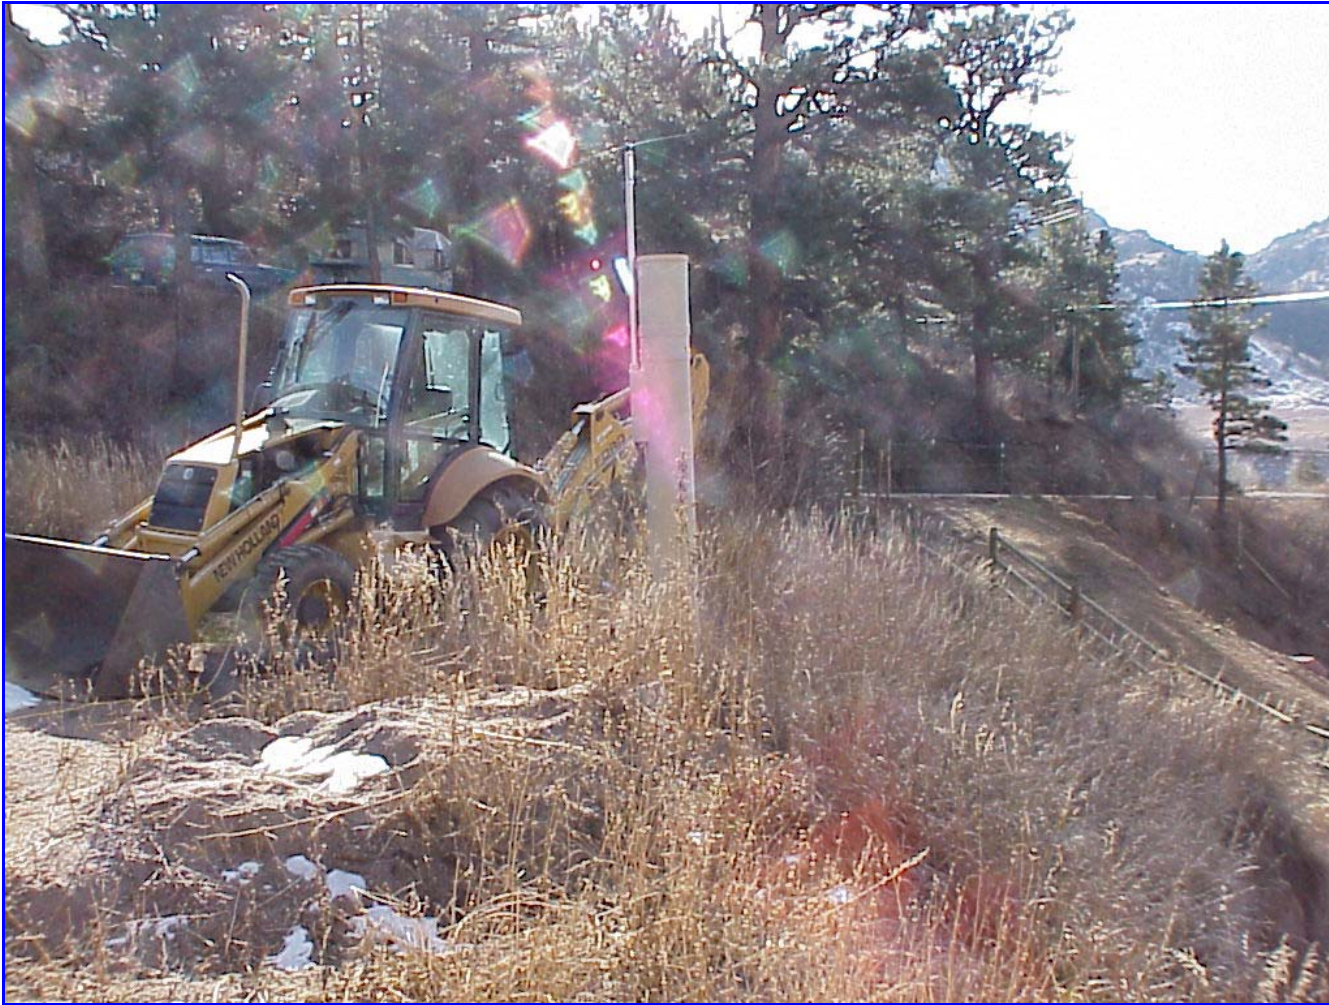
Name	ID	Sensor Type	Date Installed	Latitude	Longitude	Elevation	Gage Height	Anemometer Height	Temperature Sensor Height	Ground type
El Rancho	2340	P	10/04/93	39:42:06N	105:19:45W	7680'	9'2"	N/A	N/A	Scrub grass

Comments: Pine trees ~25' to the west. One story building ~40' to south.

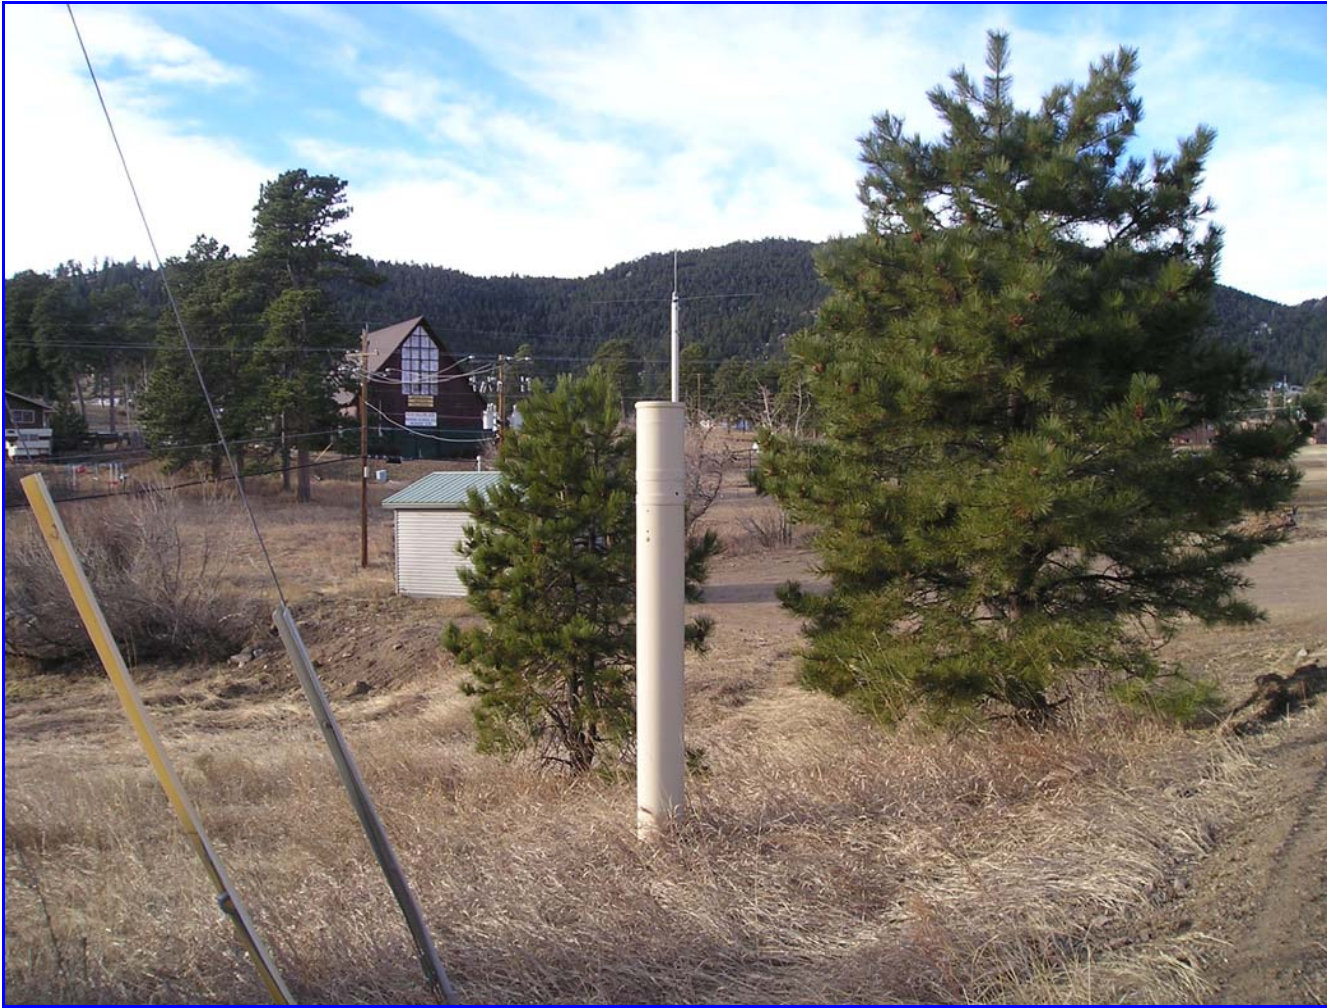
Name	ID	Sensor Type	Date Installed	Latitude	Longitude	Elevation	Gage Height	Anemometer Height	Temperature Sensor Height	Ground type
Idledale	2350	P	05/07/92	39:40:14 N	105:14:29 W	6740'	8'6"	N/A	N/A	Scrub grass

Comments: One story shack 25' to the northwest.

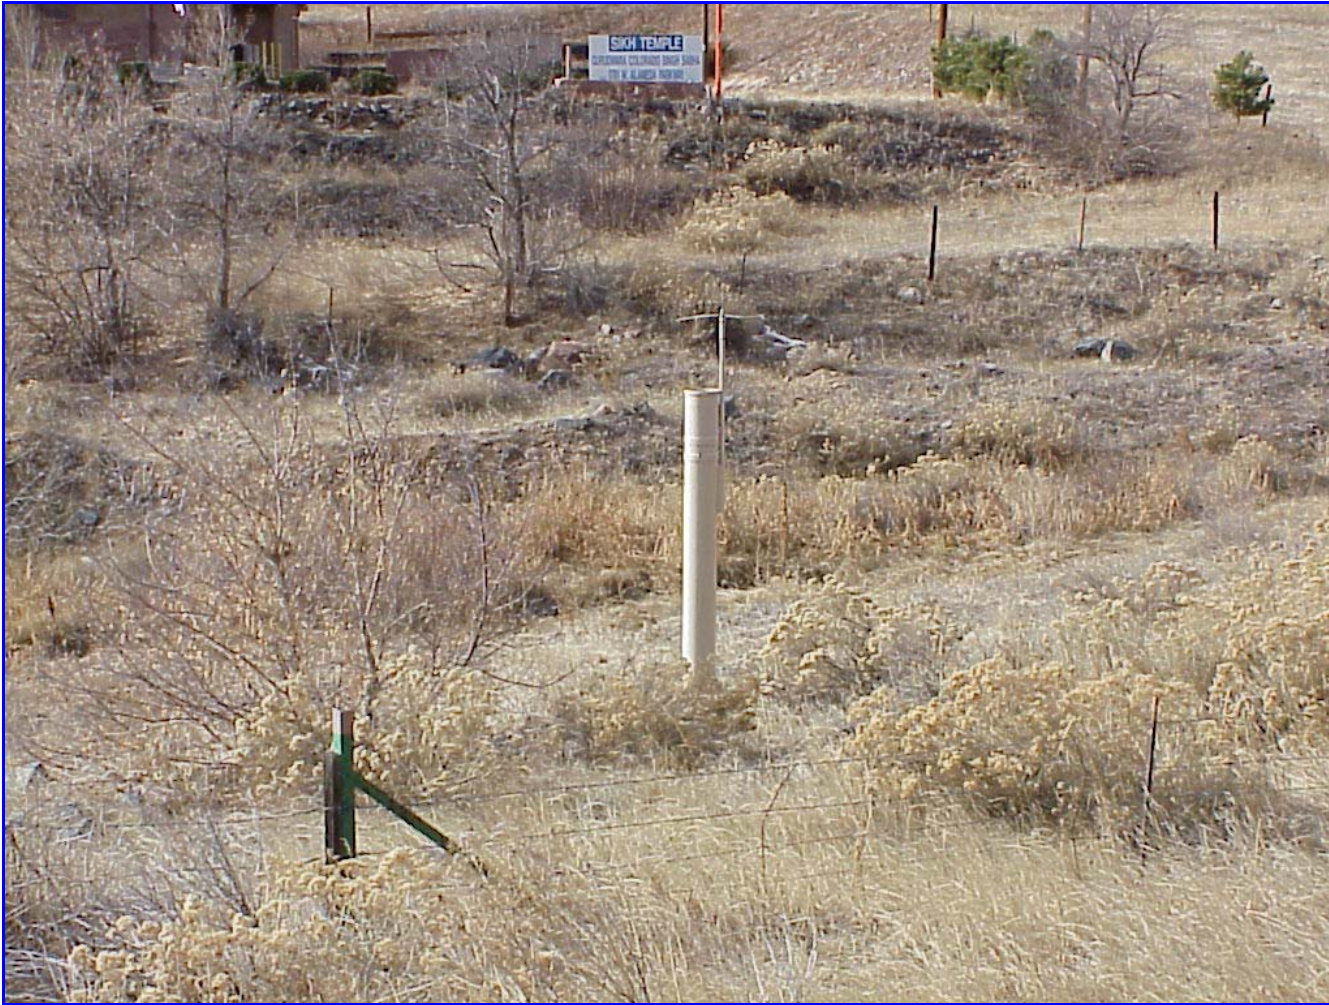
Name	ID	Sensor Type	Date Installed	Latitude	Longitude	Elevation	Gage Height	Anemometer Height	Temperature Sensor Height	Ground type
Indian Hills	2360	P	05/07/92	39:38:13 N	105:15:49 W	7375'	9'2"	N/A	N/A	Scrub grass

Comments: One story shack ~ 30' to east. 20' tree ~ 15' to west.

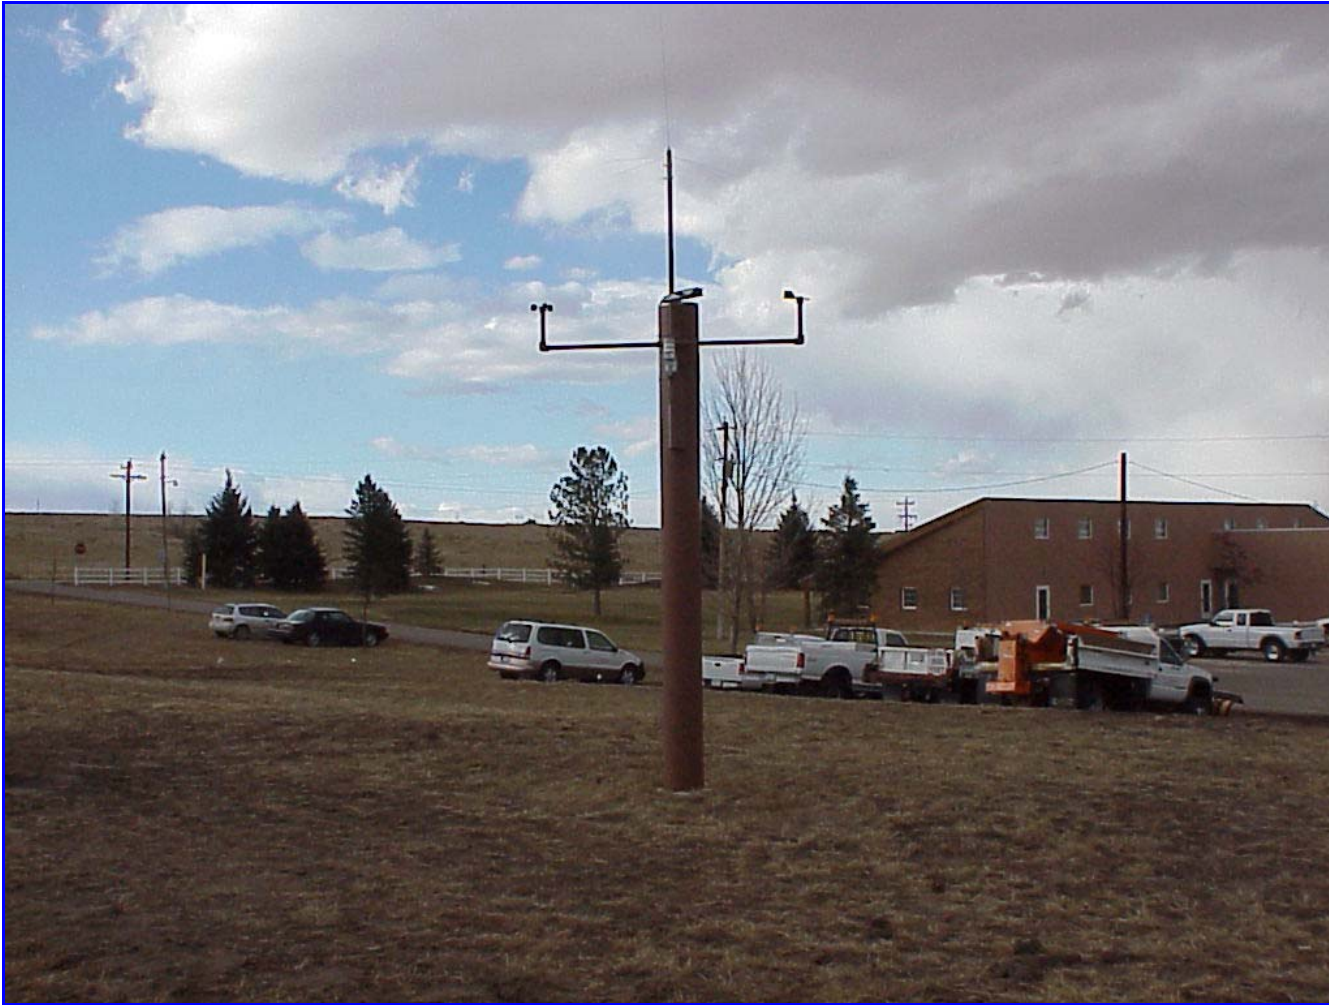
Name	ID	Sensor Type	Date Installed	Latitude	Longitude	Elevation	Gage Height	Anemometer Height	Temperature Sensor Height	Ground type
Highlands Ranch WTP	2710	Wx	04/21/98	39:33:43 N	105:01:09 W	5550'	9'2"	9'3"	8'7"	Grass

Comments: One story building 30' to the southwest.

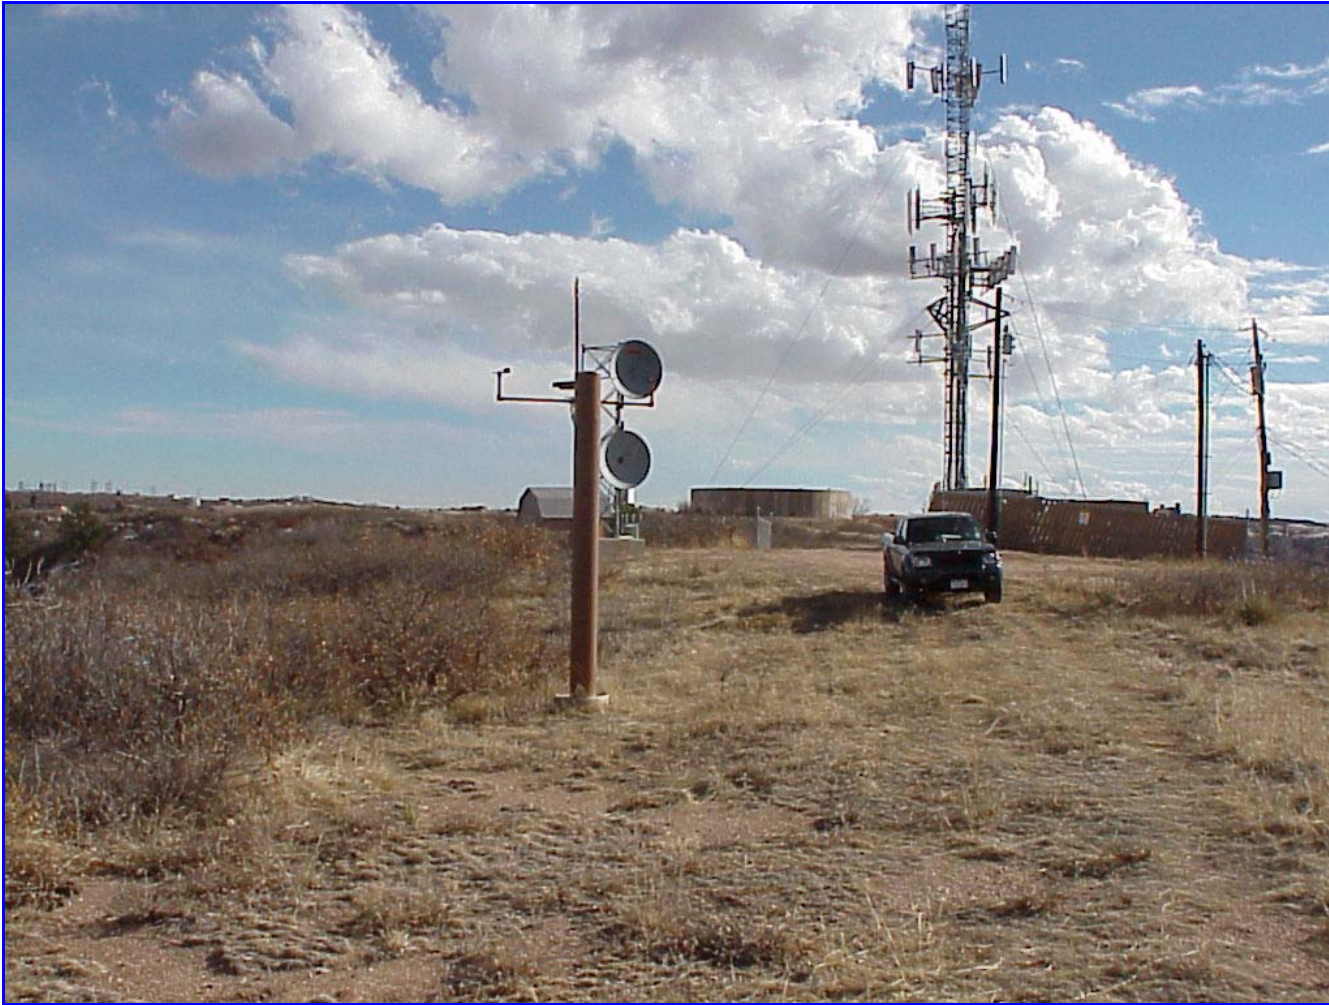
Name	ID	Sensor Type	Date Installed	Latitude	Longitude	Elevation	Gage Height	Anemometer Height	Temperature Sensor Height	Ground type
Salisbury Park	2730	Wx	04/13/98	39:33:43 N	105:01:09 W	5870'	11'5"	11'2"	10'4"	Grass, flat

Comments: No obstructions, sprinklers in and around gauge.

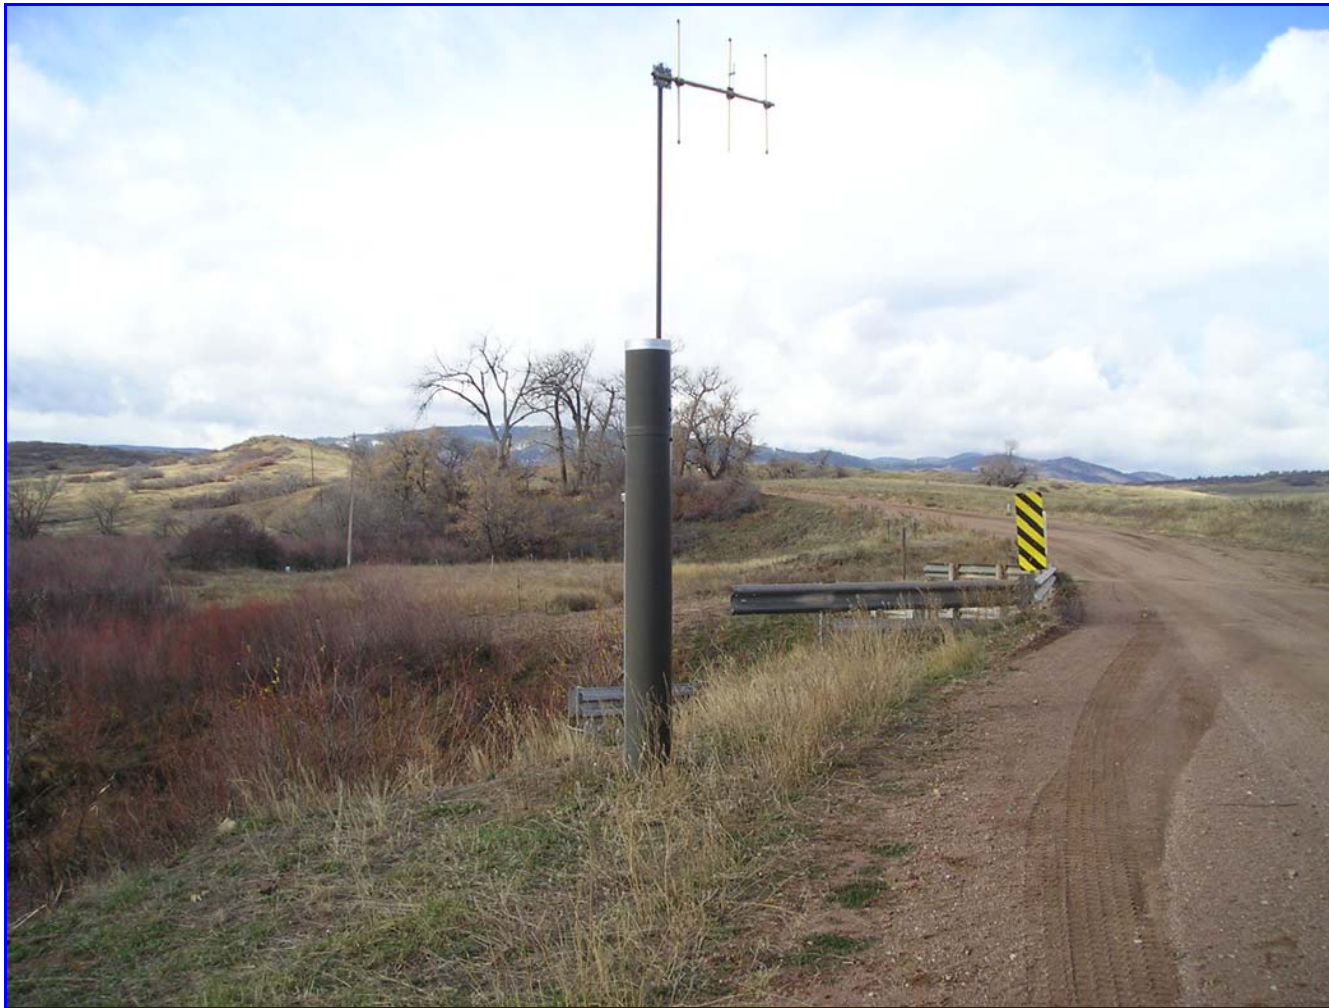
Name	ID	Sensor Type	Date Installed	Latitude	Longitude	Elevation	Gage Height	Anemometer Height	Temperature Sensor Height	Ground type
Castle Rock	2750	Wx	07/02/98	39:22:33 N	104:57:58 W	6560'	11'2"	11'2"	10'3"	Scrub grass

Comments: Site sits on a butte. Vegetation: scrub brush 2' to the North.

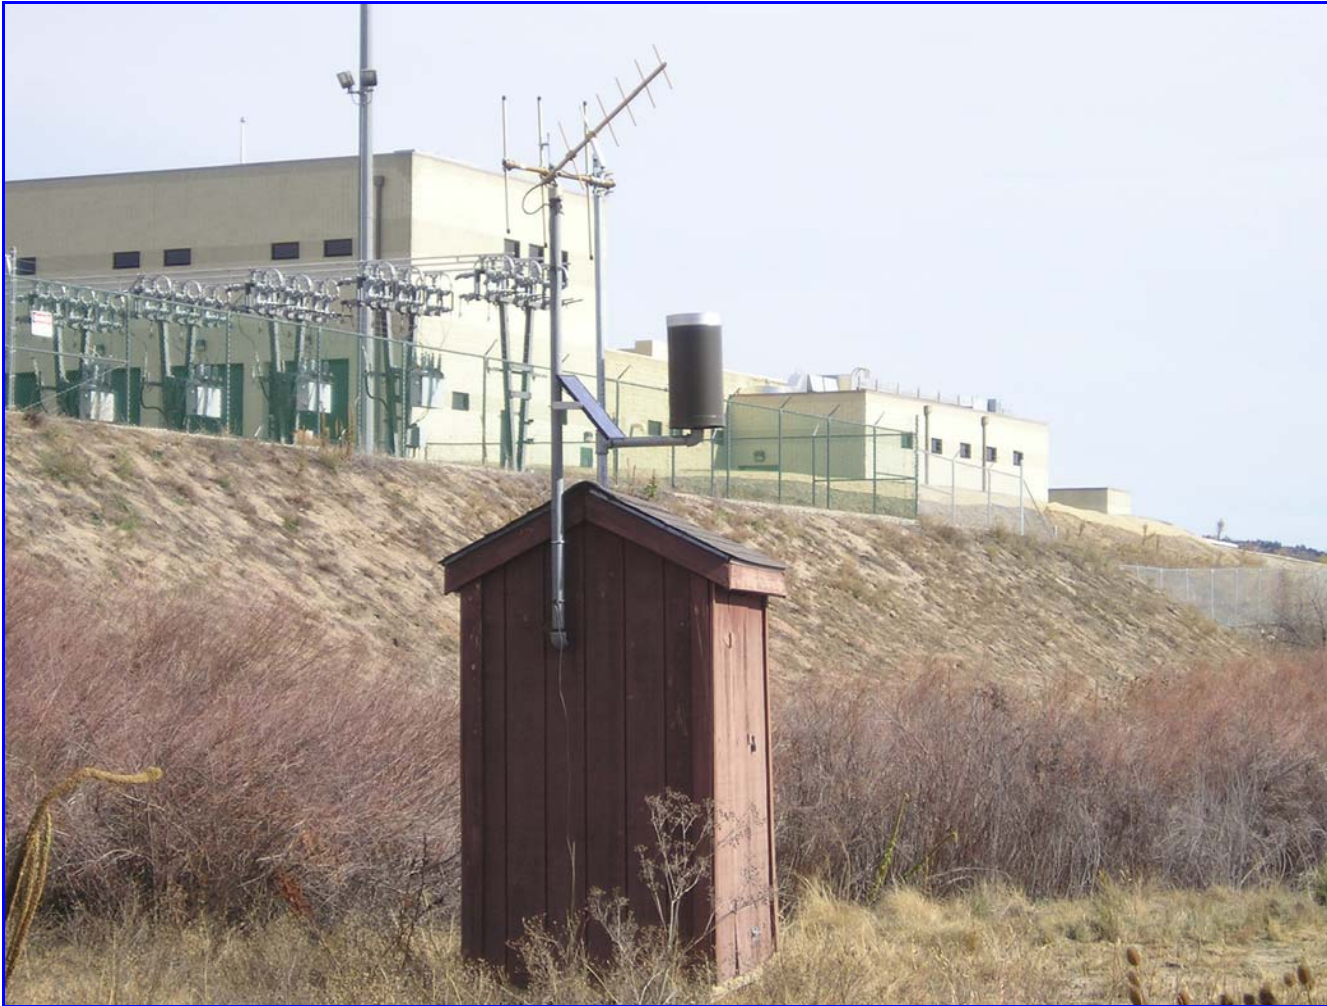
Name	ID	Sensor Type	Date Installed	Latitude	Longitude	Elevation	Gage Height	Anemometer Height	Temperature Sensor Height	Ground type
Pine Cliff Road	2810	P, S	08/27/98	39:22:20 N	104:57:58 W	5930'	9'2"	N/A	N/A	Scrub grass

Comments: Stream ~ 18' to west.

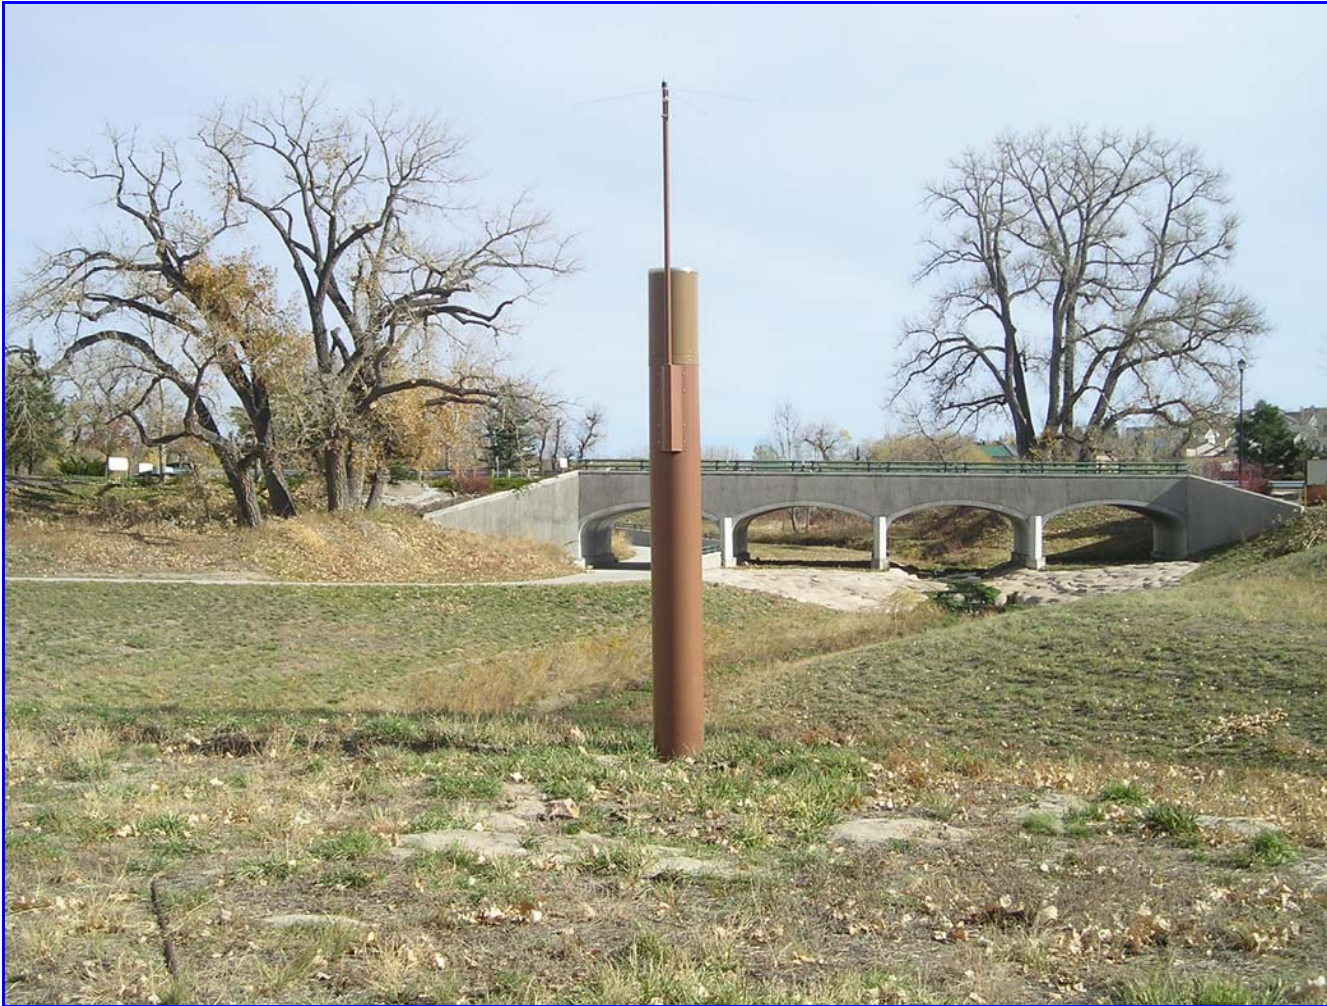
Name	ID	Sensor Type	Date Installed	Latitude	Longitude	Elevation	Gage Height	Anemometer Height	Temperature Sensor Height	Ground type
Castle Oaks Road	2830	P, S	06/11/98	39:24:59 N	104:46:07 W	6030'	10'2"	N/A	N/A	Scrub grass

Comments: Stream ~ 25' to west.

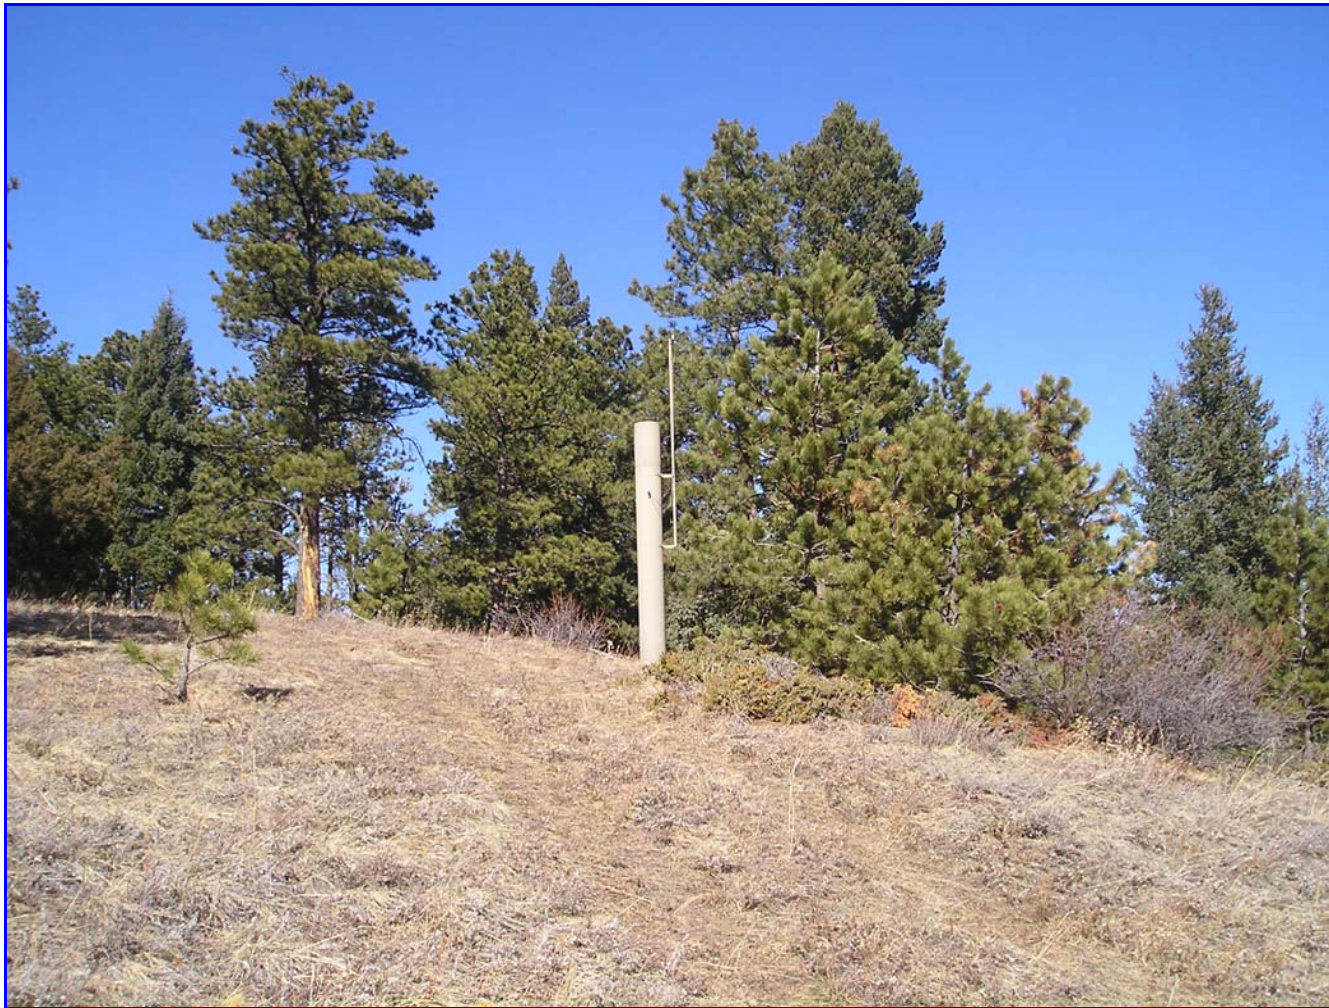
Name	ID	Sensor Type	Date Installed	Latitude	Longitude	Elevation	Gage Height	Anemometer Height	Temperature Sensor Height	Ground type
Sulpher Gulch	2840	P, S	11/26/04	39:31:01 N	104:44:45 W	5915'	9'3"	N/A	N/A	Grass

Comments: Gulch ~ 6 ' to east.

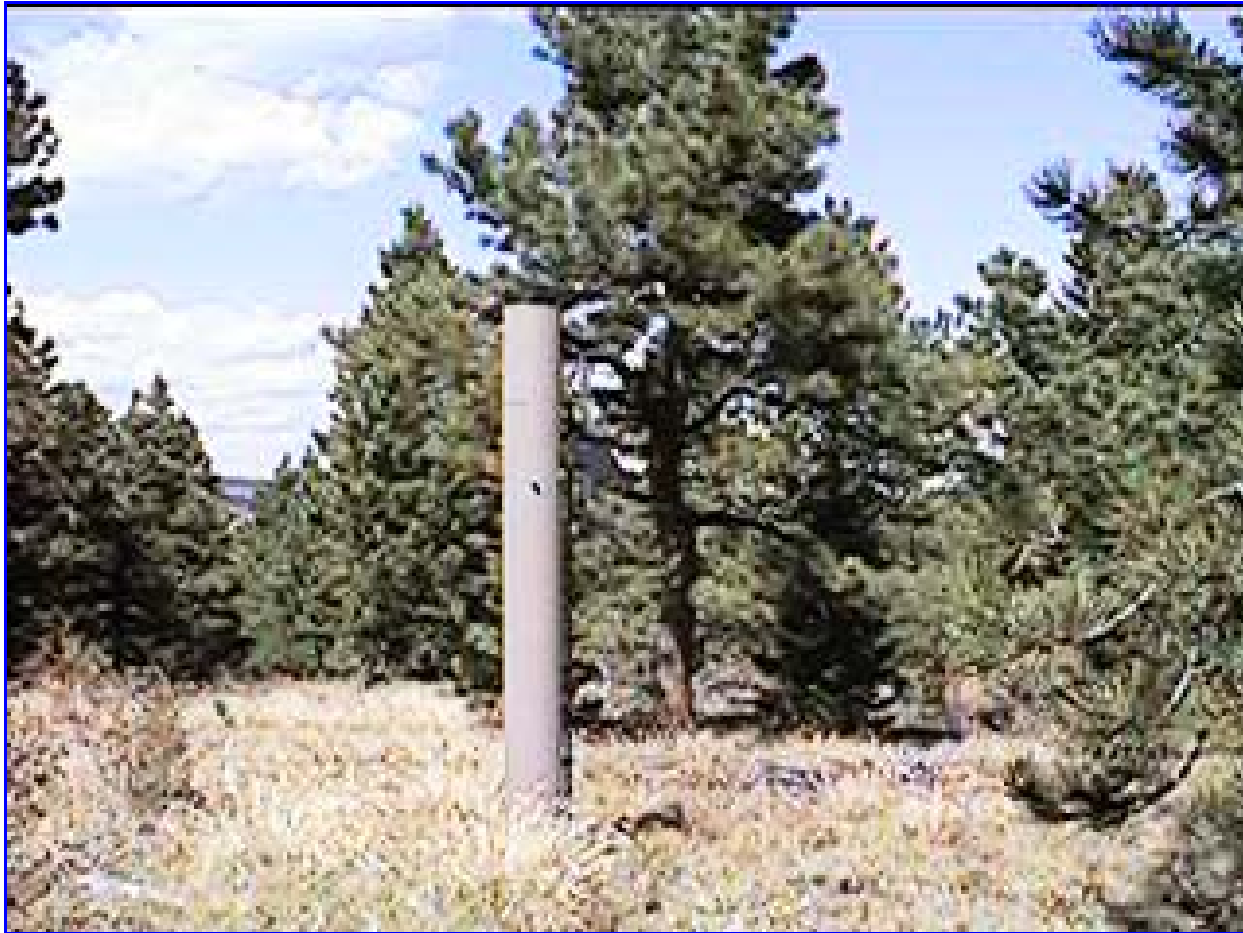
Name	ID	Sensor Type	Date Installed	Latitude	Longitude	Elevation	Gage Height	Anemometer Height	Temperature Sensor Height	Ground type
Crescent	4010	P	1979-80	39:55:27 N	105:21:50 W	7760'	9'10"	N/A	N/A	Scrub grass

Comments: 20' tree ~ 20' to the northwest.

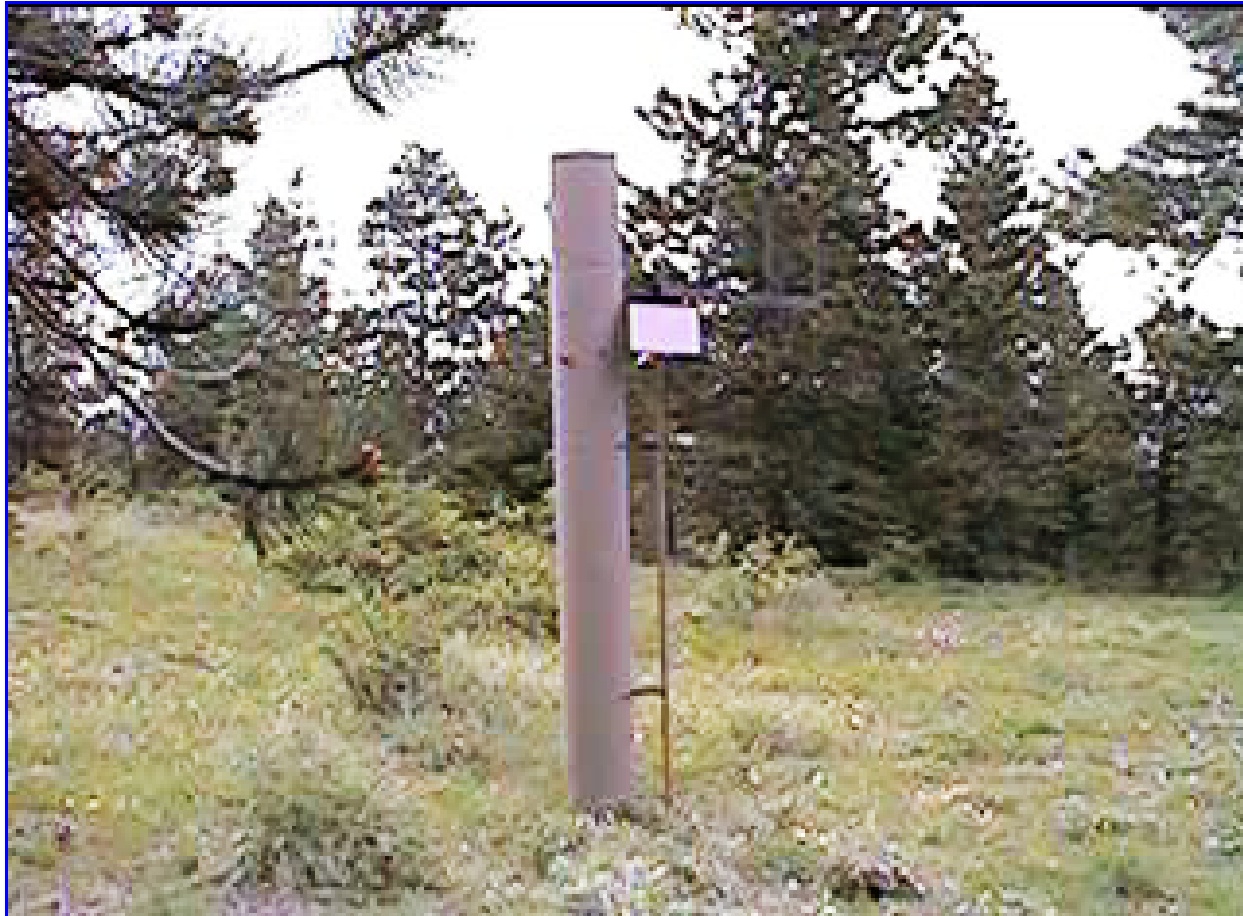
Name	ID	Sensor Type	Date Installed	Latitude	Longitude	Elevation	Gage Height	Anemometer Height	Temperature Sensor Height	Ground type
Rio Grande	4020	P	1979-80	39:55:21 N	105:19:33 W	7330'	9'11"	N/A	N/A	Scrub grass

Comments: Gage not accessible by automobile. Must walk to gage.

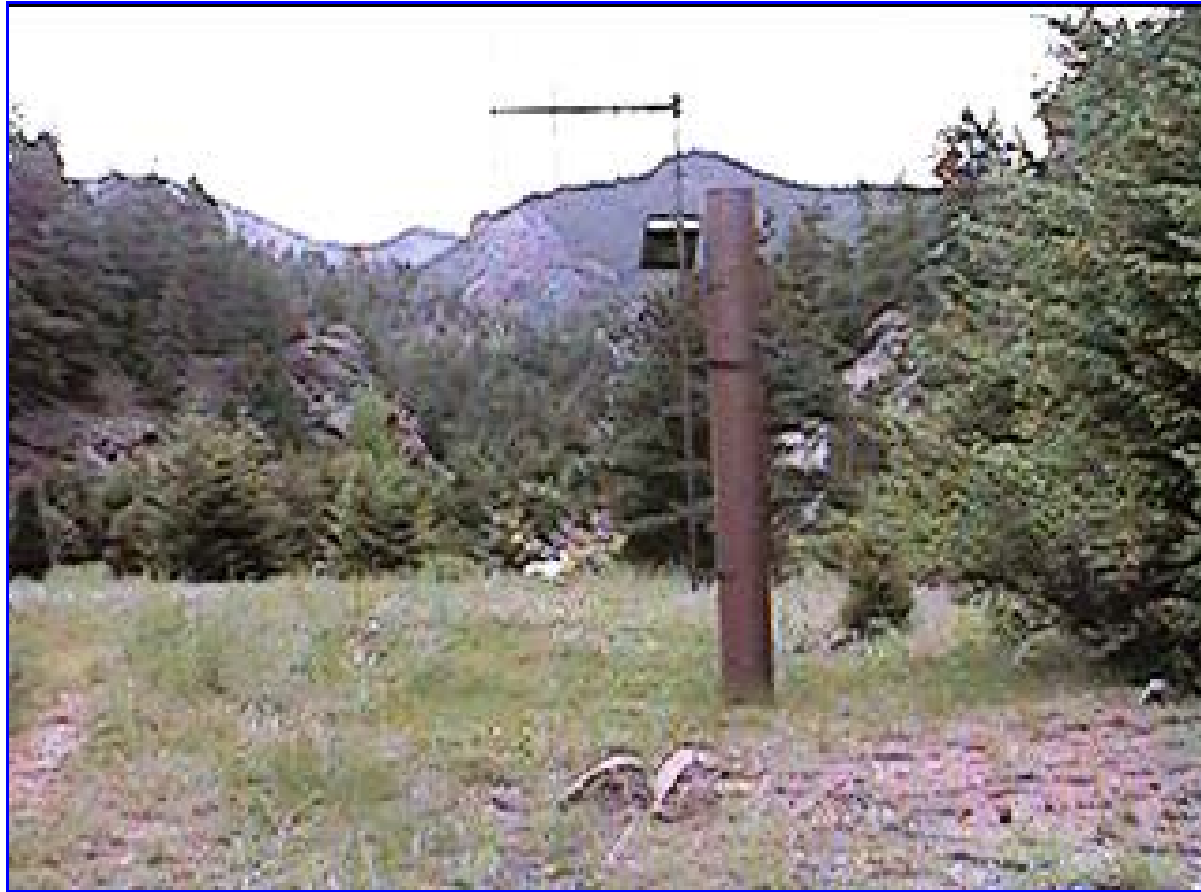
Name	ID	Sensor Type	Date Installed	Latitude	Longitude	Elevation	Gage Height	Anemometer Height	Temperature Sensor Height	Ground type
Red Garden	4030	P	1979-80	39:55:55 N	105:17:32 W	6360'	10'4"	N/A	N/A	Grass

Comments: Gage not accessible by automobile. Must walk to gage.

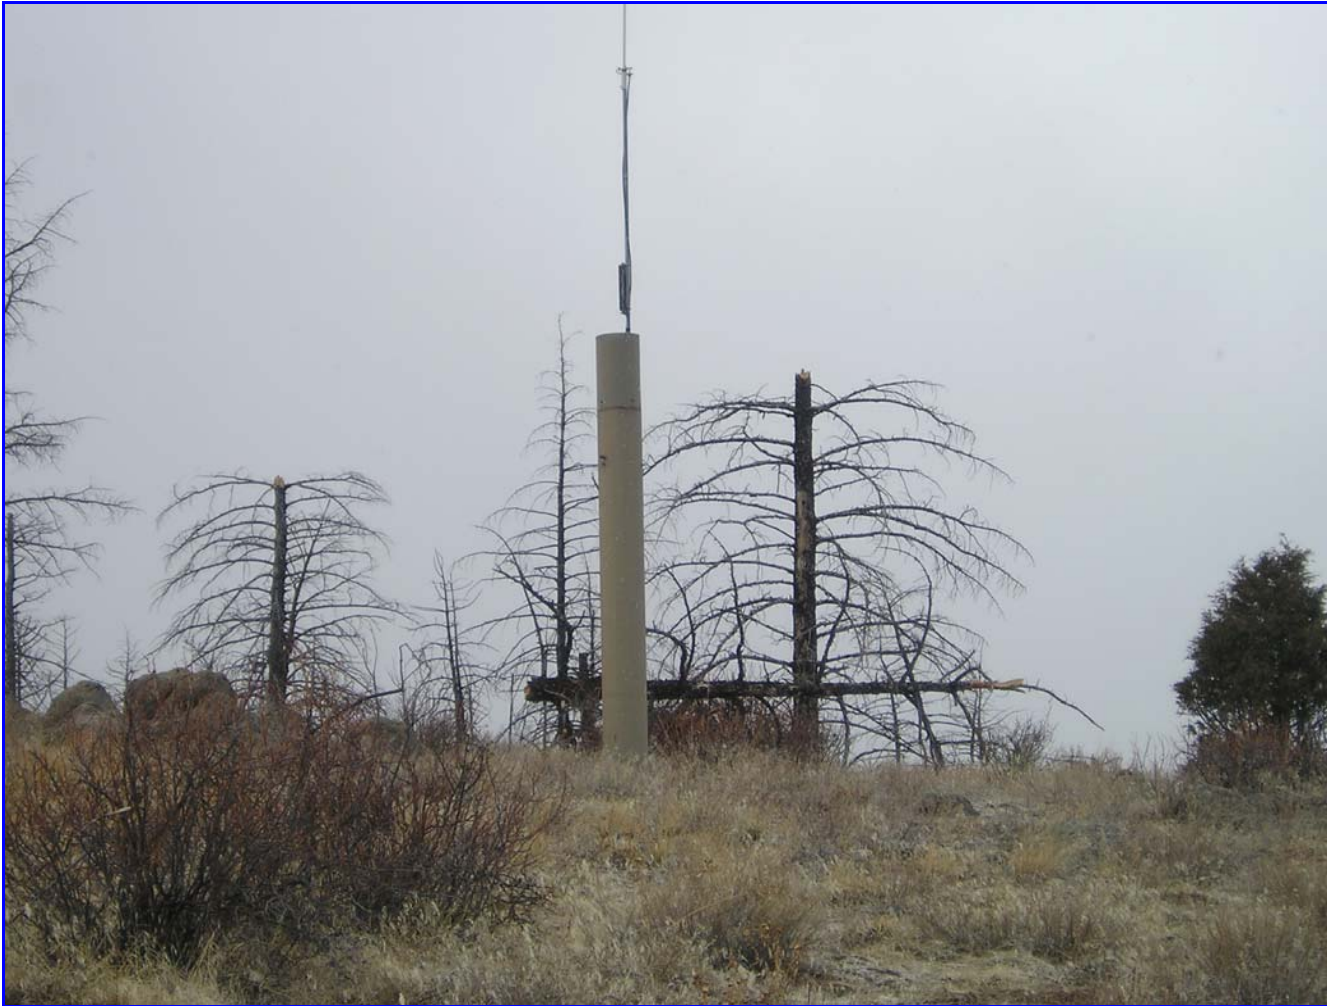
Name	ID	Sensor Type	Date Installed	Latitude	Longitude	Elevation	Gage Height	Anemometer Height	Temperature Sensor Height	Ground type
Martin Gulch	4040	P	1979-80	39:56:34 N	105:18:53 W	6520'	10'10"	N/A	N/A	Scrub grass

Comments: Obstruction will occur due to tree to the west when tree grows ~5 feet in the vertical
