APPENDIX

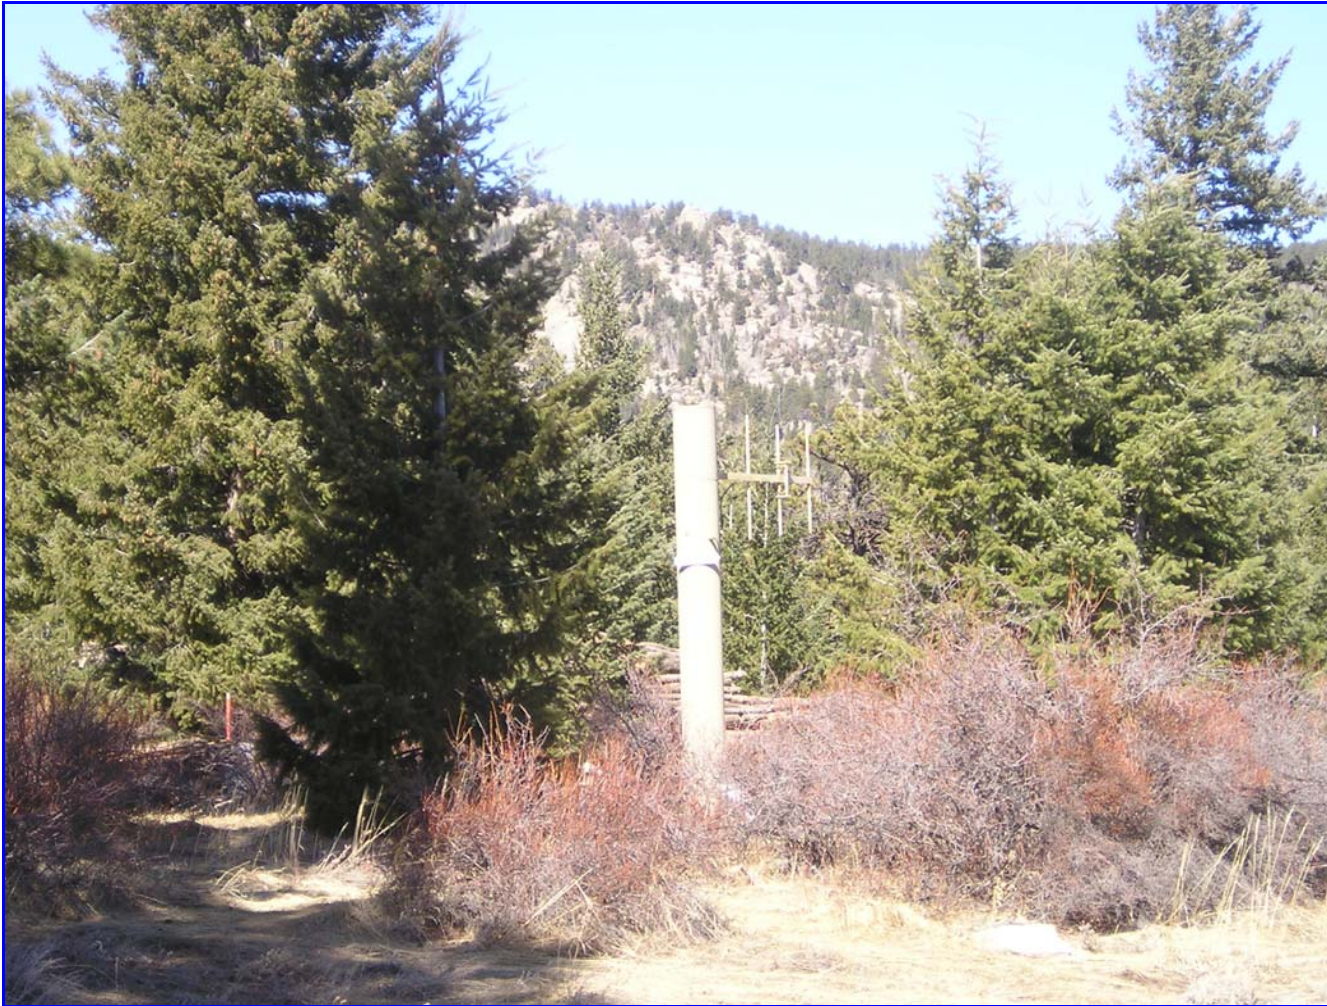
Name	ID	Sensor Type	Date Installed	Latitude	Longitude	Elevation	Gage Height	Anemometer Height	Temperature Sensor Height	Ground type
Walker Ranch	4050	P	1979-80	39:57:08 N	105:20:21 W	7320'	10'4"	N/A	N/A	Scrub grass

Comments: Gage located in a post wildfire area.

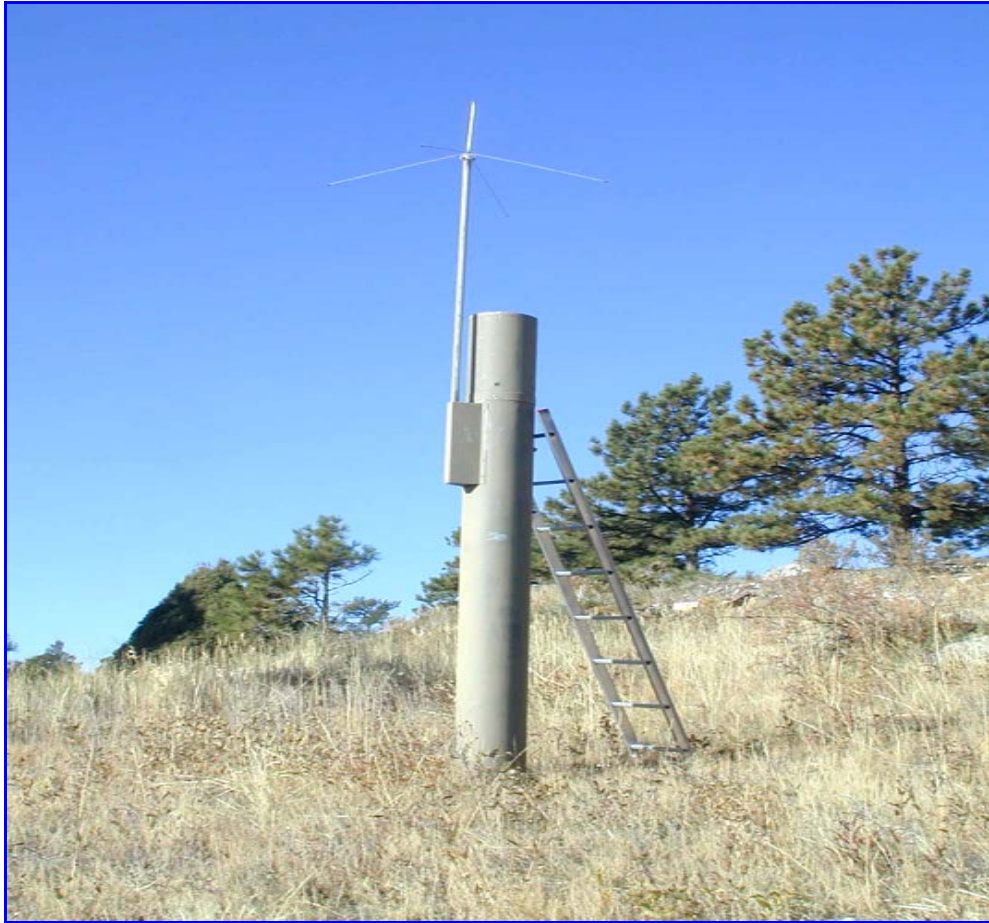
Name	ID	Sensor Type	Date Installed	Latitude	Longitude	Elevation	Gage Height	Anemometer Height	Temperature Sensor Height	Ground type
Lakeshore	4060	P	1979-80	39:57:40 N	105:22:13 W	7700'	10'3"	N/A	N/A	Scrub grass

Comments: Gage obstruction due to trees to the west and northwest of gage. Gage not accessible by vehicle, must walk a short way to access gage.

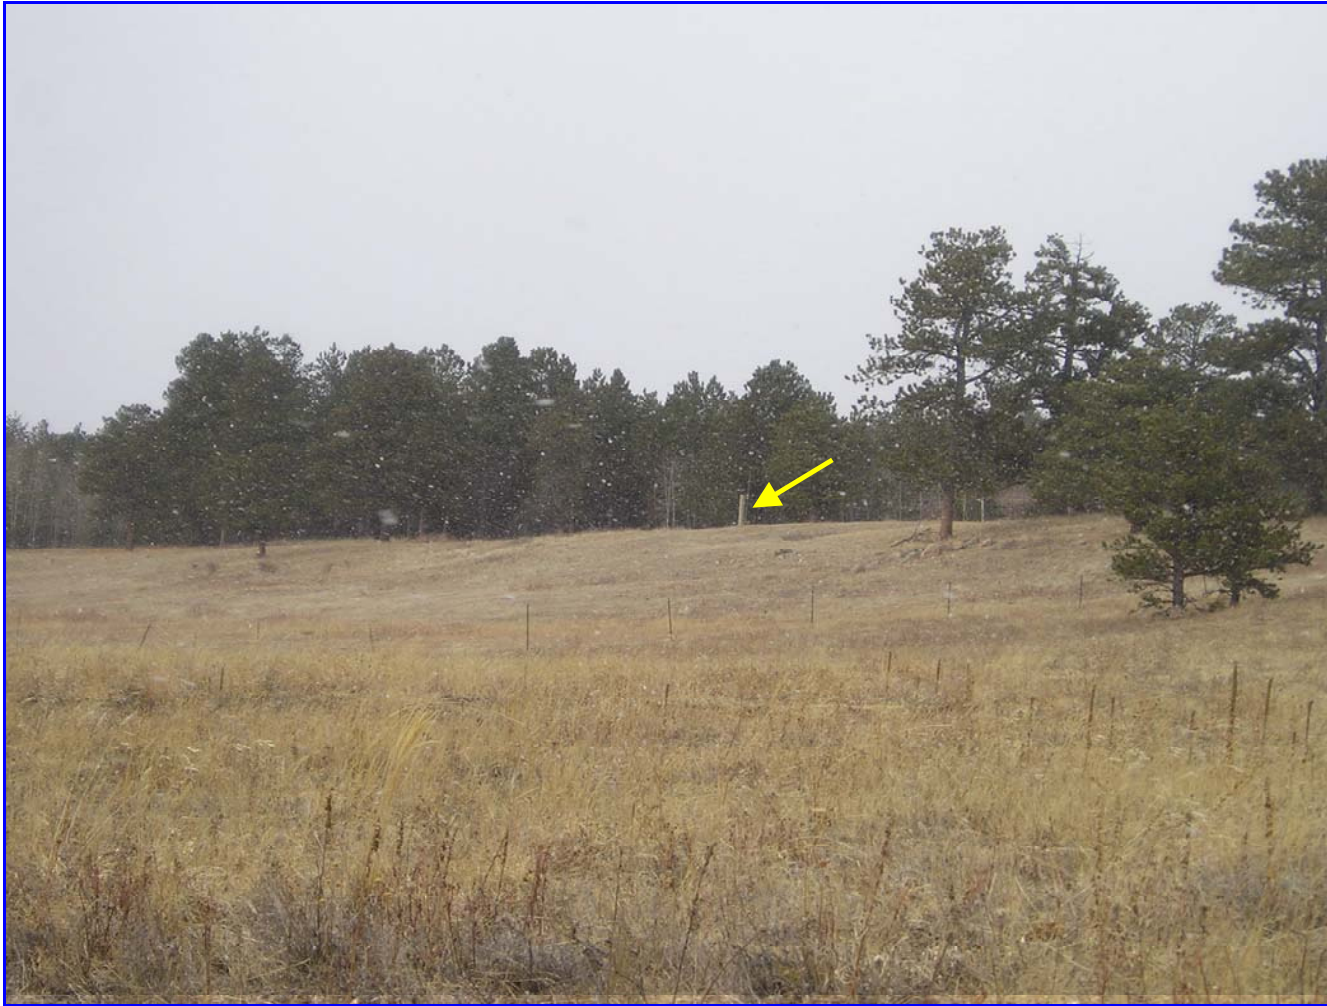
Name	ID	Sensor Type	Date Installed	Latitude	Longitude	Elevation	Gage Height	Anemometer Height	Temperature Sensor Height	Ground type
Bear Peak	4070	P	1979-80	39:58:16 N	105:18:29 W	6920'	9'4"	N/A	N/A	Scrub grass

Comments: Gage not accessible by vehicle, must walk a short way to access gage.

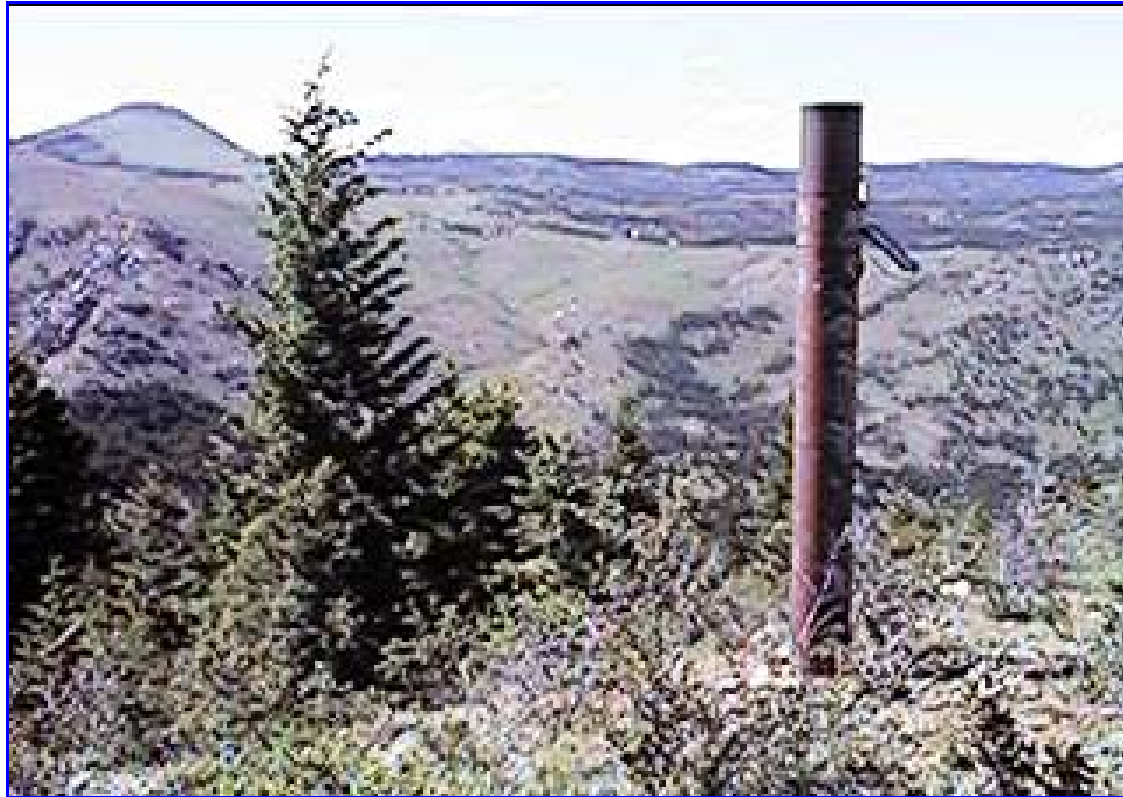
Name	ID	Sensor Type	Date Installed	Latitude	Longitude	Elevation	Gage Height	Anemometer Height	Temperature Sensor Height	Ground type
Twin Sisters	4080	P	1979-80	39:59:03 N	105:24:43 W	8120'	10'3"	N/A	N/A	Scrub grass

Comments: Gage located on private property. No vehicle access.

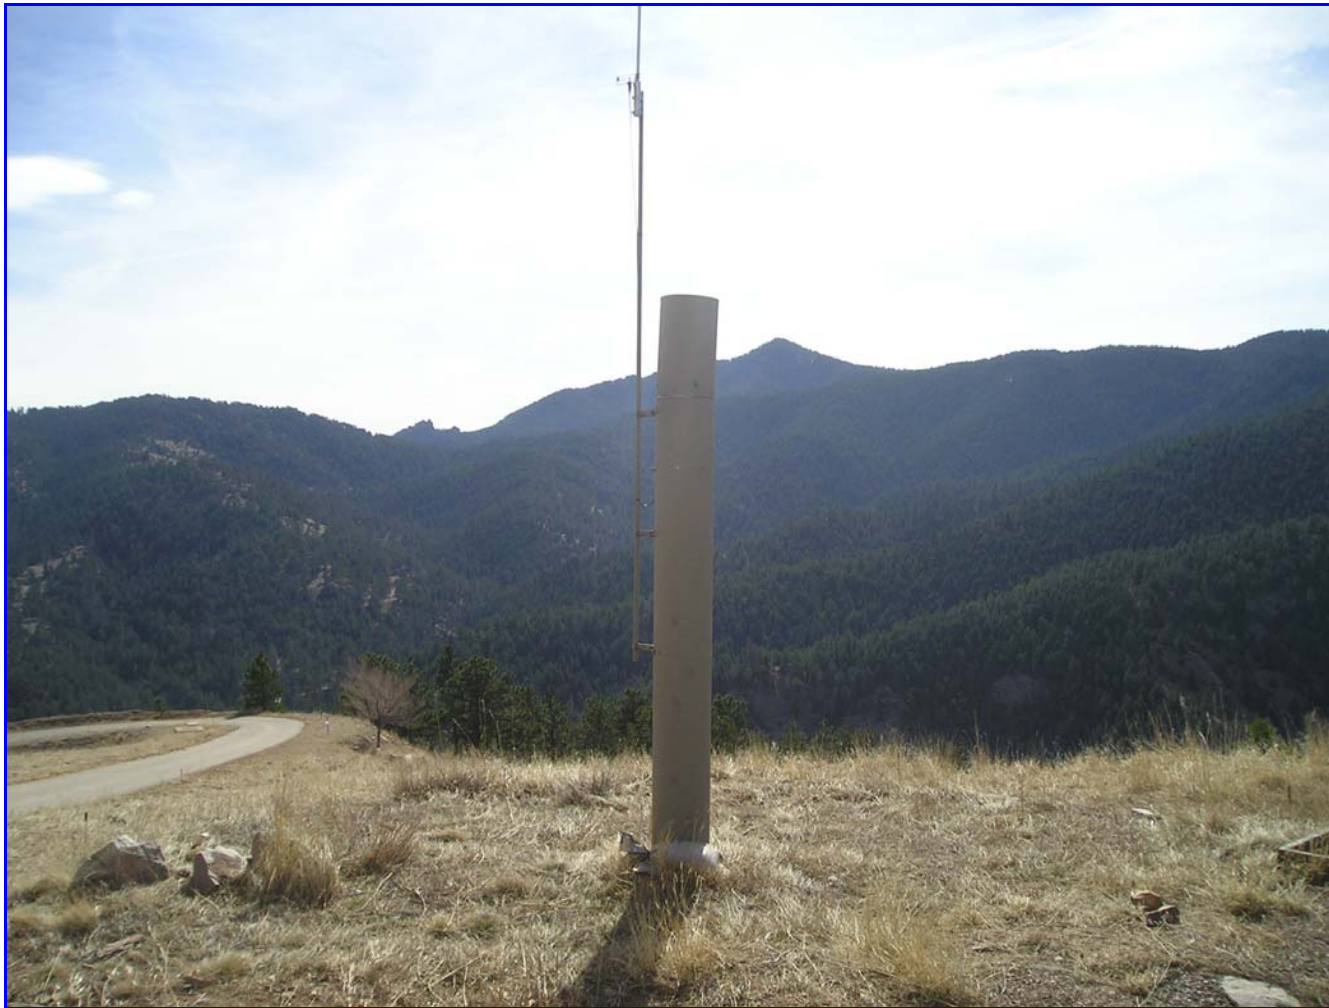
Name	ID	Sensor Type	Date Installed	Latitude	Longitude	Elevation	Gage Height	Anemometer Height	Temperature Sensor Height	Ground type
Magnolia	4090	P	1978-79	39:59:26 N	105:22:13 W	7320'	10'2"	N/A	N/A	Scrub grass

Comments: Not accessible by vehicle. Must walk to access gage.

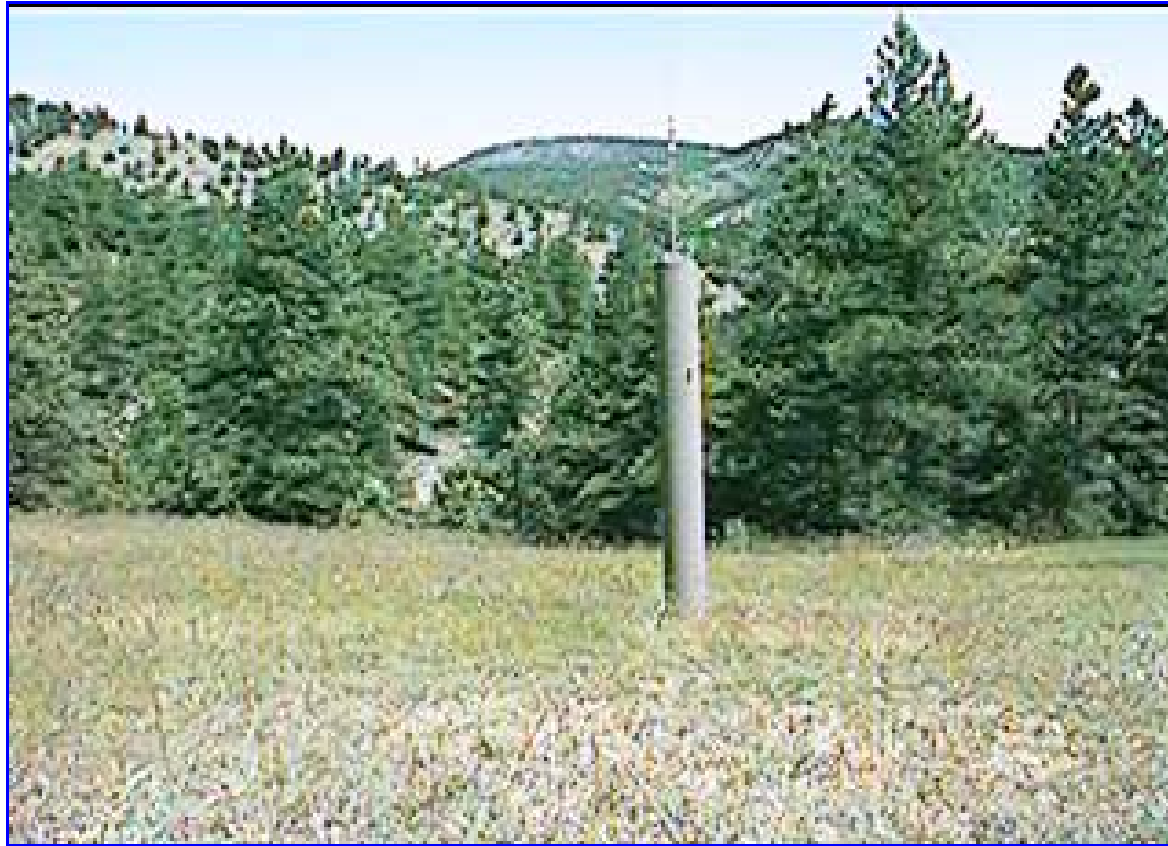
Comments: Top of gage missing a screw. Security access needed.

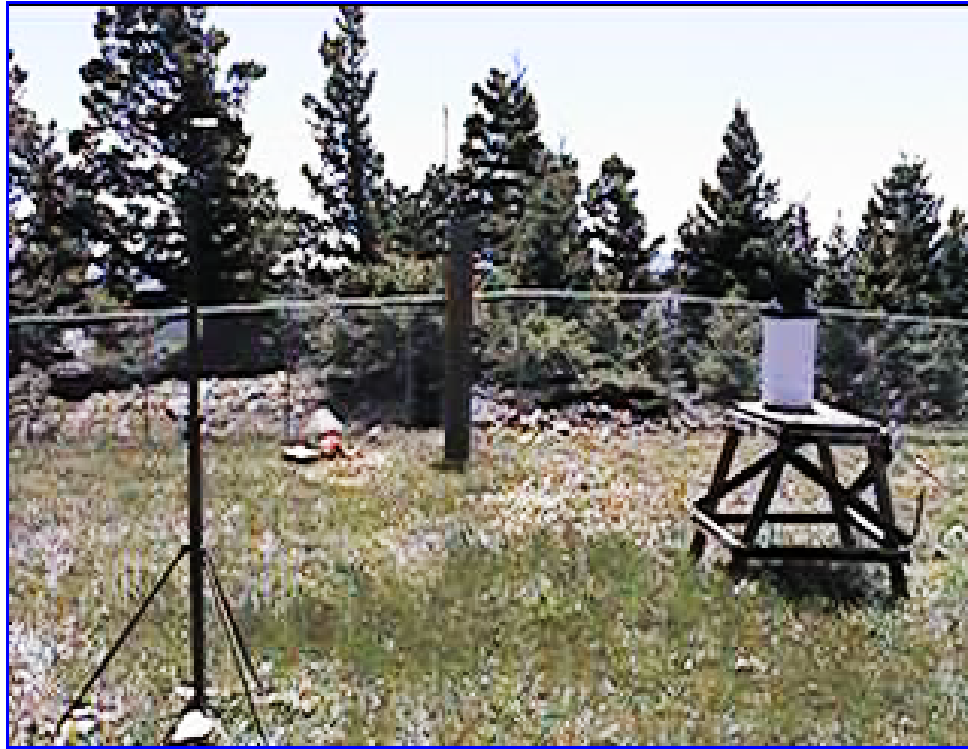
Name	ID	Sensor Type	Date Installed	Latitude	Longitude	Elevation	Gage Height	Anemometer Height	Temperature Sensor Height	Ground type
Betasso	4110	P	1978-79	40:01:26 N	105:20:22 W	6480'	10'4"	N/A	N/A	Grass

Comments: Not accessible by vehicle. Must walk a short way to access gage.

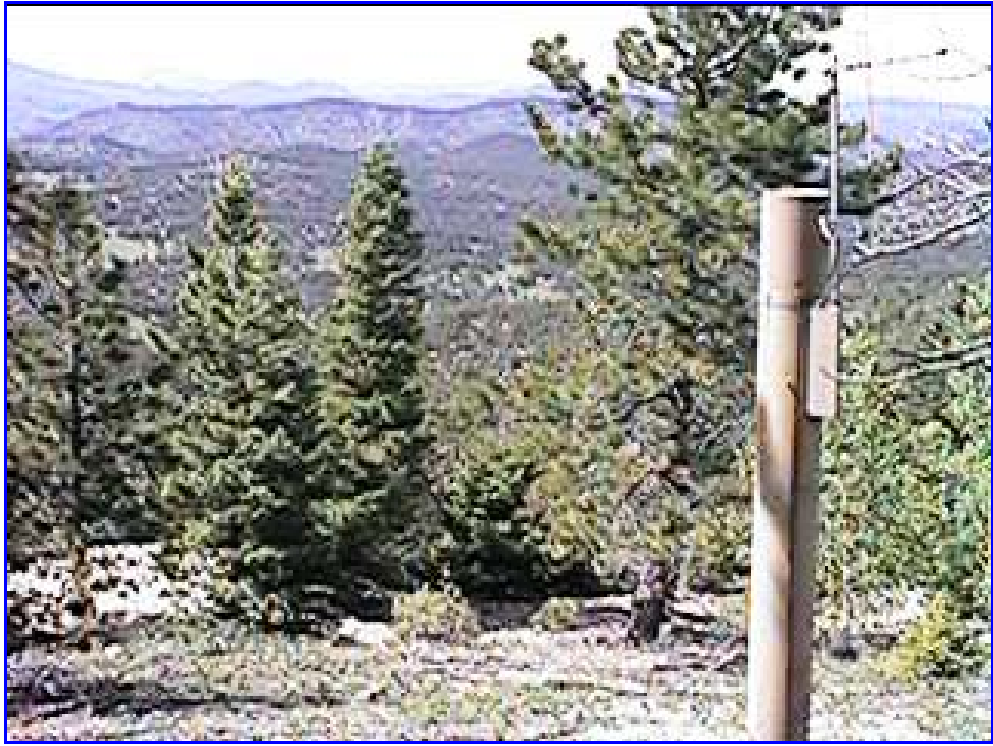
Name	ID	Sensor Type	Date Installed	Latitude	Longitude	Elevation	Gage Height	Anemometer Height	Temperature Sensor Height	Ground type
Swiss Peaks	4130	P	1978-79	40:01:22 N	105:25:42 W	8600'	9'11"	N/A	N/A	Grass

Comments: Not accessible by vehicle. Must walk to access gage.

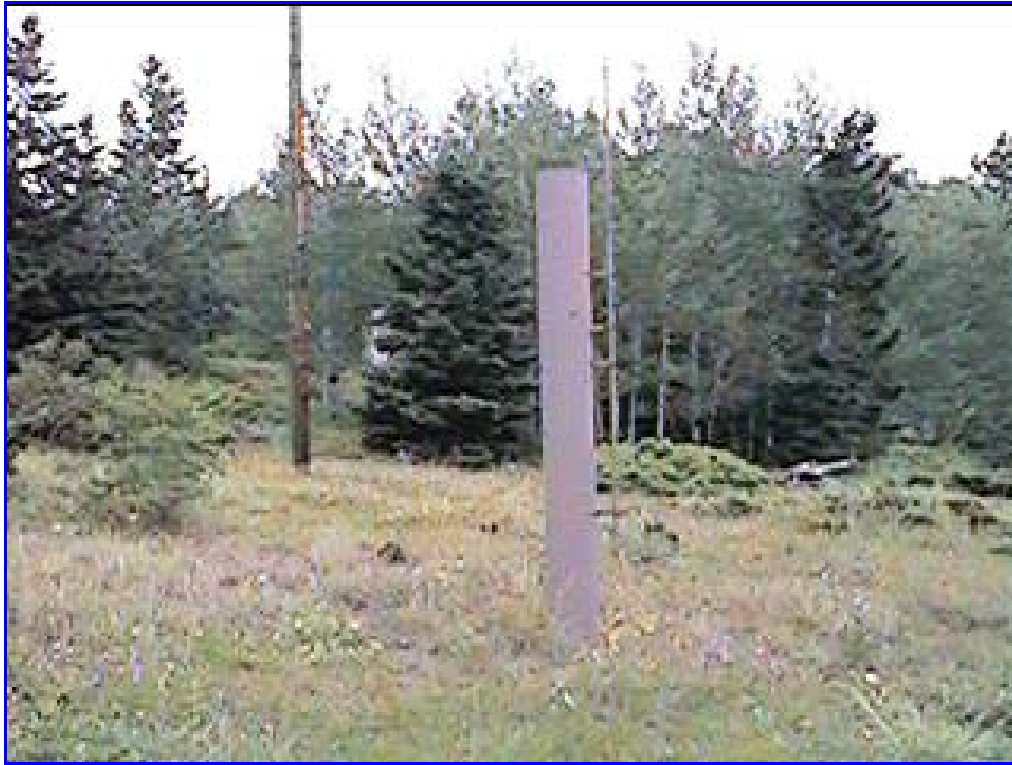
Name	ID	Sensor Type	Date Installed	Latitude	Longitude	Elevation	Gage Height	Anemometer Height	Temperature Sensor Height	Ground type
Logan Mill	4140	P	1978-79	40:02:18 N	105:22:41 W	7200'	10'6"	N/A	N/A	Scrub grass

Comments: Not accessible by vehicle. Must walk to access gage.

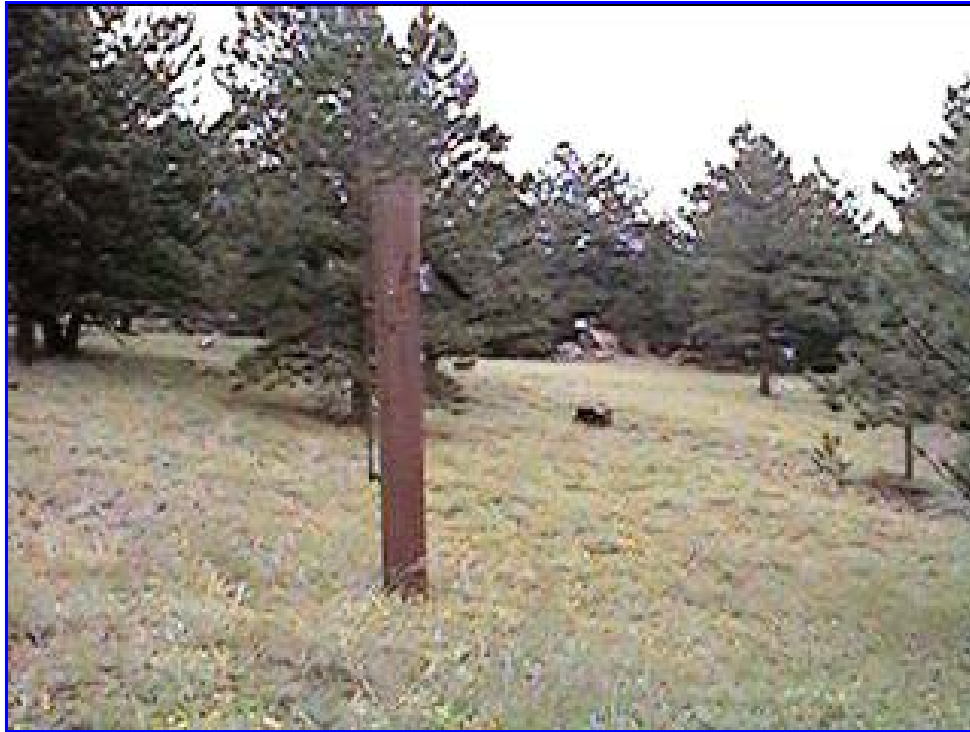
Name	ID	Sensor Type	Date Installed	Latitude	Longitude	Elevation	Gage Height	Anemometer Height	Temperature Sensor Height	Ground type
Gold Hill	4150	P	1978-79	40:03:19 N	105:24:28 W	8120'	10'6"	N/A	N/A	Scrub grass

Comments: Not accessible by vehicle. Must walk to access gage.

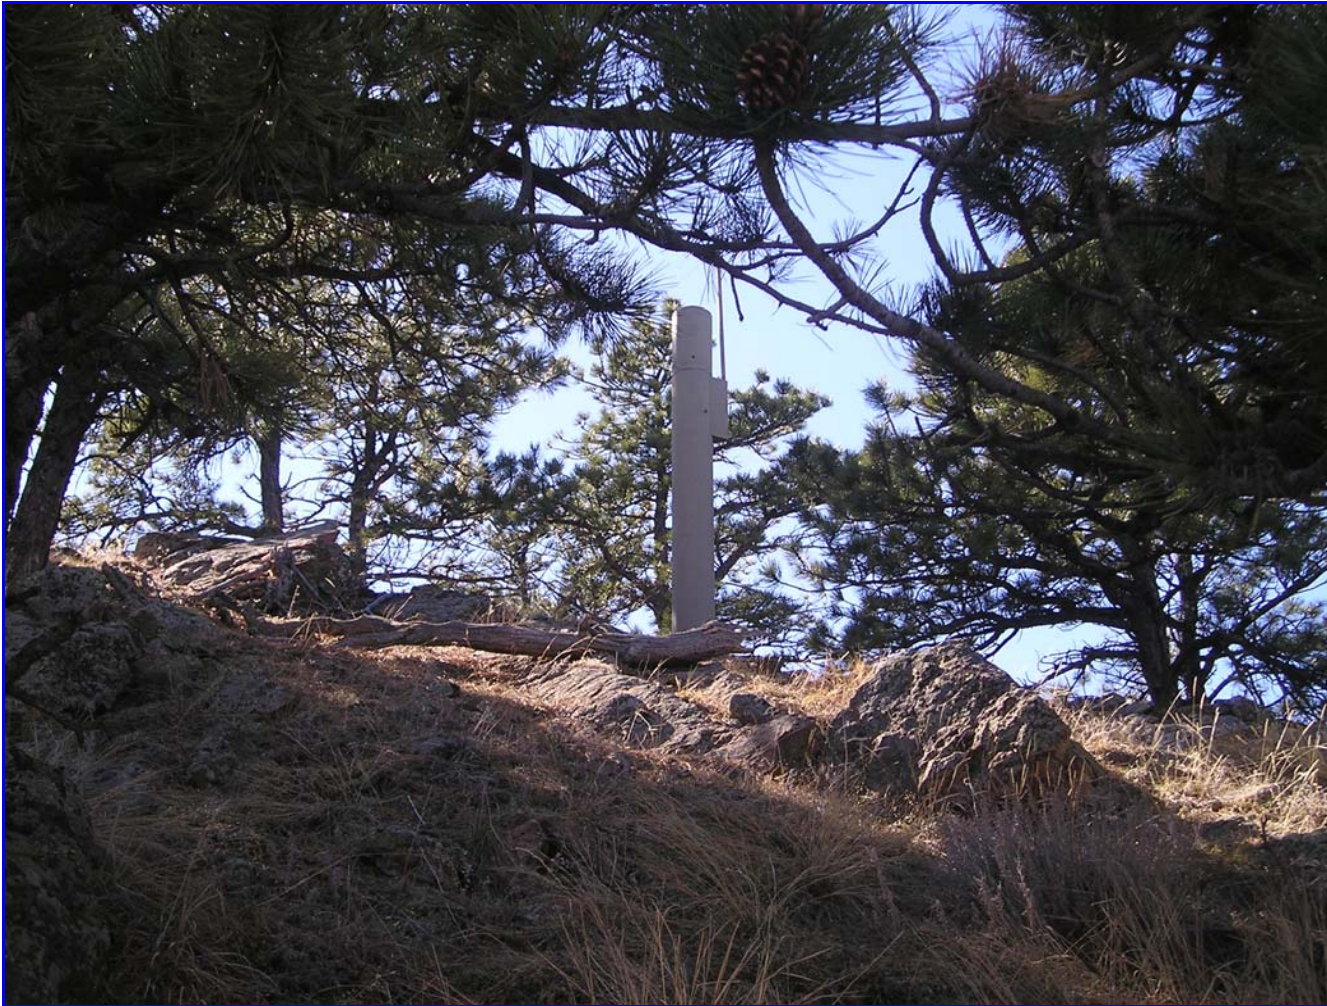
Name	ID	Sensor Type	Date Installed	Latitude	Longitude	Elevation	Gage Height	Anemometer Height	Temperature Sensor Height	Ground type
Sunshine	4160	P	1978-79	40:03:47 N	105:22:19 W	7560'	10'1"	N/A	N/A	Scrub grass

Comments: Not accessible by vehicle. Must walk to access gage.

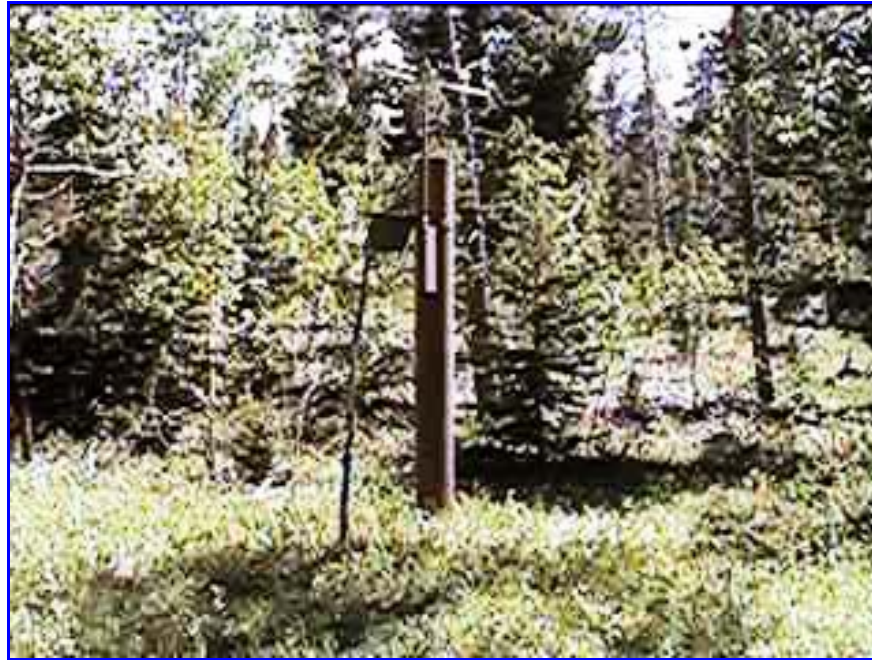
Name	ID	Sensor Type	Date Installed	Latitude	Longitude	Elevation	Gage Height	Anemometer Height	Temperature Sensor Height	Ground type
Pine Brook	4170	P	1981-82	40:03:09 N	105:19:20 W	6920'	10'4"	N/A	N/A	Rock

Comments: Obstruction due to tree south of gage. Not accessible by vehicle. Must climb ridge to access gage.

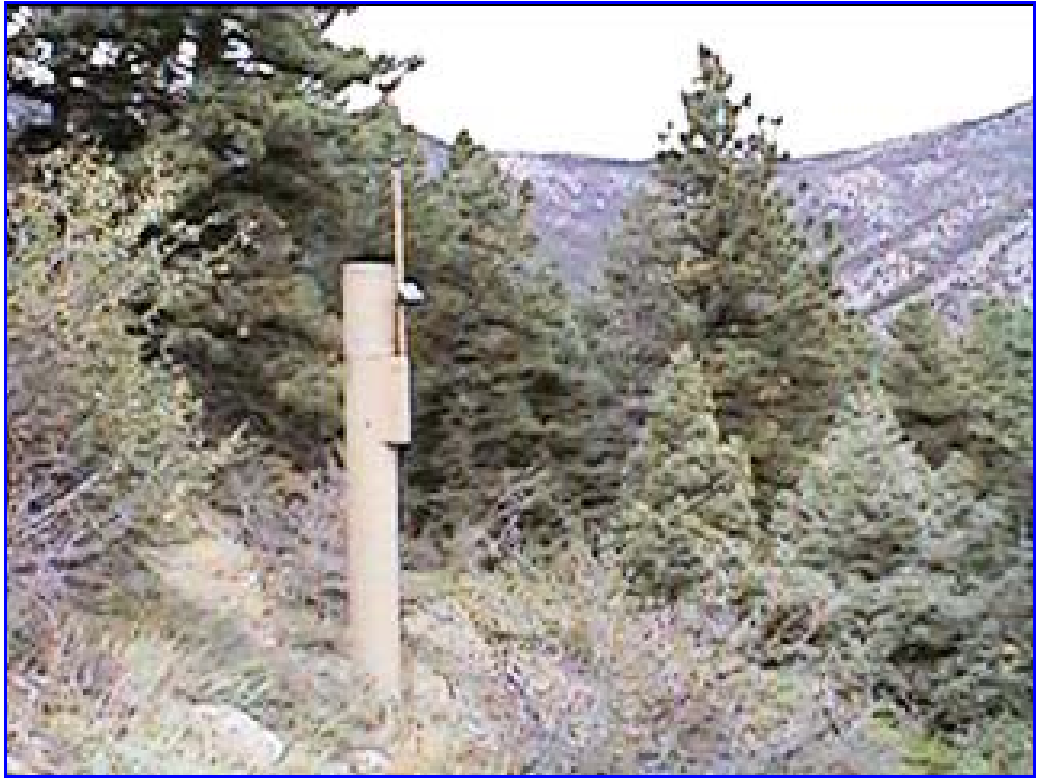
Name	ID	Sensor Type	Date Installed	Latitude	Longitude	Elevation	Gage Height	Anemometer Height	Temperature Sensor Height	Ground type
Gold Lake	4180	P	1981-82	40:05:35 N	105:26:30 W	8560'	10'4"	N/A	N/A	Grass

Comments: Not accessible by vehicle. Must walk to access gage.

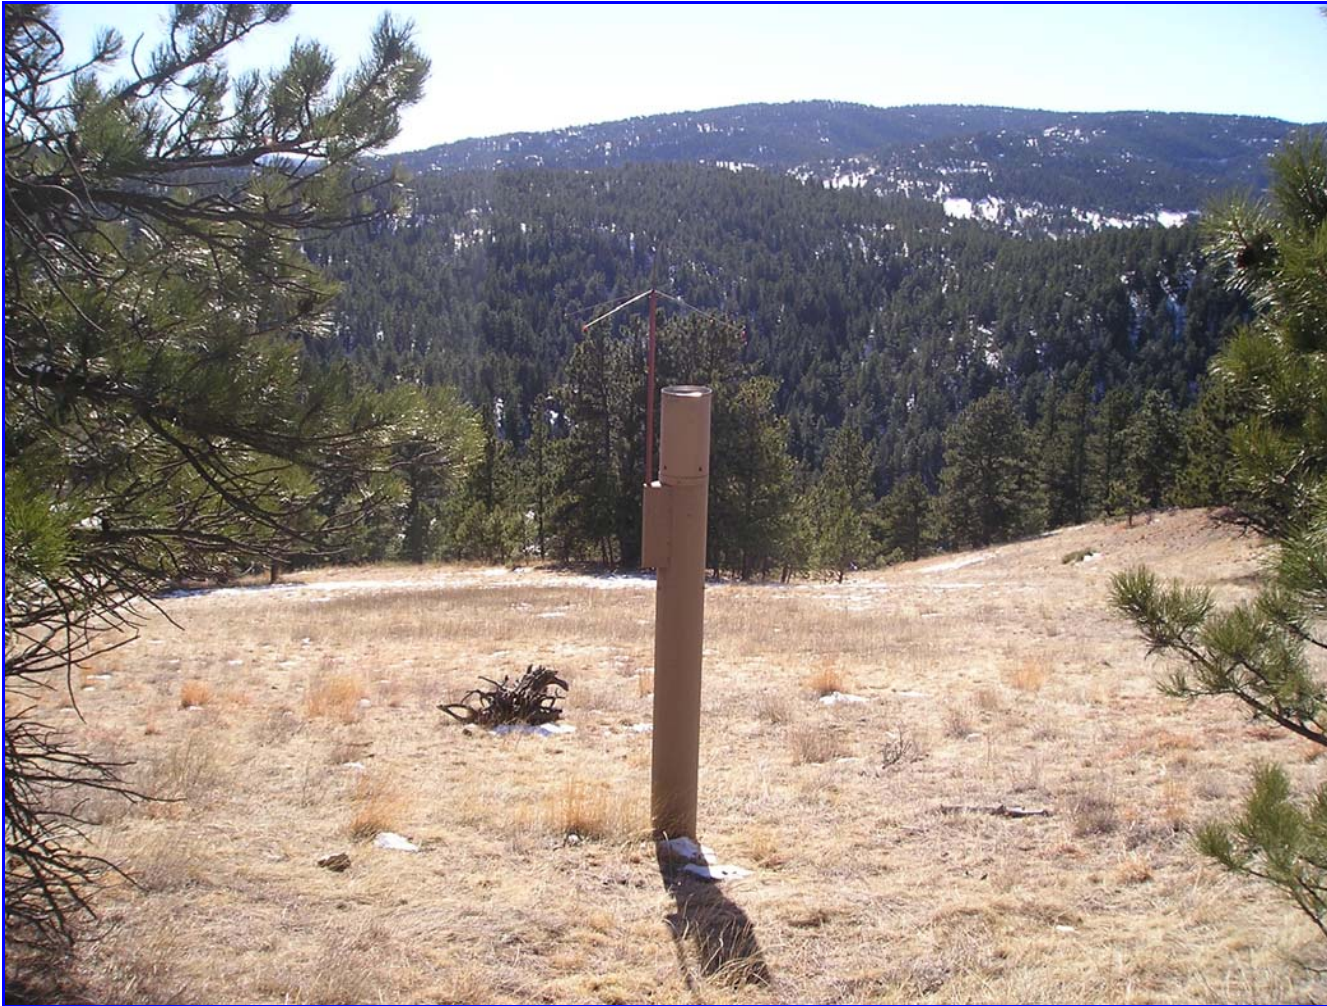
Name	ID	Sensor Type	Date Installed	Latitude	Longitude	Elevation	Gage Height	Anemometer Height	Temperature Sensor Height	Ground type
Slaughterhouse	4190	P	1981-82	40:06:06 N	105:23:01 W	7400'	10'7"	N/A	N/A	Scrub grass

Comments: Not accessible by vehicle. Must walk to access gage.

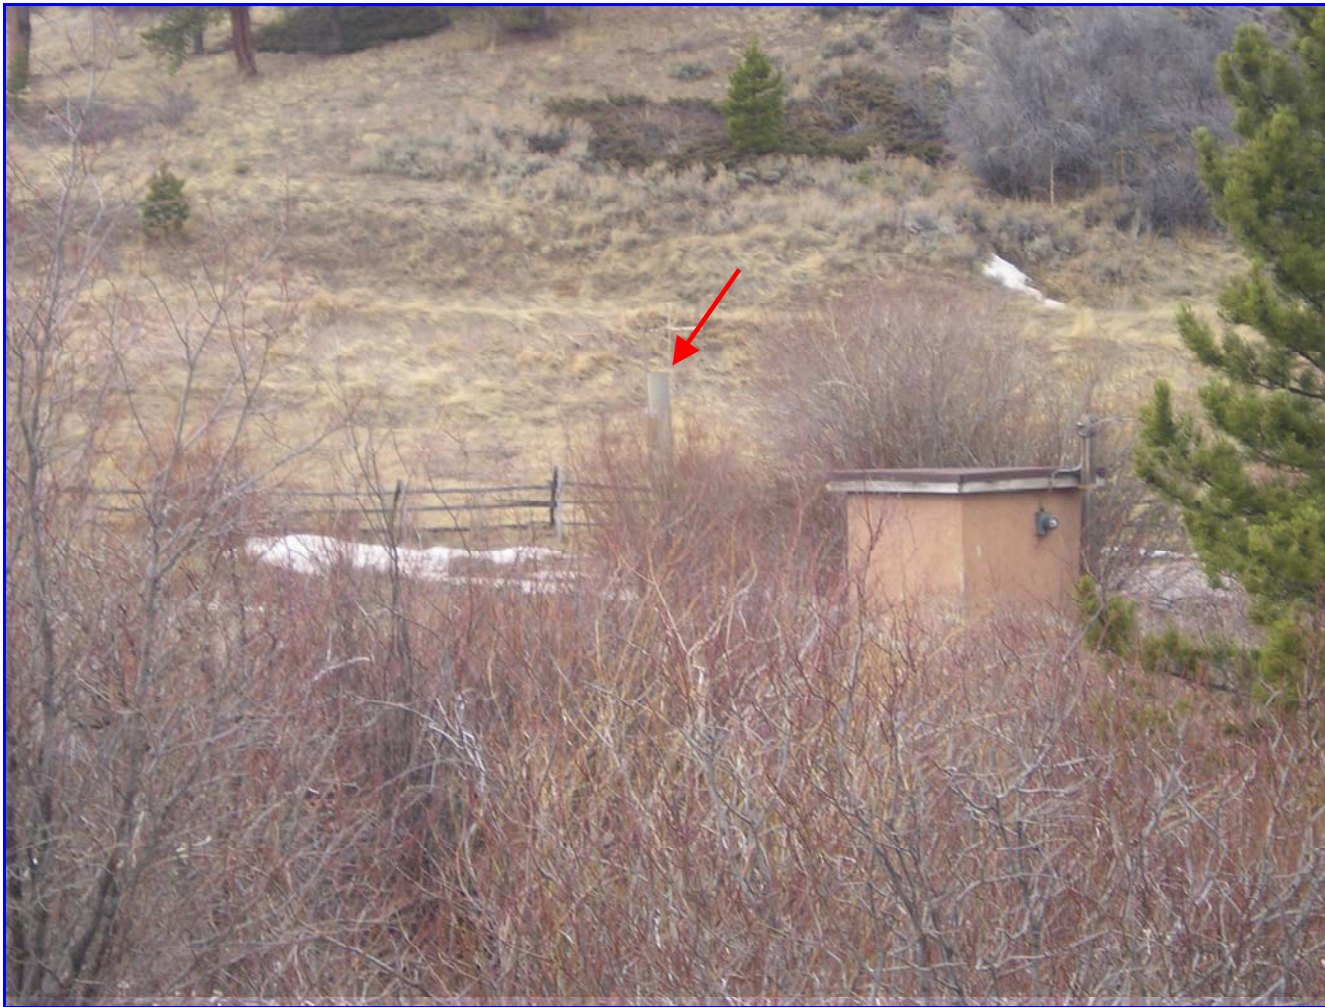
Name	ID	Sensor Type	Date Installed	Latitude	Longitude	Elevation	Gage Height	Anemometer Height	Temperature Sensor Height	Ground type
Lazy Acres	4200	P	1981-82	40:05:58 N	105:19:43 W	7020'	9'4"	N/A	N/A	Scrub grass

Comments: Not accessible by vehicle. Must walk a short distance to access gage.

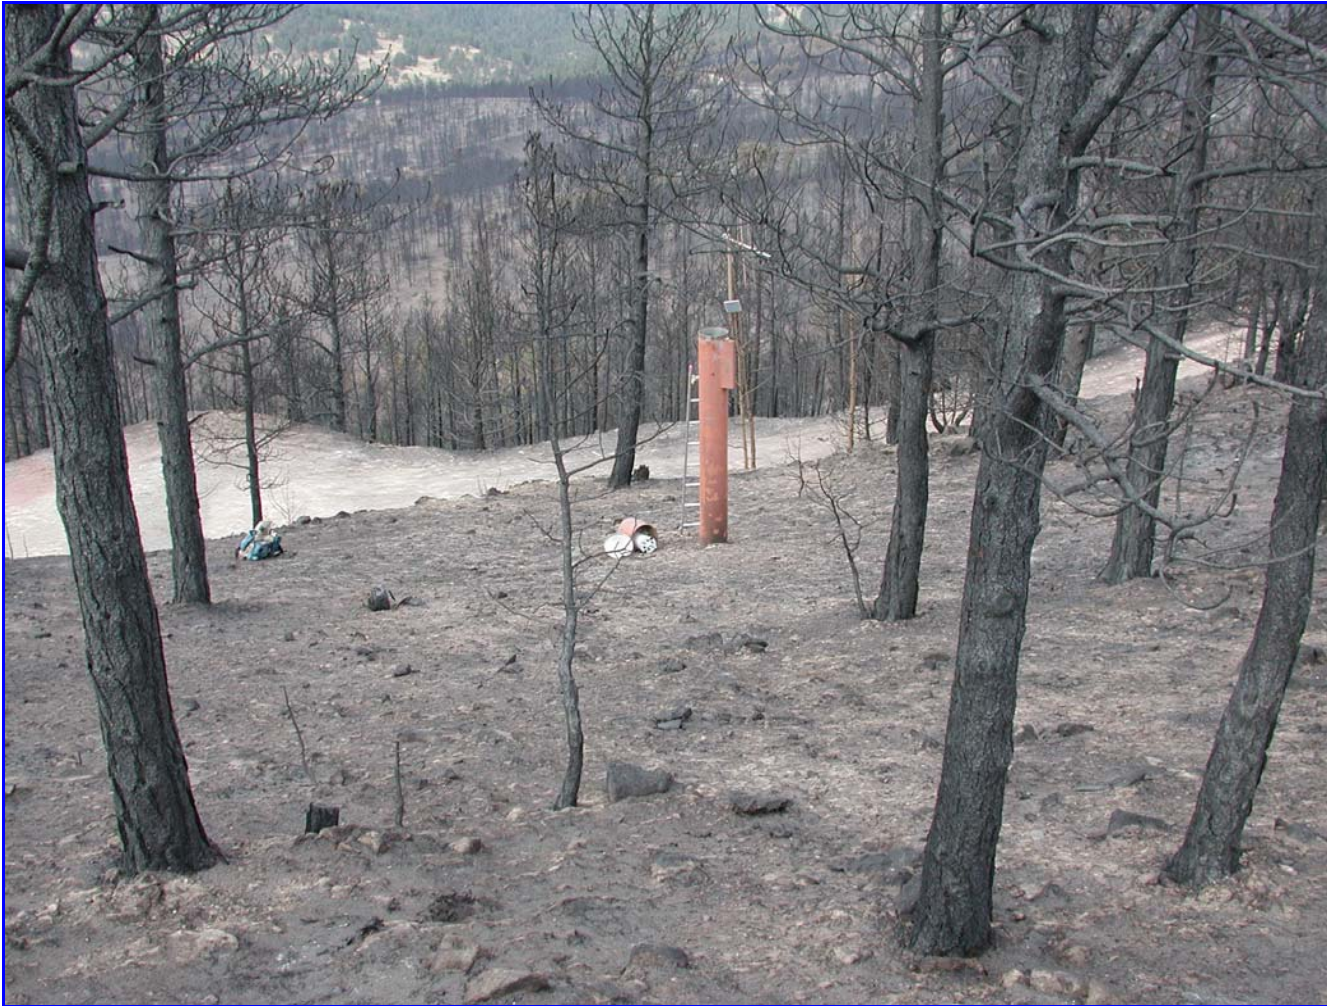
Name	ID	Sensor Type	Date Installed	Latitude	Longitude	Elevation	Gage Height	Anemometer Height	Temperature Sensor Height	Ground type
Fling's	4220	P	1981-82	40:07:05 N	105:28:44 W	8590'	9'9"	N/A	N/A	Scrub grass

Comments: Gage located ~ 5' from small stream. Gage located on private property.

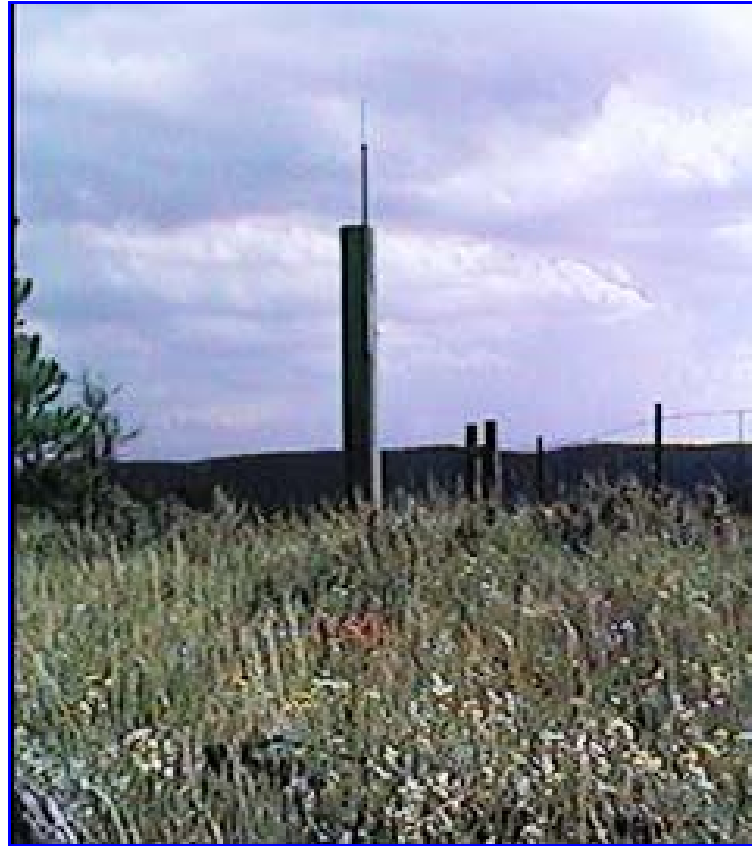
Name	ID	Sensor Type	Date Installed	Latitude	Longitude	Elevation	Gage Height	Anemometer Height	Temperature Sensor Height	Ground type
Golden Age	4230	P	1981-82	40:07:31 N	105:21:47 W	8160'	9'1"	N/A	N/A	Gravel

Comments: Not accessible by vehicle. Must walk to access gage. Located in a post wildfire area.

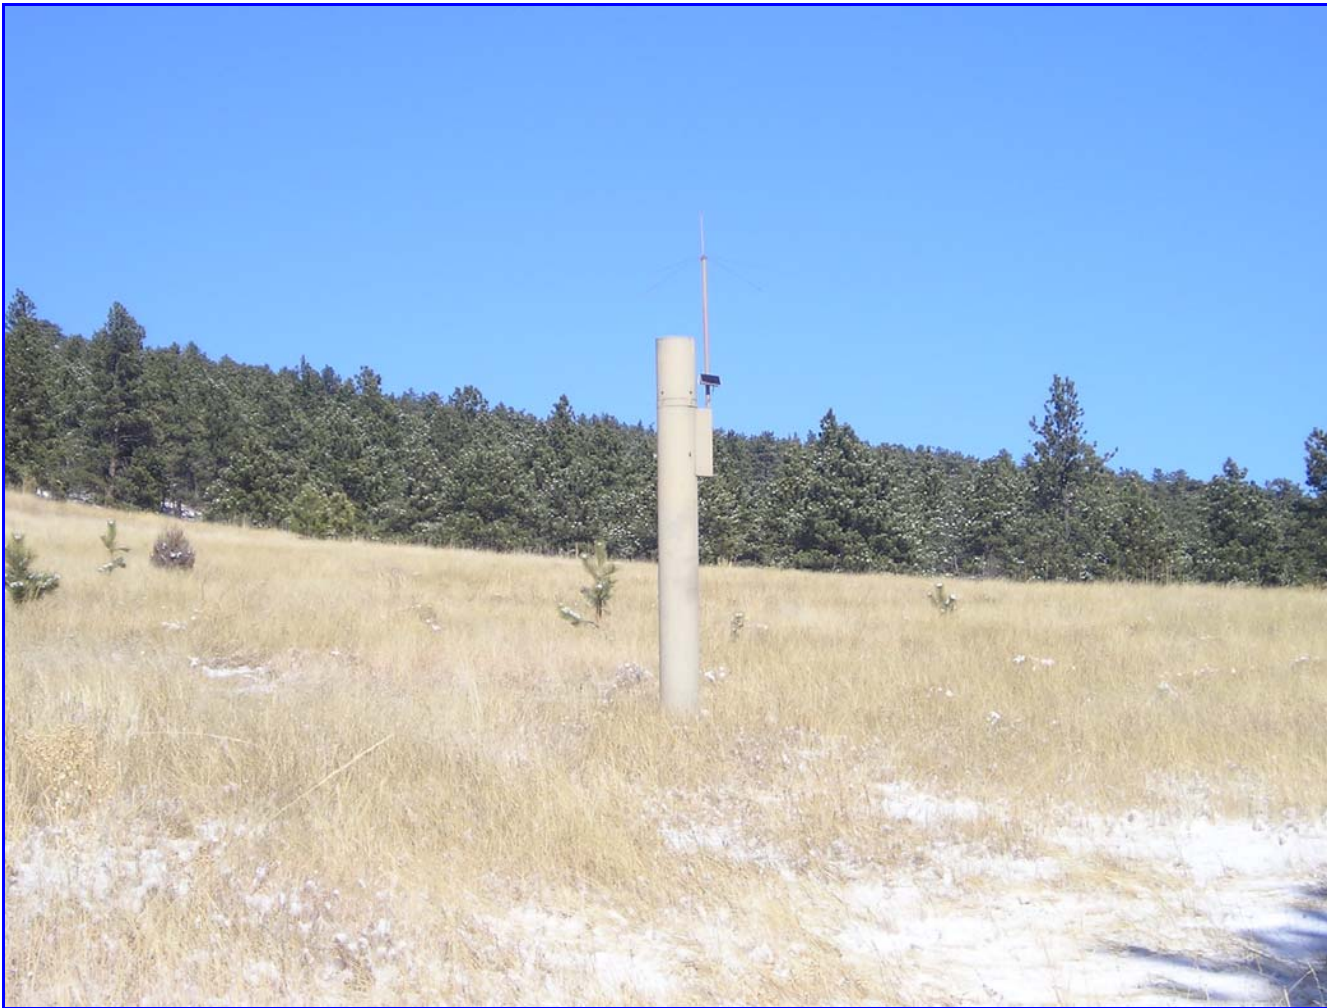
Name	ID	Sensor Type	Date Installed	Latitude	Longitude	Elevation	Gage Height	Anemometer Height	Temperature Sensor Height	Ground type
Sunset	4240	P	1981-82	40:02:56 N	105:28:17 W	8680'	9'8"	N/A	N/A	Grass

Comments: Not accessible by vehicle. Must walk to access gage.

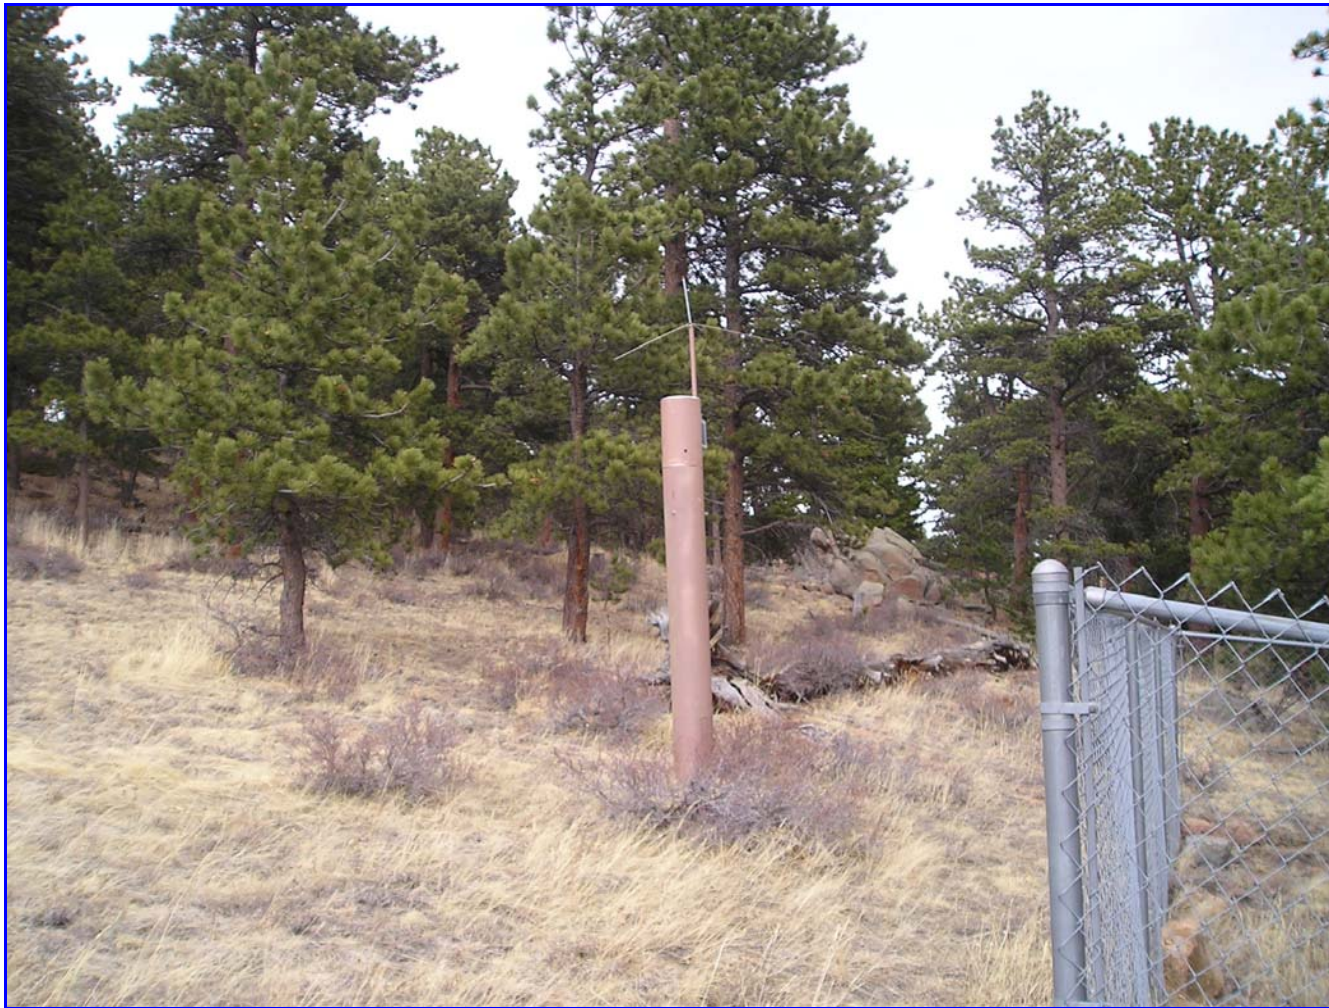
Name	ID	Sensor Type	Date Installed	Latitude	Longitude	Elevation	Gage Height	Anemometer Height	Temperature Sensor Height	Ground type
Greer Canyon	4250	P	1981-82	40:09:26 N	105:17:52 W	6080'	9'11"	N/A	N/A	Scrub grass

Comments: Not accessible by vehicle. Must walk to access gage. Locked gate on access road.

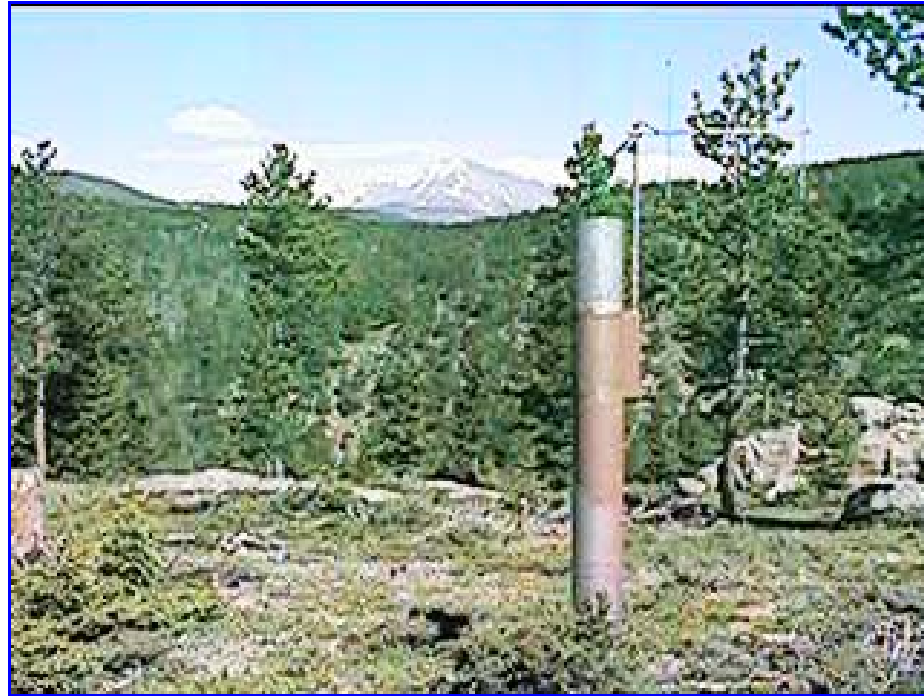
Name	ID	Sensor Type	Date Installed	Latitude	Longitude	Elevation	Gage Height	Anemometer Height	Temperature Sensor Height	Ground type
Taylor Mountain	4260	P	1981-82	40:11:28 N	105:29:06 W	8425'	9'4"	N/A	N/A	Scrub grass

Comments: Gage located on private property (behind residence). Must walk a short distance to gage.
