APPENDIX

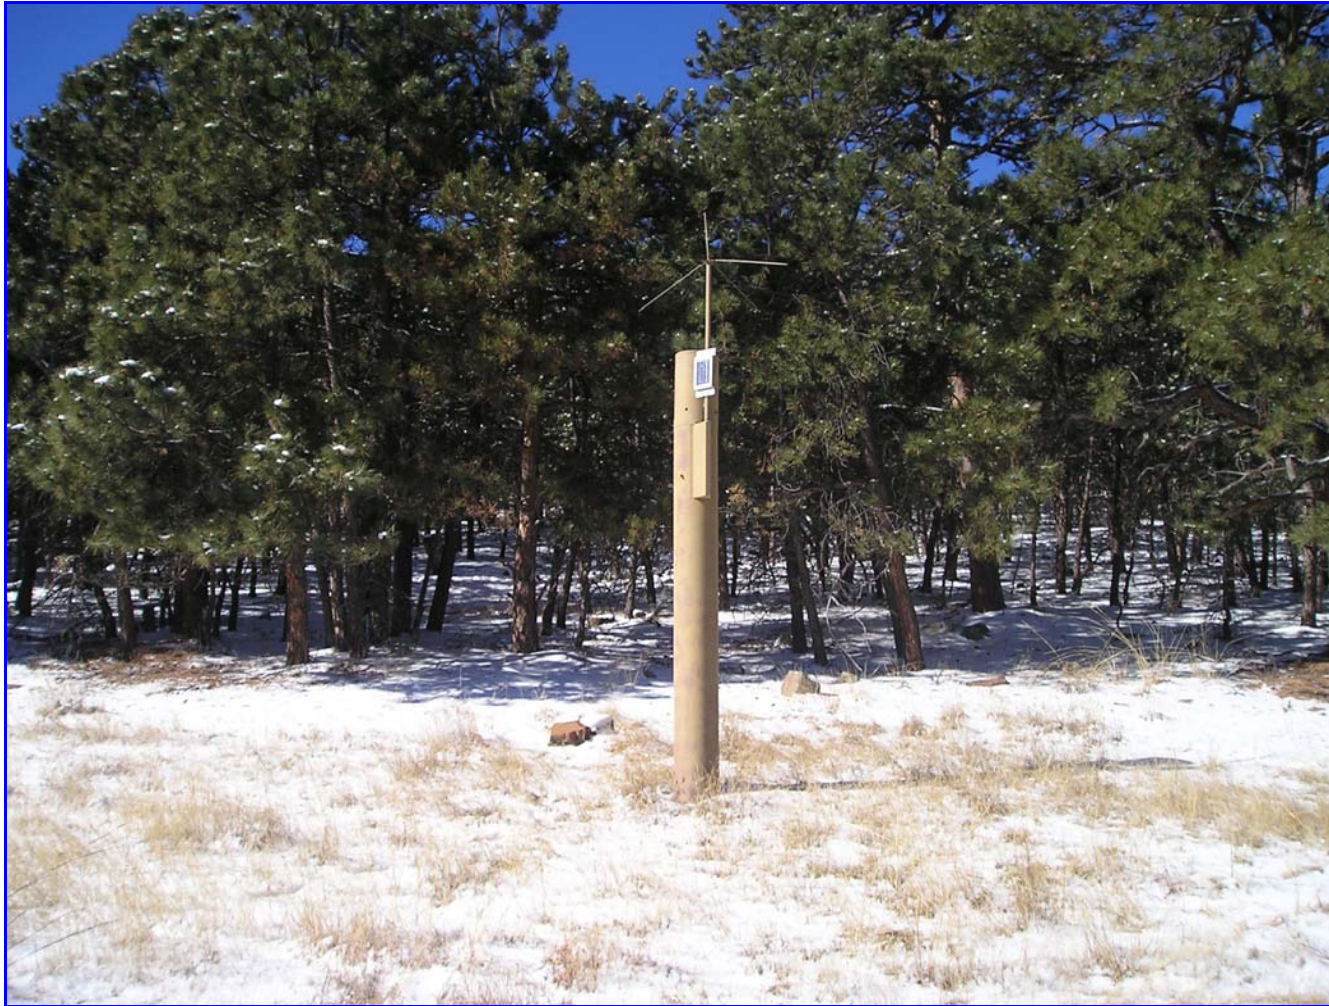
Name	ID	Sensor Type	Date Installed	Latitude	Longitude	Elevation	Gage Height	Anemometer Height	Temperature Sensor Height	Ground type
Cannon Mountain	4270	P	1981-82	40:08:58 N	105:26:00 W	8120'	9'5"	N/A	N/A	Scrub grass

Comments: Gage accessible only by 4WD.

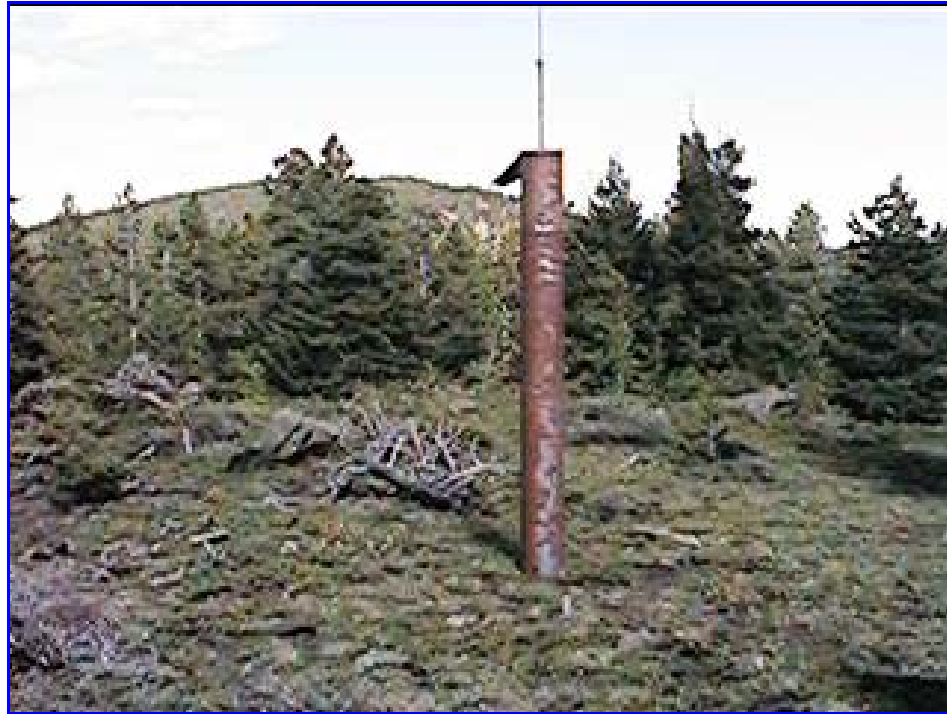
Name	ID	Sensor Type	Date Installed	Latitude	Longitude	Elevation	Gage Height	Anemometer Height	Temperature Sensor Height	Ground type
Red Hill	4290	P	1981-82	40:11:08 N	105:17:29 W	6590'	10'2"	N/A	N/A	Scrub grass

Comments: Gage accessible only by 4WD. Locked gate on access road.

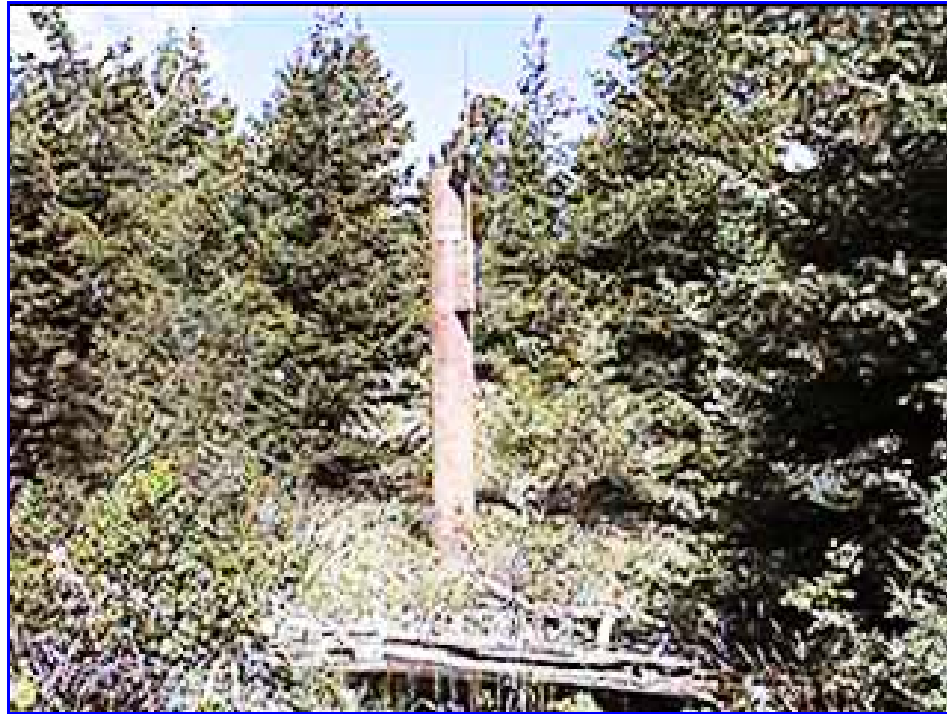
Name	ID	Sensor Type	Date Installed	Latitude	Longitude	Elevation	Gage Height	Anemometer Height	Temperature Sensor Height	Ground type
Big Elk Park	4300	P	1981-82	40:13:36 N	105:28:34 W	8600'	10'6"	N/A	N/A	Scrub grass

Comments: Gage accessible only by 4WD. Locked gate on access road.

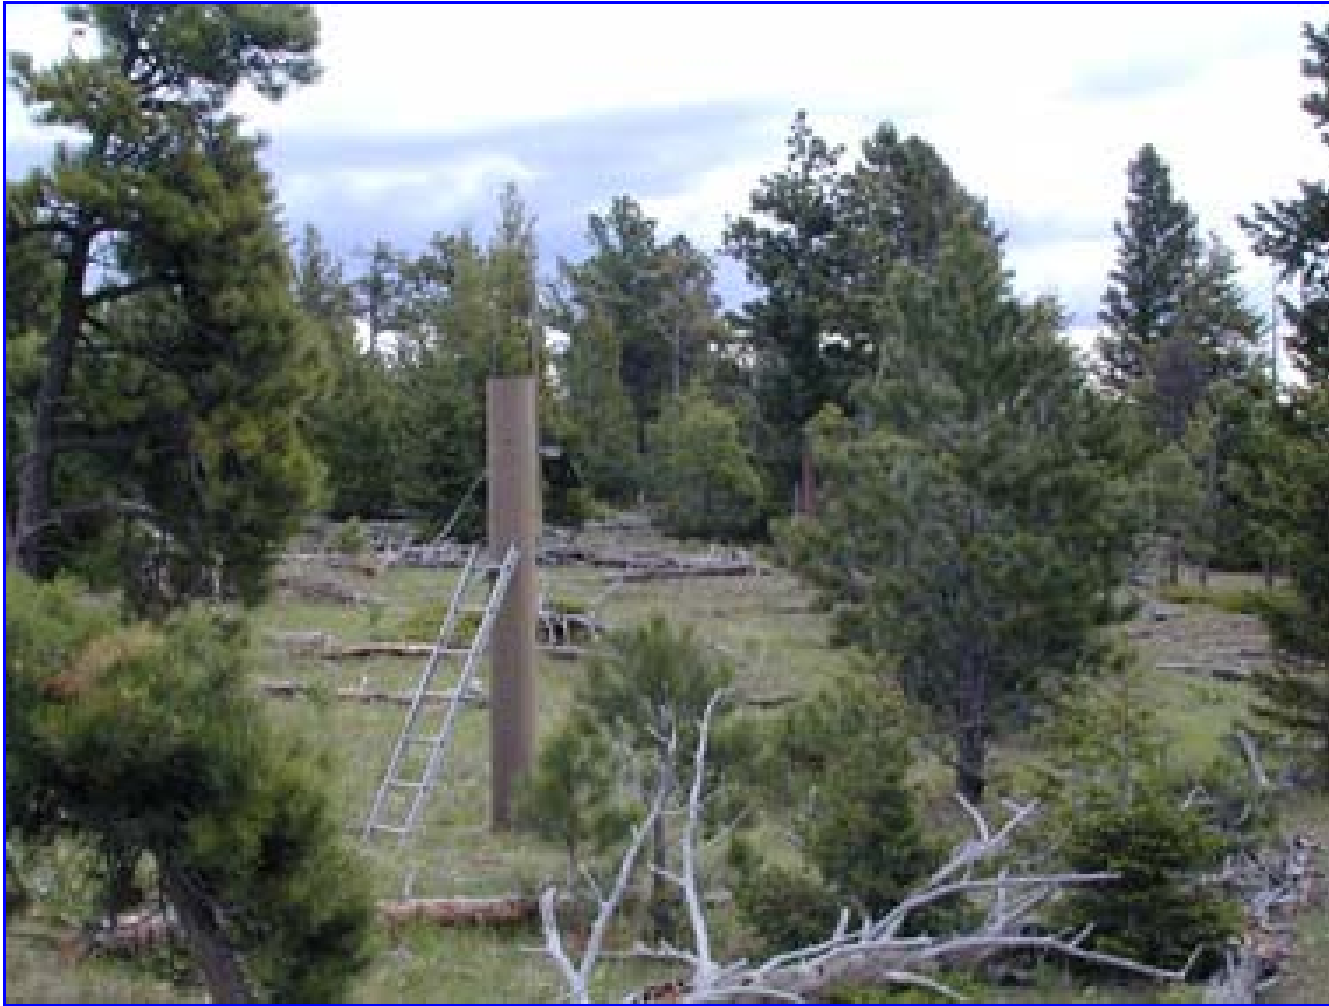
Name	ID	Sensor Type	Date Installed	Latitude	Longitude	Elevation	Gage Height	Anemometer Height	Temperature Sensor Height	Ground type
Johnny Park	4310	P	1981-82	40:14:39 N	105:24:06 W	7680'	10'2"	N/A	N/A	Scrub grass

Comments: Gage obstruction due to multiple trees located around the gage. Gage accessible only by 4WD.

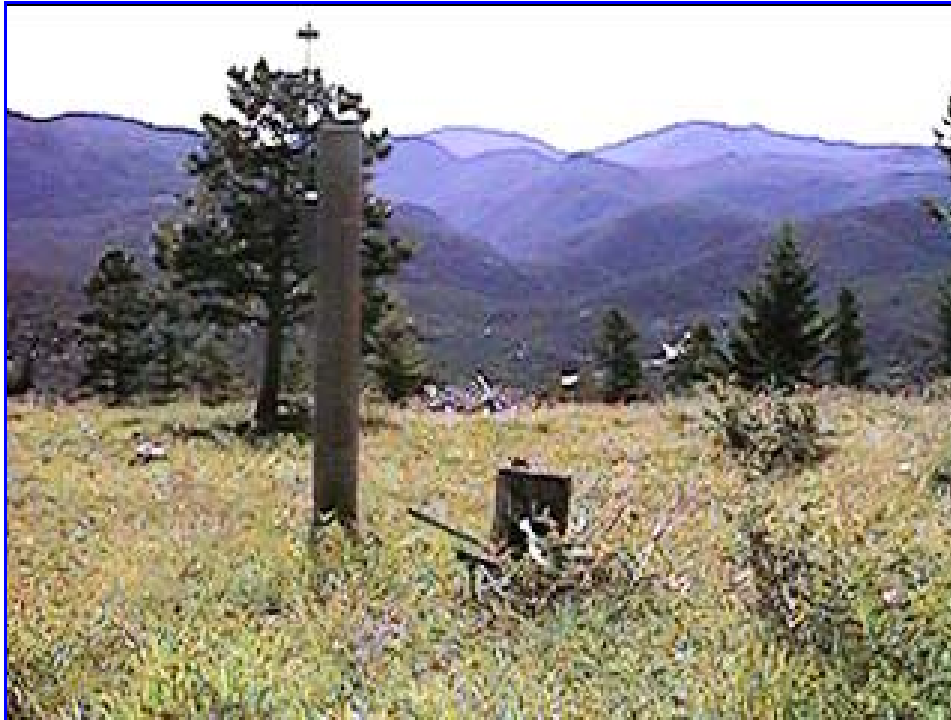
Name	ID	Sensor Type	Date Installed	Latitude	Longitude	Elevation	Gage Height	Anemometer Height	Temperature Sensor Height	Ground type
Indian Ruins	4330	P	1981-82	40:09:34 N	105:20:18 W	7790'	10'1"	N/A	N/A	Grass

Comments: Gage accessible only by 4WD. 20' tree ~ 15' from gage. Gage obstruction will occur when tree grows about 5' in the vertical.

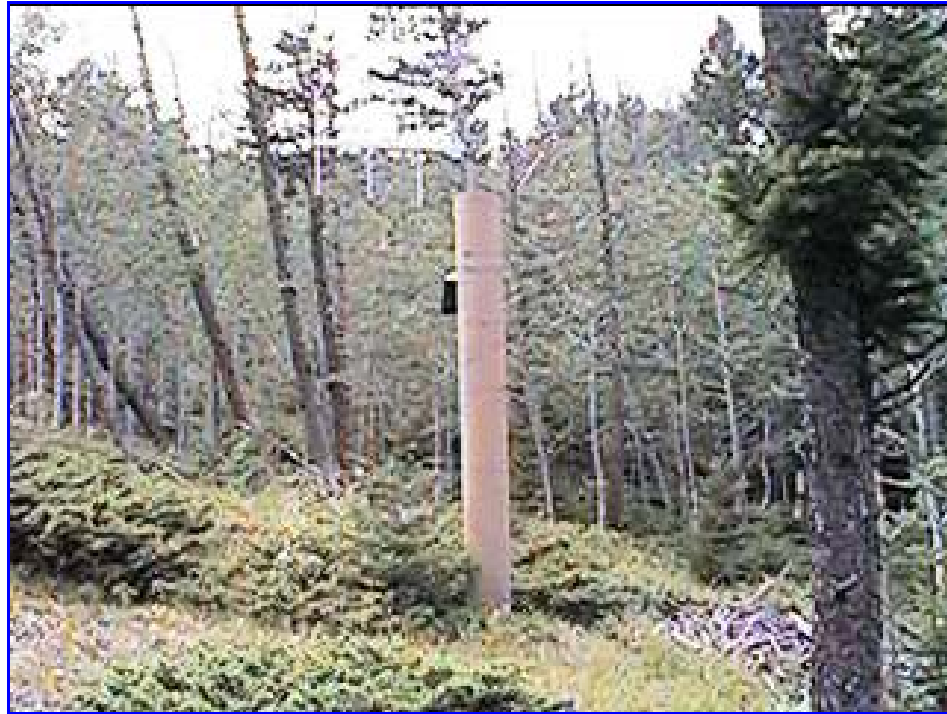
Name	ID	Sensor Type	Date Installed	Latitude	Longitude	Elevation	Gage Height	Anemometer Height	Temperature Sensor Height	Ground type
Riverside	4340	P	1981-82	40:10:47 N	105:26:36 W	8340'	9'2"	N/A	N/A	Scrub grass

Comments: Gage accessible only by 4WD. Gage located on private property.

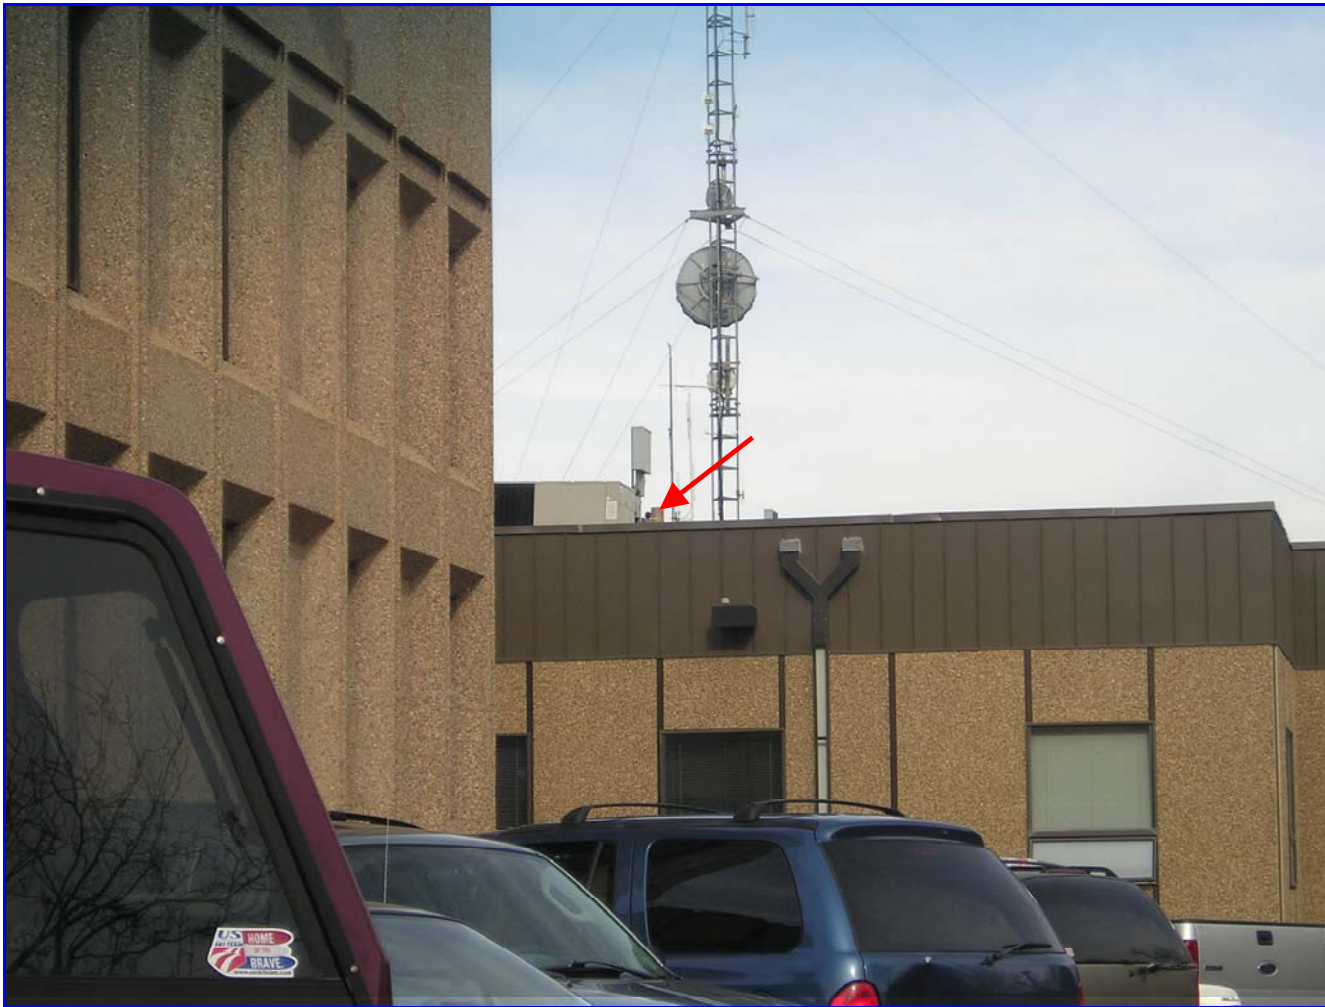
Name	ID	Sensor Type	Date Installed	Latitude	Longitude	Elevation	Gage Height	Anemometer Height	Temperature Sensor Height	Ground type
Conifer Hill	4350	P	1981-82	40:10:55 N	105:23:17 W	8120'	9'8"	N/A	N/A	Scrub grass

Comments: Not accessible by vehicle. Must walk to access gage.

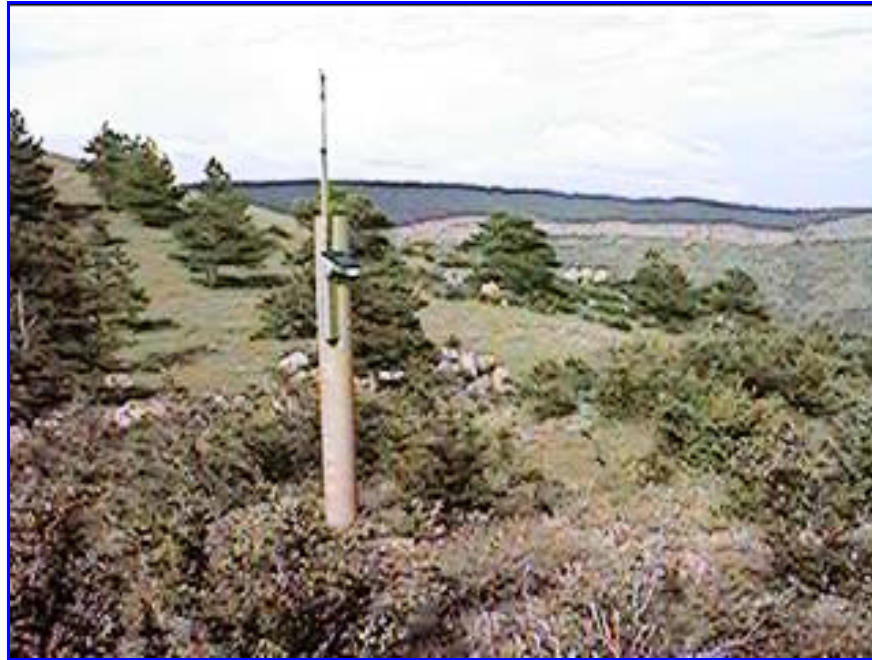
Name	ID	Sensor Type	Date Installed	Latitude	Longitude	Elevation	Gage Height	Anemometer Height	Temperature Sensor Height	Ground type
Little Narrows	4470	P, S	04/21/97	40:12:16 N	105:18:49 W	5620'	10'6"	N/A	N/A	Scrub grass

Comments: Gage located ~ 8' from stream and ~ 25' from road.

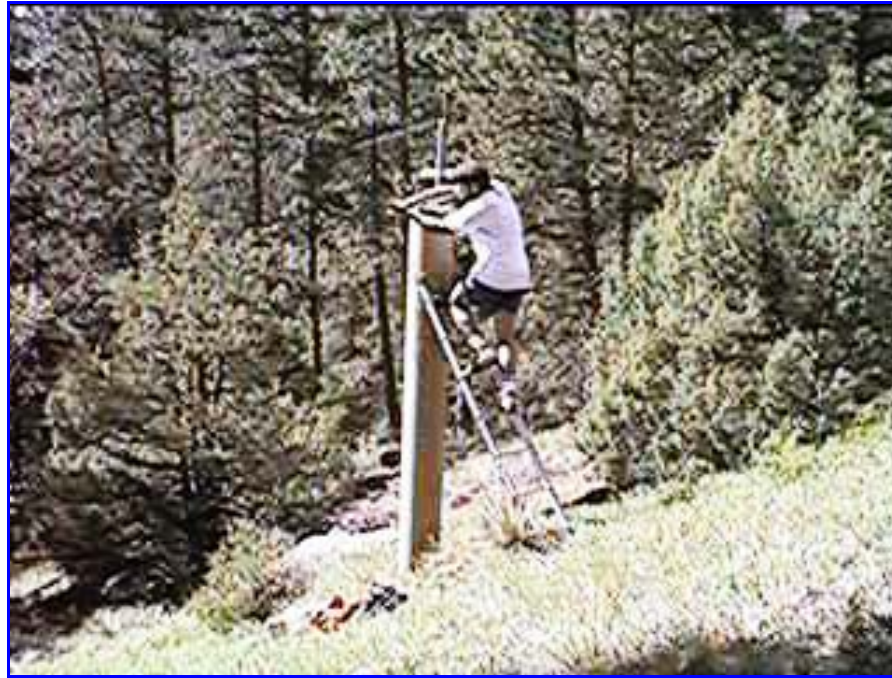
Name	ID	Sensor Type	Date Installed	Latitude	Longitude	Elevation	Gage Height	Anemometer Height	Temperature Sensor Height	Ground type
Apple Valley	4490	P	1984-85	40:14:18 N	105:18:37 W	5920'	10'6"	N/A	N/A	Scrub grass

Comments: Gage located on private property.

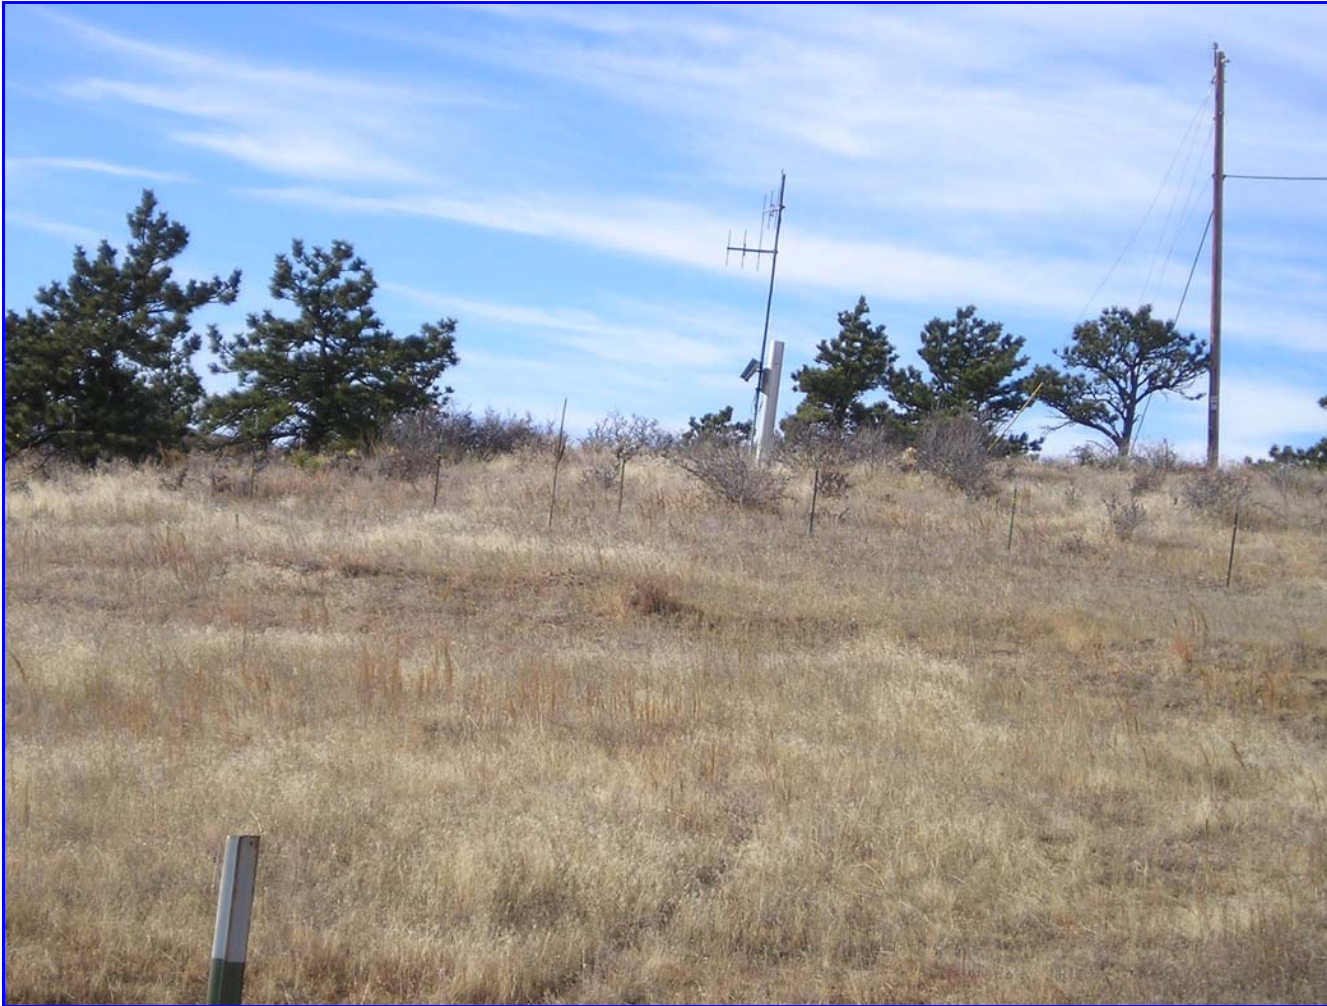
Name	ID	Sensor Type	Date Installed	Latitude	Longitude	Elevation	Gage Height	Anemometer Height	Temperature Sensor Height	Ground type
Pinewood Springs	4510	P	1984-85	40:15:40 N	105:21:08 W	6850'	9'8"	N/A	N/A	Scrub grass

Comments: Gage located on private property. 35-degree incline.

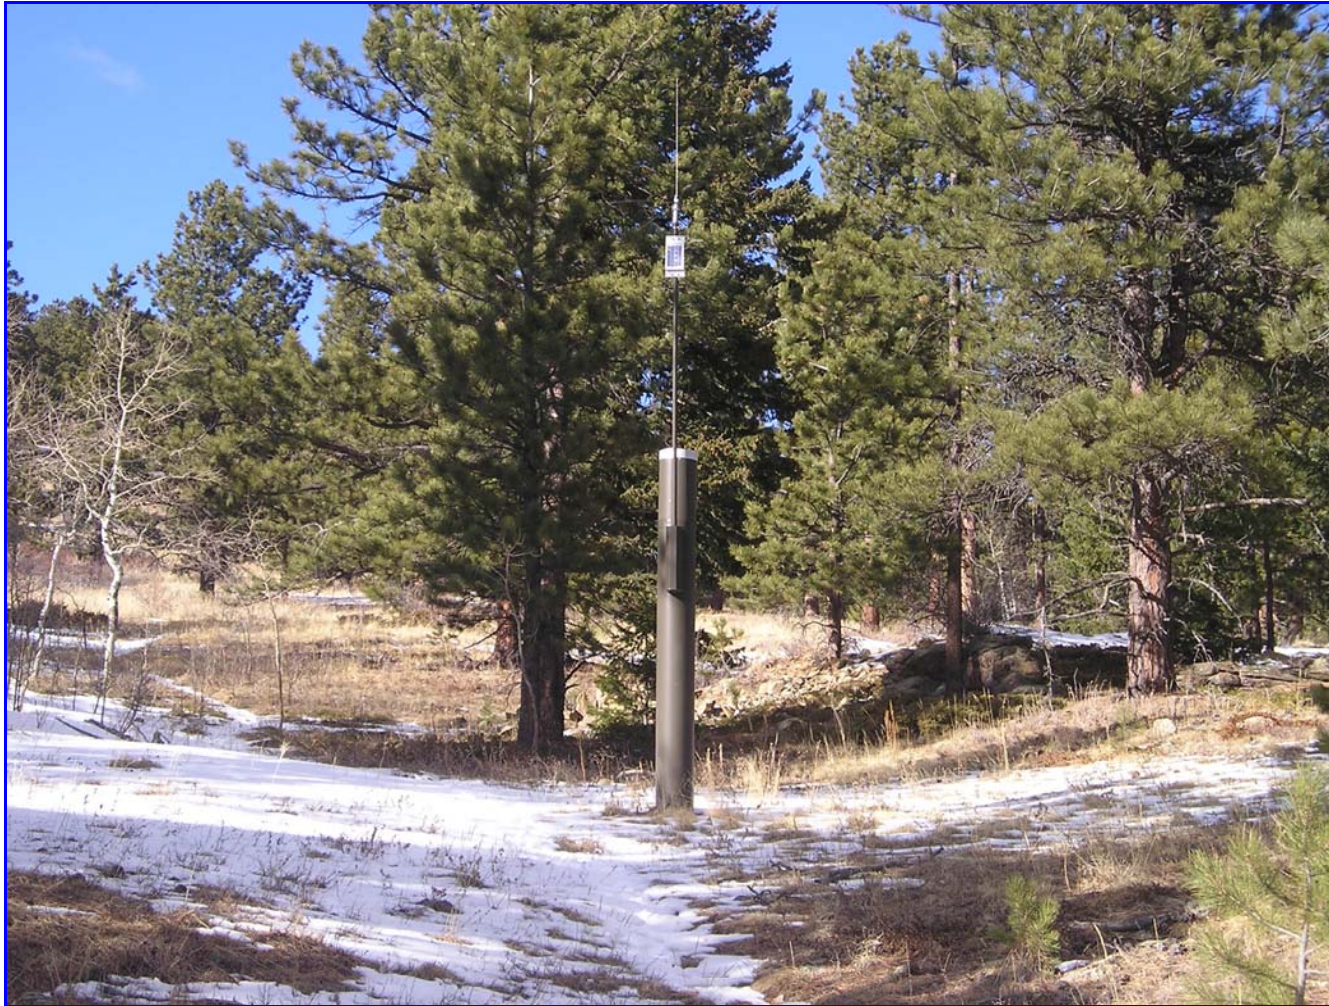
Name	ID	Sensor Type	Date Installed	Latitude	Longitude	Elevation	Gage Height	Anemometer Height	Temperature Sensor Height	Ground type
Eagle Ridge	4520	R, P	06/11/96	40:14:39 N	105:15:54 W	6280'	9'7"	N/A	N/A	Scrub grass

Comments: Gage located on private property. Accessible only by 4WD.

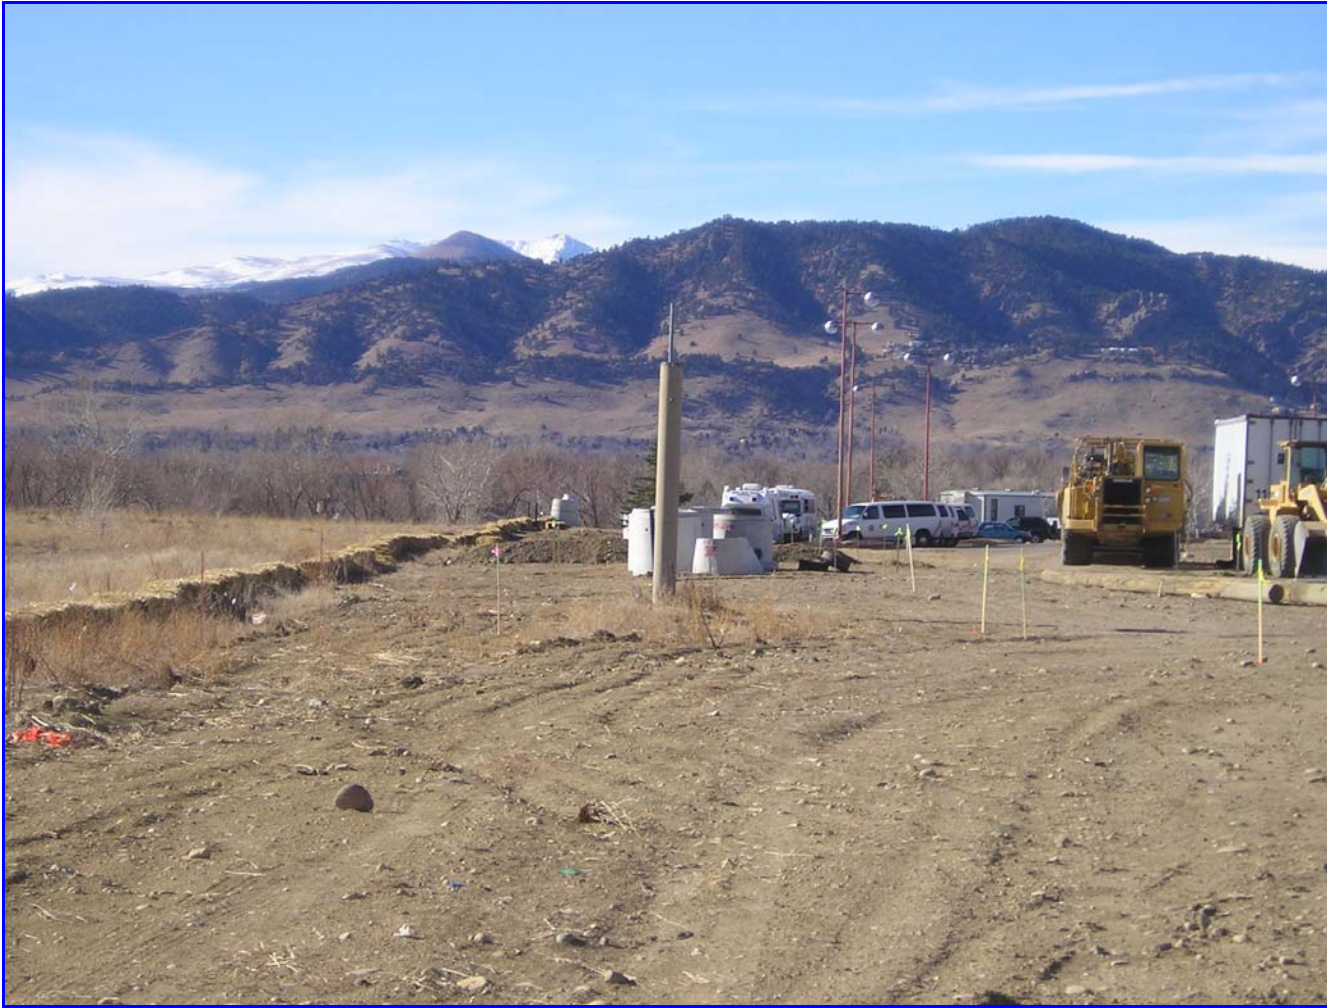
Name	ID	Sensor Type	Date Installed	Latitude	Longitude	Elevation	Gage Height	Anemometer Height	Temperature Sensor Height	Ground type
Winiger Ridge	4530	P	1984-85	39:56:53 N	105:25:27 W	8130'	9'8"	N/A	N/A	Scrub grass

Comments: Obstruction will occur due to tree to the N when tree grows ~5 feet in the vertical. Gage barely visable from road.

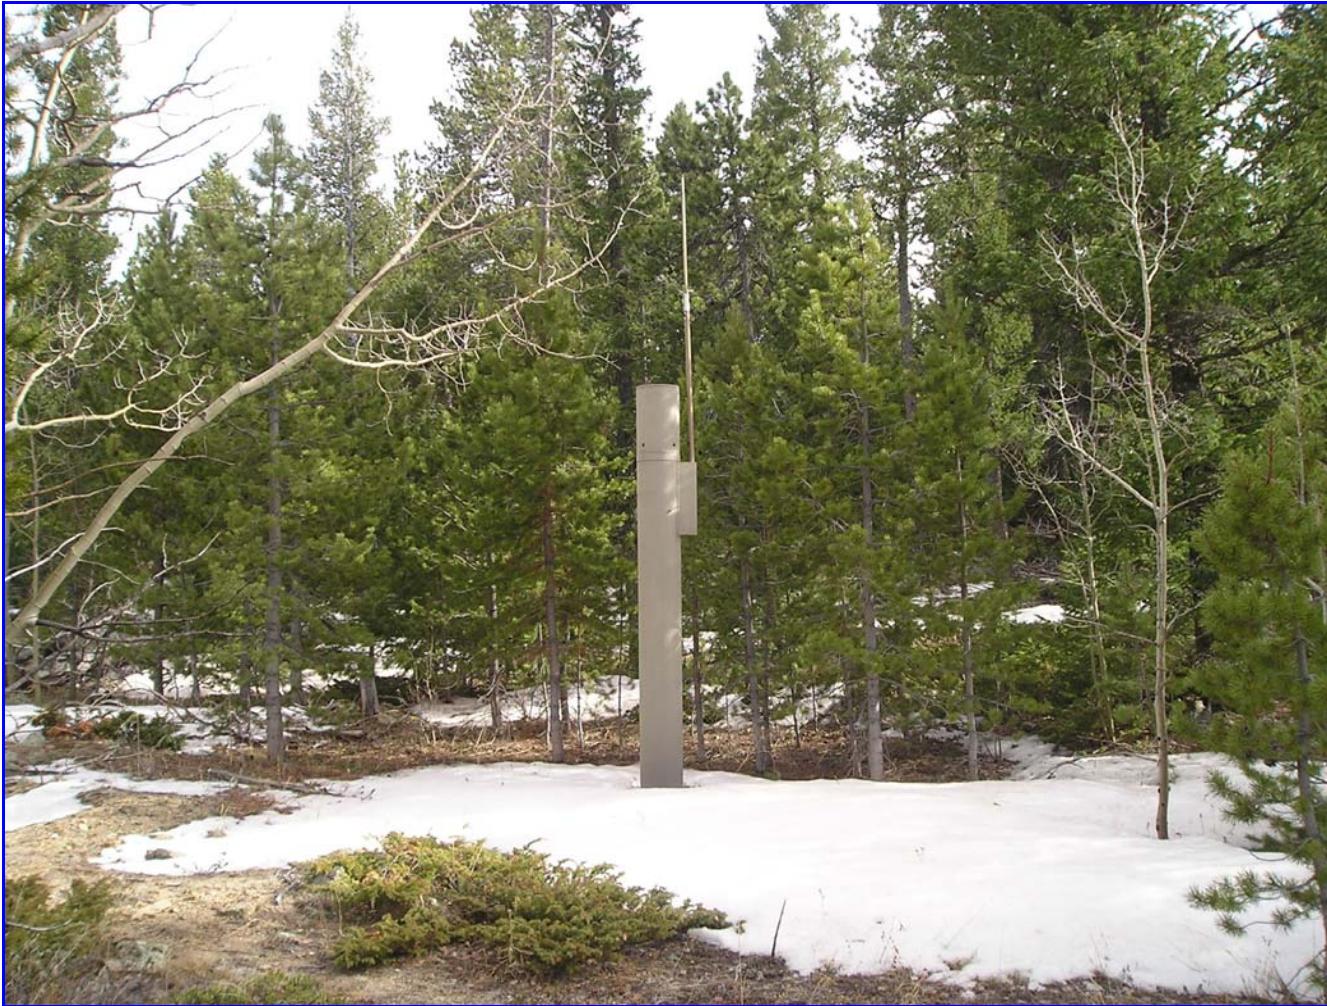
Name	ID	Sensor Type	Date Installed	Latitude	Longitude	Elevation	Gage Height	Anemometer Height	Temperature Sensor Height	Ground type
Jail (Boulder County)	4550	P	06/02/97	40:02:04 N	105:13:43 W	5290'	9'9"	N/A	N/A	Scrub grass

Comments: Must walk a short distance to access gage.

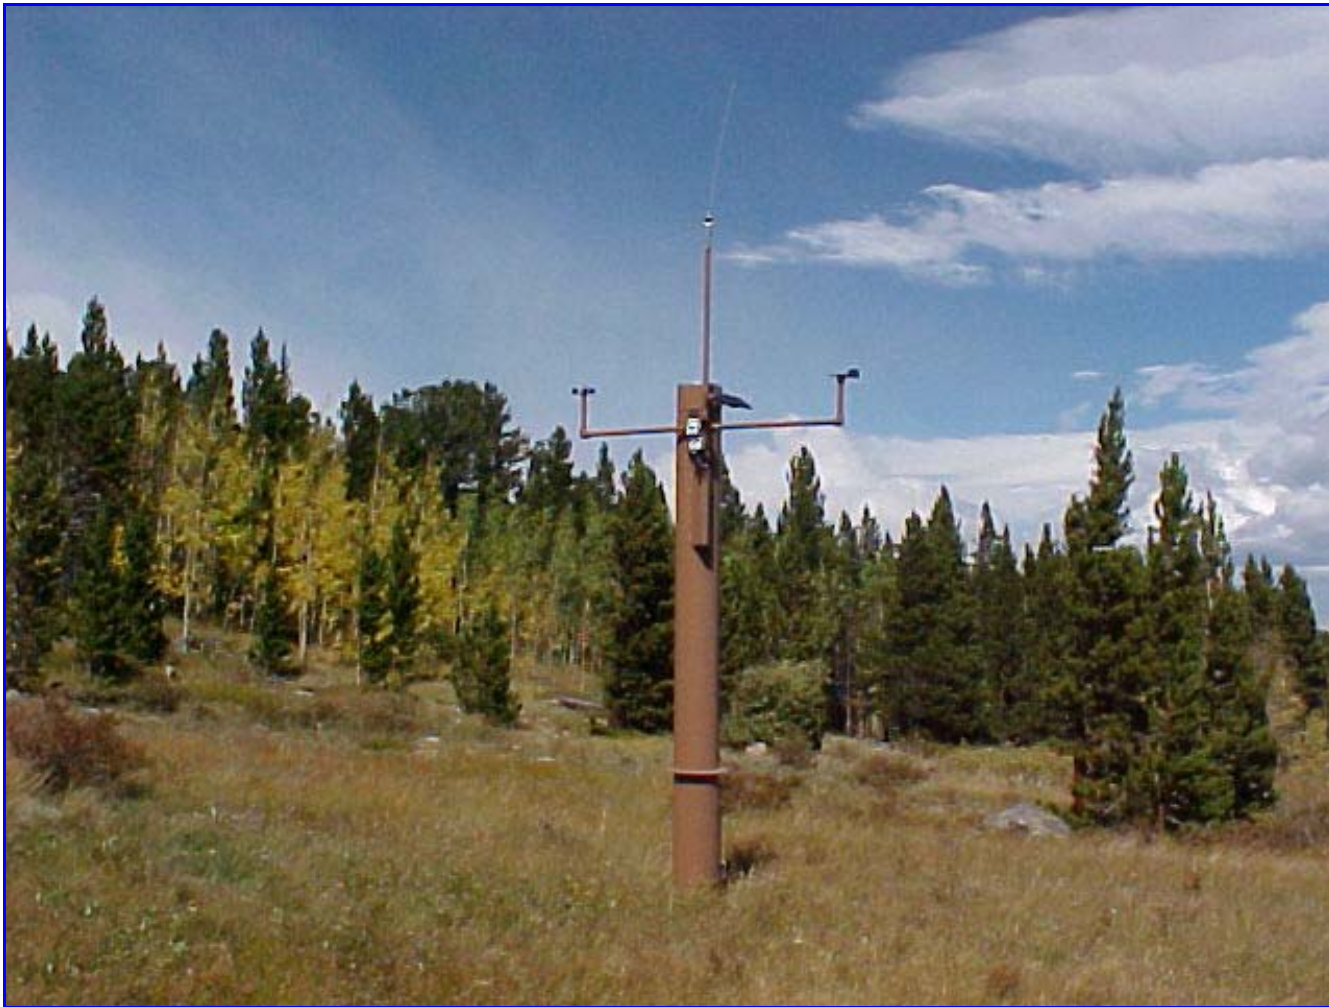
Name	ID	Sensor Type	Date Installed	Latitude	Longitude	Elevation	Gage Height	Anemometer Height	Temperature Sensor Height	Ground type
St. Antons	4570	P	1984-85	39:59:07 N	105:27:46 W	8350'	9'5"	N/A	N/A	Scrub grass

Comments: Gage obstruction due to trees to the west and southwest of gage.

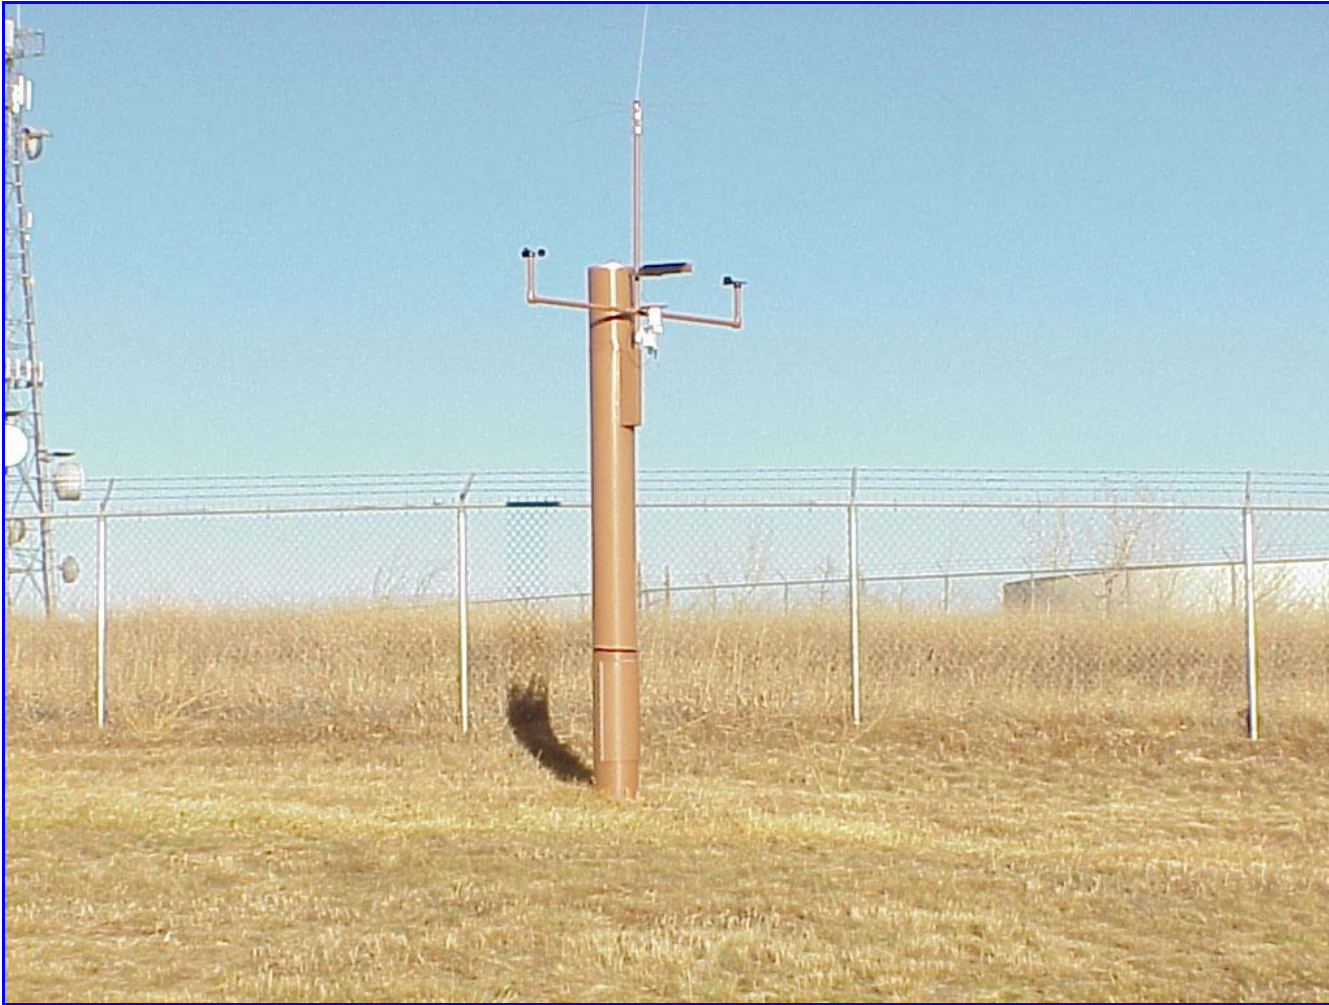
Name	ID	Sensor Type	Date Installed	Latitude	Longitude	Elevation	Gage Height	Anemometer Height	Temperature Sensor Height	Ground type
Sugarloaf	4730	Wx	06/23/97	40:01:05 N	105:24:13 W	7860'	9'2"	11'1"	10'8"	Grass, flat

Comments: Pine Trees ~10' to the west. One story building to the northeast.

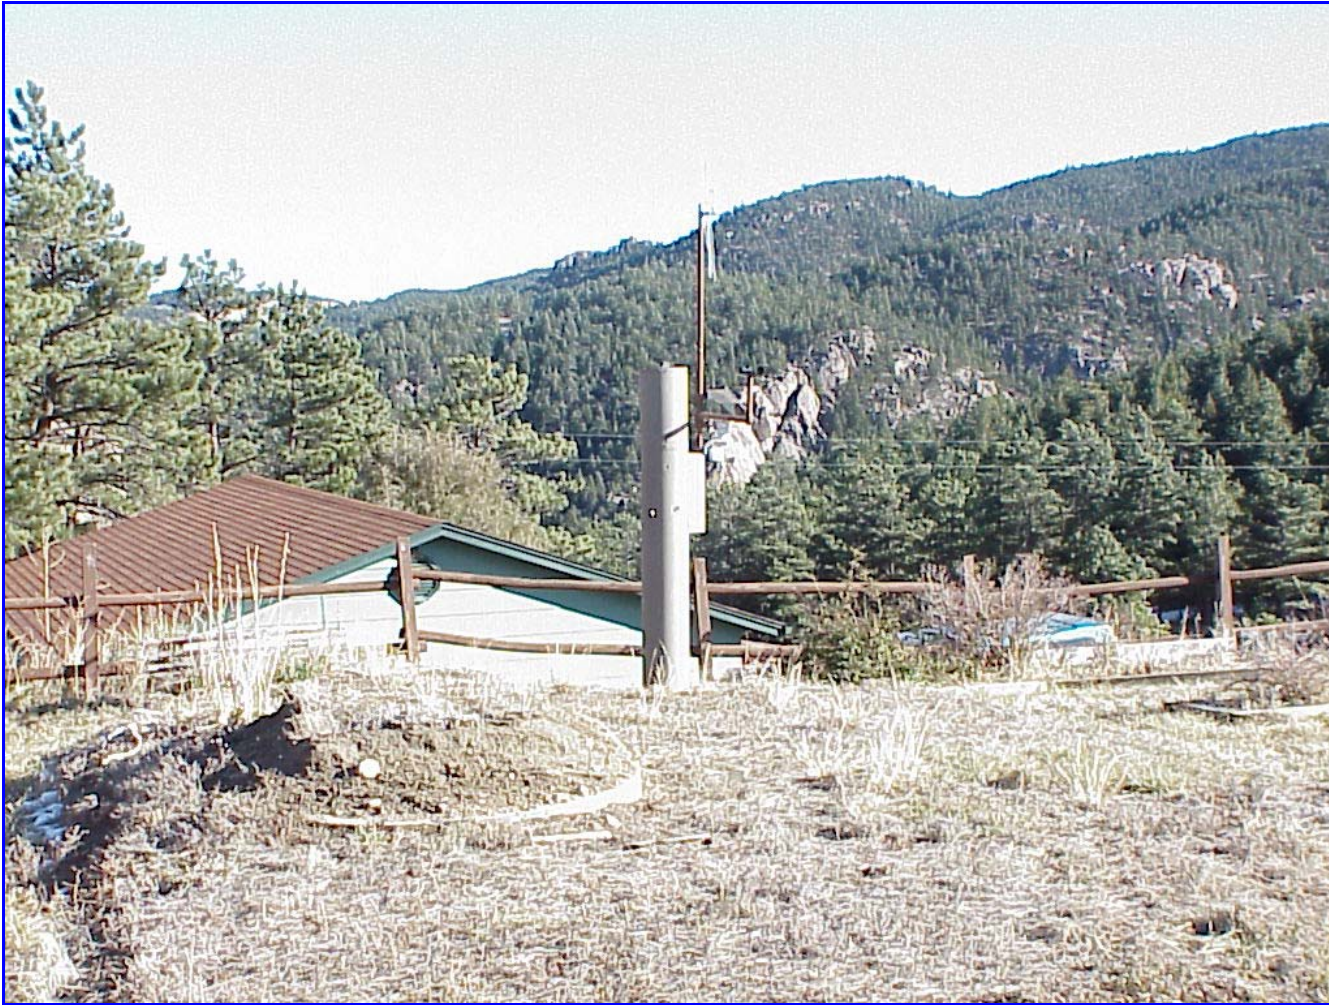
Name	ID	Sensor Type	Date Installed	Latitude	Longitude	Elevation	Gage Height	Anemometer Height	Temperature Sensor Height	Ground type
Cal-Wood Ranch	4770	Wx	06/20/97	40:08:52 N	105:23:23 W	4770'	10'4"	10'2"	9'6"	Grass

Comments: Large hill to the North. Forestation ~120' to the Northwest. 30-degree incline.

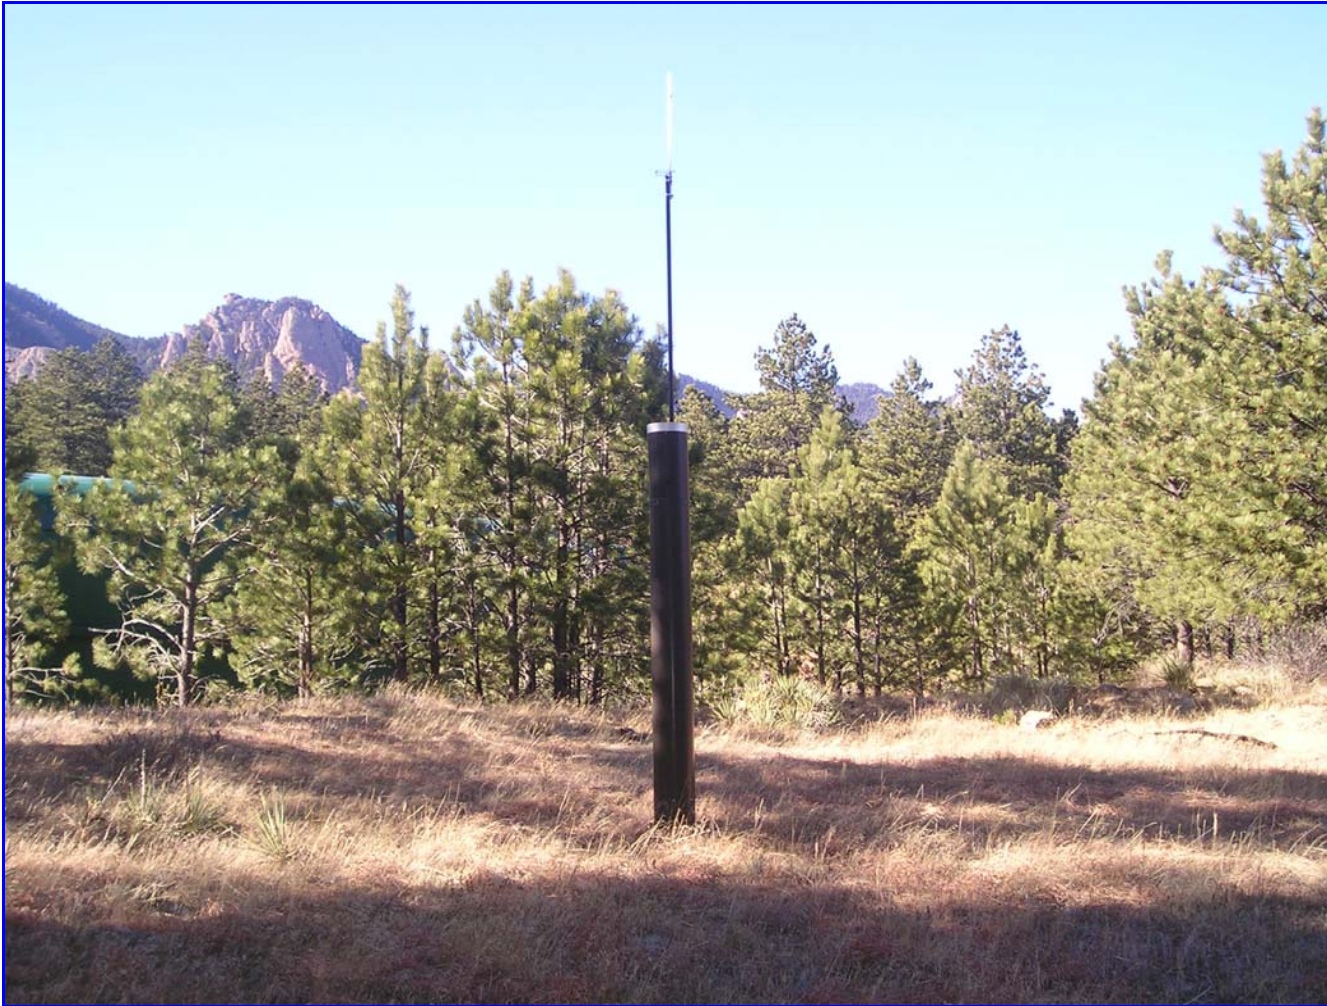
Name	ID	Sensor Type	Date Installed	Latitude	Longitude	Elevation	Gage Height	Anemometer Height	Temperature Sensor Height	Ground type
Button Rock	4790	Wx	05/11/92	40:13:15 N	105:22:07 W	6500'	7'5"	7'2"	6'2"	Grass, flat

Comments: Hill to North. Button Rock Reservoir ~ 10 miles to the southwest.

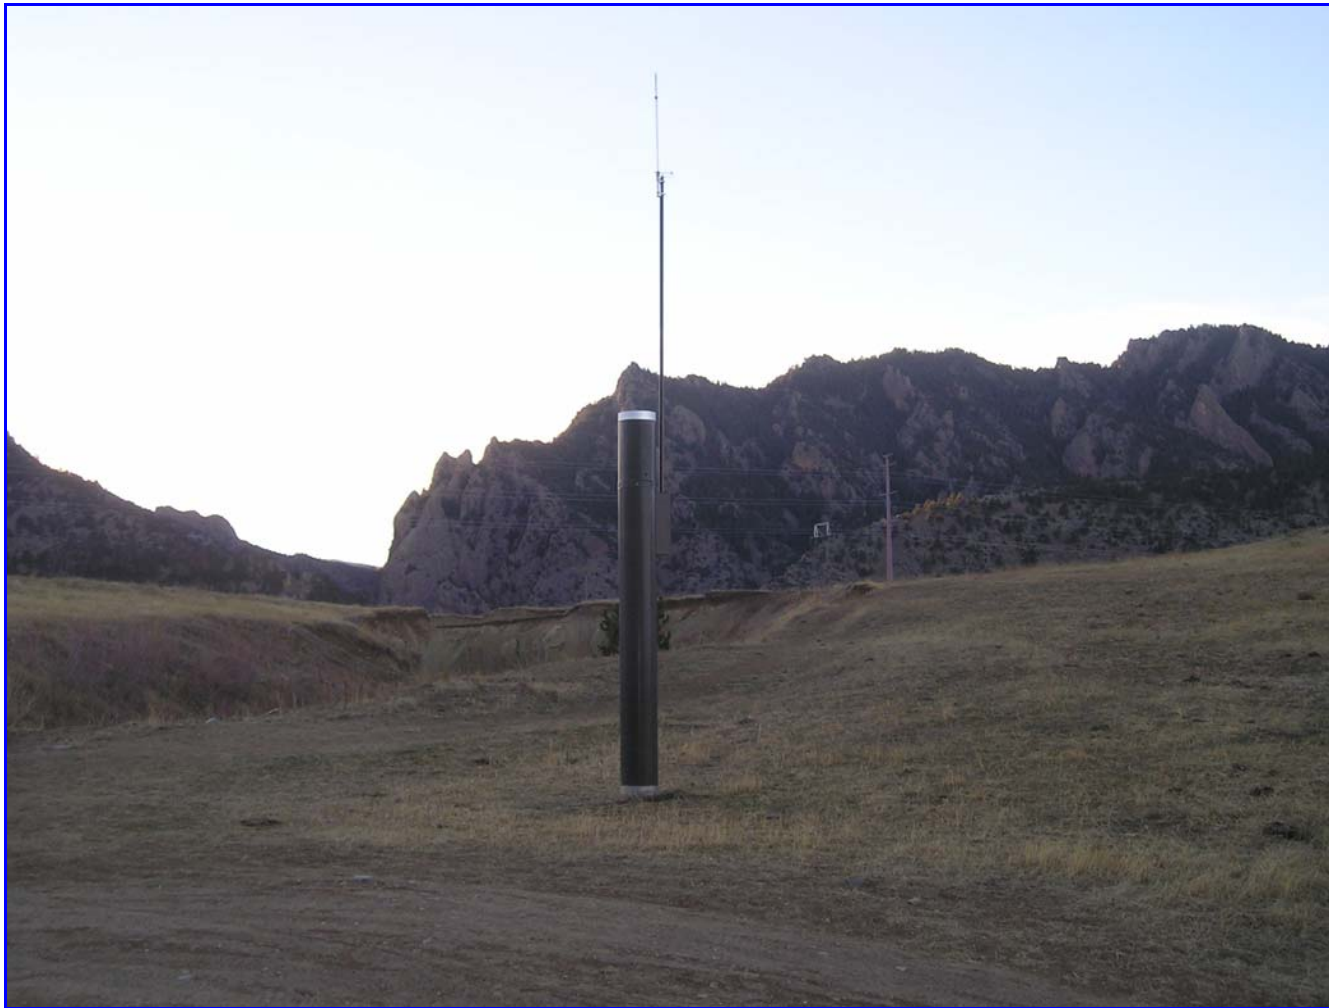
Name	ID	Sensor Type	Date Installed	Latitude	Longitude	Elevation	Gage Height	Anemometer Height	Temperature Sensor Height	Ground type
Shanahan Ridge	4810	P	09/19/02	39:57:41 N	105:15:55 W	5840'	9'6"	N/A	N/A	Scrub grass

Comments: Water tank ~ 70' to west. Must walk ~ 40' to access gage.

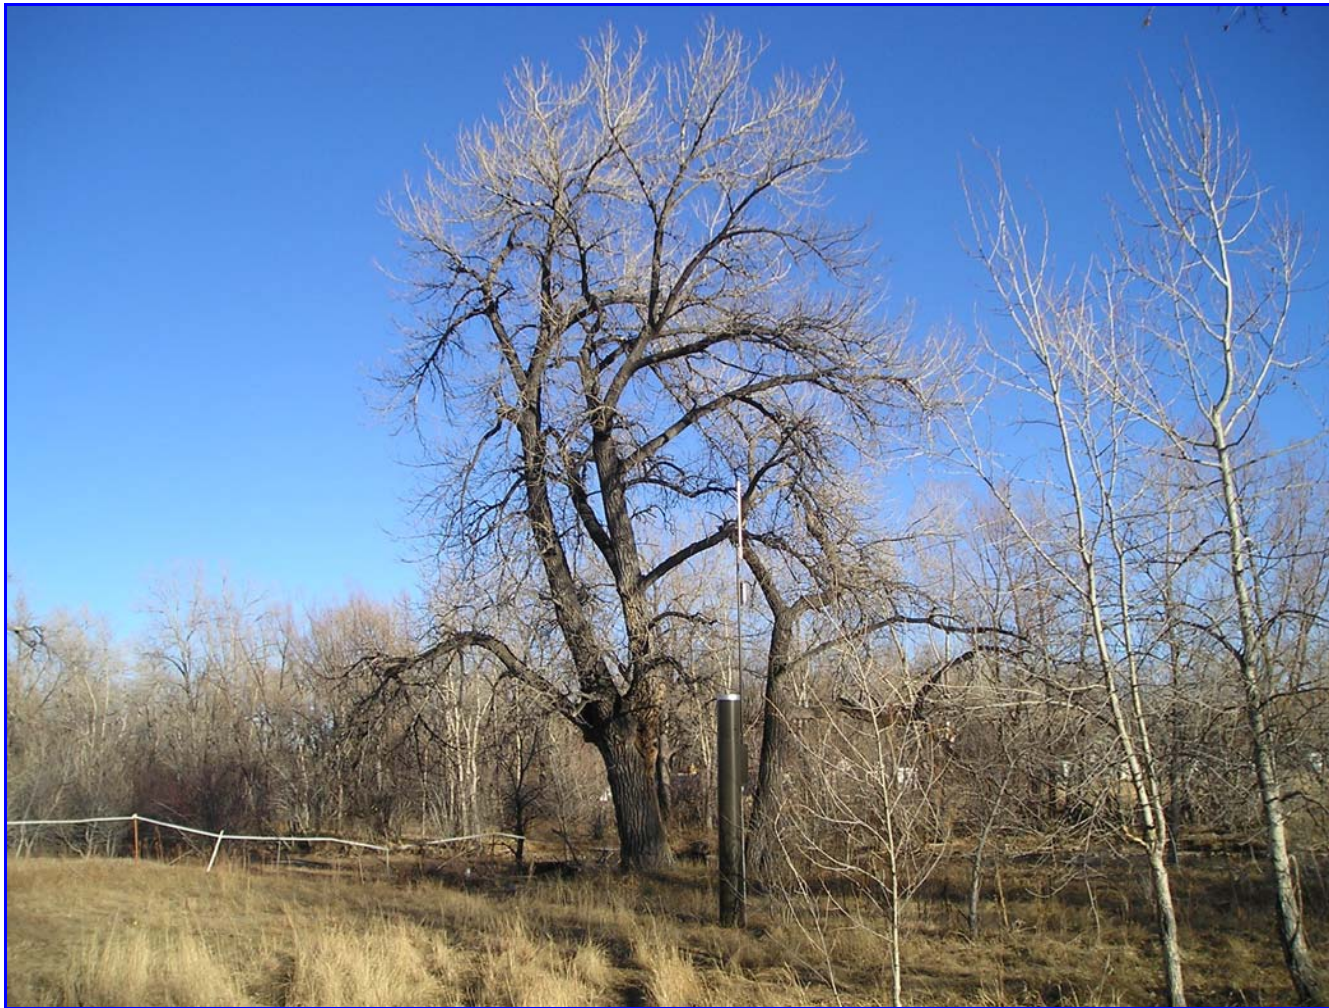
Name	ID	Sensor Type	Date Installed	Latitude	Longitude	Elevation	Gage Height	Anemometer Height	Temperature Sensor Height	Ground type
Doudy Draw	4820	P	09/20/02	39:55:56 N	105:15:25 W	5740'	10'1"	N/A	N/A	Scrub grass

Comments: Access gage on hiking trail. Creek ~ 35' to southwest.
