APPENDIX

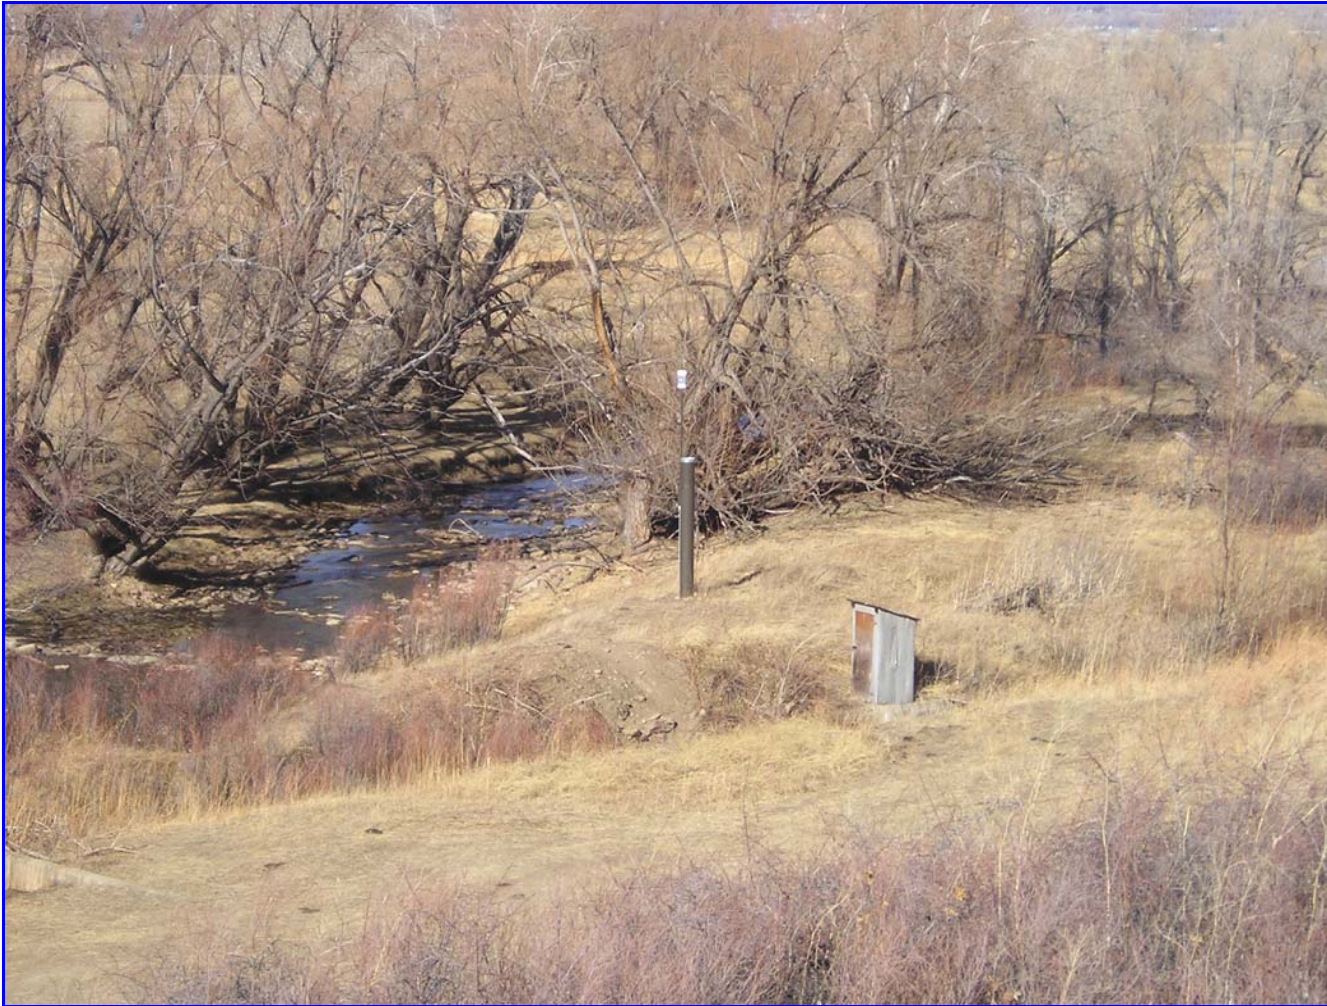
Name	ID	Sensor Type	Date Installed	Latitude	Longitude	Elevation	Gage Height	Anemometer Height	Temperature Sensor Height	Ground type
SBC @ Sans Souci	4830	P, S	09/24/02	39:57:28 N	105:14:09 W	5470'	9'11"	N/A	N/A	Scrub grass

Comments: Obstructions will occur due to tree to the E and W when both trees grows ~5 feet in the vertical. Gage not accessible by vehicle. Must walk to access gage.

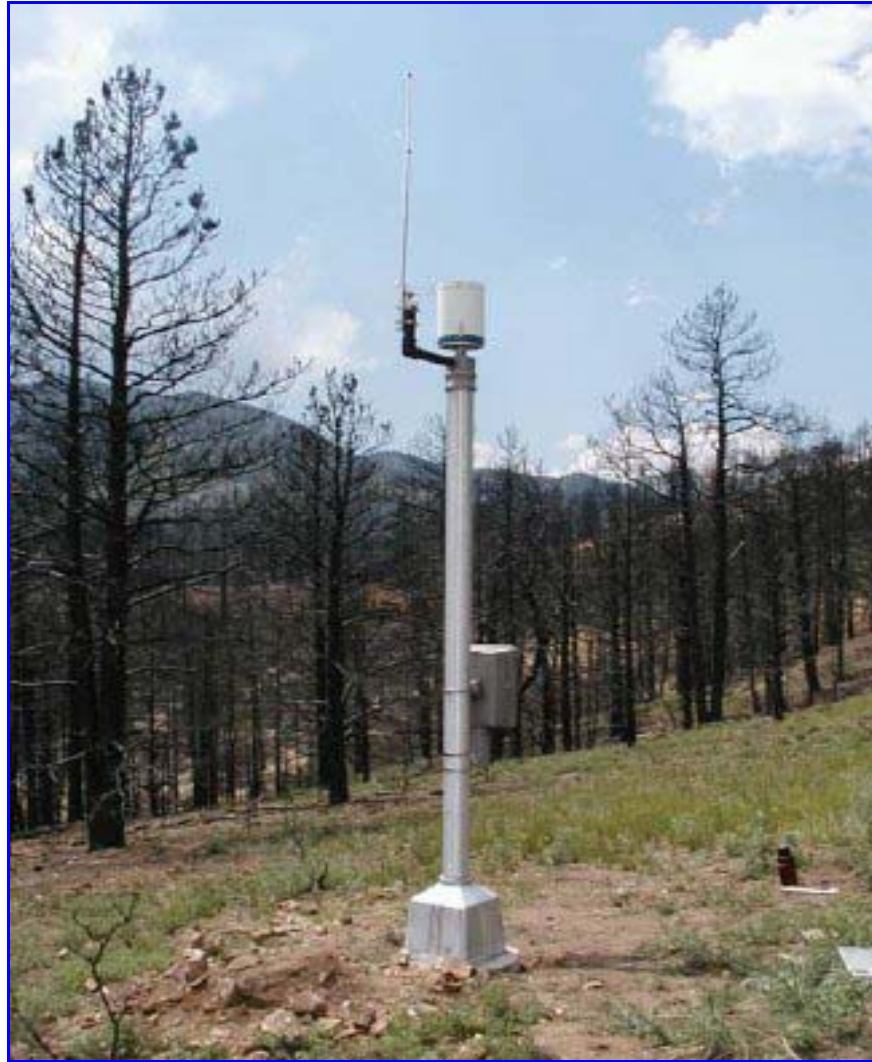
Name	ID	Sensor Type	Date Installed	Latitude	Longitude	Elevation	Gage Height	Anemometer Height	Temperature Sensor Height	Ground type
SBC @ S. Boulder Ditch	4840	P, S	10/09/02	39:58:21 N	105:13:23 W	5400'	10'2"	N/A	N/A	Scrub grass

Comments: Locked gate on access road. Gage not accessible by vehicle. Must walk to access gage.

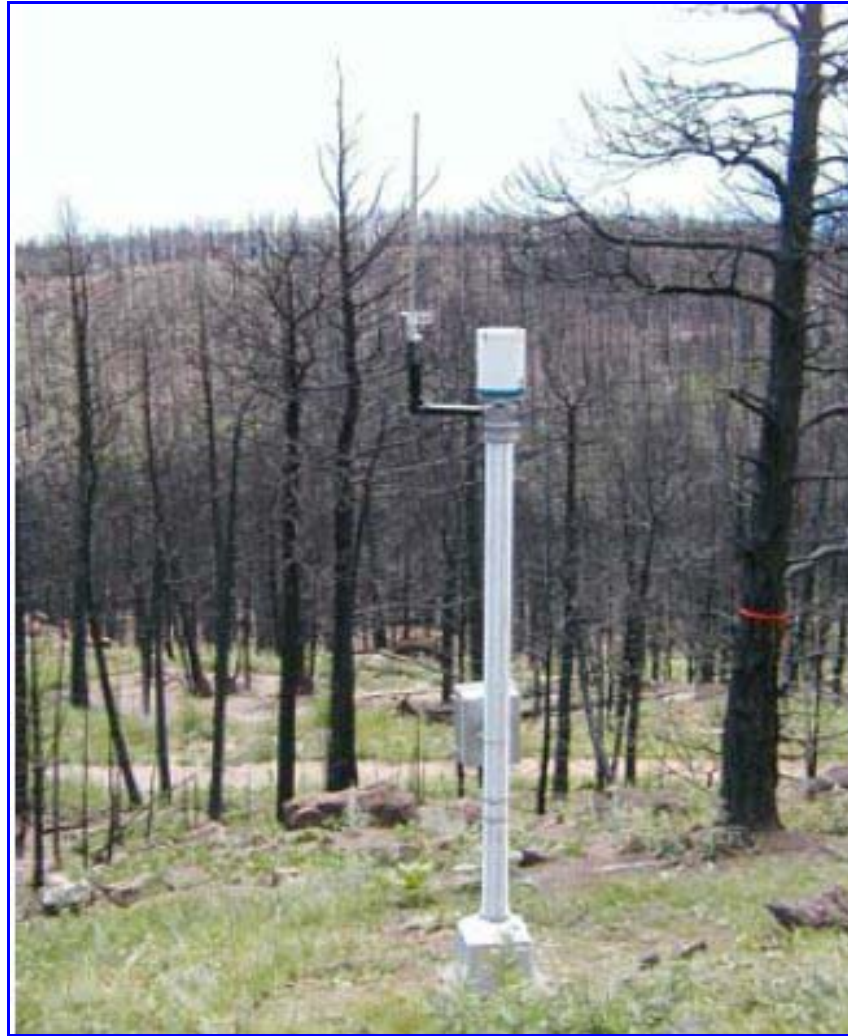
Name	ID	Sensor Type	Date Installed	Latitude	Longitude	Elevation	Gage Height	Anemometer Height	Temperature Sensor Height	Ground type
Porphory Mountain	4850	P	07/07/04	40:07:11 N	105:23:16 W	7347'	10'10"	N/A	N/A	Gravel

Comments: Gage located in a post wildfire area.
