## Urban Drainage and Flood Control District

| Site ID | Site Name | Latitude | Longitude | Elevation | Install Date | TB Mfr. | TB Condition |

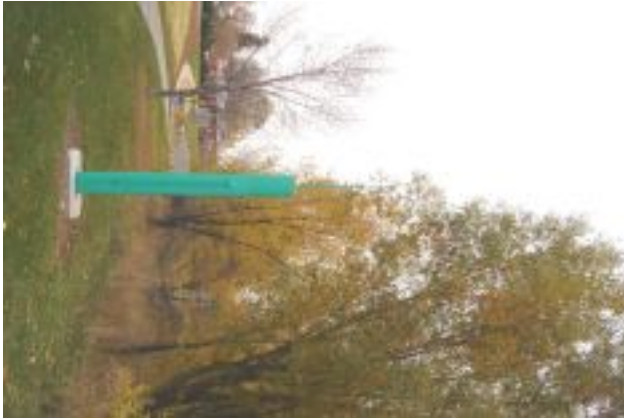
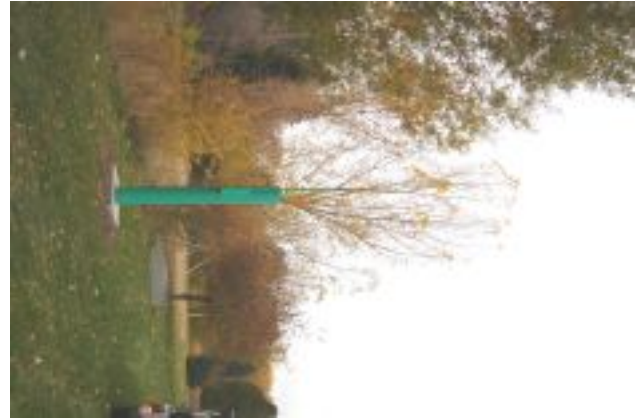
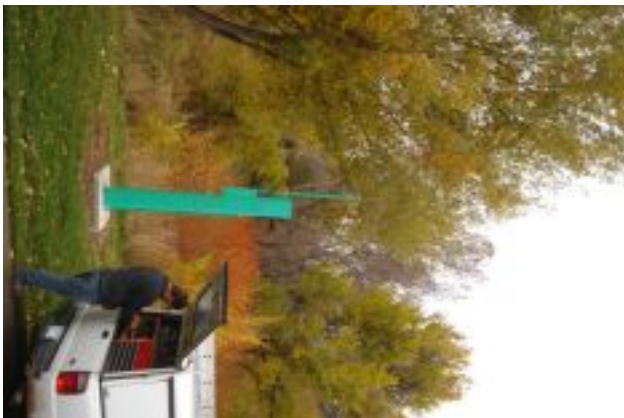
100 - Carr St - a

| Site ID | Site Name | Latitude | Longitude | Elevation | Install Date | TB Mfr. | TB Condition |
|---|---|---|---|---|---|---|---|
| 2.0 | Large tree to SE nearly overhanging standpipe, fair wind protection | | | | | | |

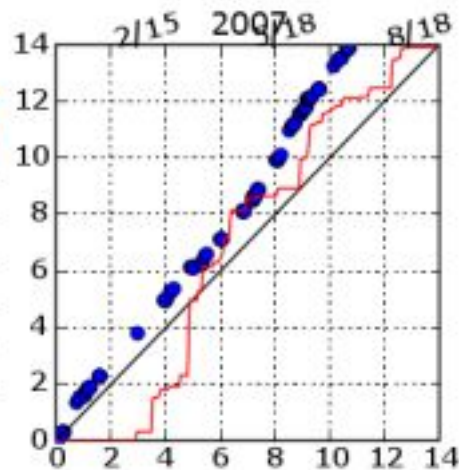
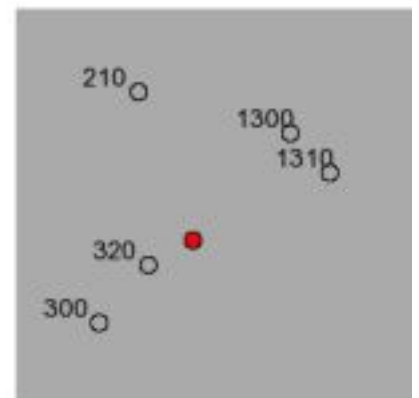
Double Mass Plot

| | Accum | #Rpts | Start | End |
| 100 | 13.909 | 780 | 03/08/07 | 10/31/07 |

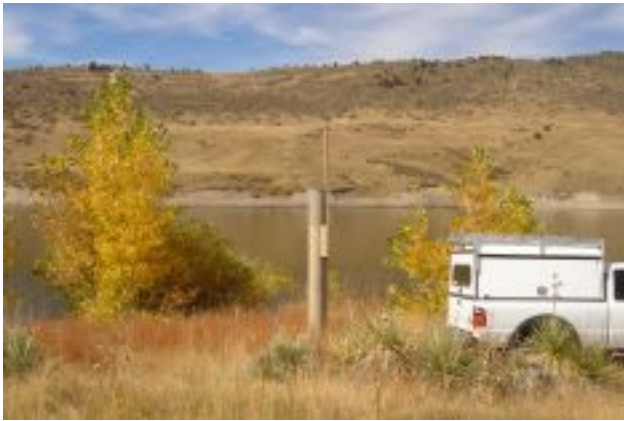
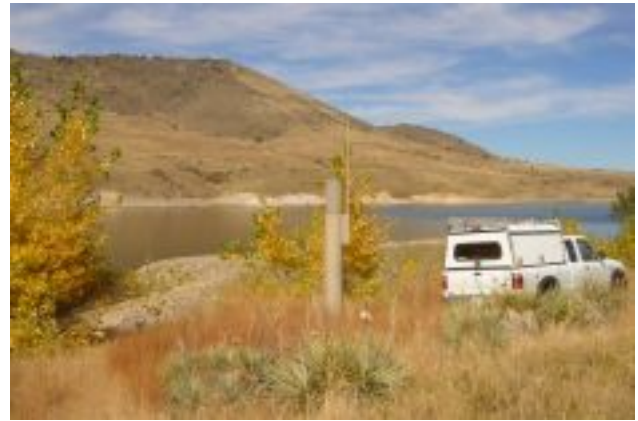
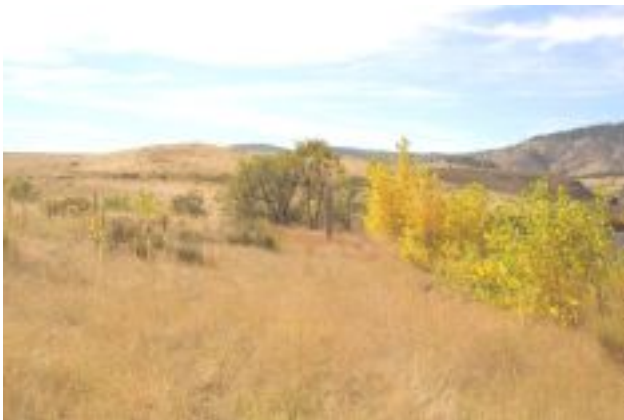
110 - Ralston Res - a

| Site ID | Site Name | Latitude | Longitude | Elevation | Install Date | TB Mfr. | TB Condition |
|---|---|---|---|---|---|---|---|
| 4.0 | Small tree to SW @ 20 ft. x 20 ft. tall, little wind protection | | | | | | |

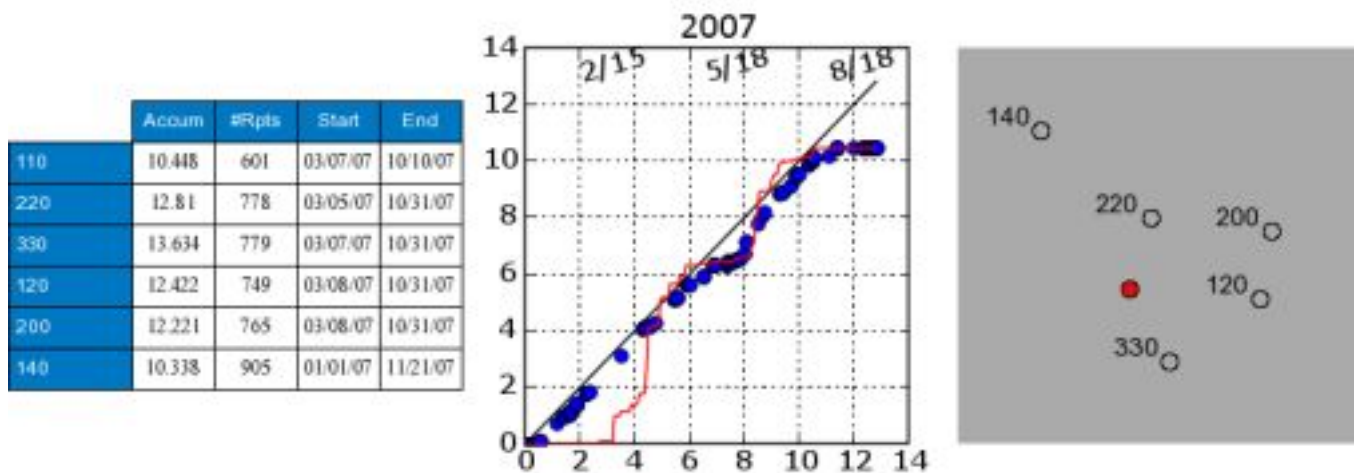
Double Mass Plot

| Site ID | Site Name | Latitude | Longitude | Elevation | Install Date | TB Mfr. | TB Condition |
|---|---|---|---|---|---|---|---|
| 110 | Ralston Res | 39 49' 23.5" | -105 14' 48.6" | 6111 | 1989-09-23 00:00:00.00 | HSE | clean & level |

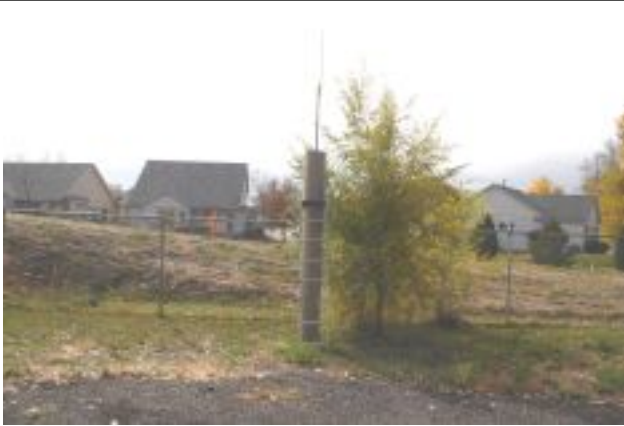
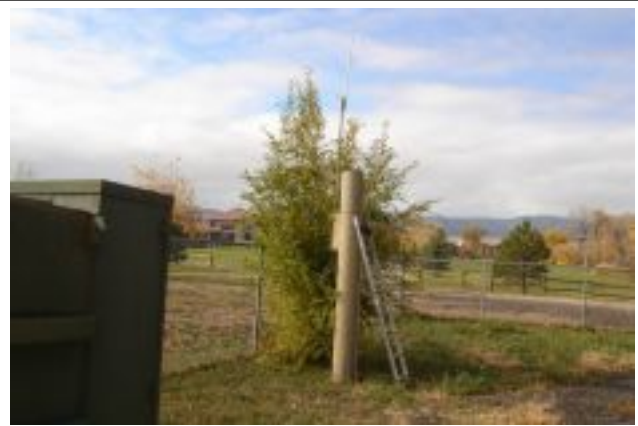
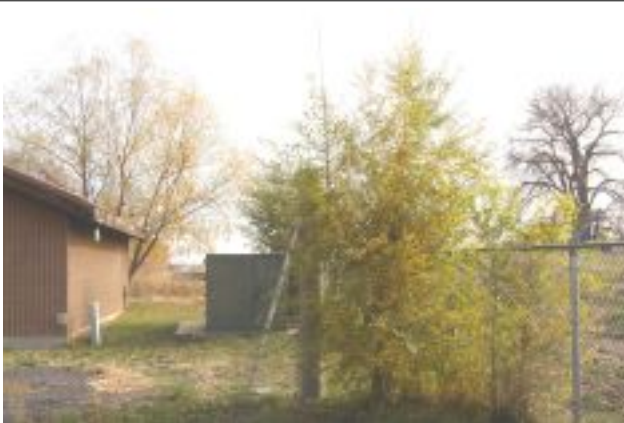
120 - Croke Pump Stn - a

| Site ID | Site Name | Latitude | Longitude | Elevation | Install Date | TB Mfr. | TB Condition |
|---|---|---|---|---|---|---|---|
| 3.0 | Small tree to W @ 3 ft. enveloping standpipe, if removed rating = 4, no wind protection | | | | | | |

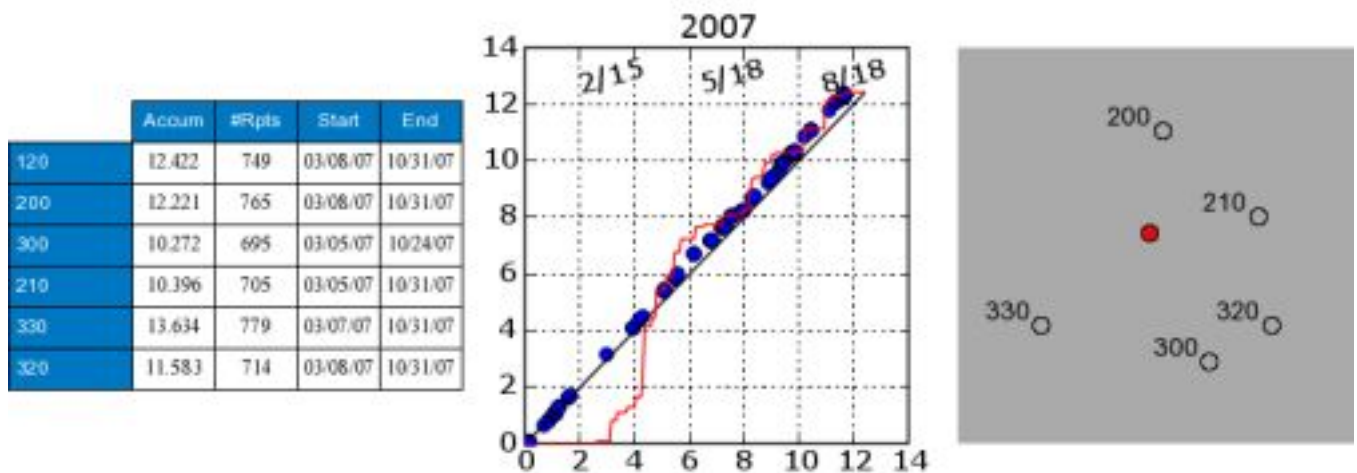
Double Mass Plot

| Site ID | Site Name | Latitude | Longitude | Elevation | Install Date | TB Mfr. | TB Condition |
|---|---|---|---|---|---|---|---|
| 120 | Croke Pump Stn | 39 49' 12.6" | -105 10' 26.9" | 5615 | 1989-08-02 00:00:00.00 | HSE | clean & level |

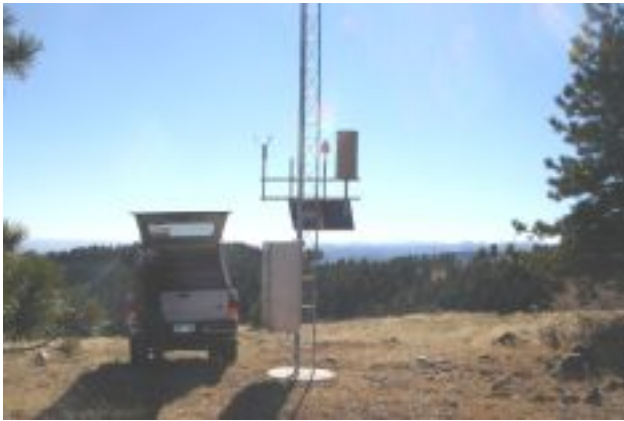
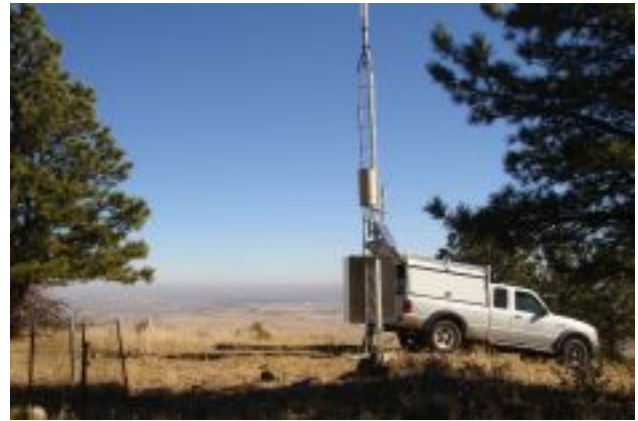
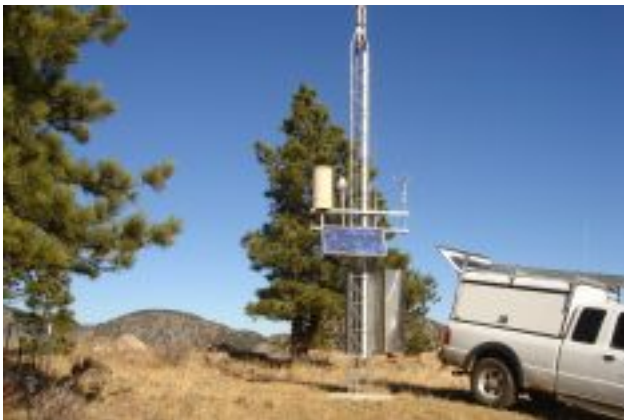
140 - Blue Mountain - c

| Site ID | Site Name | Latitude | Longitude | Elevation | Install Date | TB Mfr. | TB Condition |
|---|---|---|---|---|---|---|---|
| 4.0 | TB attached to tower, little wind protection | | | | | | |

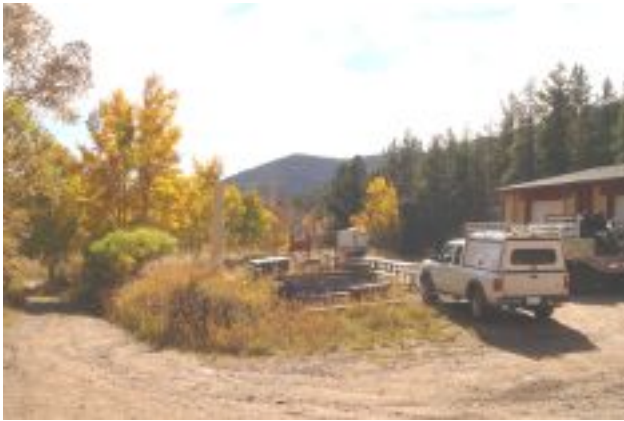
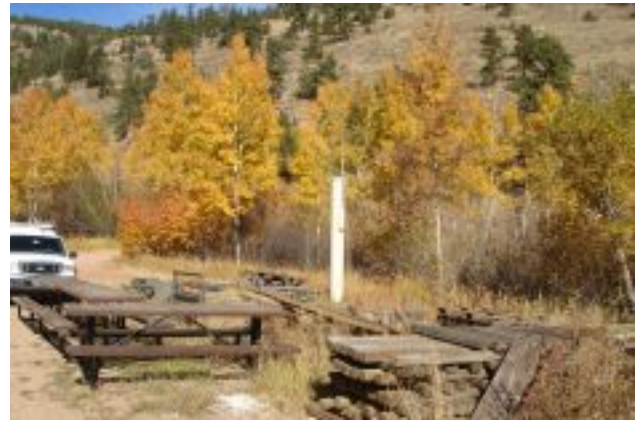
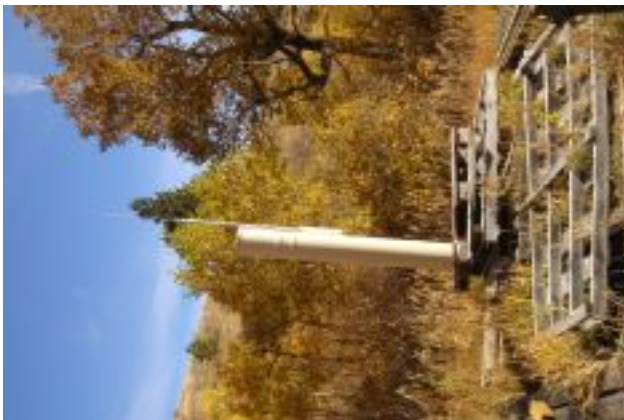
150 - Nott Creek - a

| Site ID | Site Name | Latitude | Longitude | Elevation | Install Date | TB Mfr. | TB Condition |
|---|---|---|---|---|---|---|---|
| 5.0 | Good rain catch and wind protection | | | | | | |

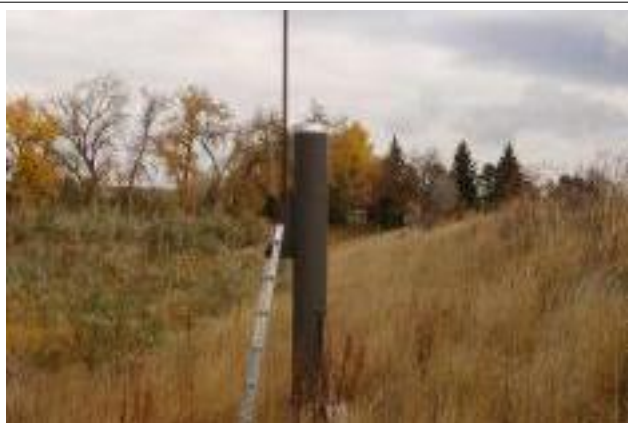
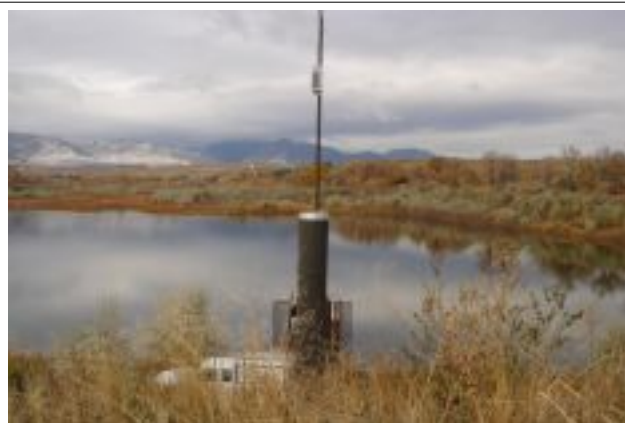
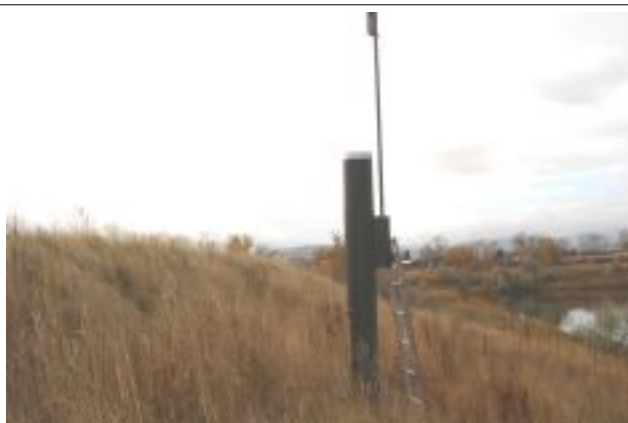
200 - Leyden Reservoir - a

| Site ID | Site Name | Latitude | Longitude | Elevation | Install Date | TB Mfr. | TB Condition |
|---|---|---|---|---|---|---|---|
| 4.0 | Good rain catch no wind protection | | | | | | |

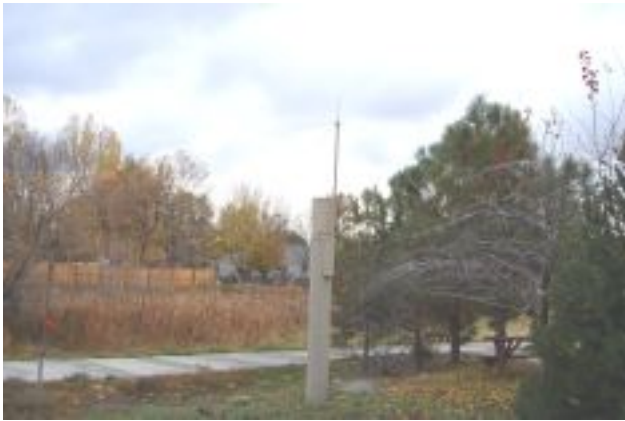
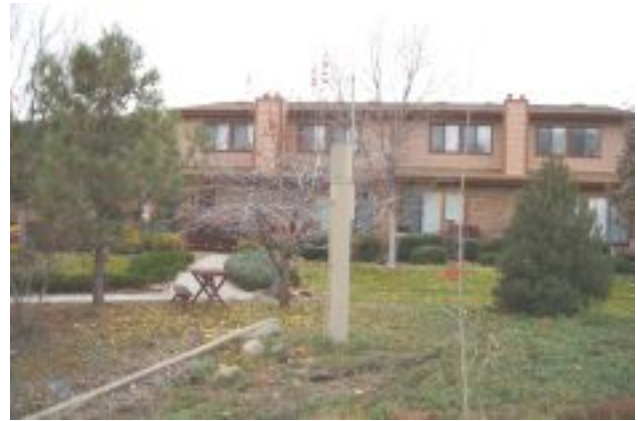
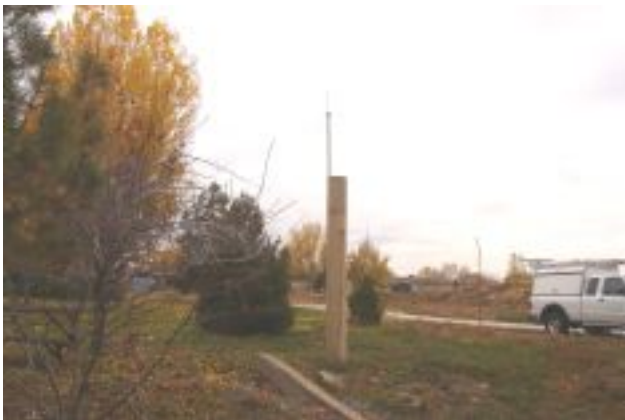
210 - Leyden Conf. - a

| Site ID | Site Name | Latitude | Longitude | Elevation | Install Date | TB Mfr. | TB Condition |
|---|---|---|---|---|---|---|---|
| 5.0 | Good rain catch and wind protection | | | | | | |

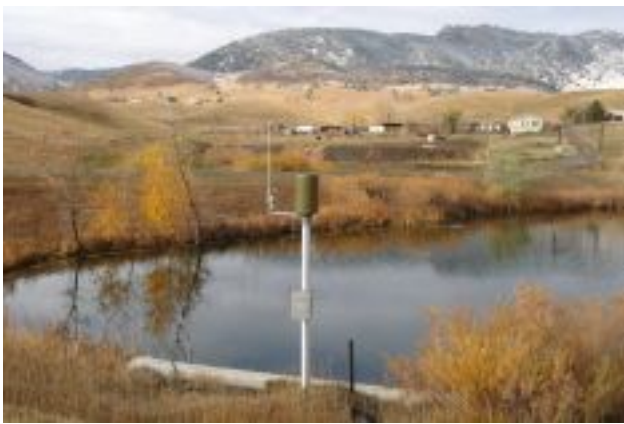
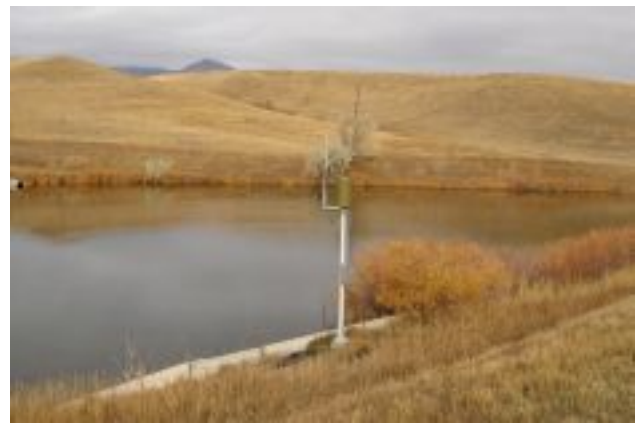
220 - Upper Leyden - a

| Site ID | Site Name | Latitude | Longitude | Elevation | Install Date | TB Mfr. | TB Condition |
|---|---|---|---|---|---|---|---|
| 4.0 | Good rain catch no wind protection | | | | | | |

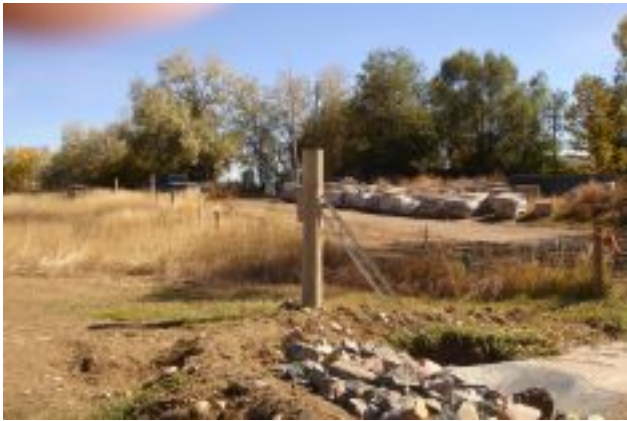
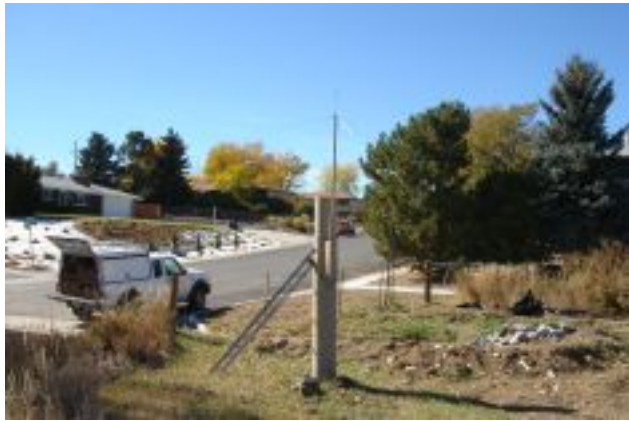
300 - Van Bibber Park - a

| Site ID | Site Name | Latitude | Longitude | Elevation | Install Date | TB Mfr. | TB Condition |
|---|---|---|---|---|---|---|---|
| 5.0 | Good rain catch and wind protection | | | | | | |

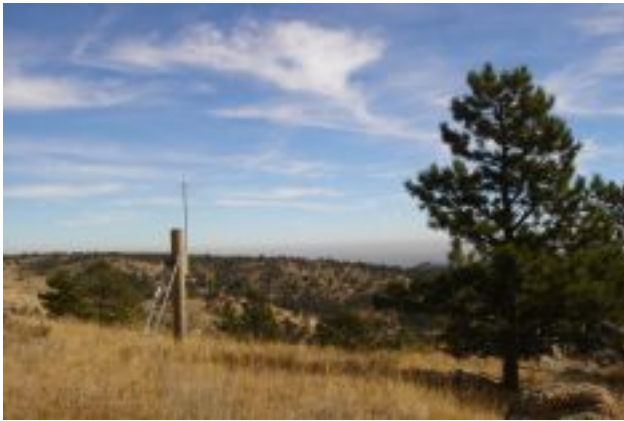
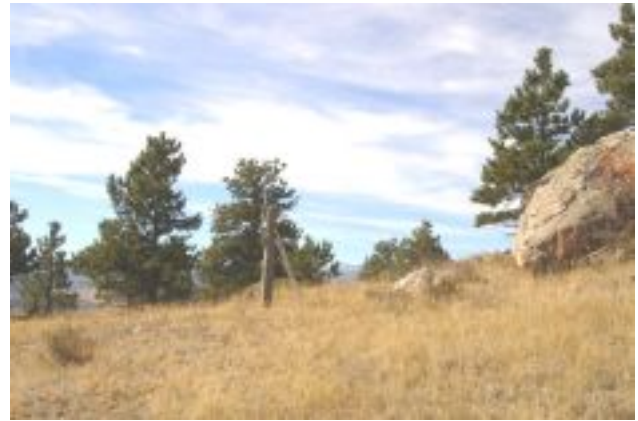
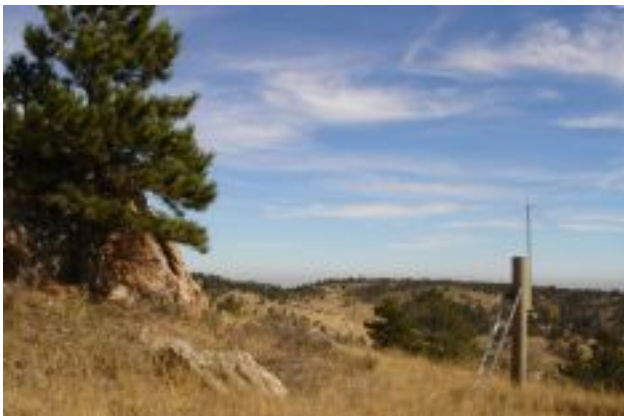
310 - Guy Hill - a

| Site ID | Site Name | Latitude | Longitude | Elevation | Install Date | TB Mfr. | TB Condition |
|---|---|---|---|---|---|---|---|
| 5.0 | Good rain catch and wind protection | | | | | | |

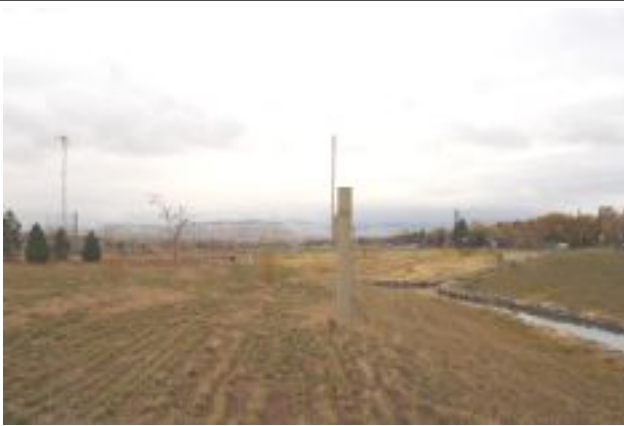
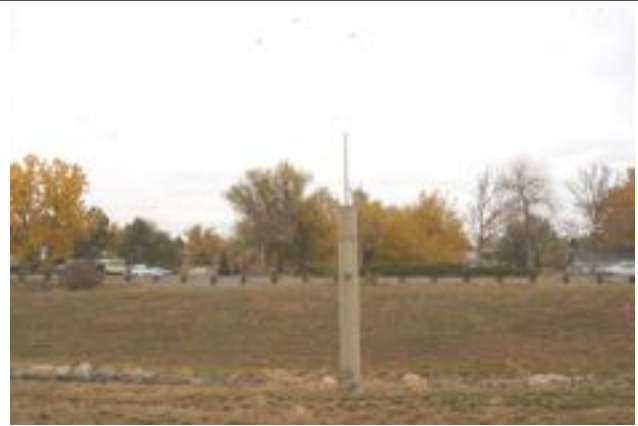
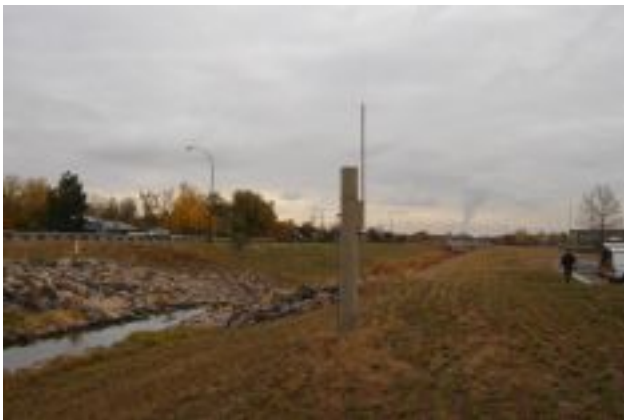
320 - Sports Complex - a

| Site ID | Site Name | Latitude | Longitude | Elevation | Install Date | TB Mfr. | TB Condition |
|---|---|---|---|---|---|---|---|
| 4.0 | Good rain catch no wind protection | | | | | | |

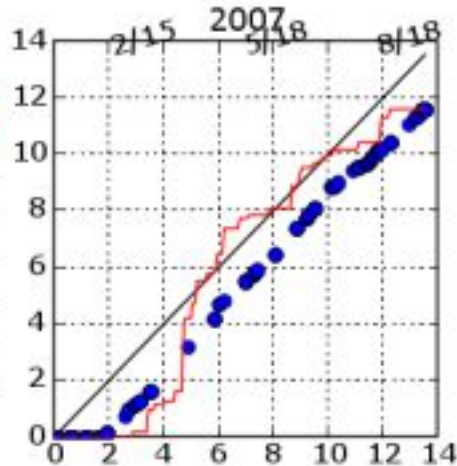
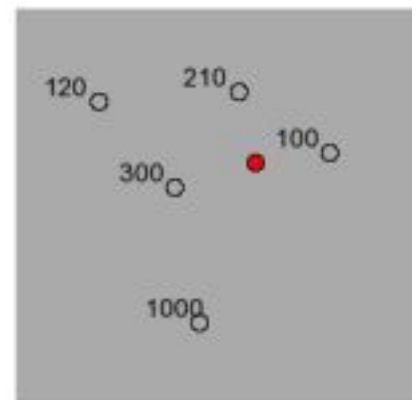
Double Mass Plot

| | Accum | #Rpts | Start | End |

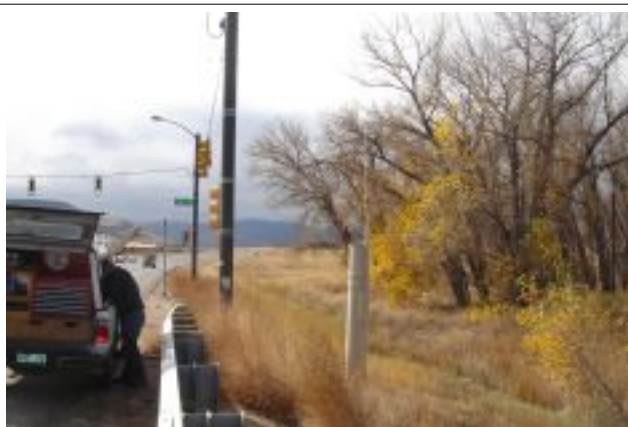
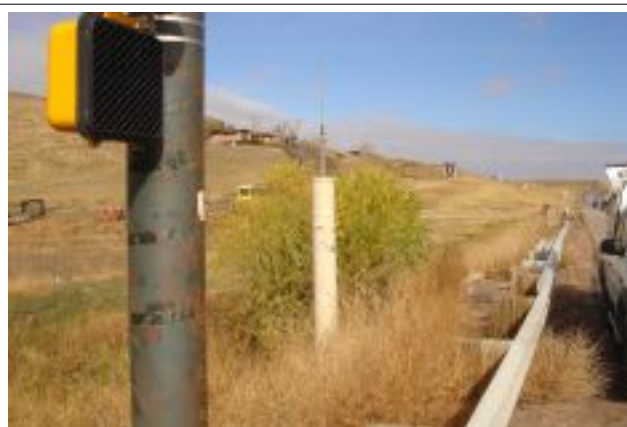
330 - Van Bibber @ 93 - a

| Site ID | Site Name | Latitude | Longitude | Elevation | Install Date | TB Mfr. | TB Condition |
|---|---|---|---|---|---|---|---|
| 4.0 | Good rain catch fair wind protection | | | | | | |

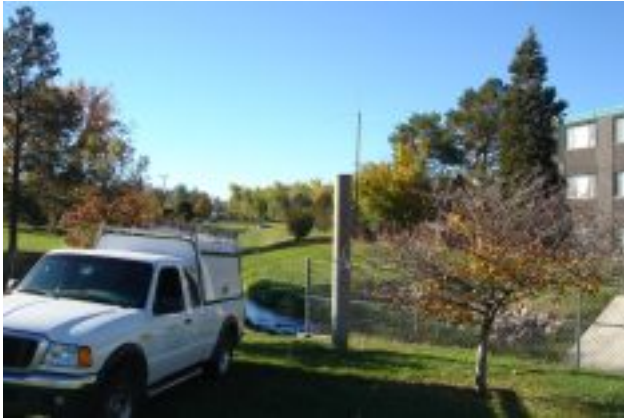
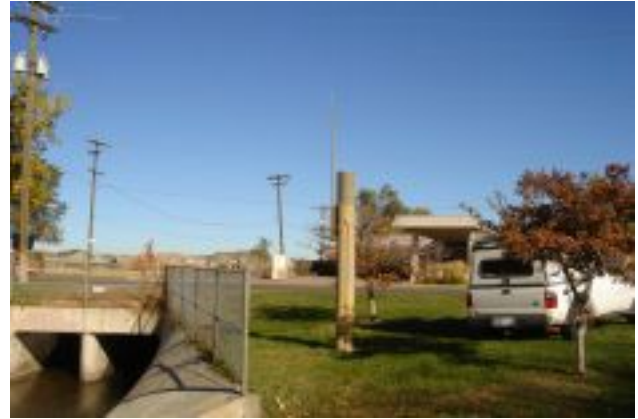
400 - Montview Park - a

| Site ID | Site Name | Latitude | Longitude | Elevation | Install Date | TB Mfr. | TB Condition |
|---|---|---|---|---|---|---|---|
| 5.0 | Good rain catch and wind protection | | | | | | |

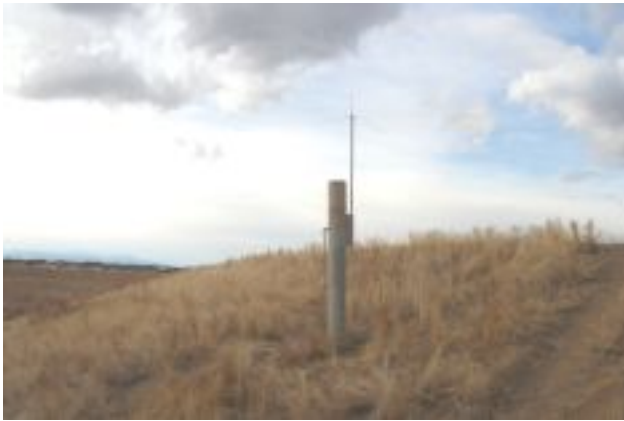
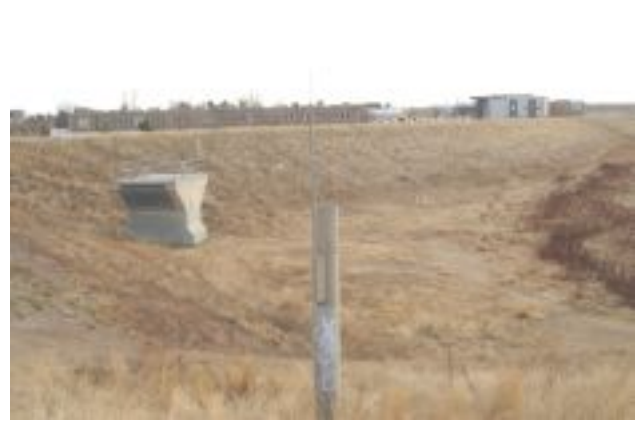
410 - Kelly Dam - a

| Site ID | Site Name | Latitude | Longitude | Elevation | Install Date | TB Mfr. | TB Condition |
|---|---|---|---|---|---|---|---|
| 4.0 | Good rain catch no wind protection | | | | | | |

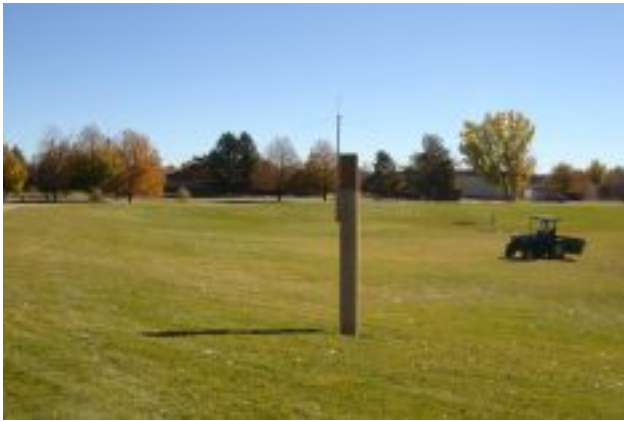
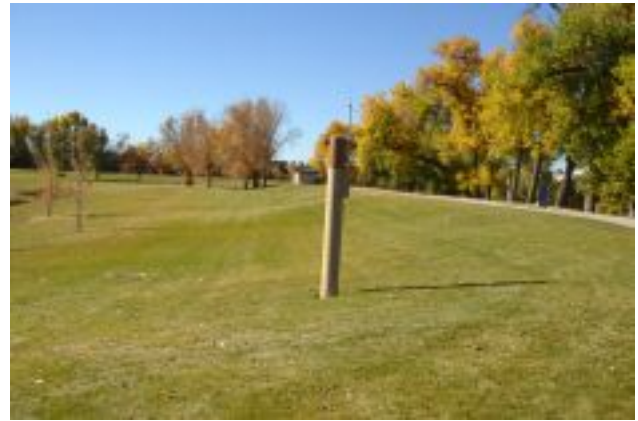
420 - Expo Park - a

| Site ID | Site Name | Latitude | Longitude | Elevation | Install Date | TB Mfr. | TB Condition |
|---|---|---|---|---|---|---|---|
| 5.0 | Good rain catch and wind protection | | | | | | |

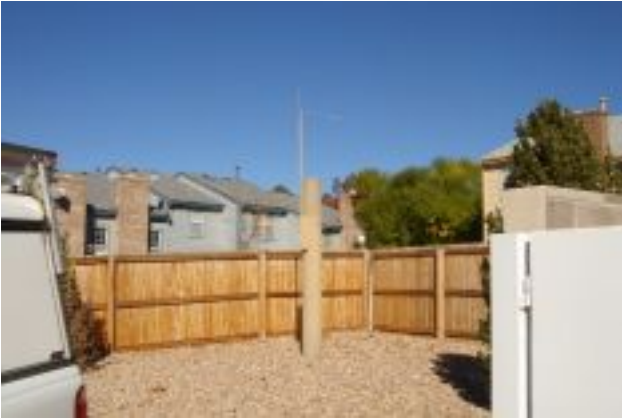
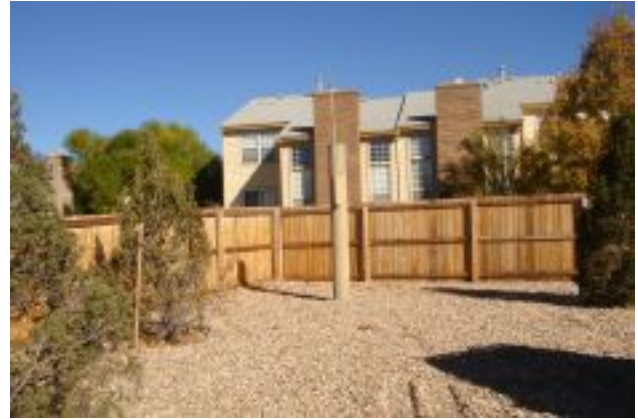
440 - Aurora FS#7 - a

| Site ID | Site Name | Latitude | Longitude | Elevation | Install Date | TB Mfr. | TB Condition |
|---|---|---|---|---|---|---|---|
| 4.0 | Good rain catch no wind protection | | | | | | |

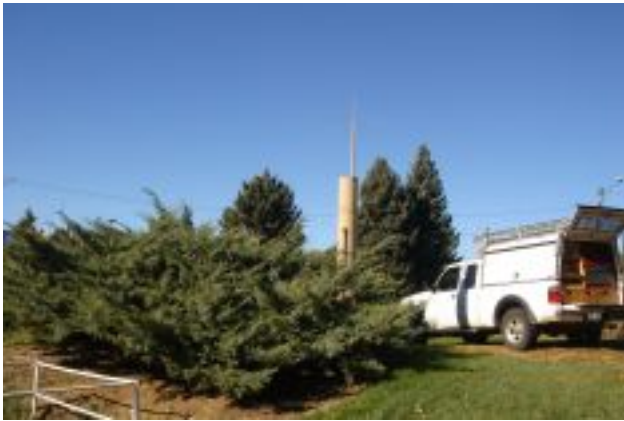
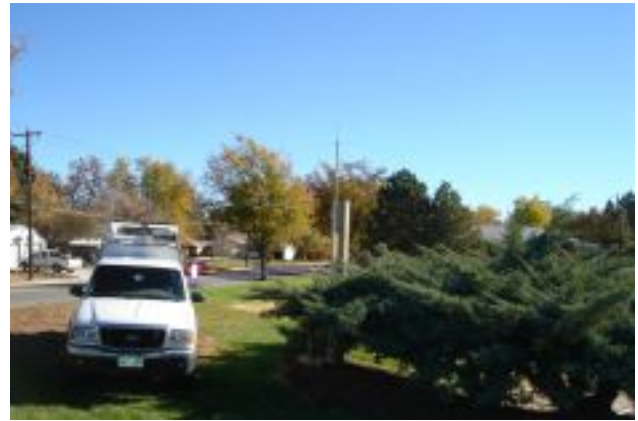
500 - Havana Park - a

| Site ID | Site Name | Latitude | Longitude | Elevation | Install Date | TB Mfr. | TB Condition |
|---|---|---|---|---|---|---|---|
| 5.0 | Good rain catch and wind protection | | | | | | |

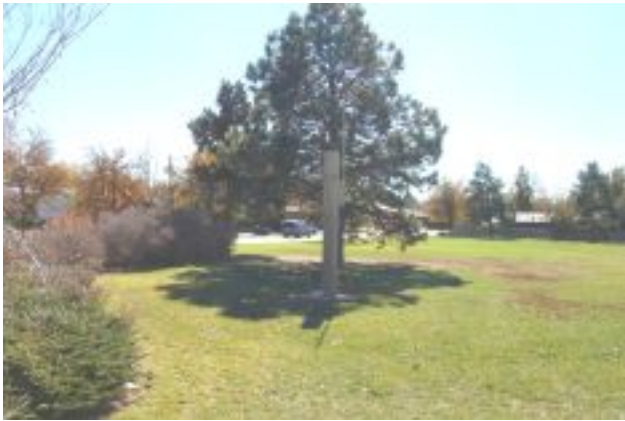
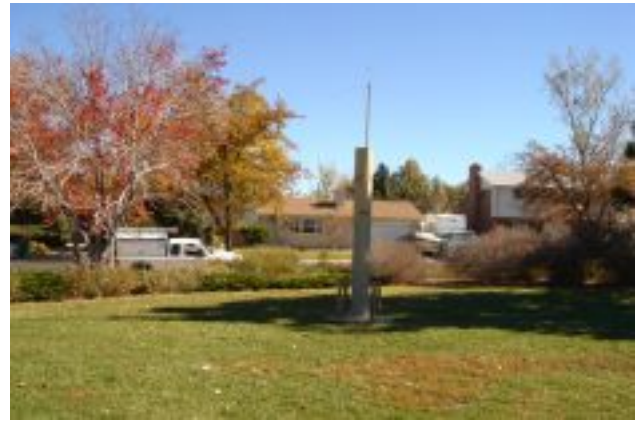
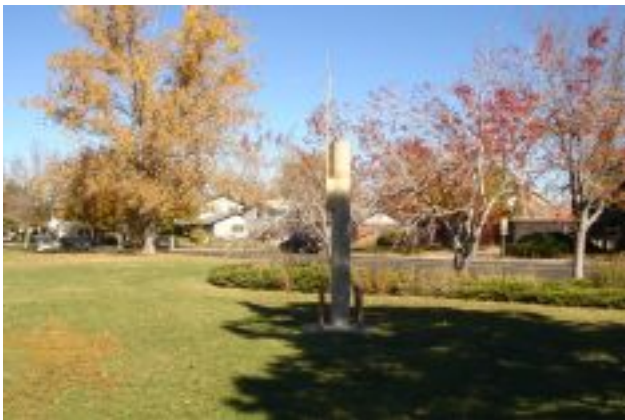
510 - Virginia Court - a

| Site ID | Site Name | Latitude | Longitude | Elevation | Install Date | TB Mfr. | TB Condition |
|---|---|---|---|---|---|---|---|
| 4.0 | Good rain catch no wind protection | | | | | | |

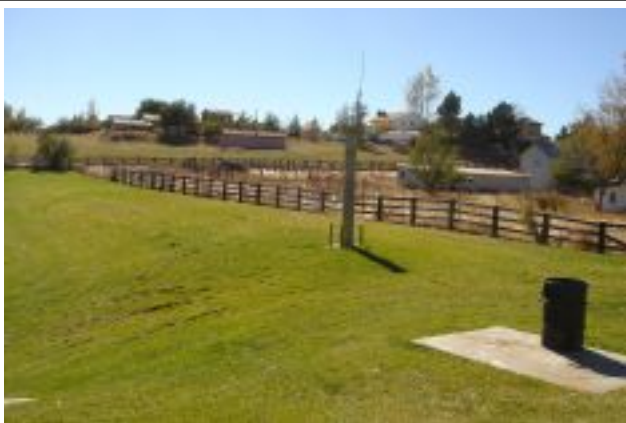
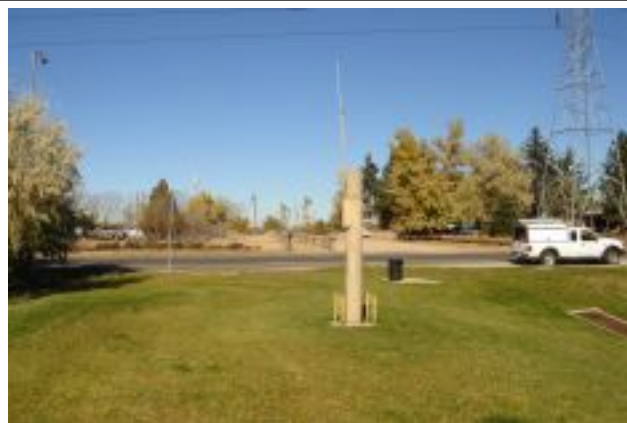
520 - Jewell Detention - a

| Site ID | Site Name | Latitude | Longitude | Elevation | Install Date | TB Mfr. | TB Condition |
|---|---|---|---|---|---|---|---|
| 5.0 | Good rain catch and wind protection | | | | | | |

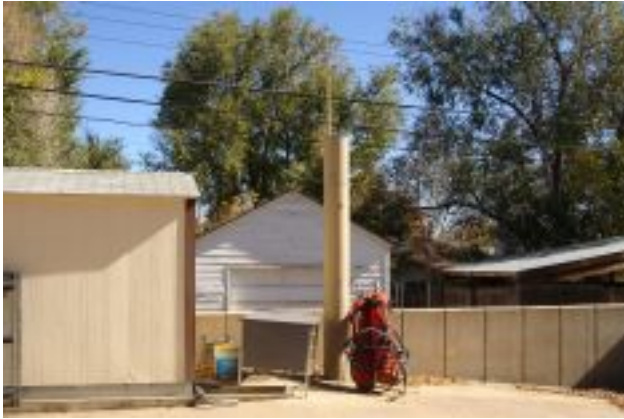
530 - Denver FS #19 - a

| Site ID | Site Name | Latitude | Longitude | Elevation | Install Date | TB Mfr. | TB Condition |
|---|---|---|---|---|---|---|---|
| 3.0 | Fair rain catch no wind protection | | | | | | |

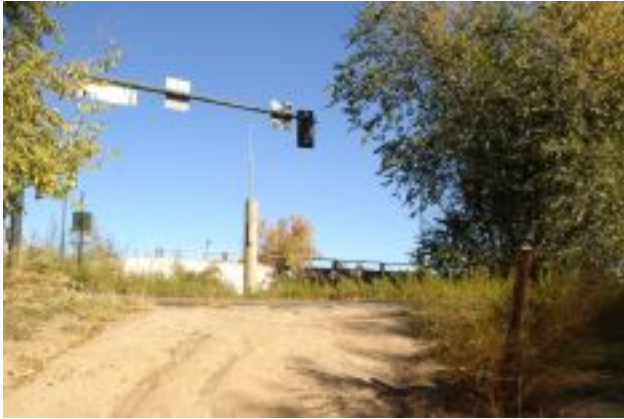
540 - Parker and Miss. - a

| Site ID | Site Name | Latitude | Longitude | Elevation | Install Date | TB Mfr. | TB Condition |
|---|---|---|---|---|---|---|---|
| 3.0 | Tree to S in cone angle, traffic signal arm to E, little wind protection | | | | | | |

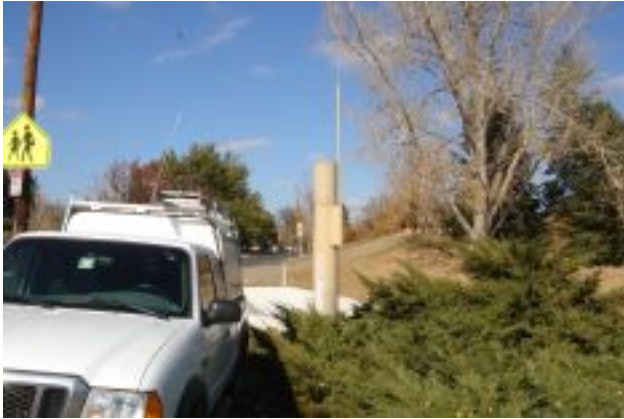
600 - Harvard Gulch Pk - a

| Site ID | Site Name | Latitude | Longitude | Elevation | Install Date | TB Mfr. | TB Condition |
|---|---|---|---|---|---|---|---|
| 4.0 | Good rain catch no wind protection | | | | | | |

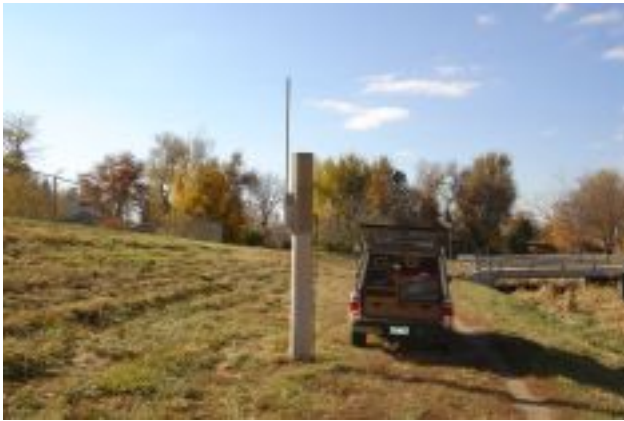
610 - Harvard/Jackson - a

| Site ID | Site Name | Latitude | Longitude | Elevation | Install Date | TB Mfr. | TB Condition |
|---|---|---|---|---|---|---|---|
| 5.0 | Good rain catch and wind protection | | | | | | |

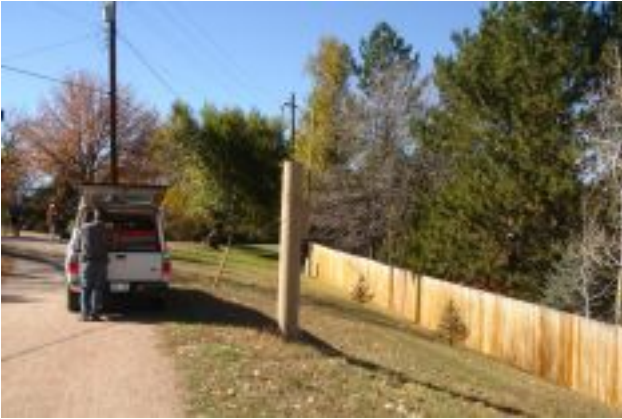
620 - Quincy/Highline - a

| Site ID | Site Name | Latitude | Longitude | Elevation | Install Date | TB Mfr. | TB Condition |
|---|---|---|---|---|---|---|---|
| 5.0 | Good rain catch and wind protection | | | | | | |

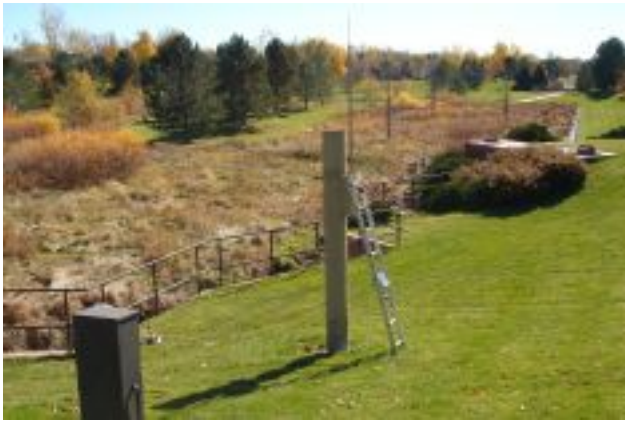
630 - Temple Pond - a

| Site ID | Site Name | Latitude | Longitude | Elevation | Install Date | TB Mfr. | TB Condition |
|---|---|---|---|---|---|---|---|
| 5.0 | Good rain catch and wind protection | | | | | | |

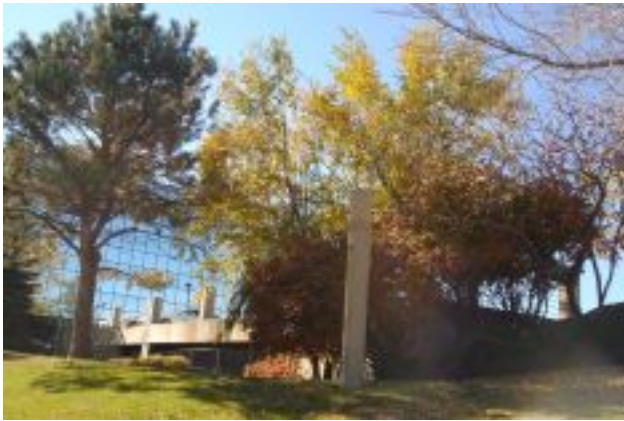
640 - Goldsmith/E'man - a

| Site ID | Site Name | Latitude | Longitude | Elevation | Install Date | TB Mfr. | TB Condition |
|---|---|---|---|---|---|---|---|
| 2.0 | Trees on 3 sides (S,W,N) in cone angle | | | | | | |

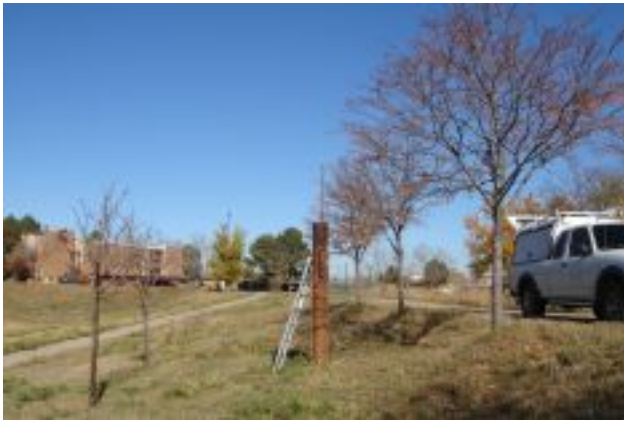
650 - Iliff Pond - a

| Site ID | Site Name | Latitude | Longitude | Elevation | Install Date | TB Mfr. | TB Condition |
|---|---|---|---|---|---|---|---|
| 3.0 | Trees to N & S on E side and smaller tree on W | | | | | | |

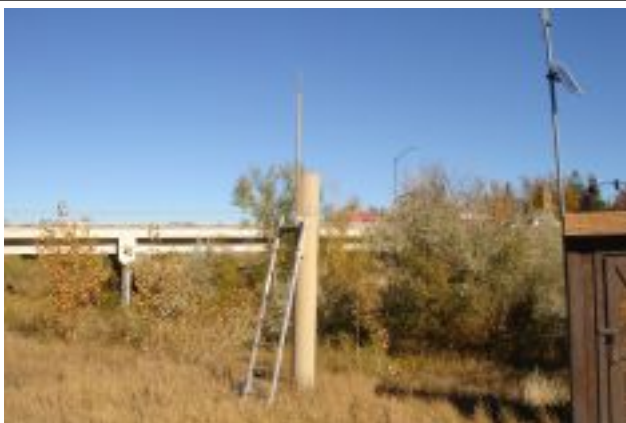
700 - Tollgate at 6th - a

| Site ID | Site Name | Latitude | Longitude | Elevation | Install Date | TB Mfr. | TB Condition |
|---|---|---|---|---|---|---|---|
| 4.0 | Good rain catch, fair wind protection | | | | | | |

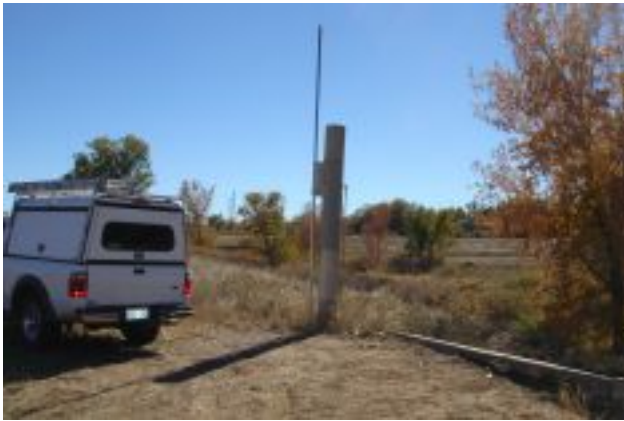
710 - Horseshoe Park - a

| Site ID | Site Name | Latitude | Longitude | Elevation | Install Date | TB Mfr. | TB Condition |
|---|---|---|---|---|---|---|---|
| 4.0 | Good rain catch, fair wind protection | | | | | | |

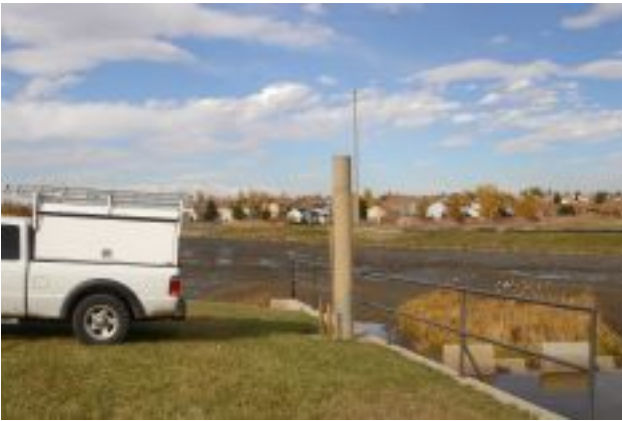
720 - Confluence Pond - a

| Site ID | Site Name | Latitude | Longitude | Elevation | Install Date | TB Mfr. | TB Condition |
|---|---|---|---|---|---|---|---|
| 5.0 | Good rain catch and wind protection | | | | | | |

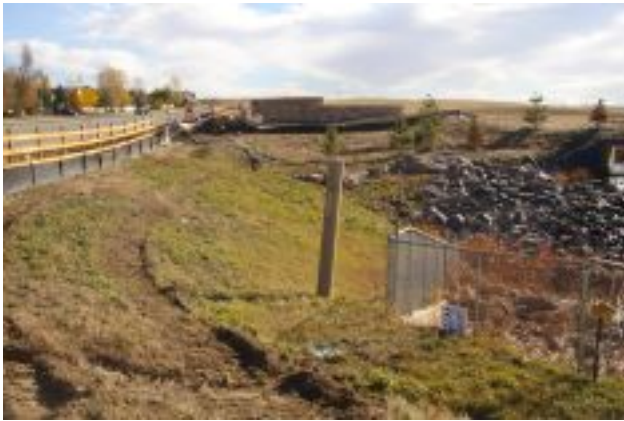
730 - No Name @ Quincy - a

| Site ID | Site Name | Latitude | Longitude | Elevation | Install Date | TB Mfr. | TB Condition |
|---|---|---|---|---|---|---|---|
| 3.0 | Reduced rain catch, standpipe no longer perpendicular, fair wind protection | | | | | | |

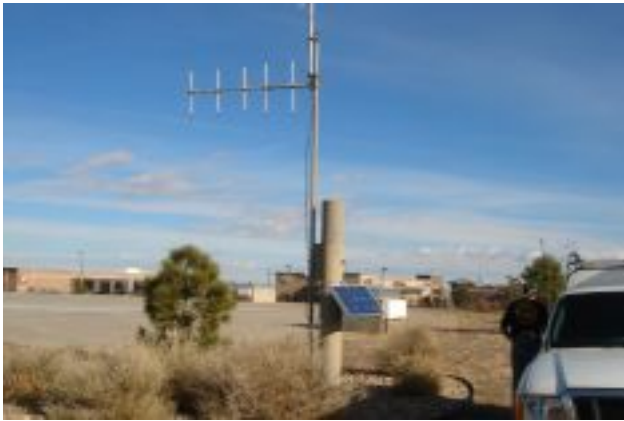
740 - Smoky Hill - a

| Site ID | Site Name | Latitude | Longitude | Elevation | Install Date | TB Mfr. | TB Condition |
|---|---|---|---|---|---|---|---|
| 4.0 | Good rain catch no wind protection | | | | | | |

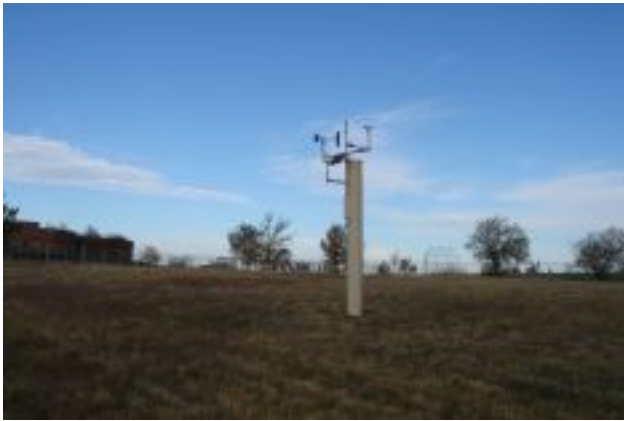
750 - Quincy Reservoir - a

| Site ID | Site Name | Latitude | Longitude | Elevation | Install Date | TB Mfr. | TB Condition |
|---|---|---|---|---|---|---|---|
| 4.0 | Good rain catch no wind protection | | | | | | |

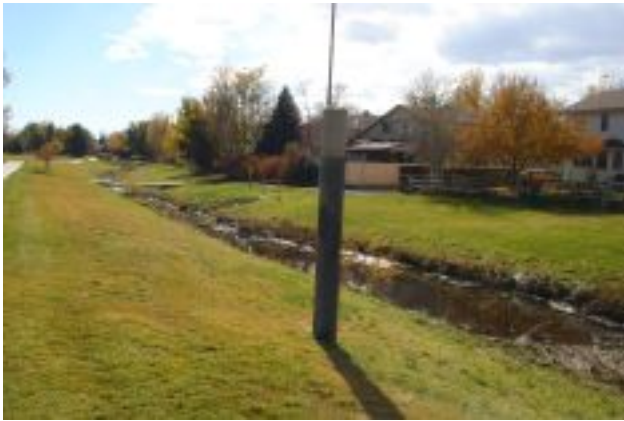
760 - Mission Viejo Pk - a

| Site ID | Site Name | Latitude | Longitude | Elevation | Install Date | TB Mfr. | TB Condition |
|---|---|---|---|---|---|---|---|
| 5.0 | Good rain catch and wind protection | | | | | | |

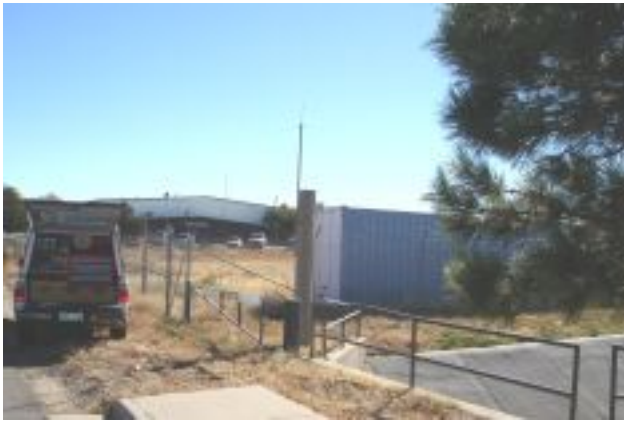
800 - Sable Ditch - a

| Site ID | Site Name | Latitude | Longitude | Elevation | Install Date | TB Mfr. | TB Condition |
|---|---|---|---|---|---|---|---|
| 4.0 | Good rain catch fair wind protection | | | | | | |

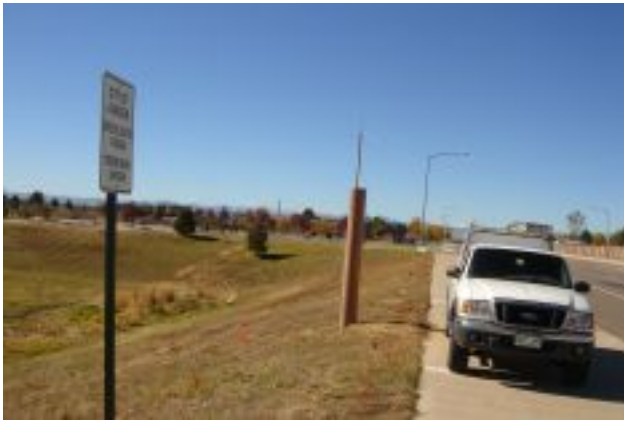
810 - Grandby Ditch - a

| Site ID | Site Name | Latitude | Longitude | Elevation | Install Date | TB Mfr. | TB Condition |
|---|---|---|---|---|---|---|---|
| 4.0 | Good rain catch no wind protection | | | | | | |

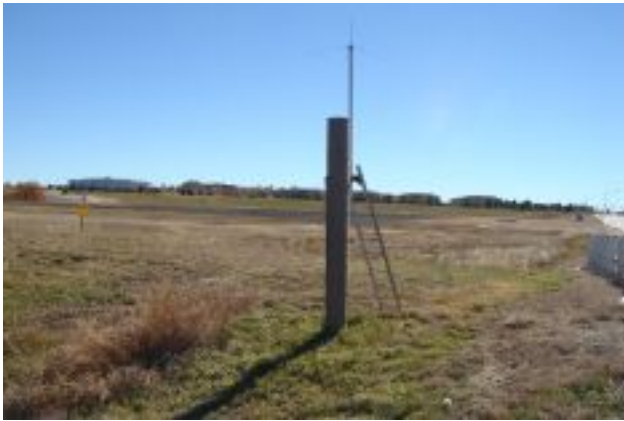
820 - ETG @ Buckley - a

| Site ID | Site Name | Latitude | Longitude | Elevation | Install Date | TB Mfr. | TB Condition |
|---|---|---|---|---|---|---|---|
| 4.0 | Good rain catch no wind protection | | | | | | |

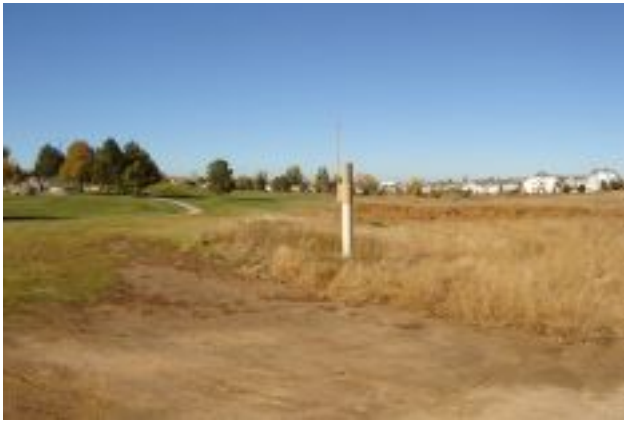
830 - Side Creek Park - a

| Site ID | Site Name | Latitude | Longitude | Elevation | Install Date | TB Mfr. | TB Condition |
|---|---|---|---|---|---|---|---|
| 5.0 | Good rain catch and wind protection | | | | | | |
