## Urban Drainage and Flood Control District

| Site ID | Site Name | Latitude | Longitude | Elevation | Install Date | TB Mfr. | TB Condition |

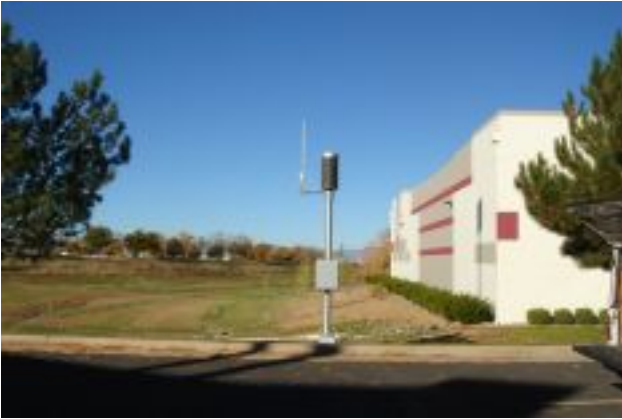
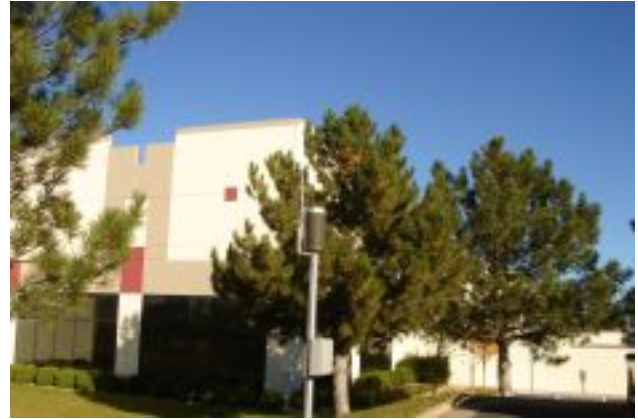
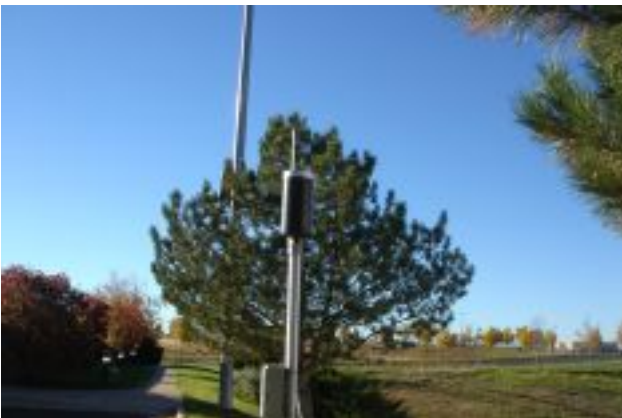
| Site ID | Site Name | Latitude | Longitude | Elevation | Install Date | TB Mfr. | TB Condition |
|---|---|---|---|---|---|---|---|
| 4.0 | Good rain catch no wind protection | | | | | | |

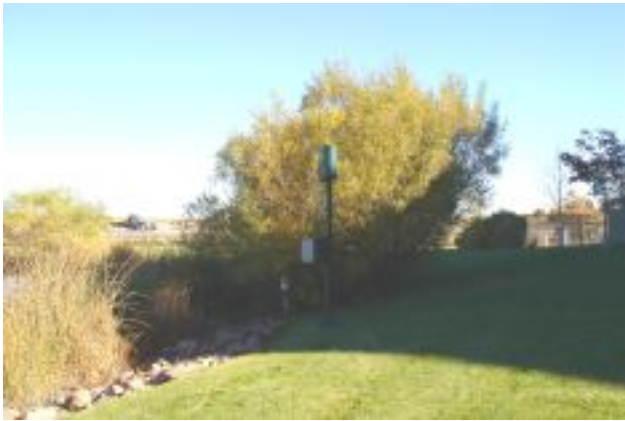
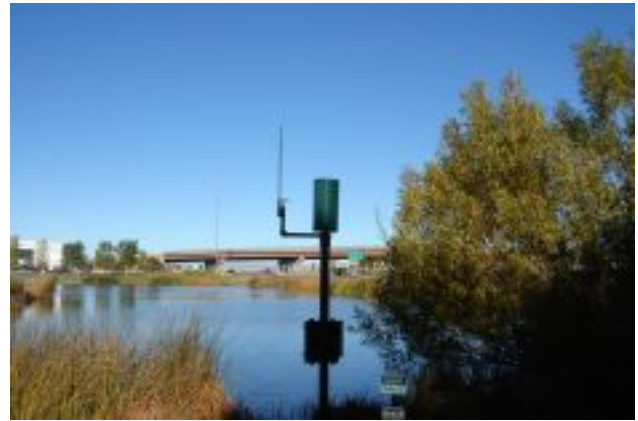
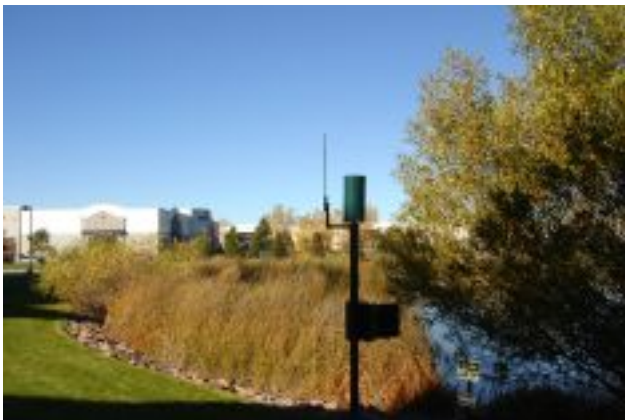
| Site ID | Site Name | Latitude | Longitude | Elevation | Install Date | TB Mfr. | TB Condition |
|---|---|---|---|---|---|---|---|
| 4.0 | Good rain catch no wind protection | | | | | | |

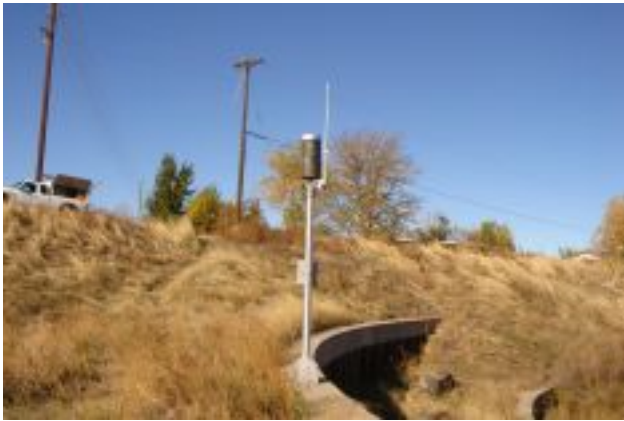
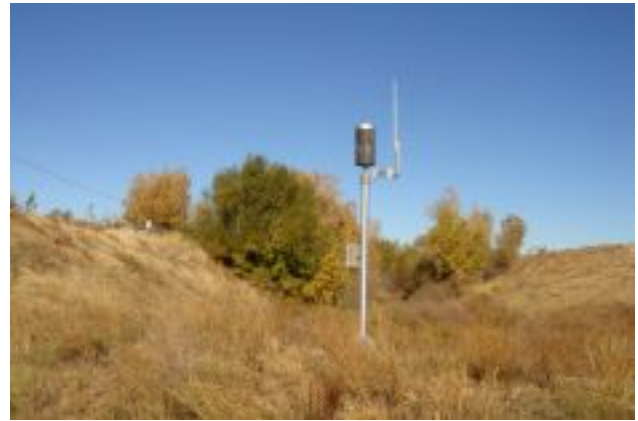
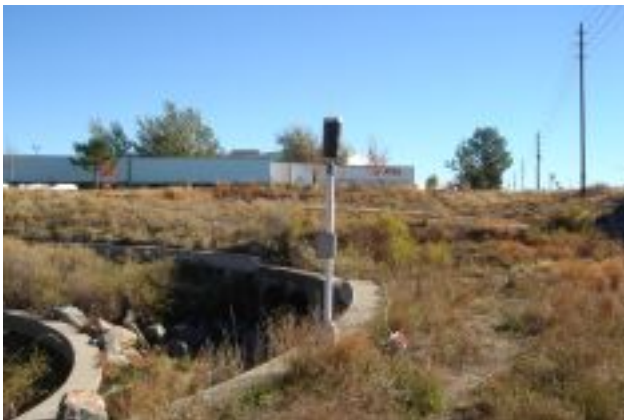
| Site ID | Site Name | Latitude | Longitude | Elevation | Install Date | TB Mfr. | TB Condition |
|---|---|---|---|---|---|---|---|
| 5.0 | Good rain catch good wind protection note: Site to be moved to higher ground | | | | | | |

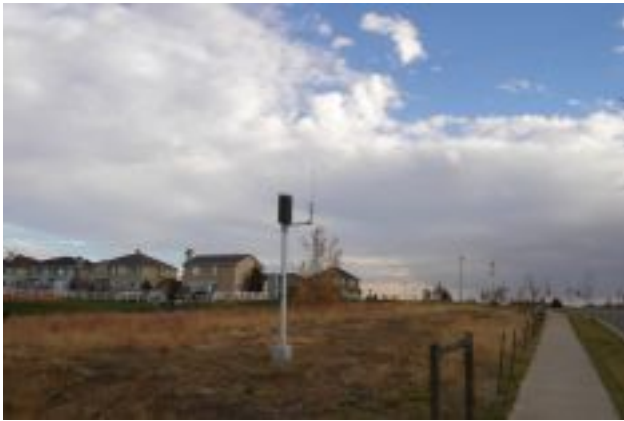
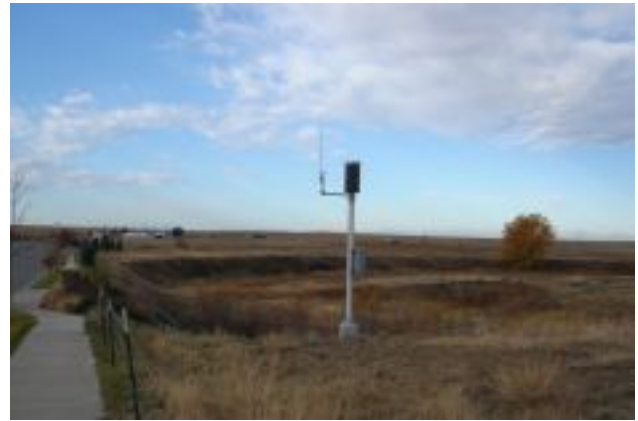
| Site ID | Site Name | Latitude | Longitude | Elevation | Install Date | TB Mfr. | TB Condition |
|---|---|---|---|---|---|---|---|
| 4.0 | Good rain catch no wind protection | | | | | | |

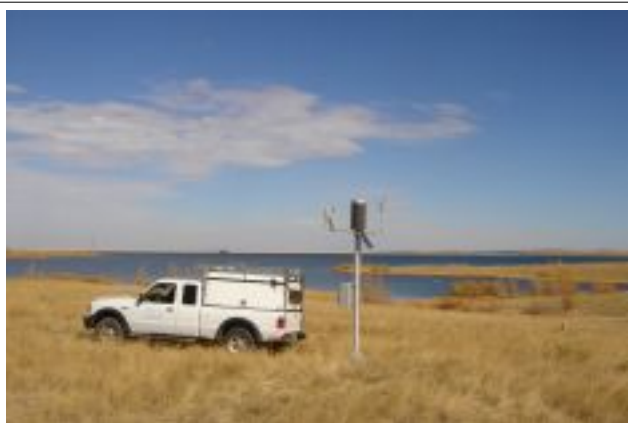
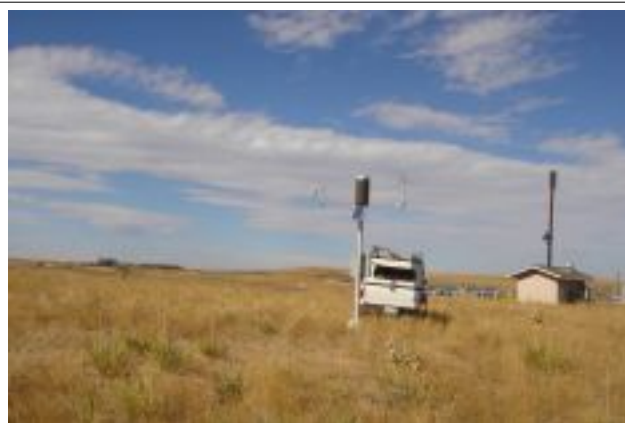
| Site ID | Site Name | Latitude | Longitude | Elevation | Install Date | TB Mfr. | TB Condition |
|---|---|---|---|---|---|---|---|
| 4.0 | Good rain catch no wind protection | | | | | | |

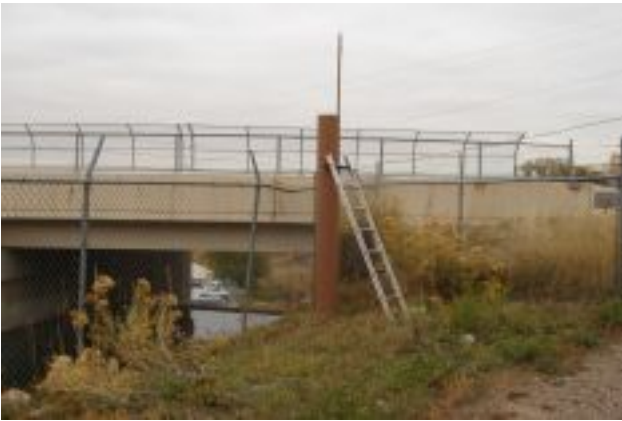
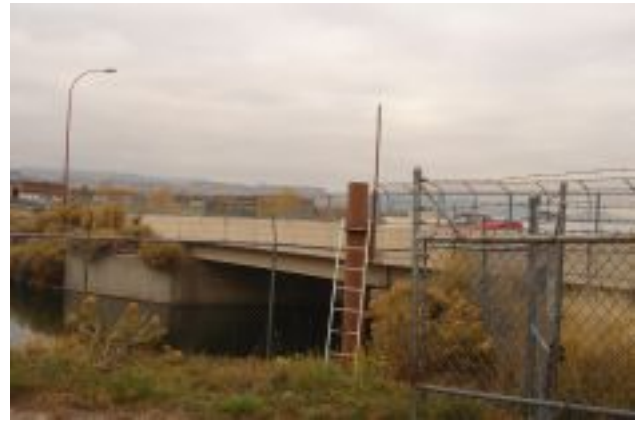
| Site ID | Site Name | Latitude | Longitude | Elevation | Install Date | TB Mfr. | TB Condition |
|---|---|---|---|---|---|---|---|
| 4.0 | Good rain catch no wind protection | | | | | | |

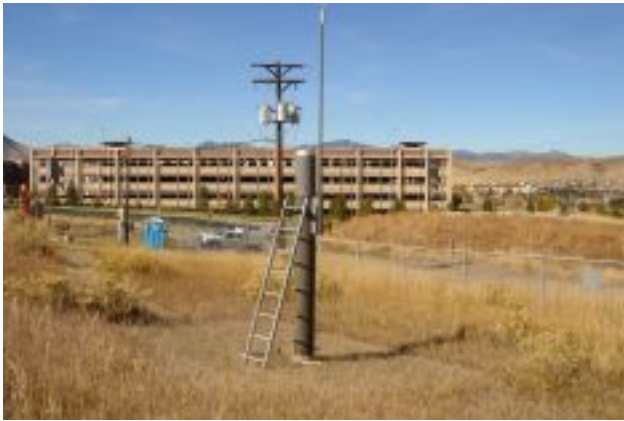
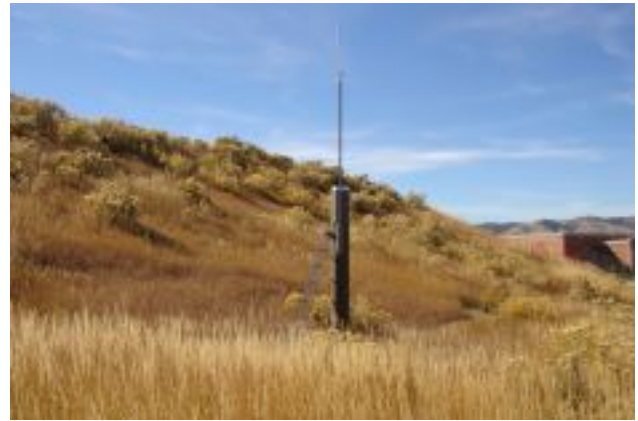
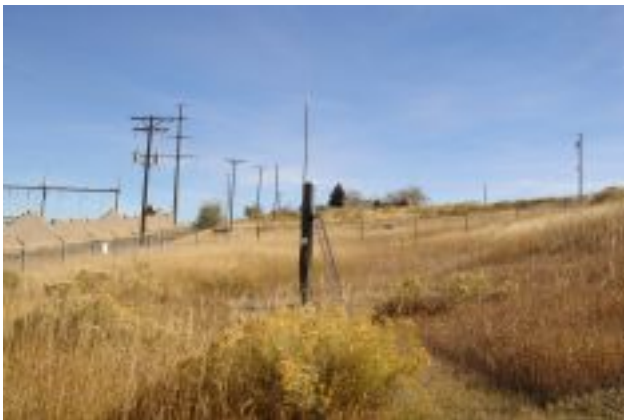
| Site ID | Site Name | Latitude | Longitude | Elevation | Install Date | TB Mfr. | TB Condition |
|---|---|---|---|---|---|---|---|
| 4.0 | Good rain catch no wind protection | | | | | | |

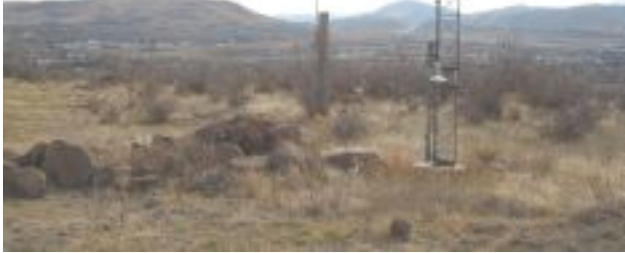
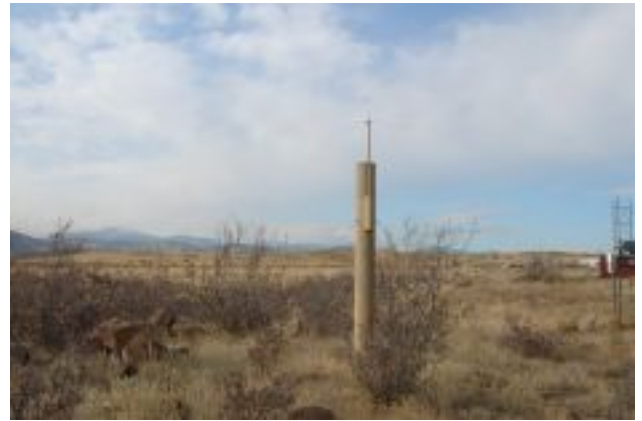
| Site ID | Site Name | Latitude | Longitude | Elevation | Install Date | TB Mfr. | TB Condition |
|---|---|---|---|---|---|---|---|
| 4.0 | Good rain catch no wind protection | | | | | | |

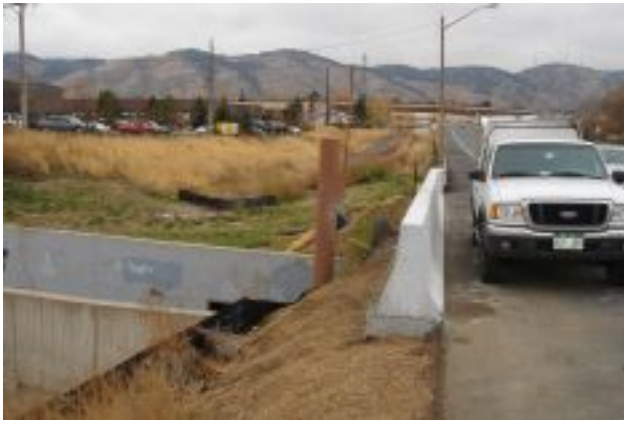
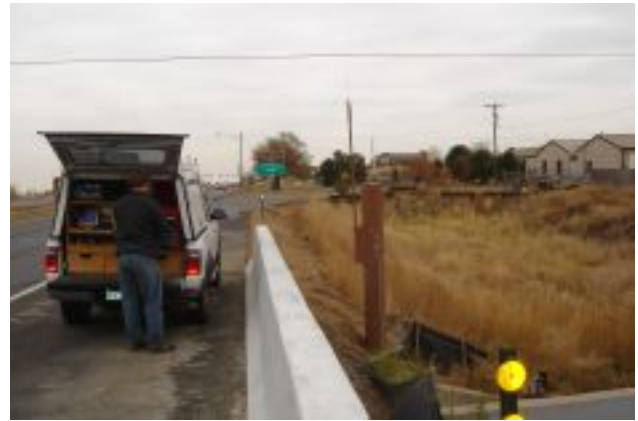
| Site ID | Site Name | Latitude | Longitude | Elevation | Install Date | TB Mfr. | TB Condition |
|---|---|---|---|---|---|---|---|
| 4.0 | Good rain catch little wind protection/traffic turbulence | | | | | | |

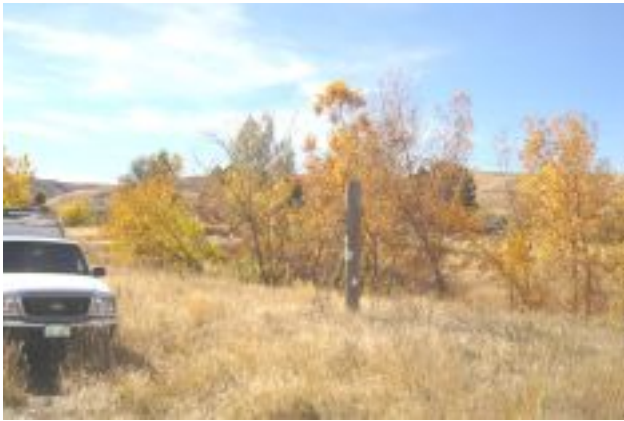
1050 - Fairgrounds - a

| Site ID | Site Name | Latitude | Longitude | Elevation | Install Date | TB Mfr. | TB Condition |
|---|---|---|---|---|---|---|---|
| 5.0 | Good rain catch and wind protection | | | | | | |

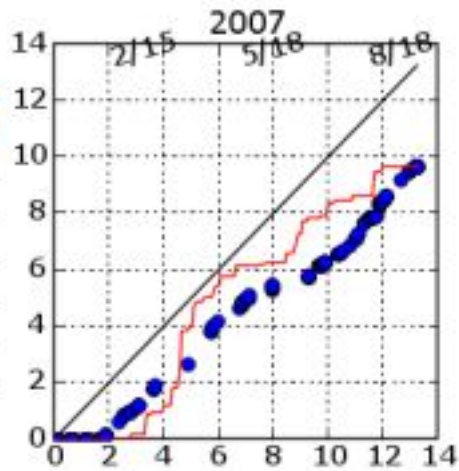
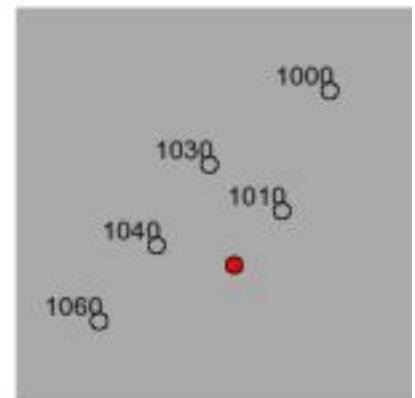
Double Mass Plot

| | Accum | #Rpts | Start | End |
|---|---|---|---|---|
| 1060 | 10.039 | 657 | 03/06/07 | 10/09/07 |
| 1000 | 13.525 | 1307 | 01/01/07 | 11/01/07 |

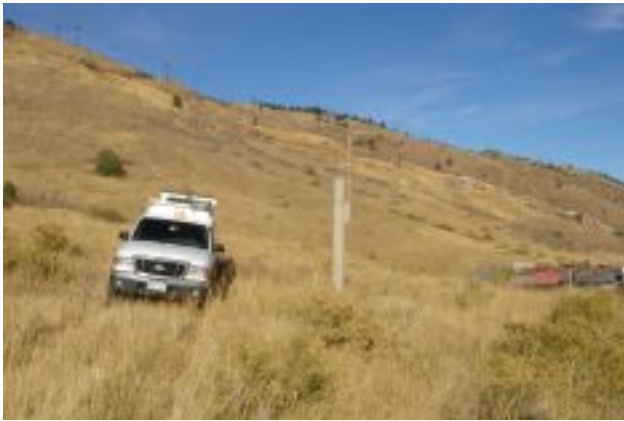
1060 - Apex - a

| Site ID | Site Name | Latitude | Longitude | Elevation | Install Date | TB Mfr. | TB Condition |
|---|---|---|---|---|---|---|---|
| 4.0 | Good rain catch no wind protection | | | | | | |

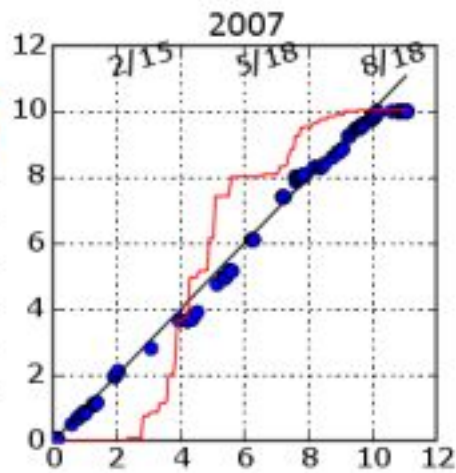
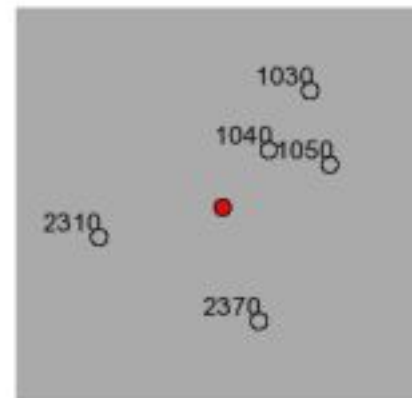
Double Mass Plot

| | Accum | #Rpts | Start | End |
|---|---|---|---|---|
| 2310 | 11.149 | 586 | 03/29/07 | 10/03/07 |
| 1030 | 9.428 | 676 | 03/06/07 | 11/12/07 |

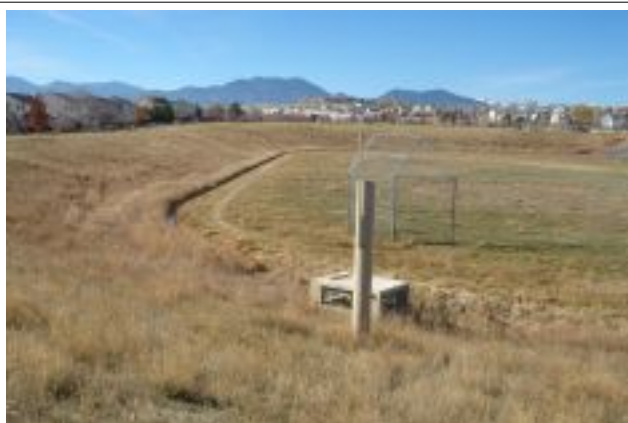
1100 - L'ville Dwy "D" - a

| Site ID | Site Name | Latitude | Longitude | Elevation | Install Date | TB Mfr. | TB Condition |
|---|---|---|---|---|---|---|---|
| 4.0 | Good rain catch no wind protection | | | | | | |

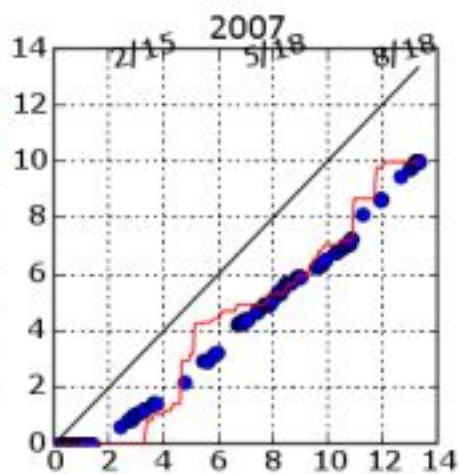
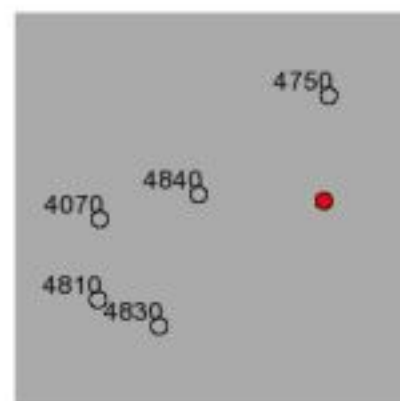
Double Mass Plot

| | Accum | #Rpts | Start | End |
|---|---|---|---|---|
| 4070 | 13.979 | 965 | 01/01/07 | 11/20/07 |
| 4810 | 14.016 | 965 | 01/01/07 | 11/21/07 |

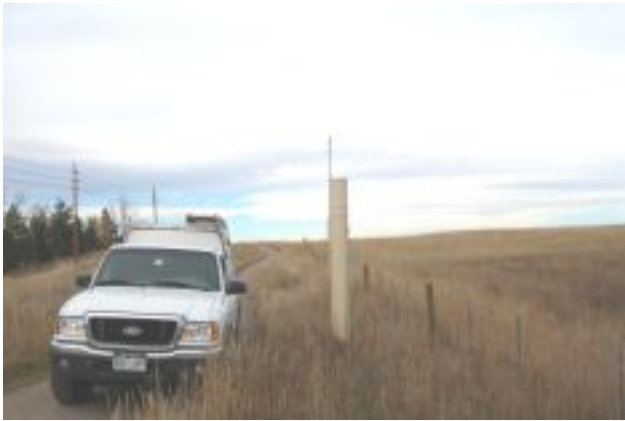
1110 - Gunbarrel - a

| Site ID | Site Name | Latitude | Longitude | Elevation | Install Date | TB Mfr. | TB Condition |
|---|---|---|---|---|---|---|---|
| 5.0 | Good rain catch and wind protection | | | | | | |

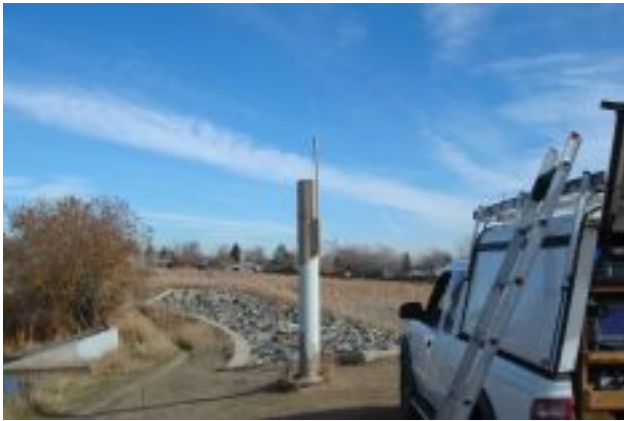
1200 - Broomfield #3207 - a

| Site ID | Site Name | Latitude | Longitude | Elevation | Install Date | TB Mfr. | TB Condition |
|---|---|---|---|---|---|---|---|
| 4.0 | Good rain catch little wind protection | | | | | | |

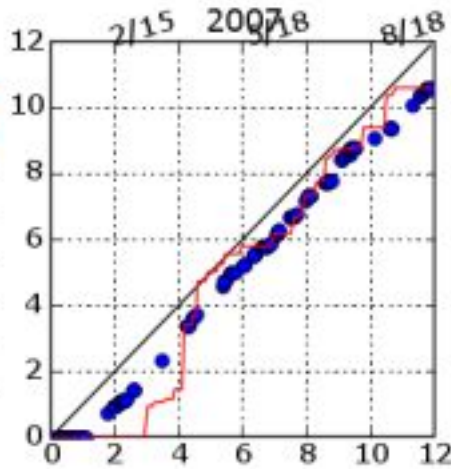
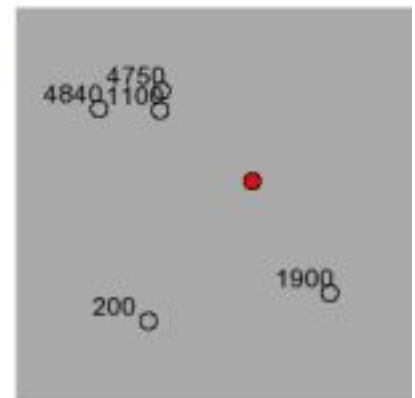
Double Mass Plot

| | Accum | #Rpts | Start | End |
|---|---|---|---|---|
| 4840 | 14.292 | 958 | 01/01/07 | 11/21/07 |
| 200 | 12.221 | 765 | 03/08/07 | 10/31/07 |

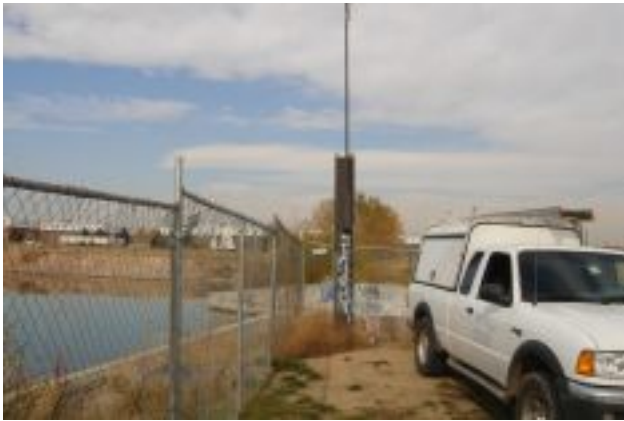
1300 - Hidden Lake - a

| Site ID | Site Name | Latitude | Longitude | Elevation | Install Date | TB Mfr. | TB Condition |
|---|---|---|---|---|---|---|---|
| 4.0 | Good rain catch no wind protection | | | | | | |

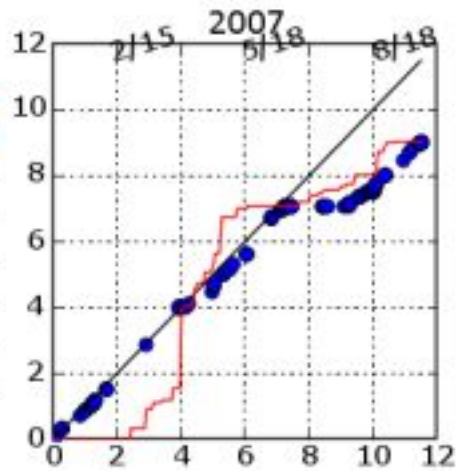
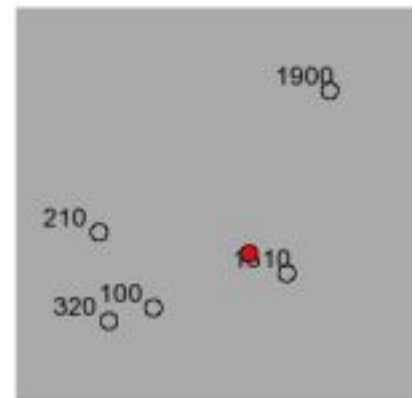
Double Mass Plot

| | Accum | #Rpts | Start | End |
|---|---|---|---|---|
| 320 | 11.583 | 714 | 03/08/07 | 10/31/07 |
| 210 | 10.396 | 705 | 03/05/07 | 10/31/07 |

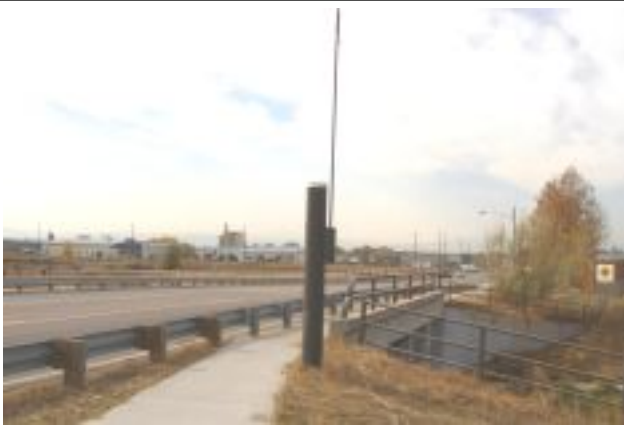
1310 - Little Dry Creek @ 64th - a

| Site ID | Site Name | Latitude | Longitude | Elevation | Install Date | TB Mfr. | TB Condition |
|---|---|---|---|---|---|---|---|
| 4.0 | Good rain catch no wind protection | | | | | | |

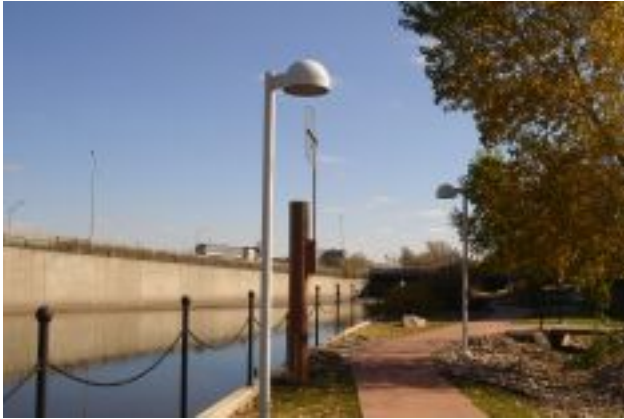
1320 - SPR @ 3rd (Mausoleum) - a

| Site ID | Site Name | Latitude | Longitude | Elevation | Install Date | TB Mfr. | TB Condition |
|---|---|---|---|---|---|---|---|
| 4.0 | Tree to SW in cone angle | | | | | | |

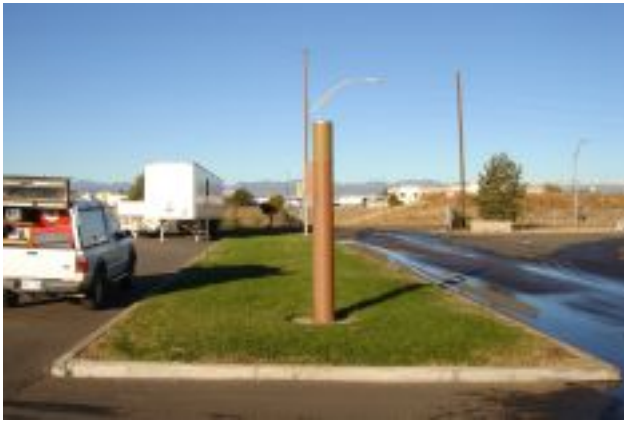
1330 - Roslyn - a

| Site ID | Site Name | Latitude | Longitude | Elevation | Install Date | TB Mfr. | TB Condition |
|---|---|---|---|---|---|---|---|
| 4.0 | Good rain catch no wind protection | | | | | | |

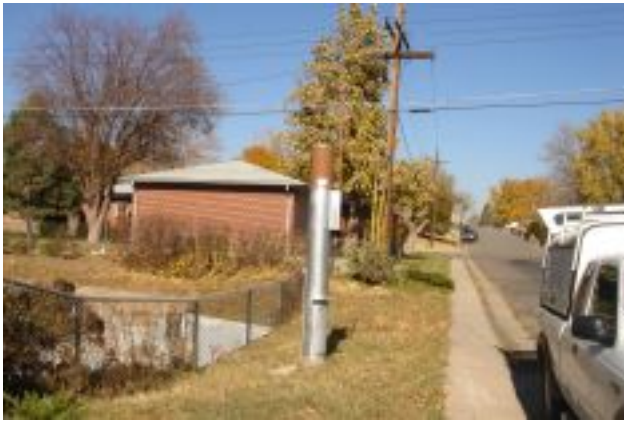
1340 - Sanderson Gulch - a

| Site ID | Site Name | Latitude | Longitude | Elevation | Install Date | TB Mfr. | TB Condition |
|---|---|---|---|---|---|---|---|
| 5.0 | Good rain catch and wind protection | | | | | | |

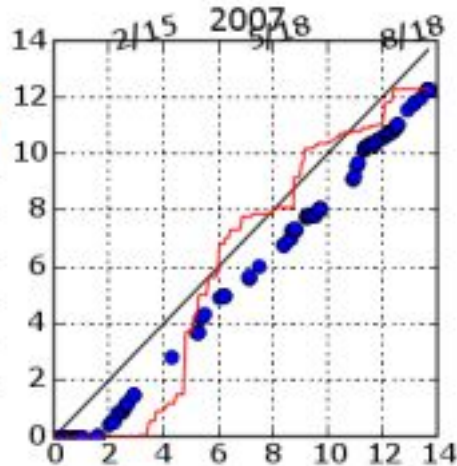
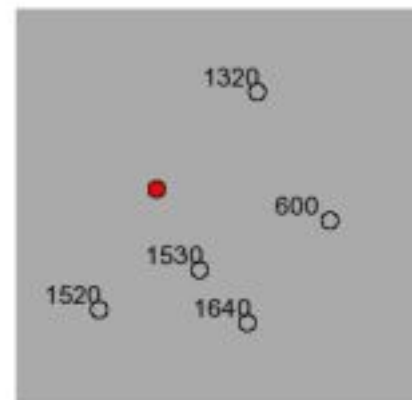
Double Mass Plot

| | Accum | #Rpts | Start | End |
|---|---|---|---|---|
| 1520 | 12.744 | 913 | 01/01/07 | 11/21/07 |
| 1640 | 13.719 | 925 | 01/01/07 | 11/21/07 |

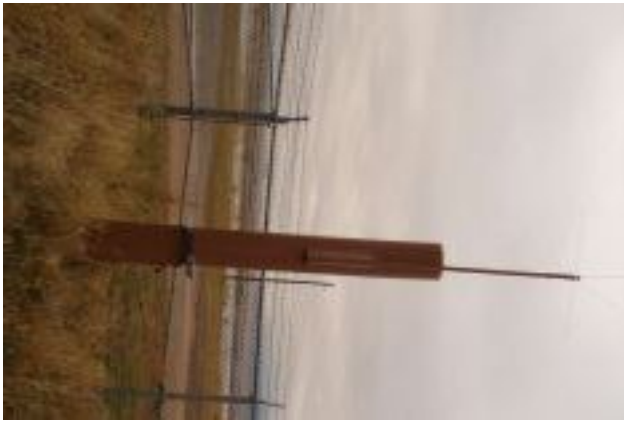
1350 - Chatfield Dam - a

| Site ID | Site Name | Latitude | Longitude | Elevation | Install Date | TB Mfr. | TB Condition |
|---|---|---|---|---|---|---|---|
| 4.0 | Good rain catch no wind protection | | | | | | |

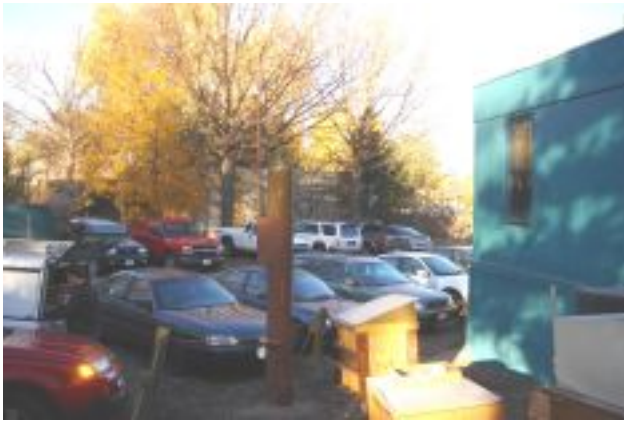
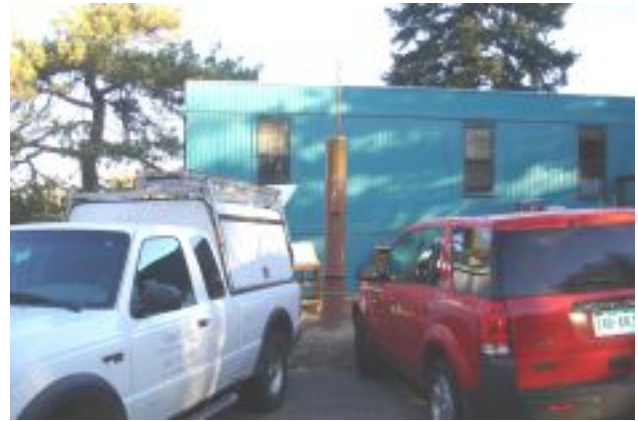
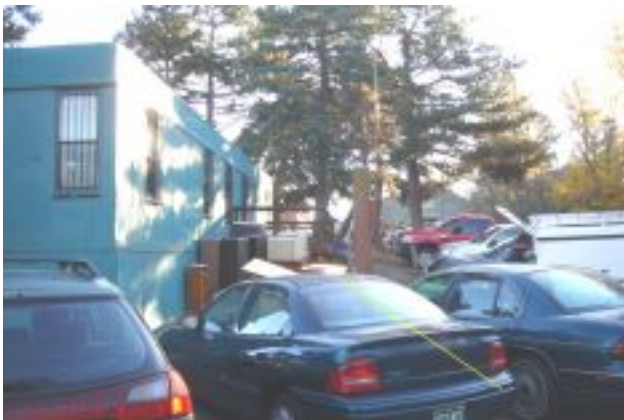
| Site ID | Site Name | Latitude | Longitude | Elevation | Install Date | TB Mfr. | TB Condition |
|---|---|---|---|---|---|---|---|
| 4.0 | Fair rain catch and good wind protection | | | | | | |

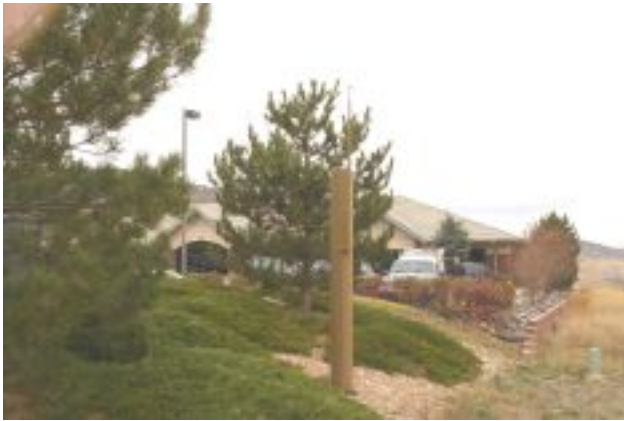
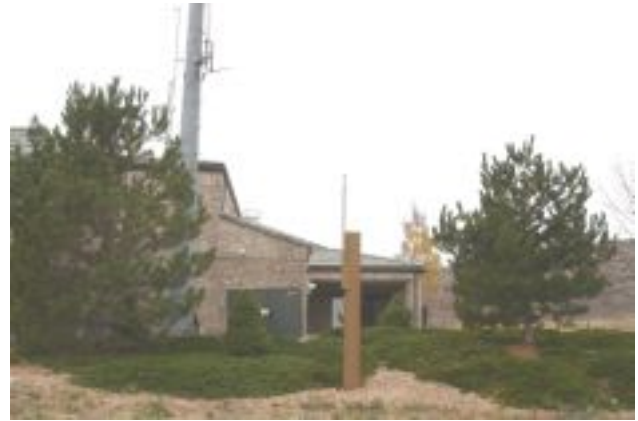
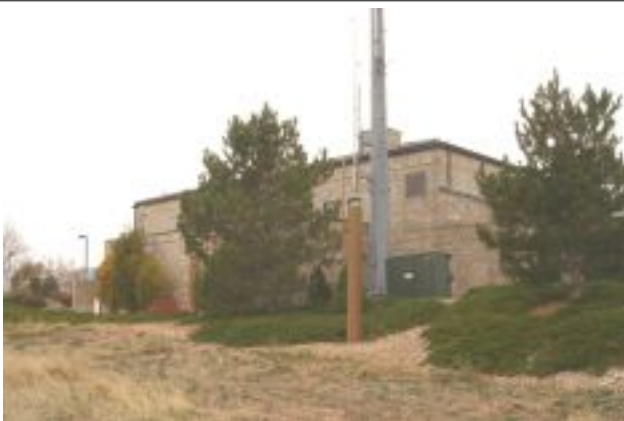
| Site ID | Site Name | Latitude | Longitude | Elevation | Install Date | TB Mfr. | TB Condition |
|---|---|---|---|---|---|---|---|
| 4.0 | Cell tower proximity | | | | | | |

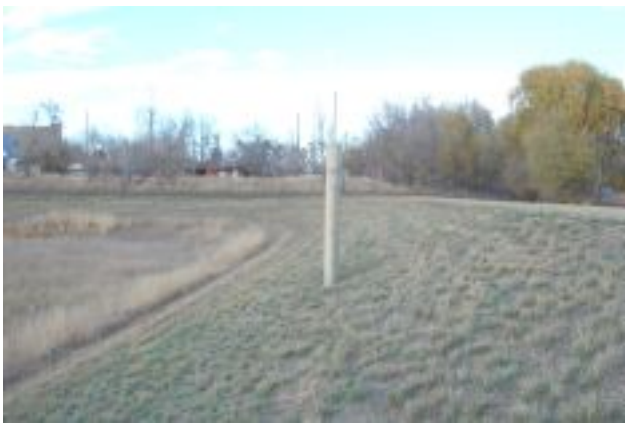
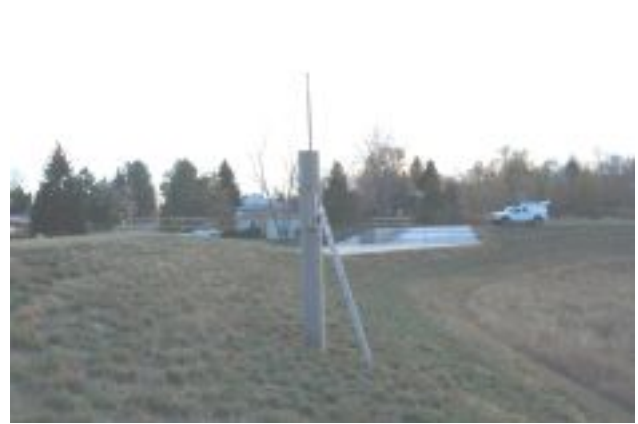
| Site ID | Site Name | Latitude | Longitude | Elevation | Install Date | TB Mfr. | TB Condition |
|---|---|---|---|---|---|---|---|
| 4.0 | Good rain catch no wind protection | | | | | | |

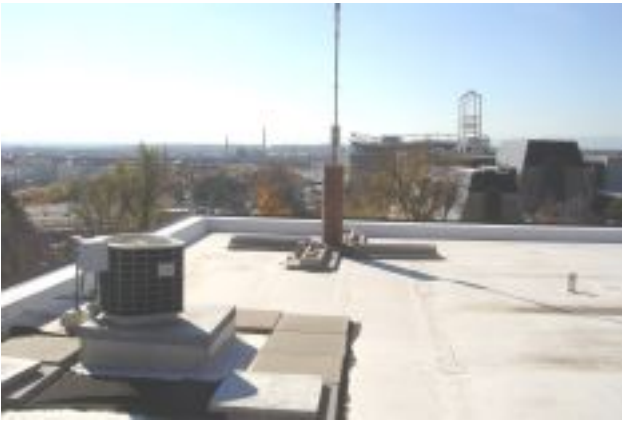
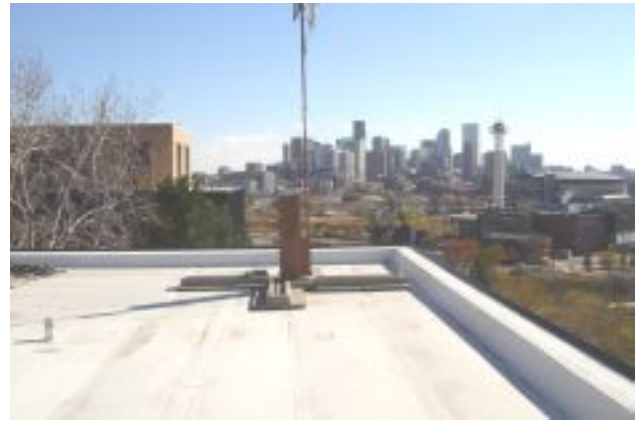
| Site ID | Site Name | Latitude | Longitude | Elevation | Install Date | TB Mfr. | TB Condition |
|---|---|---|---|---|---|---|---|
| 4.0 | Exposure to wind on roof | | | | | | |

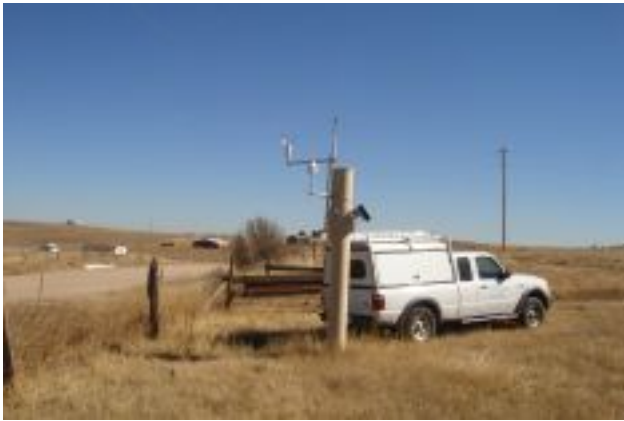
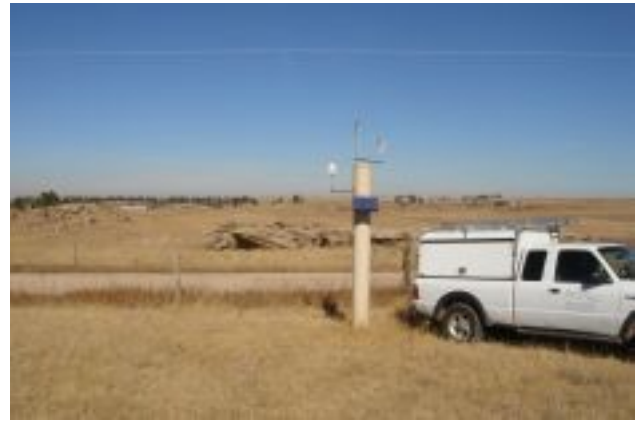
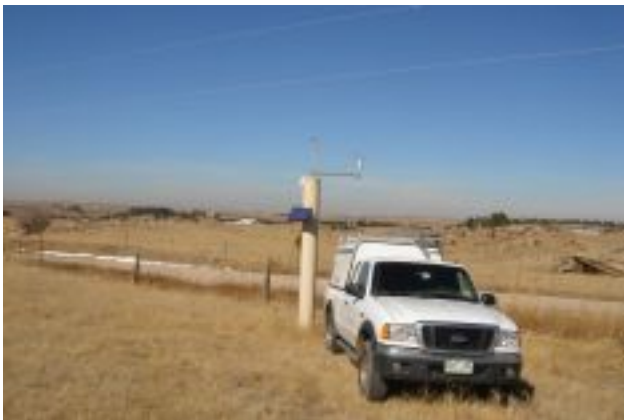
| Site ID | Site Name | Latitude | Longitude | Elevation | Install Date | TB Mfr. | TB Condition |
|---|---|---|---|---|---|---|---|
| 4.0 | Good rain catch no wind protection | | | | | | |

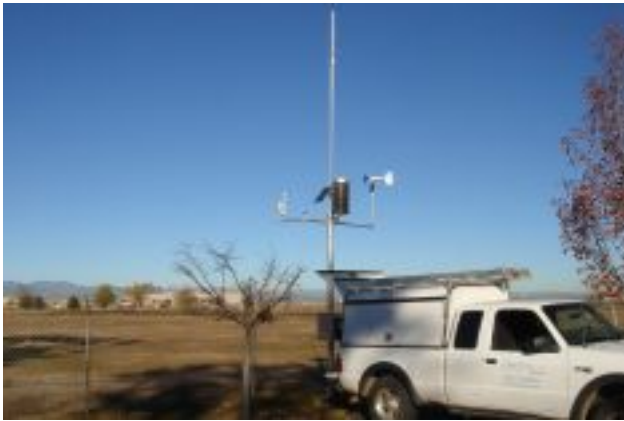
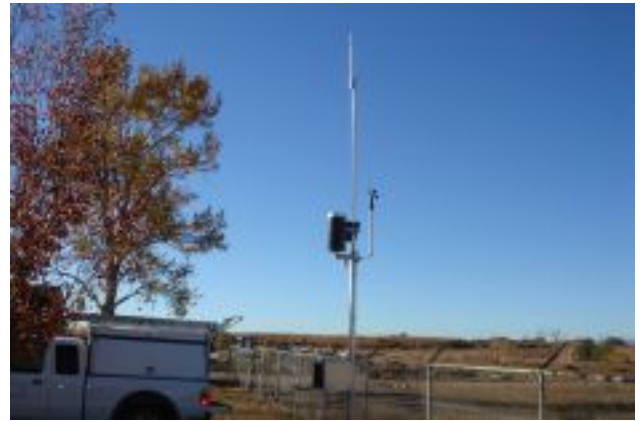
| Site ID | Site Name | Latitude | Longitude | Elevation | Install Date | TB Mfr. | TB Condition |
|---|---|---|---|---|---|---|---|
| 4.0 | Good rain catch no wind protection | | | | | | |

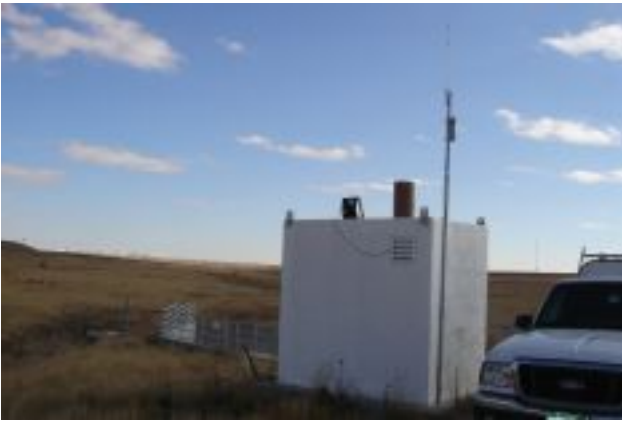
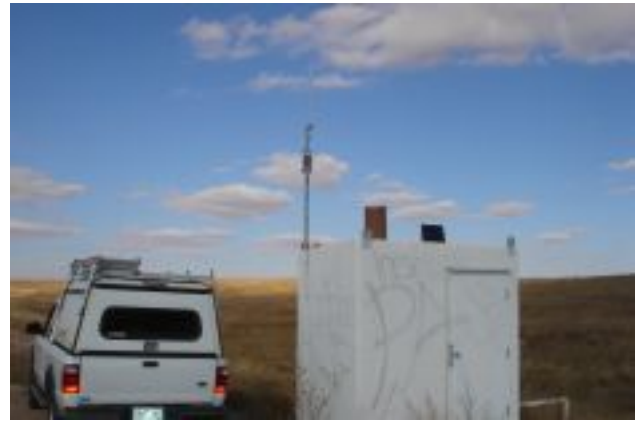
| Site ID | Site Name | Latitude | Longitude | Elevation | Install Date | TB Mfr. | TB Condition |
|---|---|---|---|---|---|---|---|
| 4.0 | Atop building, good rain catch no wind protection | | | | | | |

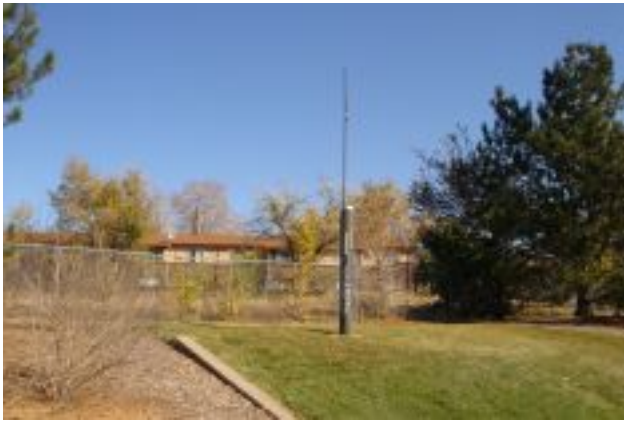
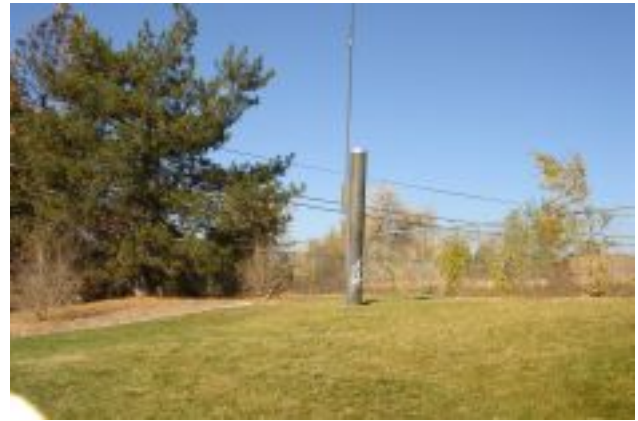
| Site ID | Site Name | Latitude | Longitude | Elevation | Install Date | TB Mfr. | TB Condition |
|---|---|---|---|---|---|---|---|
| 5.0 | Irrigation contamination, good rain catch and wind protection | | | | | | |

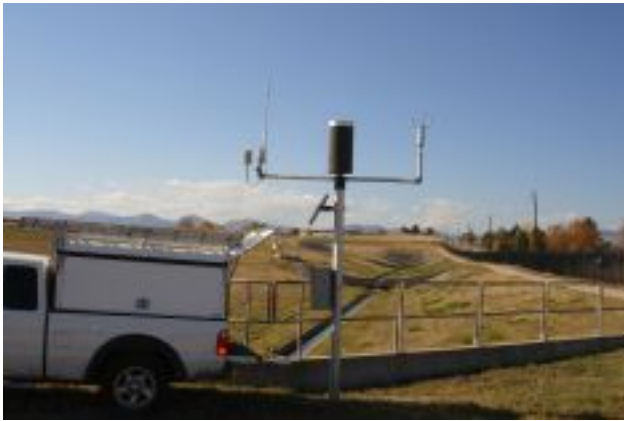
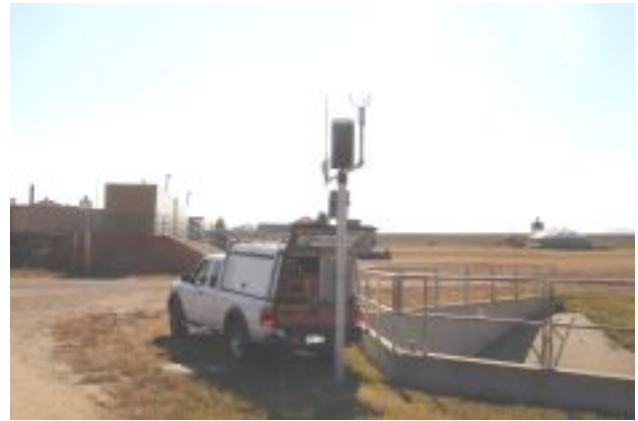
| Site ID | Site Name | Latitude | Longitude | Elevation | Install Date | TB Mfr. | TB Condition |
|---|---|---|---|---|---|---|---|
| 4.0 | Good rain catch no wind protection | | | | | | |

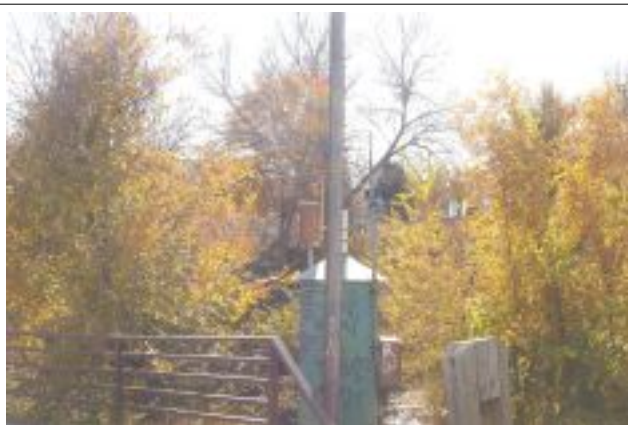
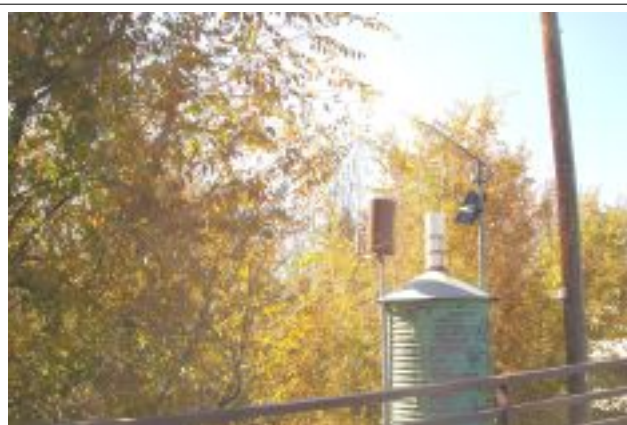
| Site ID | Site Name | Latitude | Longitude | Elevation | Install Date | TB Mfr. | TB Condition |
|---|---|---|---|---|---|---|---|
| 4.0 | Atop USGS "hut" with trees just outside of cone angle | | | | | | |

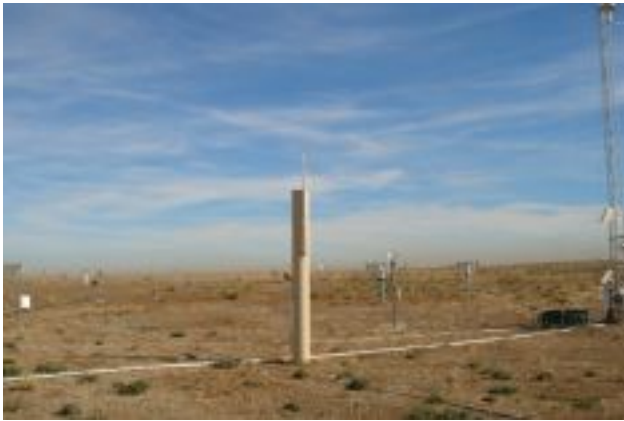
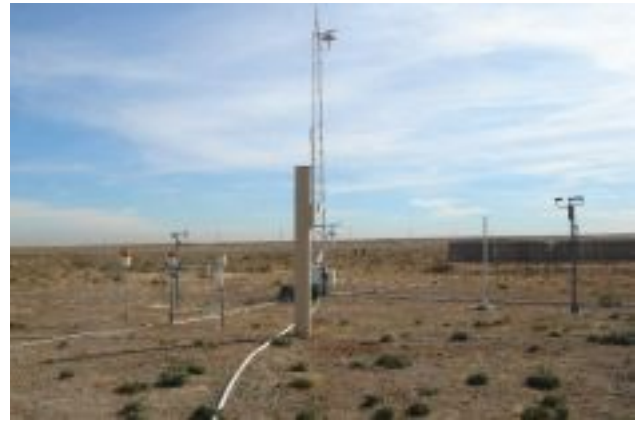
1540 - Marshall Test - a

| Site ID | Site Name | Latitude | Longitude | Elevation | Install Date | TB Mfr. | TB Condition |
|---|---|---|---|---|---|---|---|
| 4.0 | Good rain catch no wind protection | | | | | | |

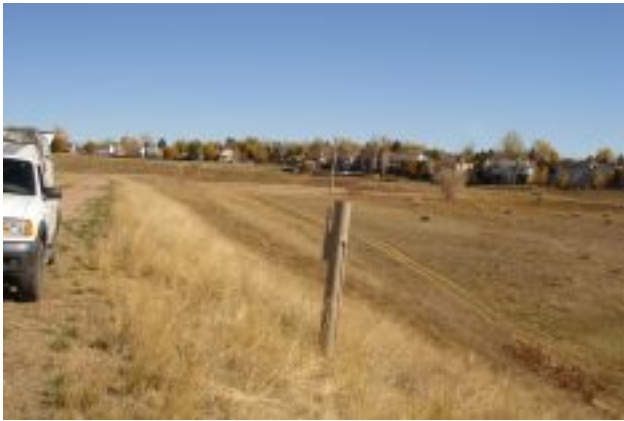
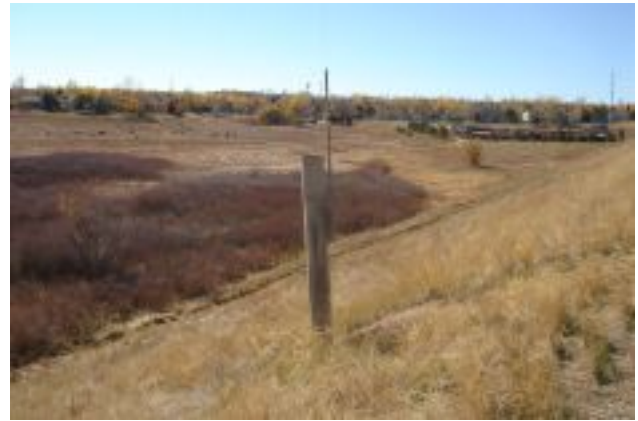
1600 - Englewood Dam - a

| Site ID | Site Name | Latitude | Longitude | Elevation | Install Date | TB Mfr. | TB Condition |
|---|---|---|---|---|---|---|---|
| 4.0 | Good rain catch no wind protection | | | | | | |

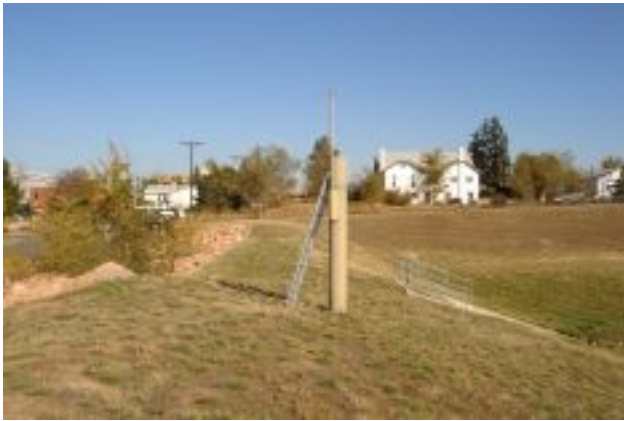
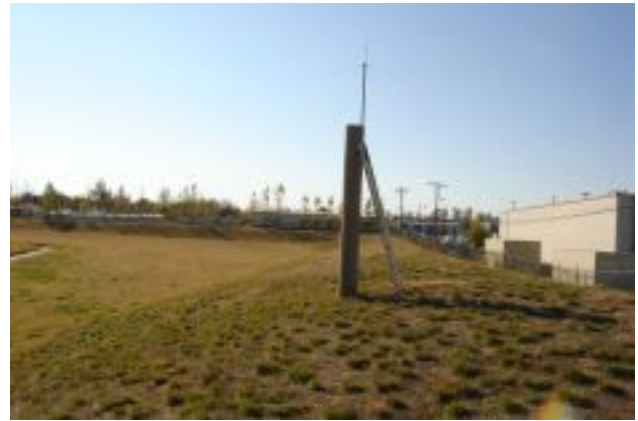
1620 - Slaughterhouse - a

| Site ID | Site Name | Latitude | Longitude | Elevation | Install Date | TB Mfr. | TB Condition |
|---|---|---|---|---|---|---|---|
| 4.0 | Good rain catch no wind protection | | | | | | |

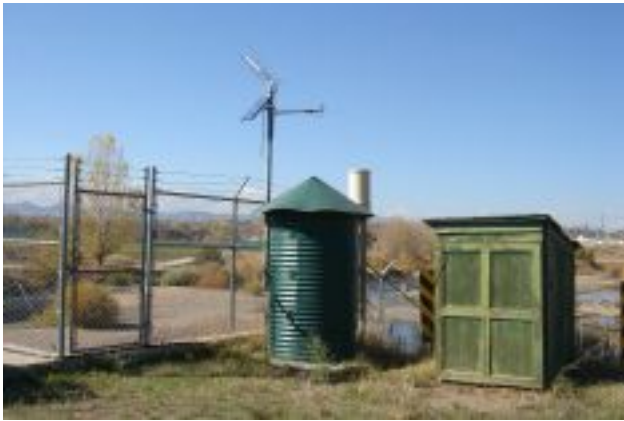
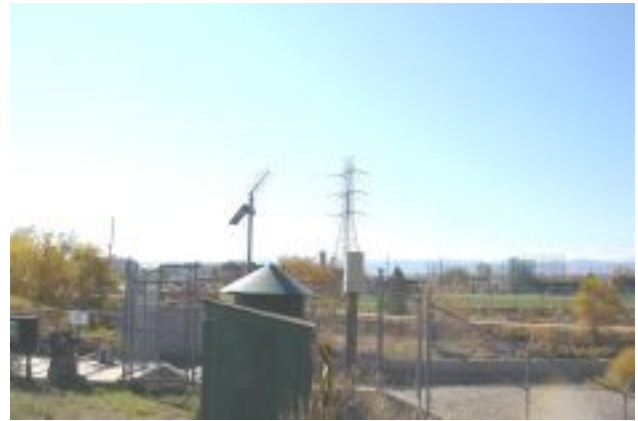
1640 - SPR at Union Ave. - a

| Site ID | Site Name | Latitude | Longitude | Elevation | Install Date | TB Mfr. | TB Condition |
|---|---|---|---|---|---|---|---|
| 4.0 | Good rain catch no wind protection | | | | | | |

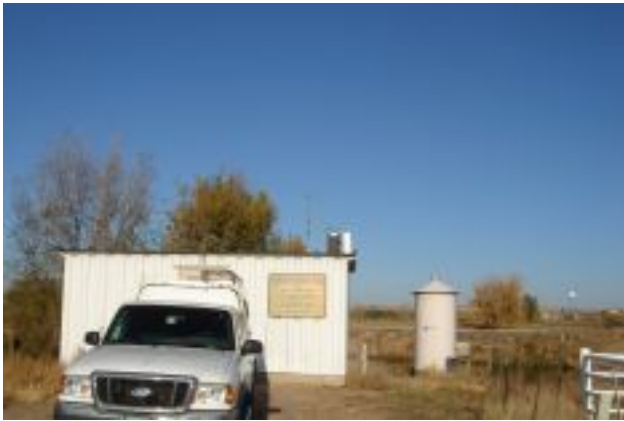
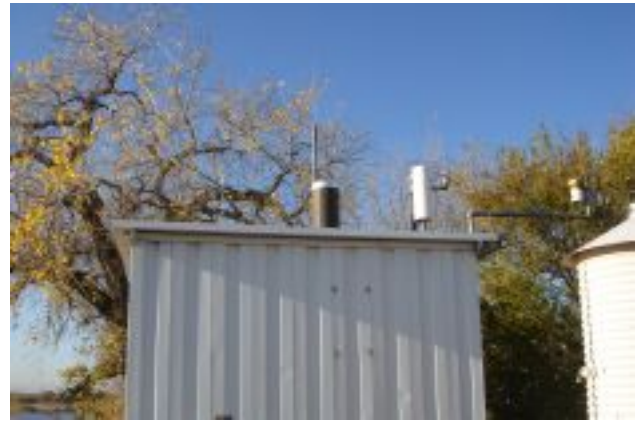
1660 - SPR at Henderson - a

| Site ID | Site Name | Latitude | Longitude | Elevation | Install Date | TB Mfr. | TB Condition |
|---|---|---|---|---|---|---|---|
| 4.0 | Atop USGS building/partial exposure to wind | | | | | | |

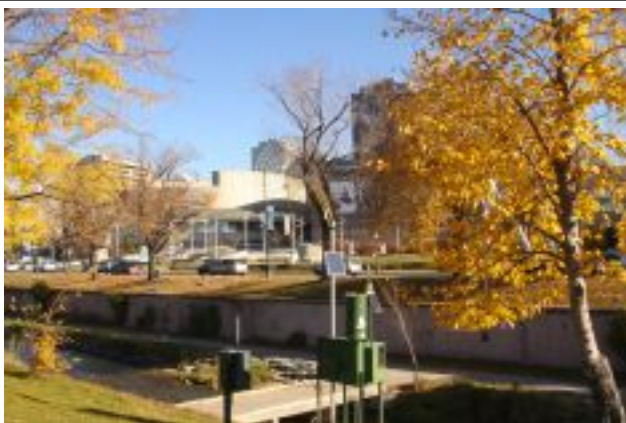
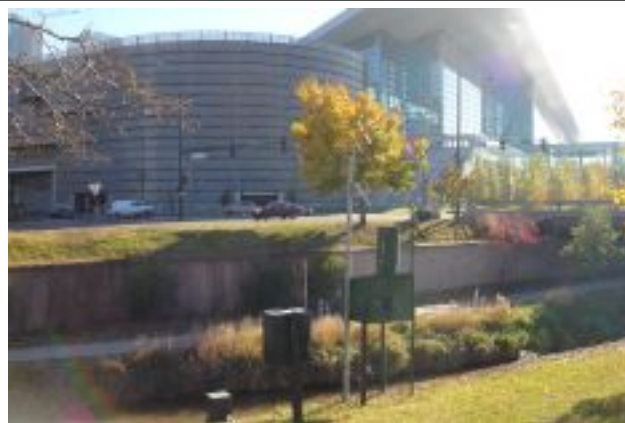
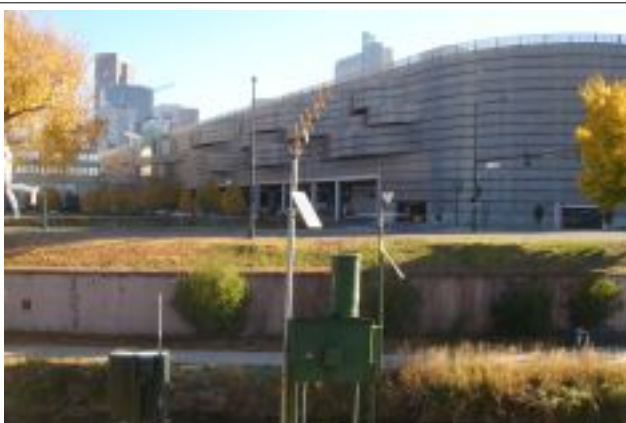
1700 - Cherry Ck @ Champa - a

| Site ID | Site Name | Latitude | Longitude | Elevation | Install Date | TB Mfr. | TB Condition |
|---|---|---|---|---|---|---|---|
| 3.0 | Tree to N in cone angle, little wind protection | | | | | | |
