## Urban Drainage and Flood Control District

| Site ID | Site Name | Latitude | Longitude | Elevation | Install Date | TB Mfr. | TB Condition |

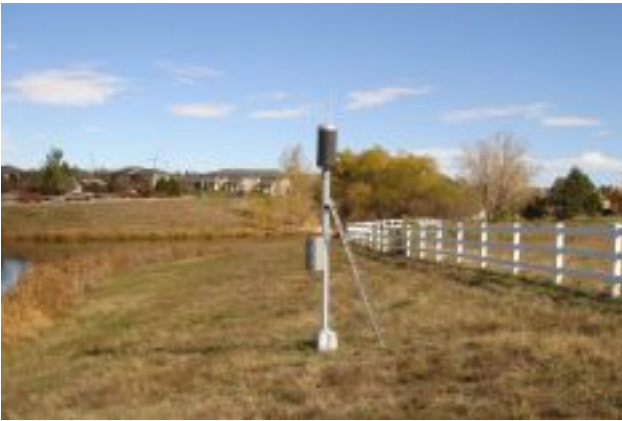
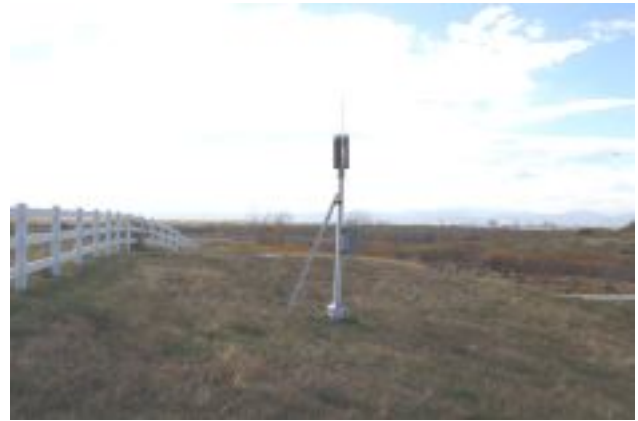
1710 - Shop Creek - a

| Site ID | Site Name | Latitude | Longitude | Elevation | Install Date | TB Mfr. | TB Condition |
|---|---|---|---|---|---|---|---|
| 4.0 | Good rain catch no wind protection | | | | | | |

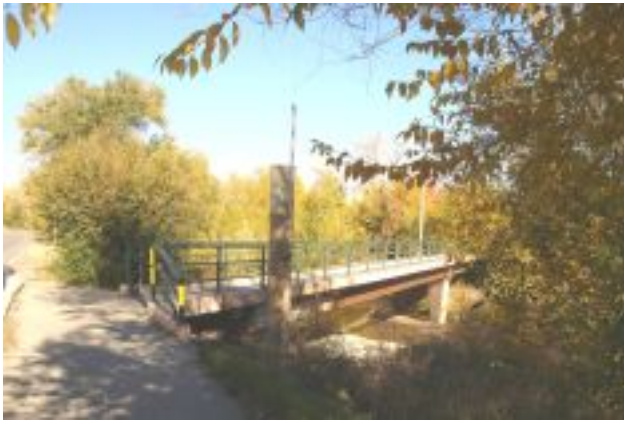
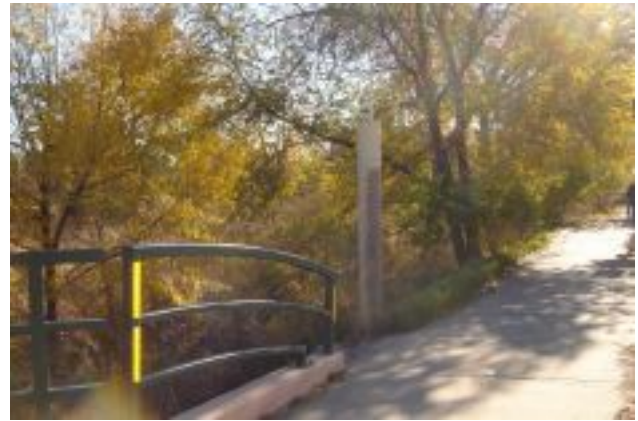
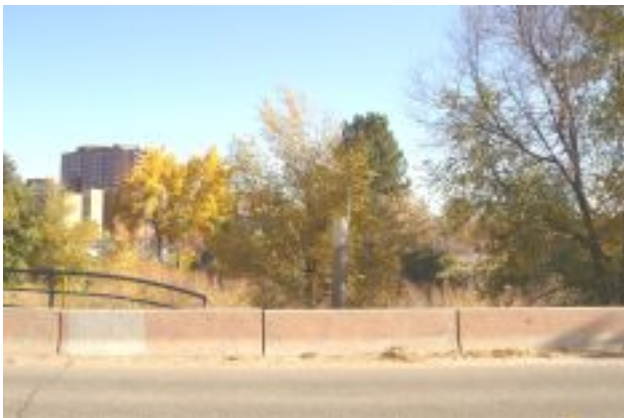
1720 - Cherry Ck/Steele - a

| Site ID | Site Name | Latitude | Longitude | Elevation | Install Date | TB Mfr. | TB Condition |
|---|---|---|---|---|---|---|---|
| 3.0 | Large tree to E in cone angle, small tree to N just outside cone angle | | | | | | |

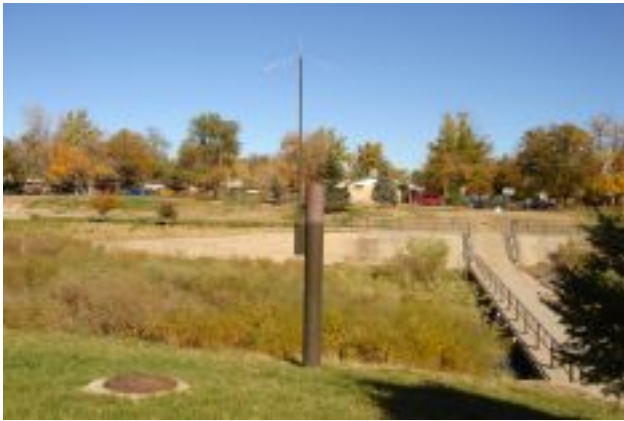
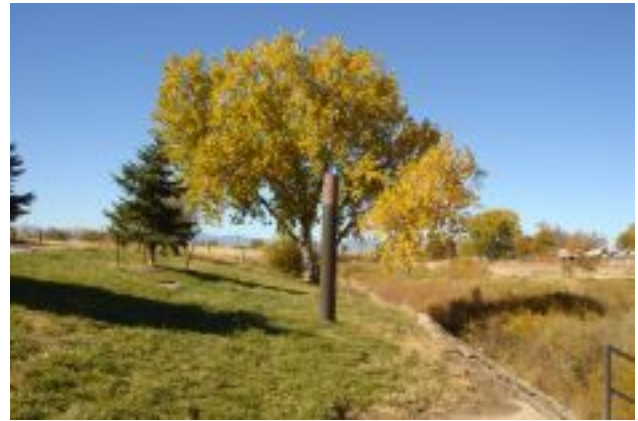
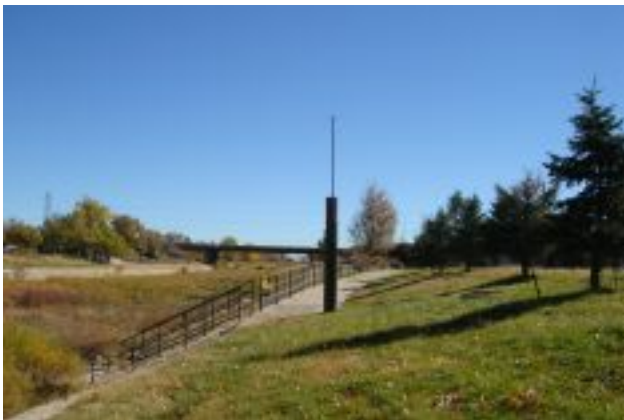
1800 - Sand Creek Park - a

| Site ID | Site Name | Latitude | Longitude | Elevation | Install Date | TB Mfr. | TB Condition |
|---|---|---|---|---|---|---|---|
| 5.0 | Good rain catch, fair wind protection | | | | | | |

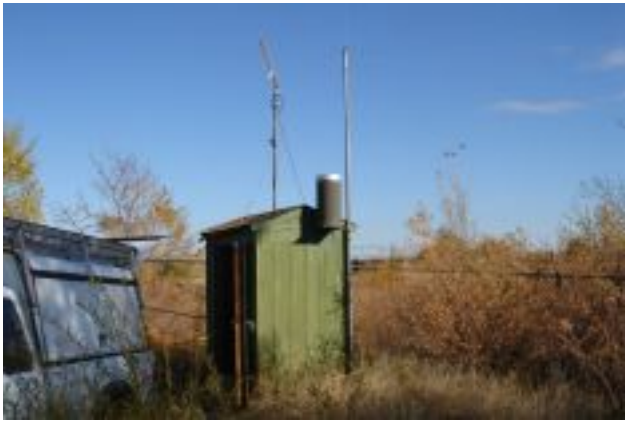
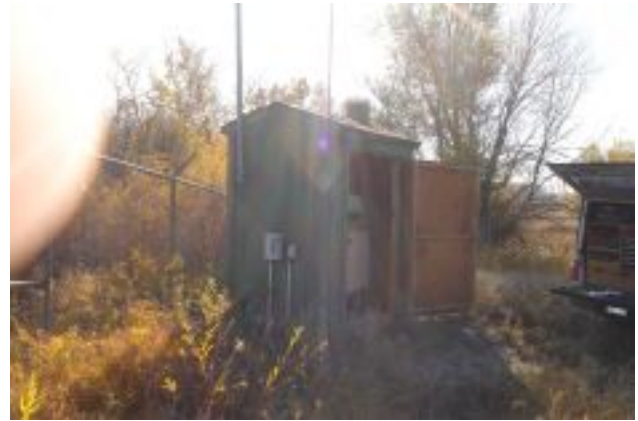
1810 - Sand Creek Mouth - a

| Site ID | Site Name | Latitude | Longitude | Elevation | Install Date | TB Mfr. | TB Condition |
|---|---|---|---|---|---|---|---|
| 4.0 | Mounted on side of USGS hut, Good rain catch no wind protection | | | | | | |

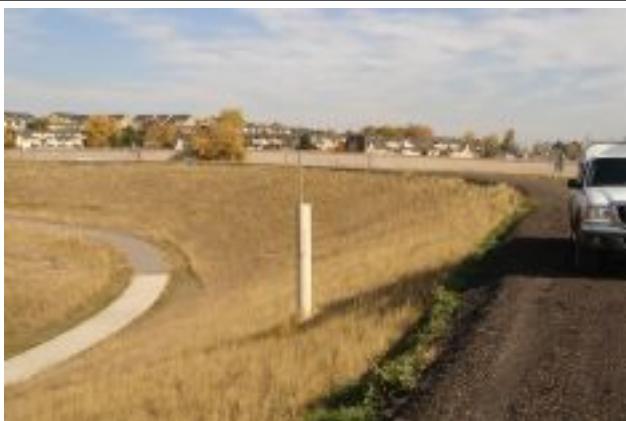
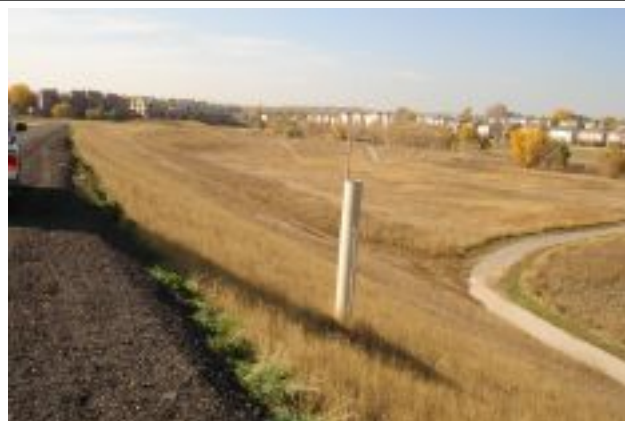
1900 - Niver Detention - a

| Site ID | Site Name | Latitude | Longitude | Elevation | Install Date | TB Mfr. | TB Condition |
|---|---|---|---|---|---|---|---|
| 4.0 | Good rain catch no wind protection | | | | | | |

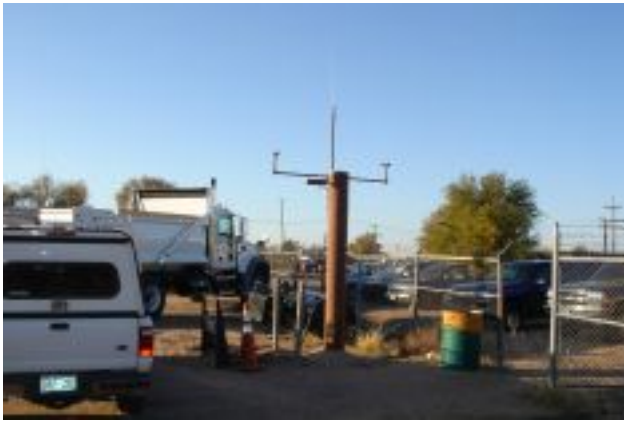
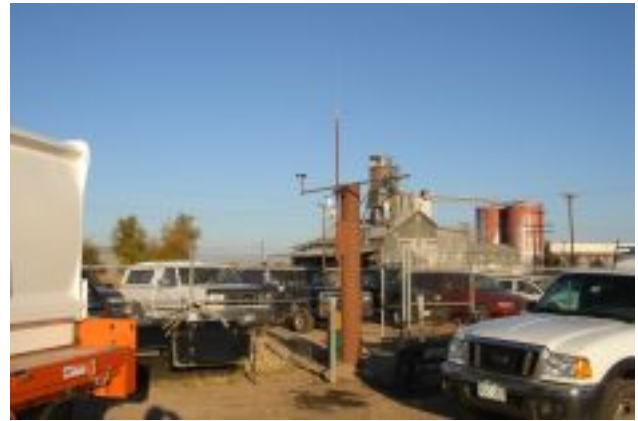
| Site ID | Site Name | Latitude | Longitude | Elevation | Install Date | TB Mfr. | TB Condition |
|---|---|---|---|---|---|---|---|
| 4.0 | Good rain catch no wind protection (move expected) | | | | | | |

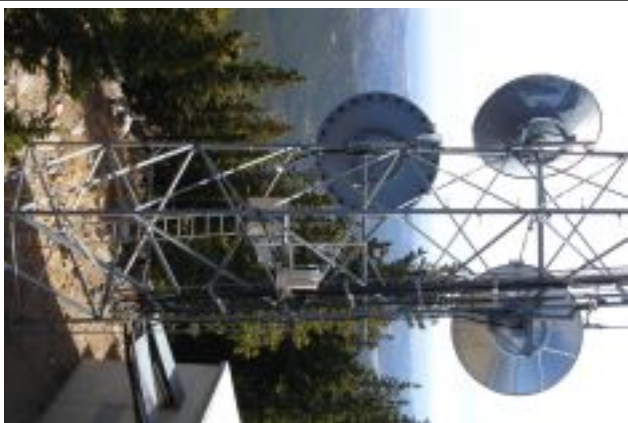
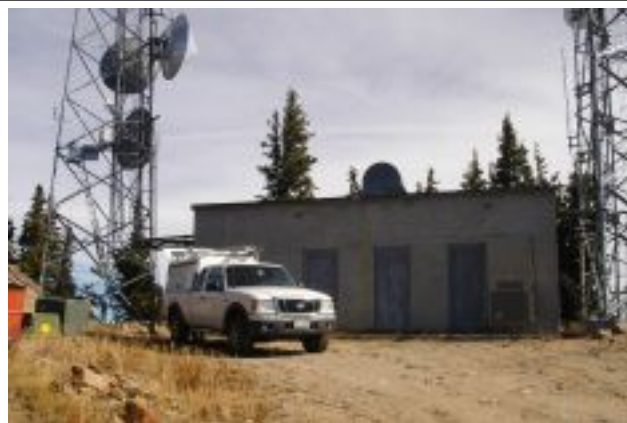
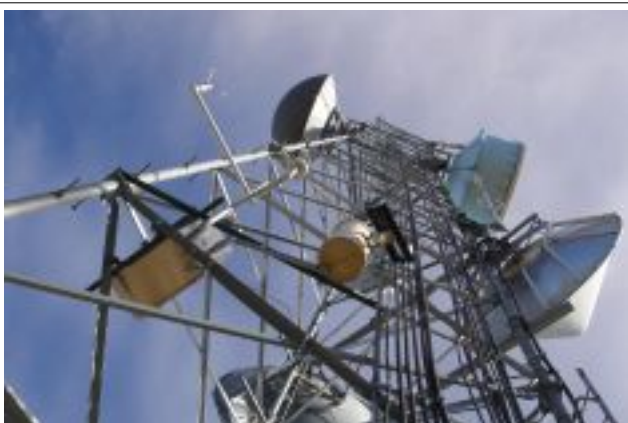
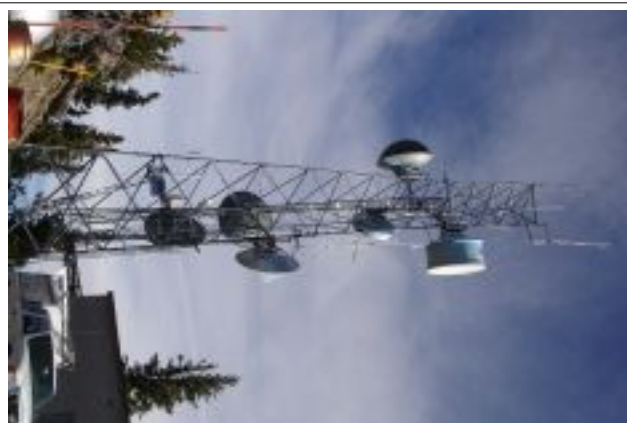
| Site ID | Site Name | Latitude | Longitude | Elevation | Install Date | TB Mfr. | TB Condition |
|---|---|---|---|---|---|---|---|
| 3.0 | Mounted on side of large tower, very windy | | | | | | |

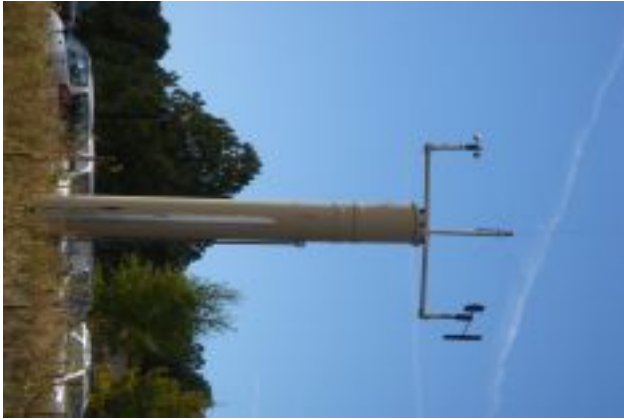
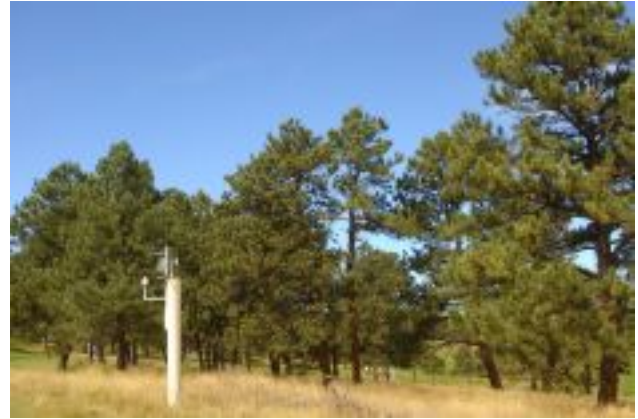
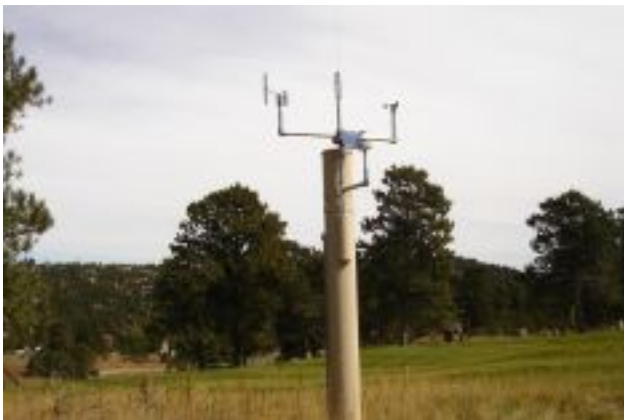
| Site ID | Site Name | Latitude | Longitude | Elevation | Install Date | TB Mfr. | TB Condition |
|---|---|---|---|---|---|---|---|
| 5.0 | Tree to N outside of cone angle, good rain catch and wind protection | | | | | | |

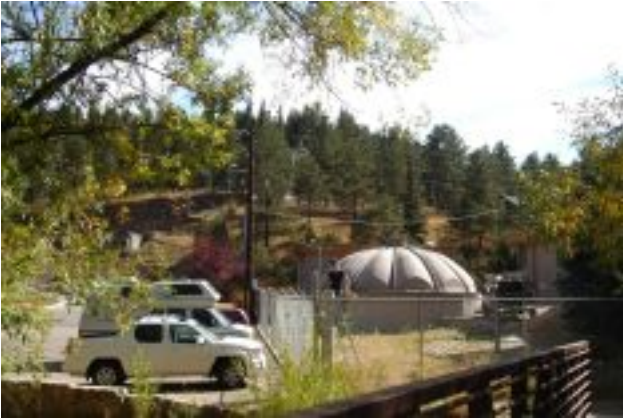
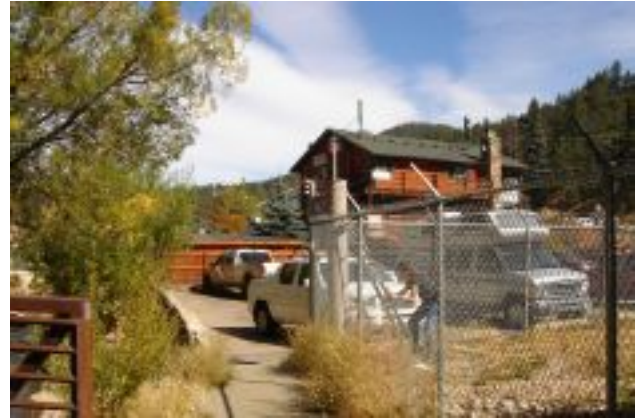
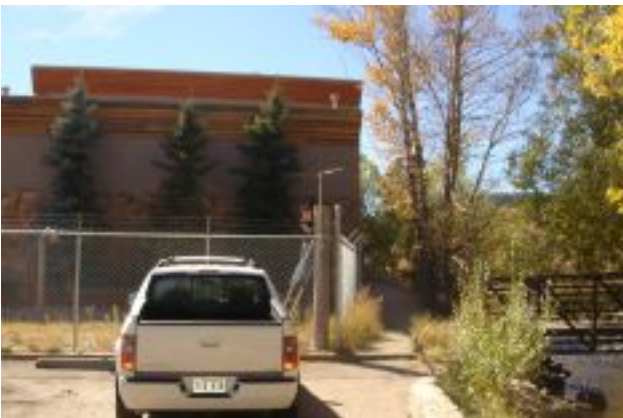
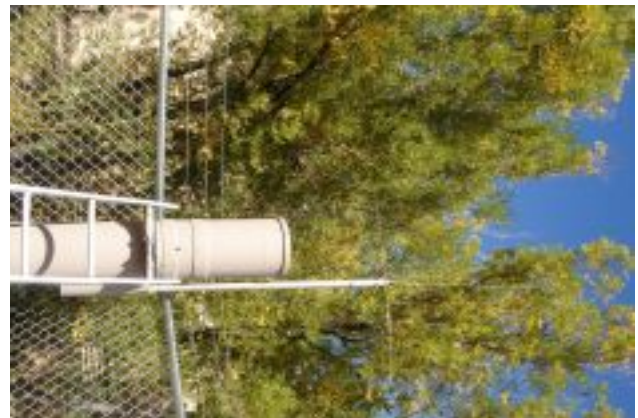
| Site ID | Site Name | Latitude | Longitude | Elevation | Install Date | TB Mfr. | TB Condition |
|---|---|---|---|---|---|---|---|
| 3.0 | Trees @ ~ 60-70 degrees creekside, canopy too close | | | | | | |

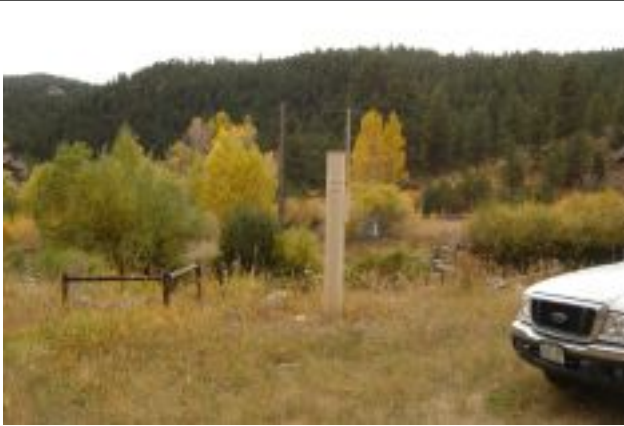
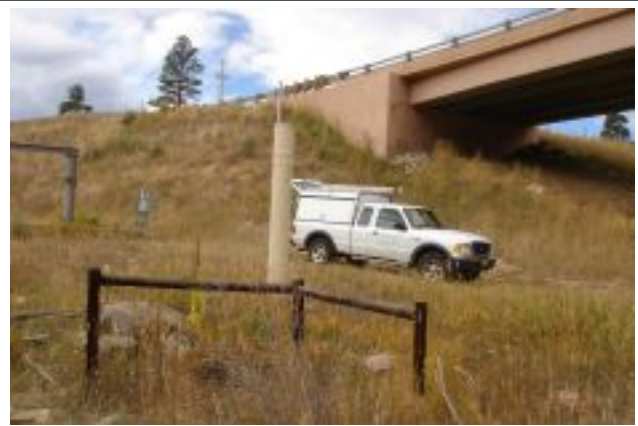
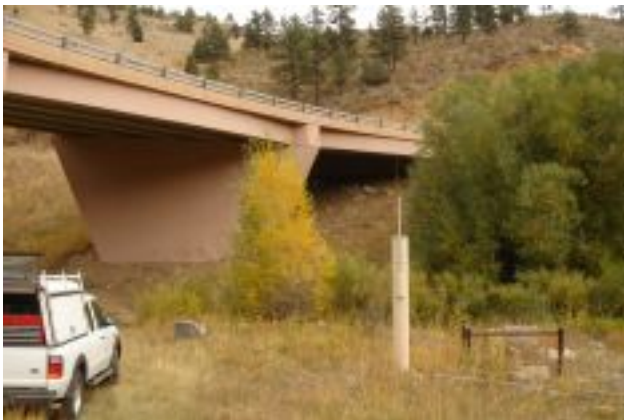
| Site ID | Site Name | Latitude | Longitude | Elevation | Install Date | TB Mfr. | TB Condition |
|---|---|---|---|---|---|---|---|
| 5.0 | Good rain catch fair wind protection, by elevated roadway | | | | | | |

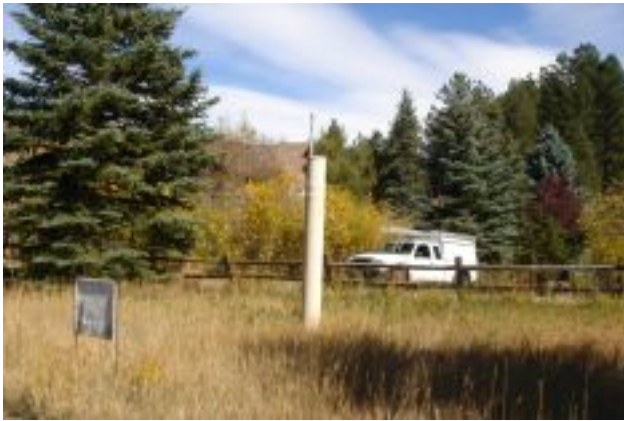
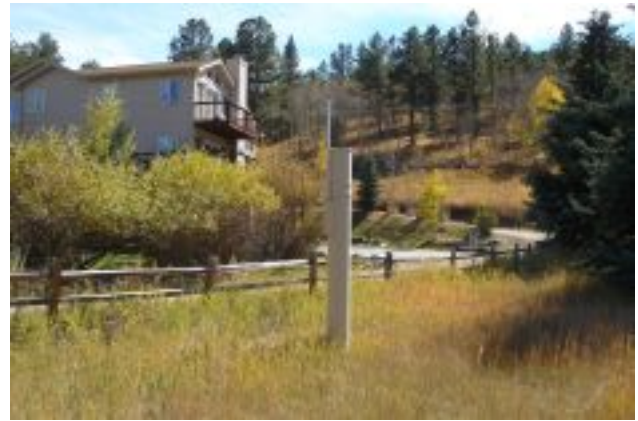
| Site ID | Site Name | Latitude | Longitude | Elevation | Install Date | TB Mfr. | TB Condition |
|---|---|---|---|---|---|---|---|
| 5.0 | Good rain exposure and wind protection | | | | | | |

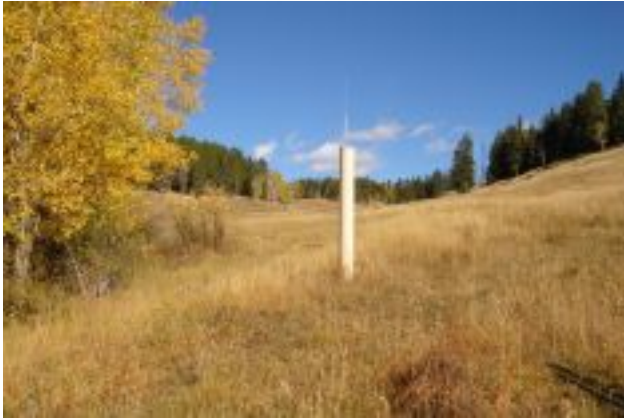
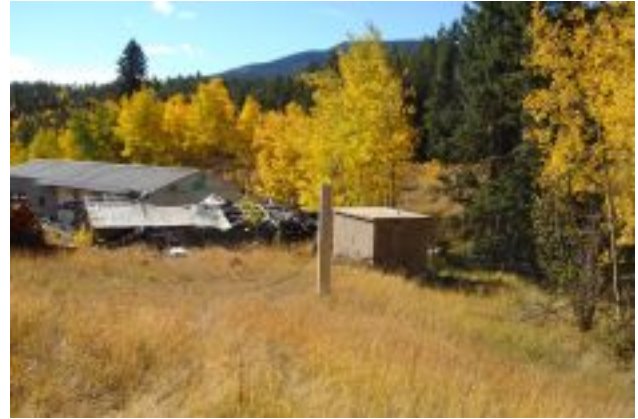
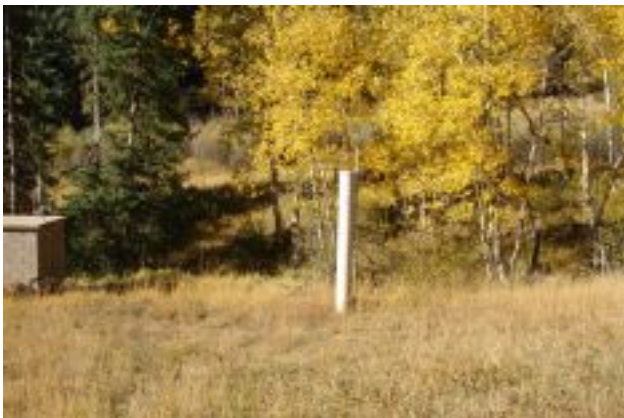
| Site ID | Site Name | Latitude | Longitude | Elevation | Install Date | TB Mfr. | TB Condition |
|---|---|---|---|---|---|---|---|
| 5.0 | Aspen trees to W outside of cone angle, Good rain catch and wind protection | | | | | | |

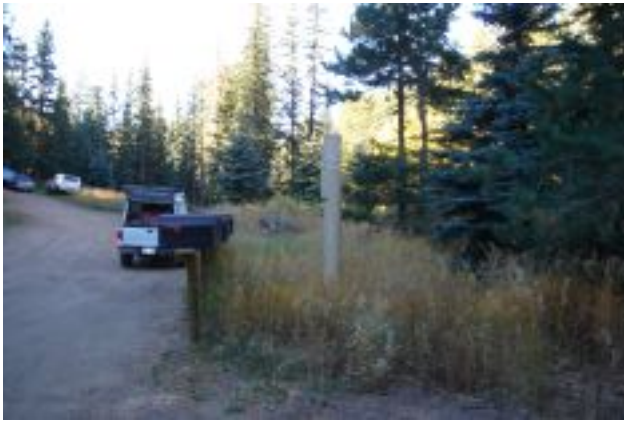
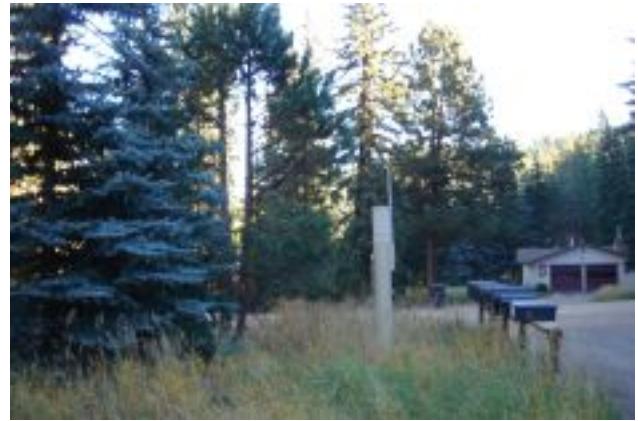
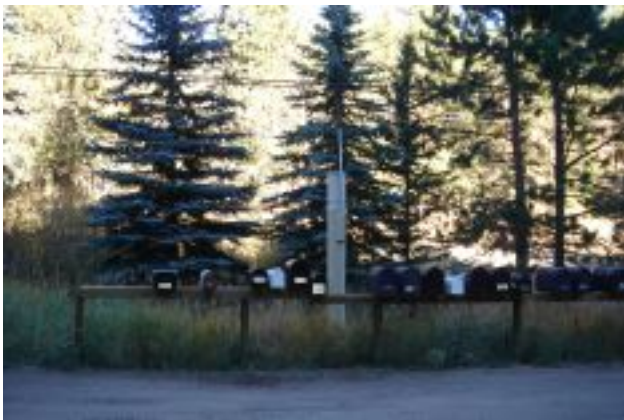
| Site ID | Site Name | Latitude | Longitude | Elevation | Install Date | TB Mfr. | TB Condition |
|---|---|---|---|---|---|---|---|
| 3.0 | Trees to W in the cone angle | | | | | | |

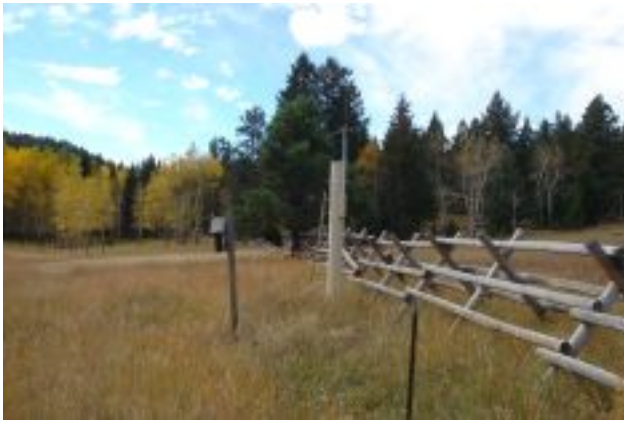
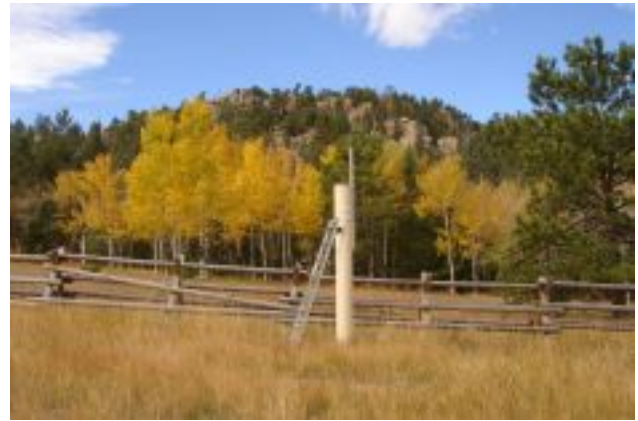
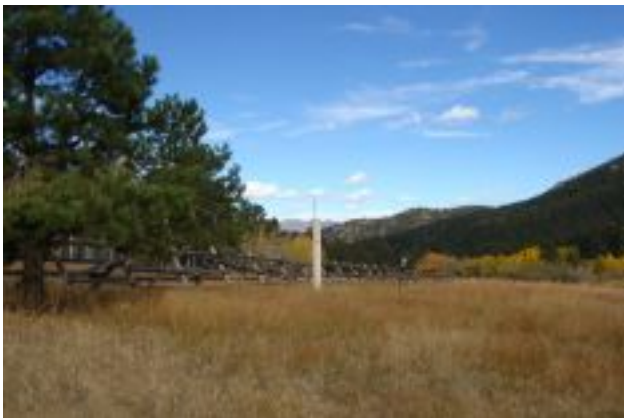
| Site ID | Site Name | Latitude | Longitude | Elevation | Install Date | TB Mfr. | TB Condition |
|---|---|---|---|---|---|---|---|
| 5.0 | Good rain catch and wind protection | | | | | | |

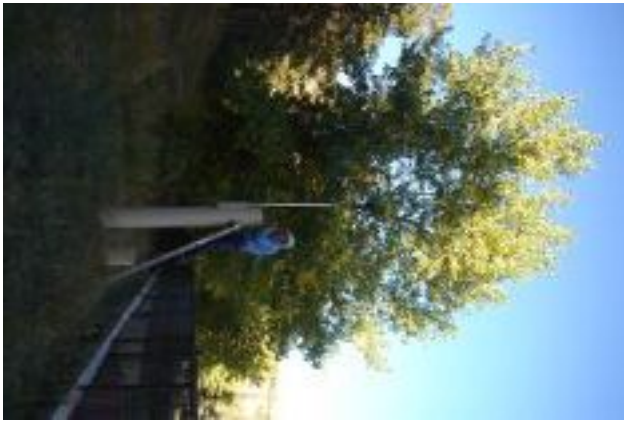
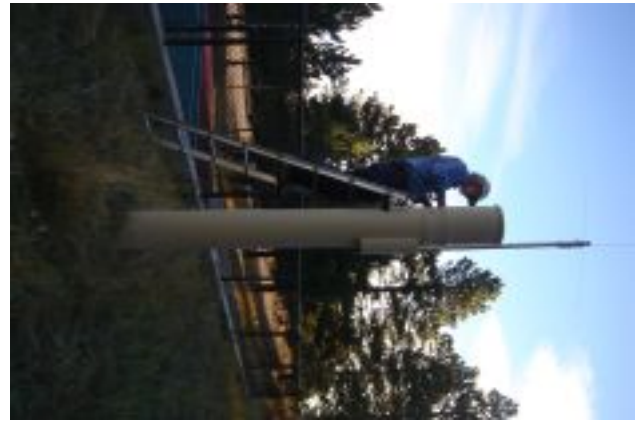
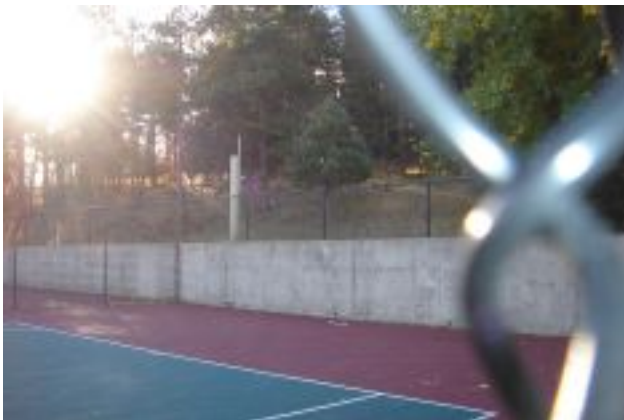
| Site ID | Site Name | Latitude | Longitude | Elevation | Install Date | TB Mfr. | TB Condition |
|---|---|---|---|---|---|---|---|
| 4.0 | Large tree to W in cone angle, good wind protection | | | | | | |

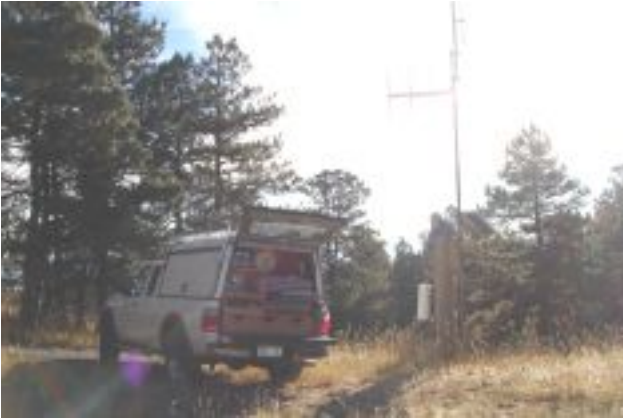
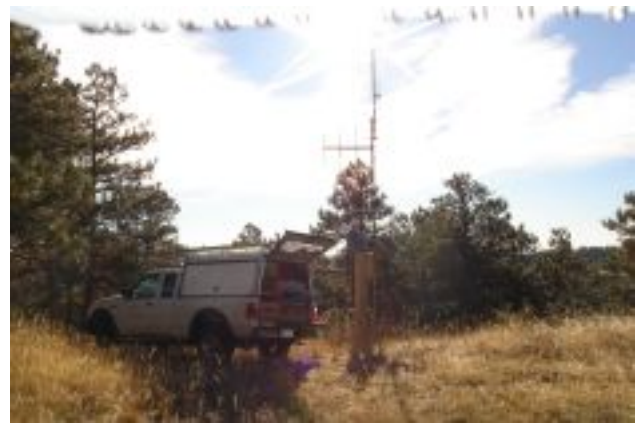
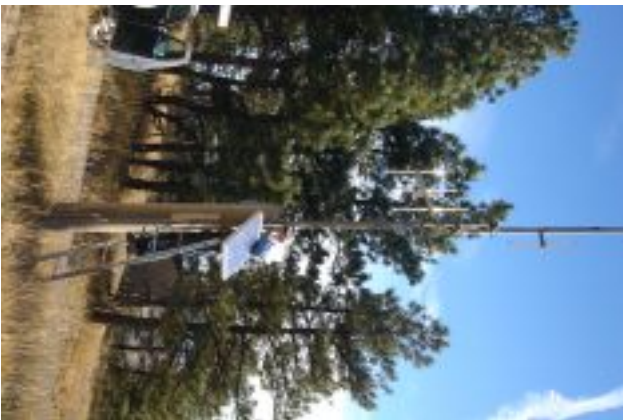
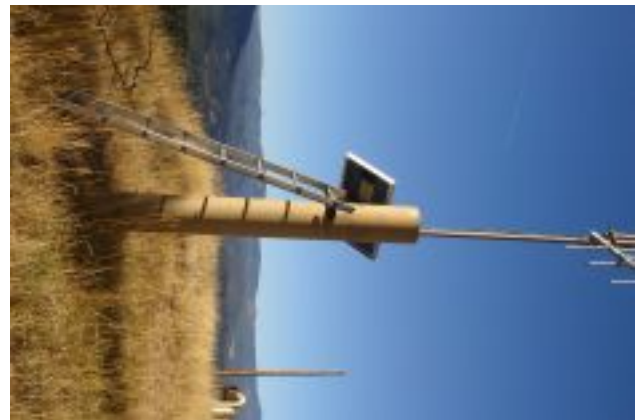
| Site ID | Site Name | Latitude | Longitude | Elevation | Install Date | TB Mfr. | TB Condition |
|---|---|---|---|---|---|---|---|
| 5.0 | Good rain catch and wind protection | | | | | | |

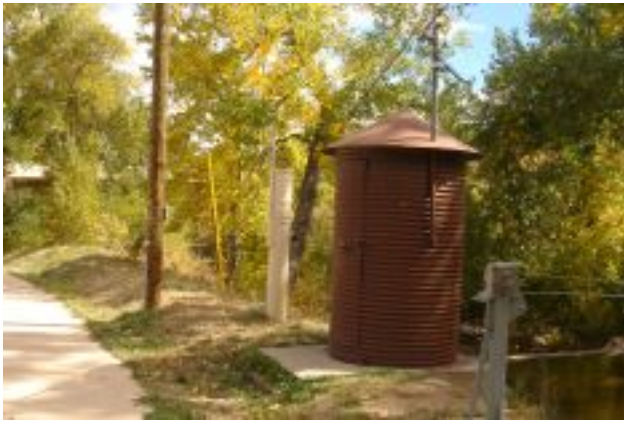
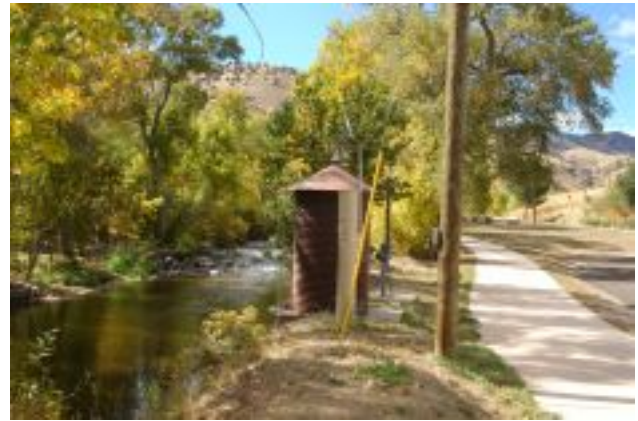
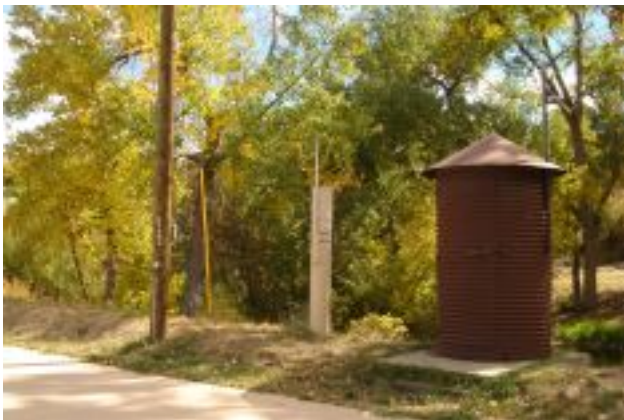
| Site ID | Site Name | Latitude | Longitude | Elevation | Install Date | TB Mfr. | TB Condition |
|---|---|---|---|---|---|---|---|
| 4.0 | Large trees along creek, fair rain catch, good wind protection | | | | | | |

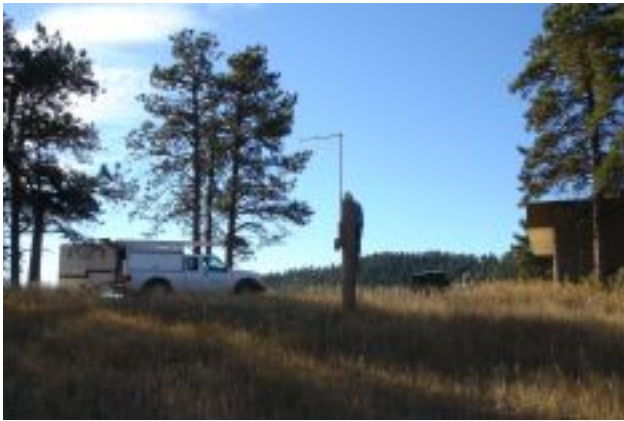
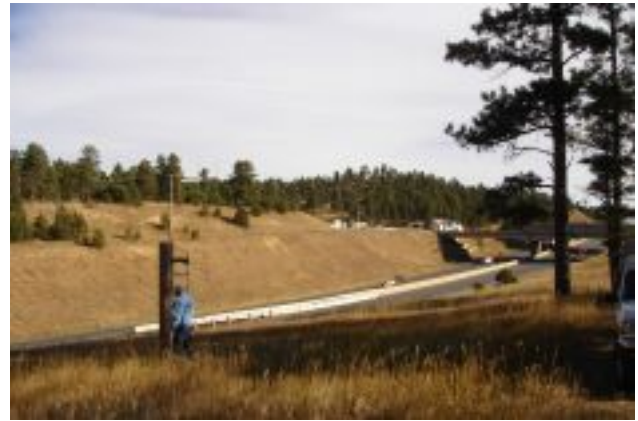
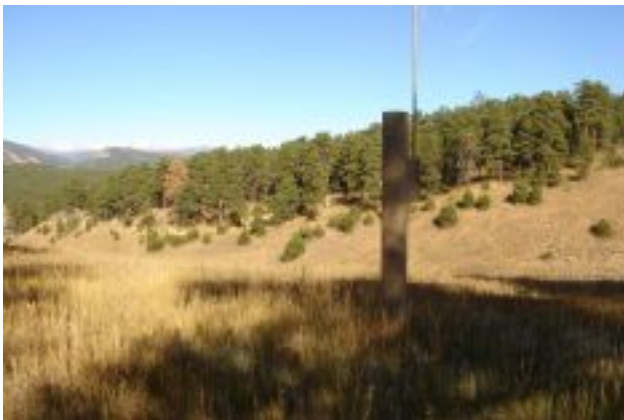
| Site ID | Site Name | Latitude | Longitude | Elevation | Install Date | TB Mfr. | TB Condition |
|---|---|---|---|---|---|---|---|
| 5.0 | Canopy excellent, wind run from west improved by presence of forest across highway, other angles sheltered | | | | | | |

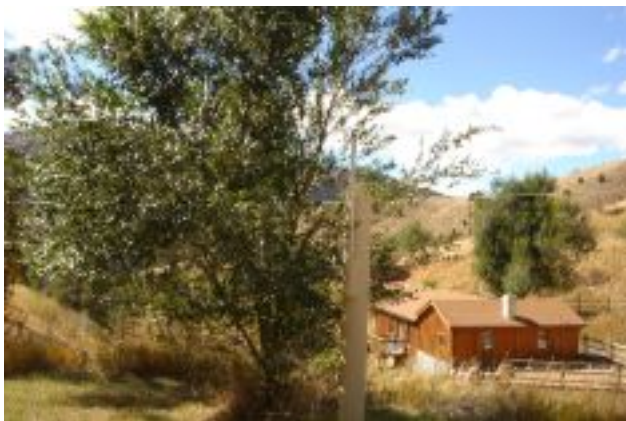
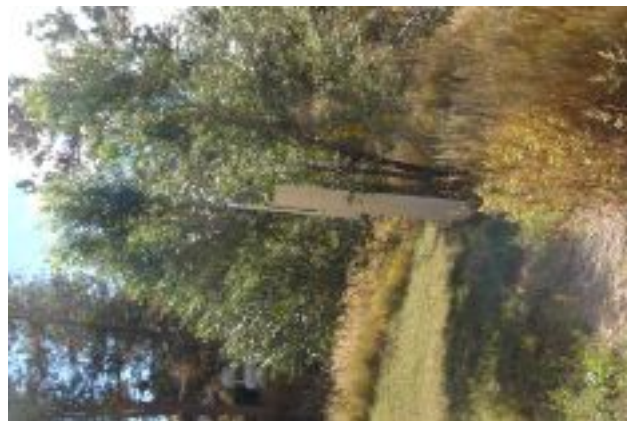
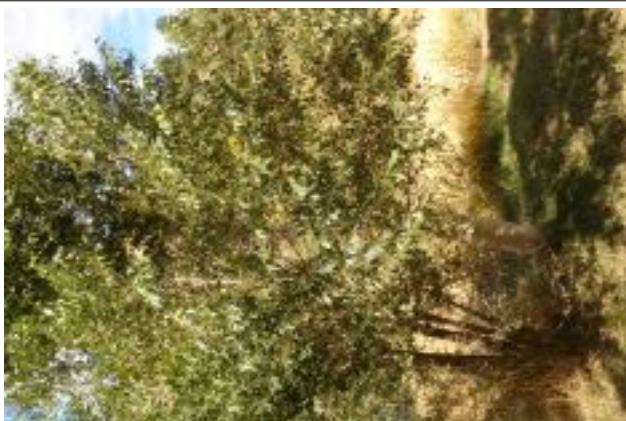
| Site ID | Site Name | Latitude | Longitude | Elevation | Install Date | TB Mfr. | TB Condition |
|---|---|---|---|---|---|---|---|
| 1.0 | Tree almost enveloping standpipe | | | | | | |

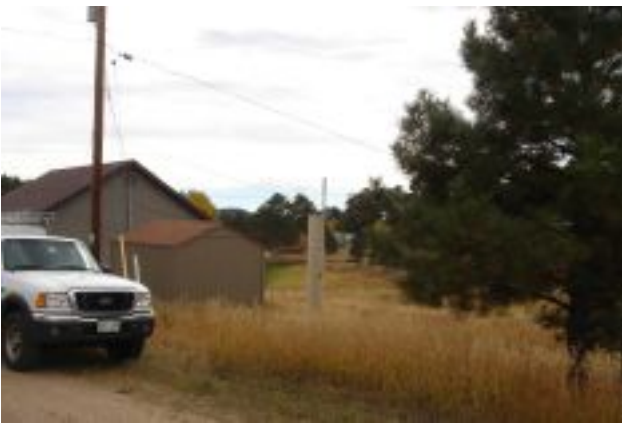
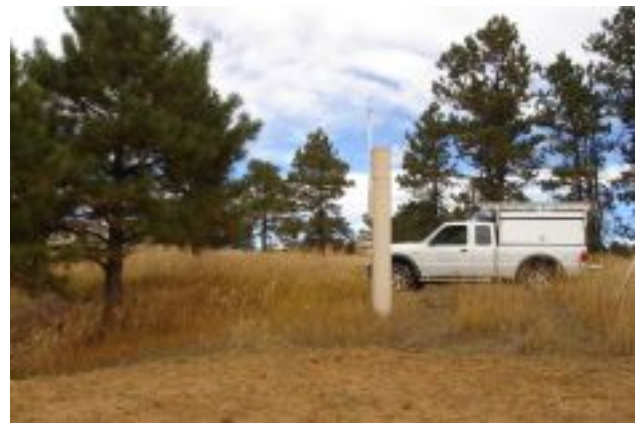
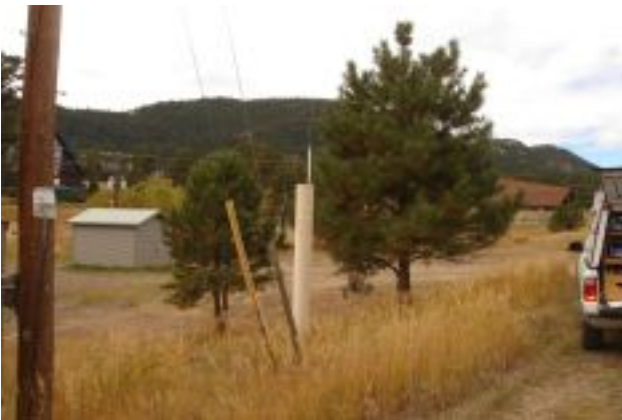
| Site ID | Site Name | Latitude | Longitude | Elevation | Install Date | TB Mfr. | TB Condition |
|---|---|---|---|---|---|---|---|
| 4.0 | Tree to W @ 20 ft., 30 ft. tall, in cone angle, good wind protection | | | | | | |

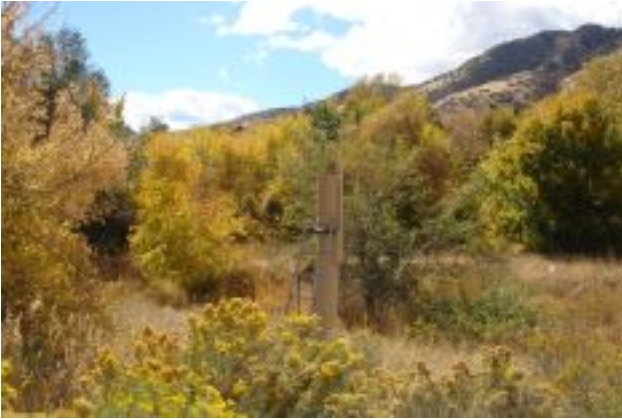
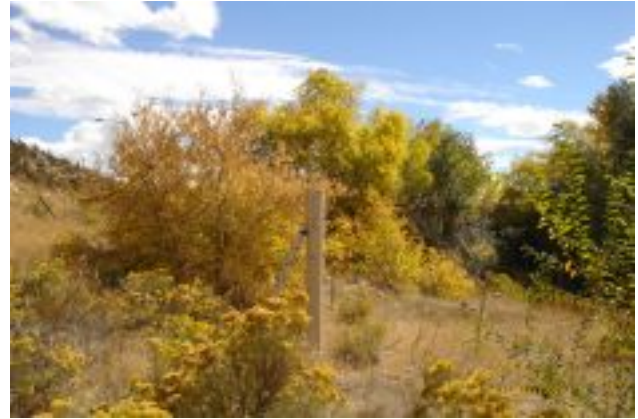
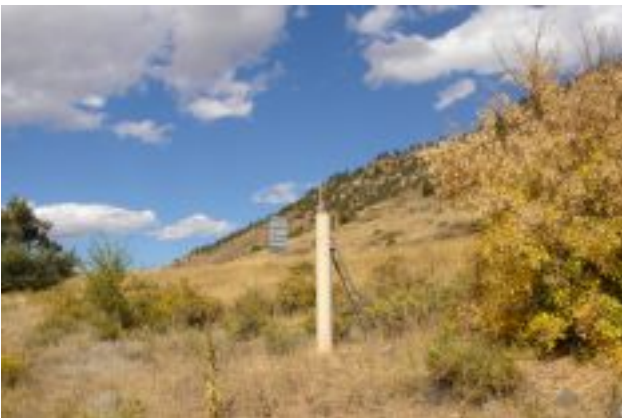
| Site ID | Site Name | Latitude | Longitude | Elevation | Install Date | TB Mfr. | TB Condition |
|---|---|---|---|---|---|---|---|
| 5.0 | Good rain catch and wind protection | | | | | | |

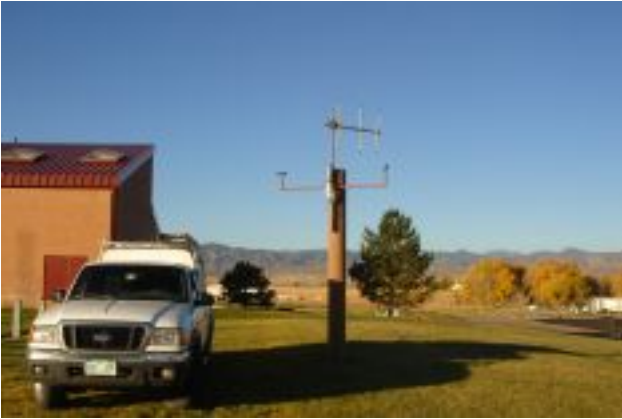
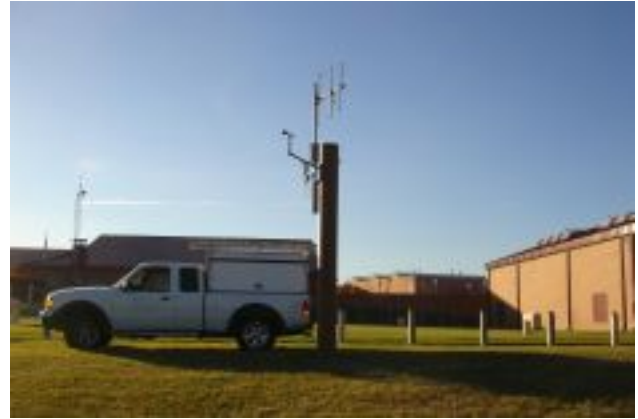
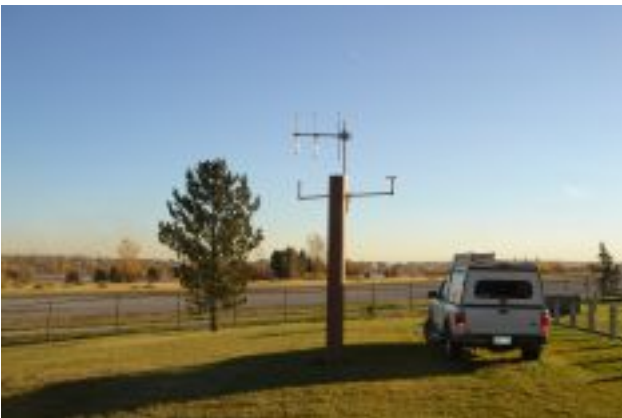
| Site ID | Site Name | Latitude | Longitude | Elevation | Install Date | TB Mfr. | TB Condition |
|---|---|---|---|---|---|---|---|
| 4.0 | Good rain catch and minor wind protection | | | | | | |

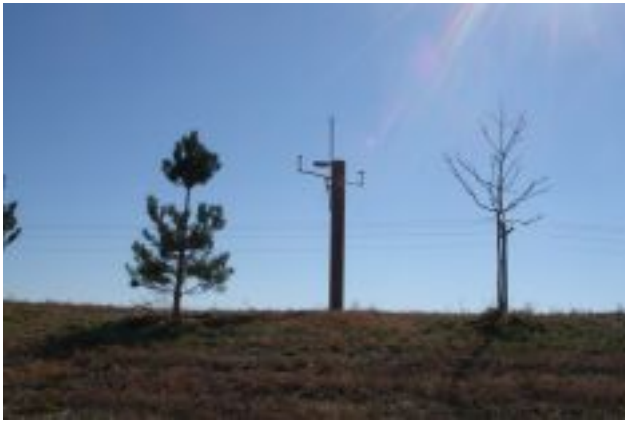
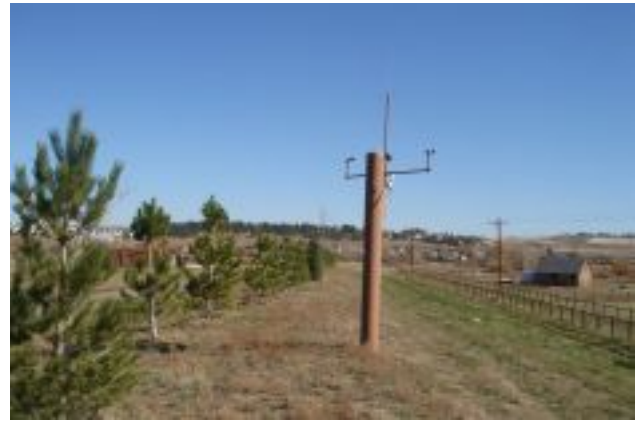
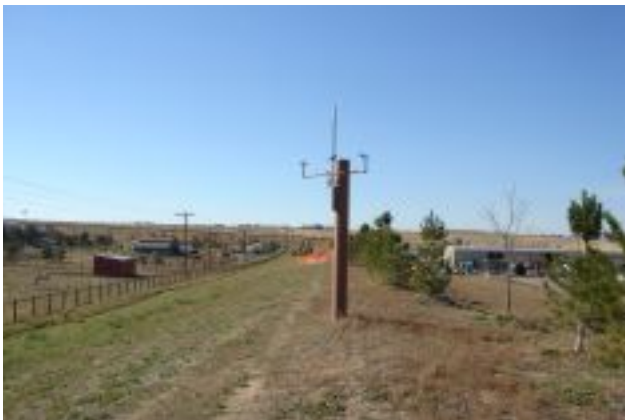
| Site ID | Site Name | Latitude | Longitude | Elevation | Install Date | TB Mfr. | TB Condition |
|---|---|---|---|---|---|---|---|
| 4.0 | Good rain catch, no wind protection yet (young trees) | | | | | | |

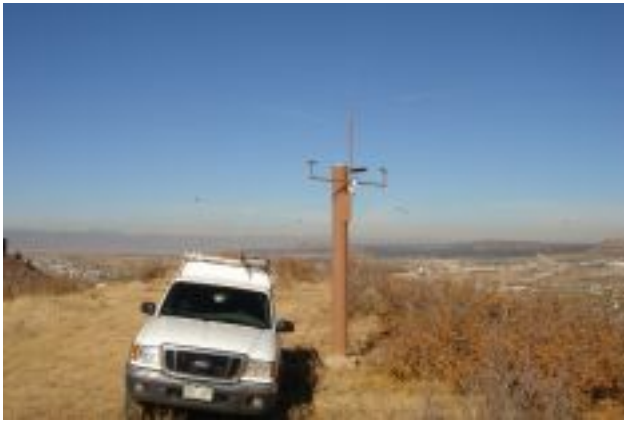
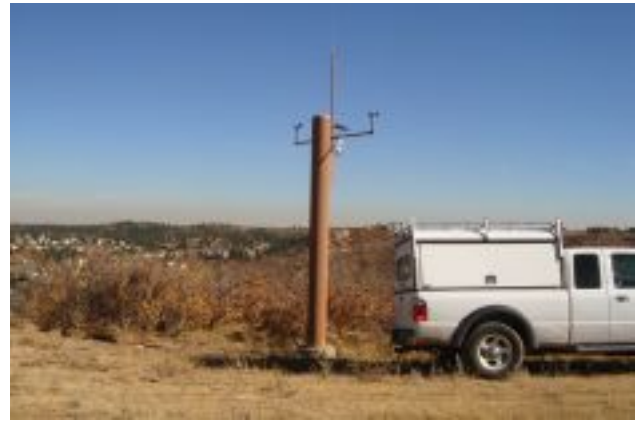
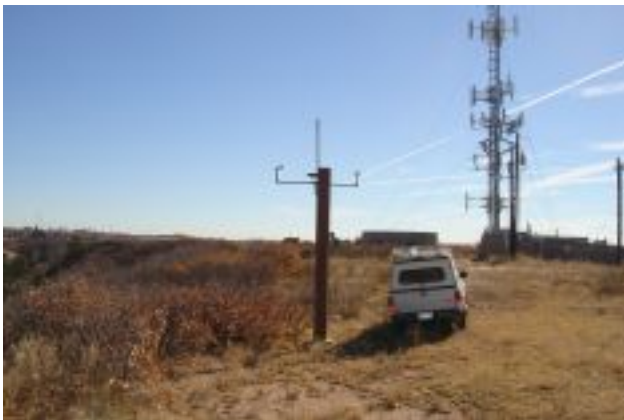
| Site ID | Site Name | Latitude | Longitude | Elevation | Install Date | TB Mfr. | TB Condition |
|---|---|---|---|---|---|---|---|
| 4.0 | Good rain catch no wind protection | | | | | | |

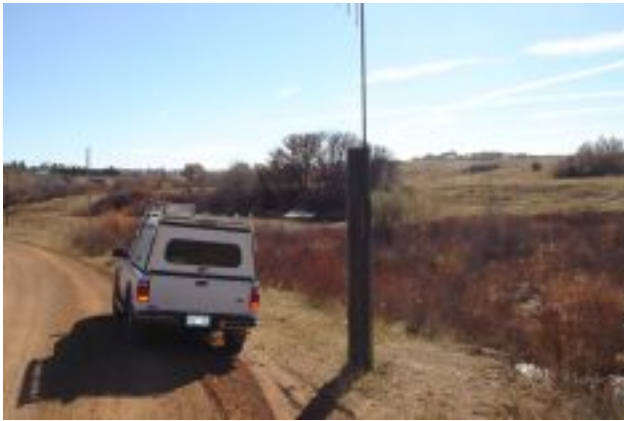
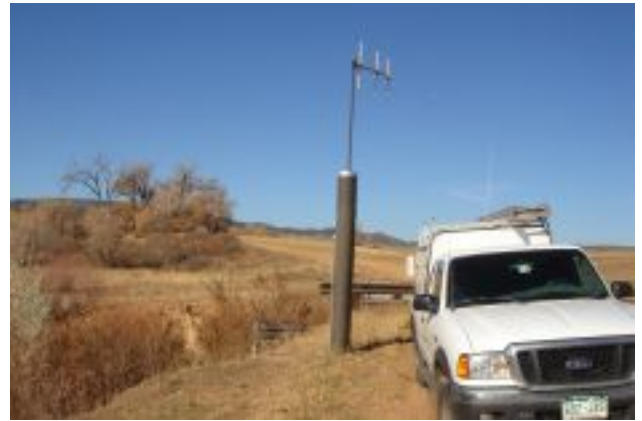
| Site ID | Site Name | Latitude | Longitude | Elevation | Install Date | TB Mfr. | TB Condition |
|---|---|---|---|---|---|---|---|
| 5.0 | Good rain catch fair wind protection | | | | | | |

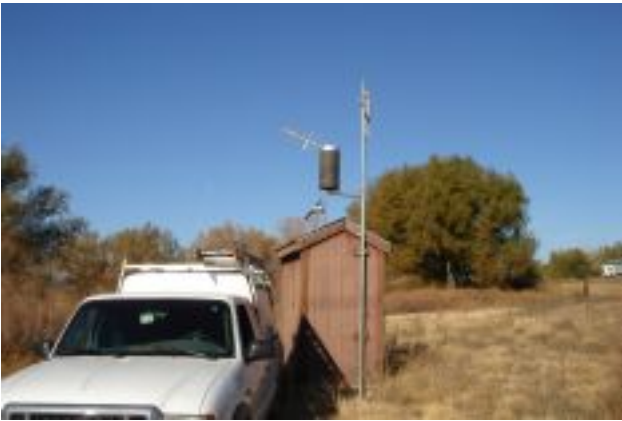
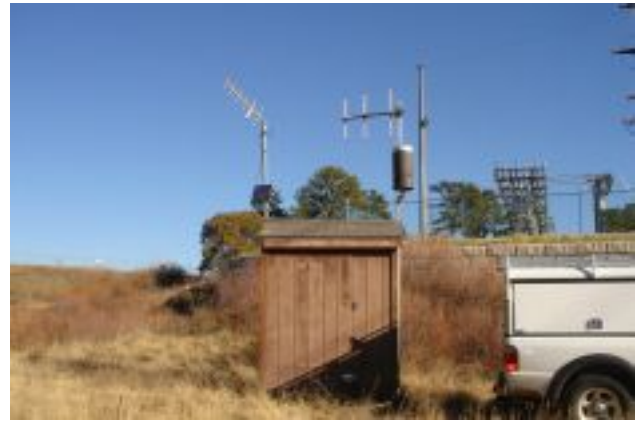
| Site ID | Site Name | Latitude | Longitude | Elevation | Install Date | TB Mfr. | TB Condition |
|---|---|---|---|---|---|---|---|
| 5.0 | Good rain catch and wind protection | | | | | | |

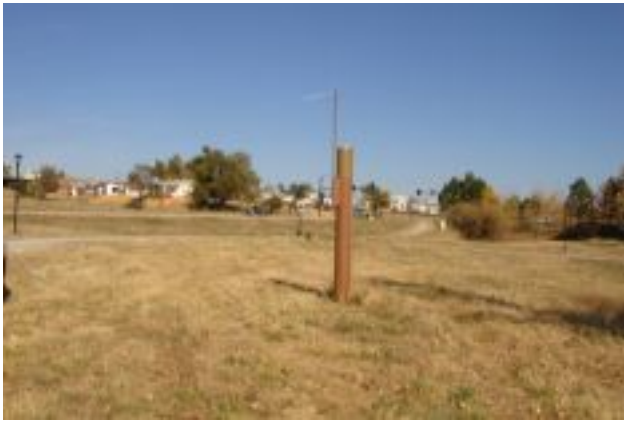
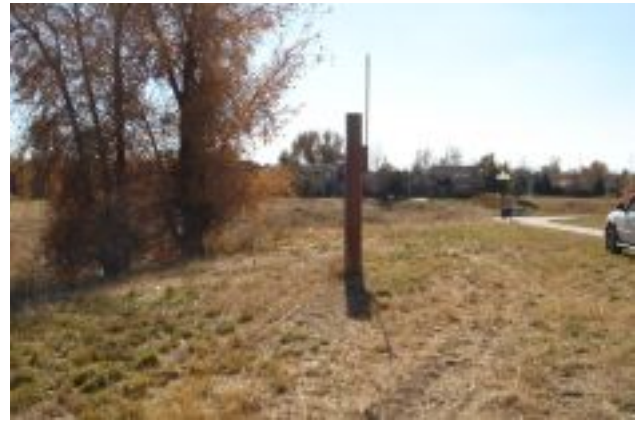
| Site ID | Site Name | Latitude | Longitude | Elevation | Install Date | TB Mfr. | TB Condition |
|---|---|---|---|---|---|---|---|
| 5.0 | Good rain catch and wind protection | | | | | | |

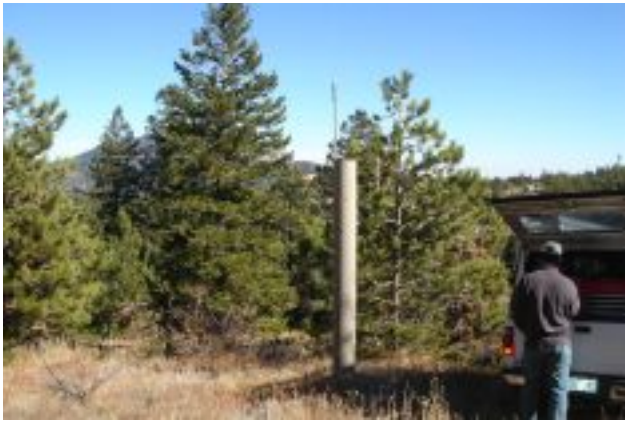
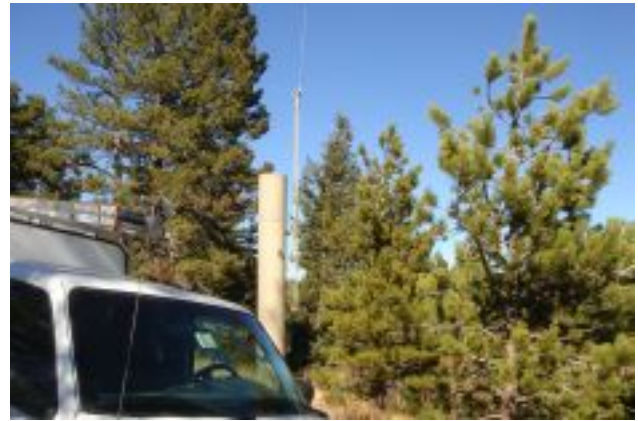
| Site ID | Site Name | Latitude | Longitude | Elevation | Install Date | TB Mfr. | TB Condition |
|---|---|---|---|---|---|---|---|
| 5.0 | Good rain catch and wind protection | | | | | | |

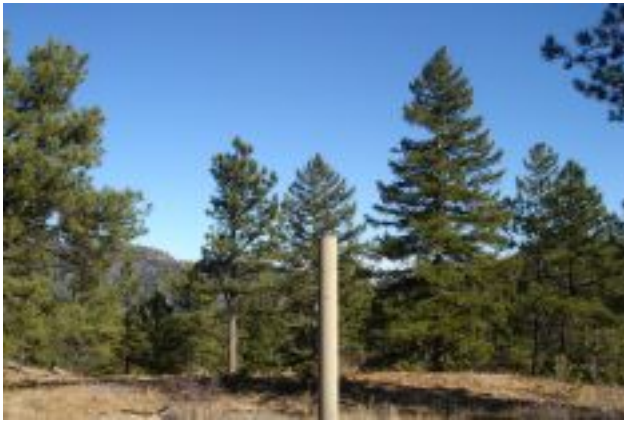
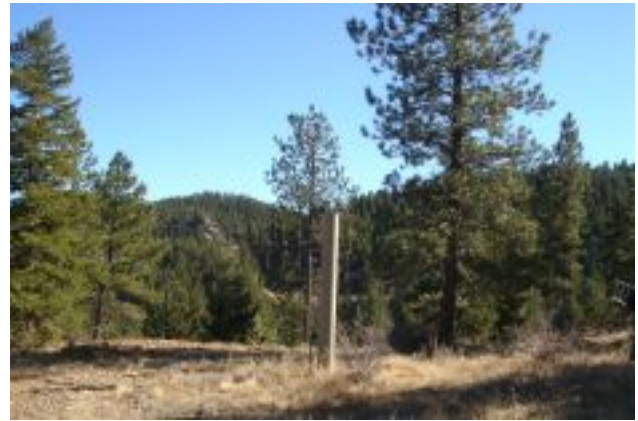
| Site ID | Site Name | Latitude | Longitude | Elevation | Install Date | TB Mfr. | TB Condition |
|---|---|---|---|---|---|---|---|
| 5.0 | Good rain catch and wind protection | | | | | | |
