## Urban Drainage and Flood Control District

| Site ID | Site Name | Latitude | Longitude | Elevation | Install Date | TB Mfr. | TB Condition |

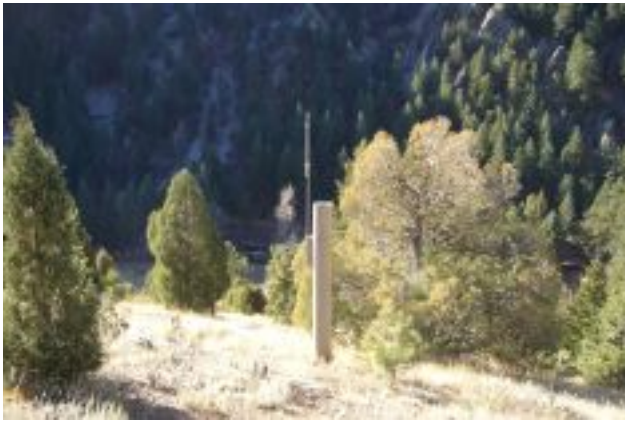
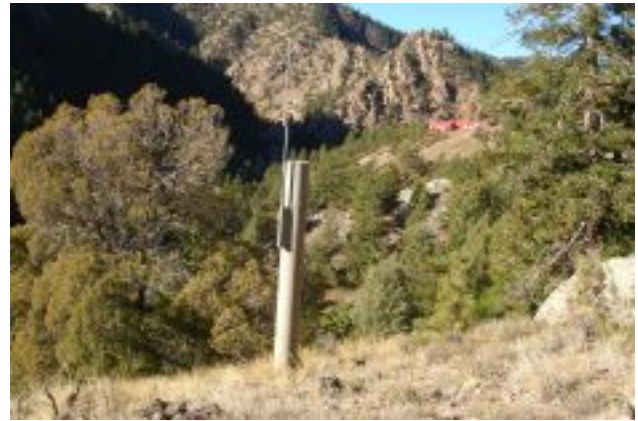
4030 - Red Garden Rain - a

| Site ID | Site Name | Latitude | Longitude | Elevation | Install Date | TB Mfr. | TB Condition |
|---|---|---|---|---|---|---|---|
| 5.0 | Good rain catch and wind protection | | | | | | |

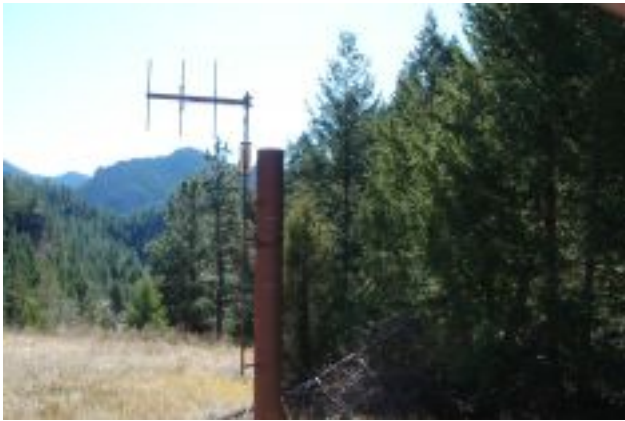
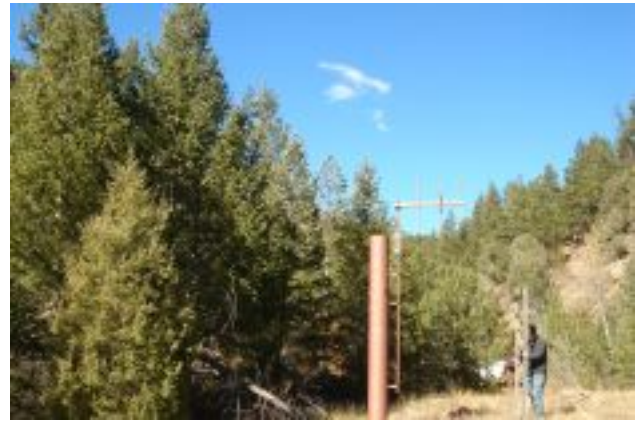
4040 - Martin Gulch - a

| Site ID | Site Name | Latitude | Longitude | Elevation | Install Date | TB Mfr. | TB Condition |
|---|---|---|---|---|---|---|---|
| 3.0 | Tree to SW in cone angle, good wind protection | | | | | | |

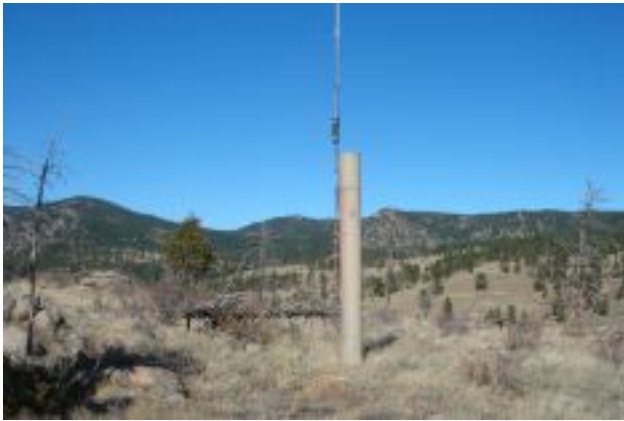
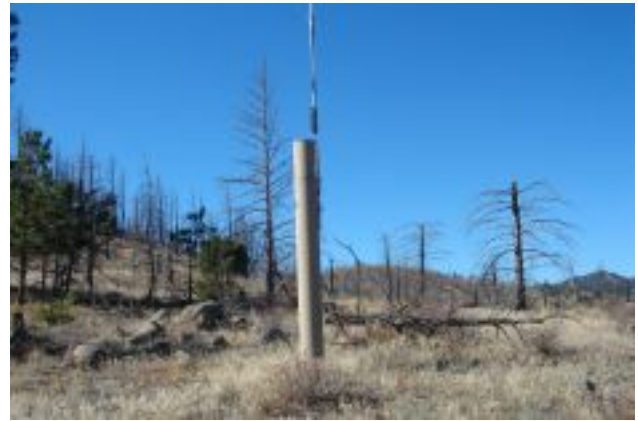
4050 - Walker Ranch - a

| Site ID | Site Name | Latitude | Longitude | Elevation | Install Date | TB Mfr. | TB Condition |
|---|---|---|---|---|---|---|---|
| 4.0 | Good rain catch no wind protection | | | | | | |

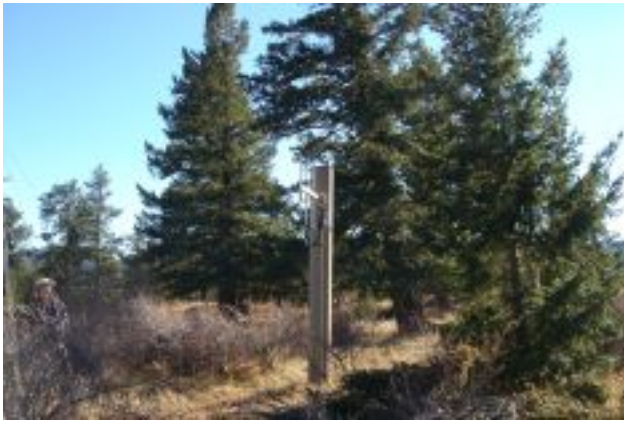
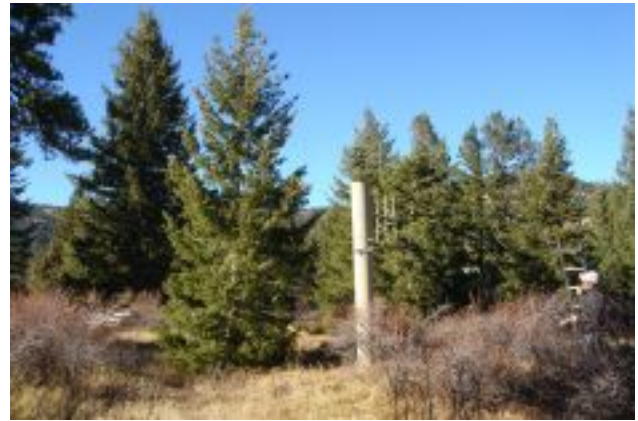
4060 - Lakeshore - a

| Site ID | Site Name | Latitude | Longitude | Elevation | Install Date | TB Mfr. | TB Condition |
|---|---|---|---|---|---|---|---|
| 3.0 | Tree to W in cone angle, good wind protection | | | | | | |

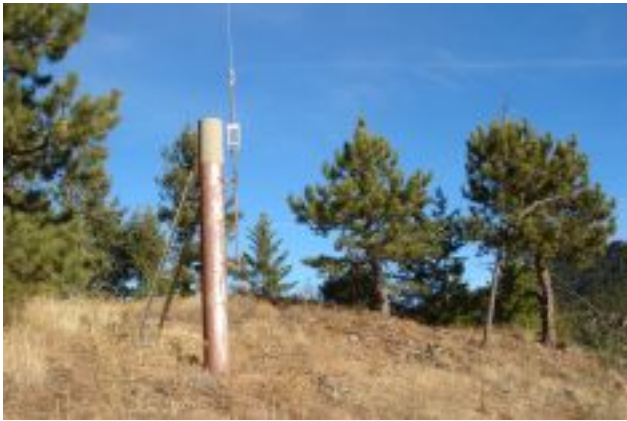
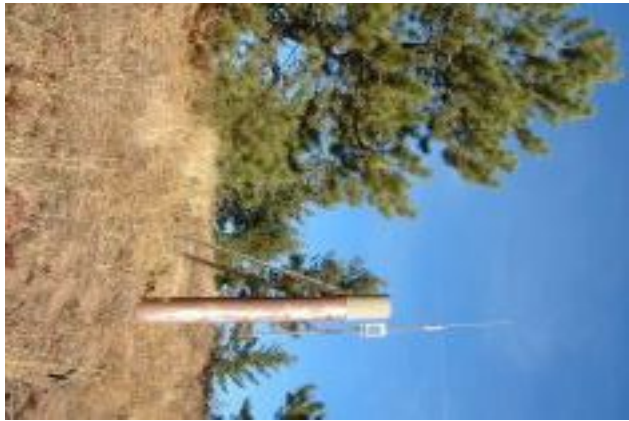
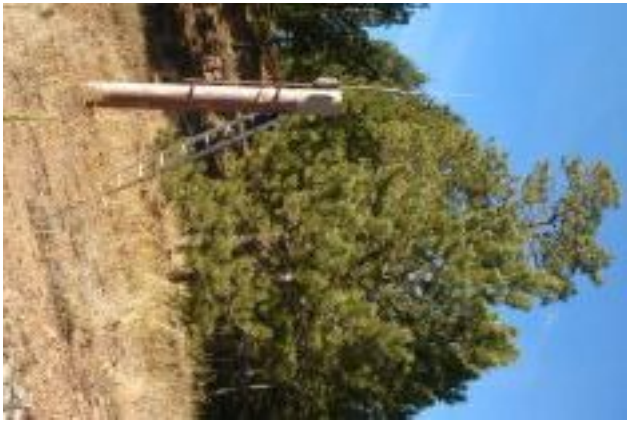
4070 - Bear Peak - a

| Site ID | Site Name | Latitude | Longitude | Elevation | Install Date | TB Mfr. | TB Condition |
|---|---|---|---|---|---|---|---|
| 3.0 | 2 trees to W in cone angle, good wind protection | | | | | | |

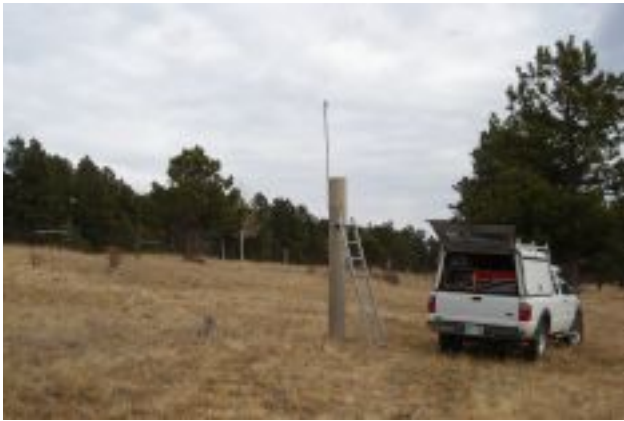
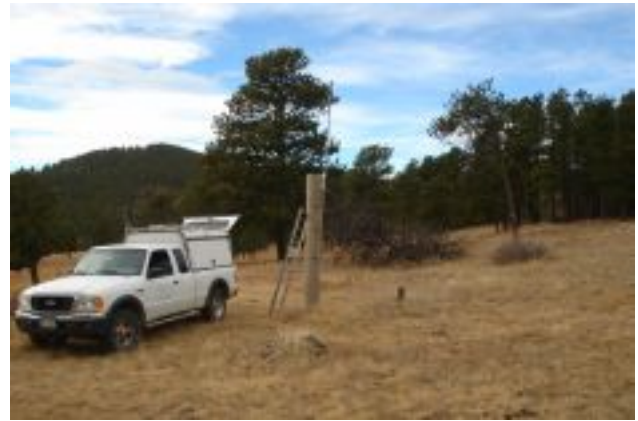
4080 - Twin Sisters - a

| Site ID | Site Name | Latitude | Longitude | Elevation | Install Date | TB Mfr. | TB Condition |
|---|---|---|---|---|---|---|---|
| 5.0 | Good rain catch and wind protection | | | | | | |

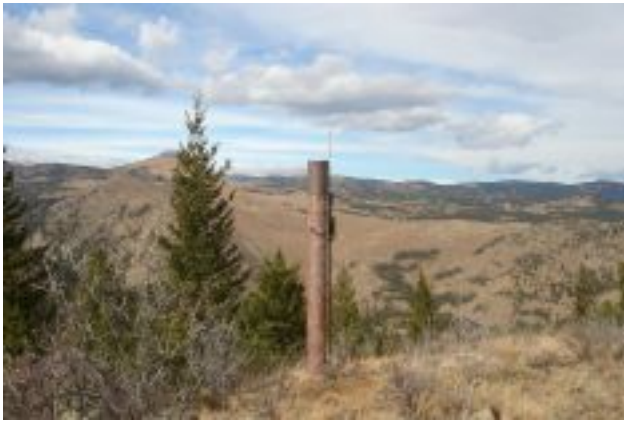
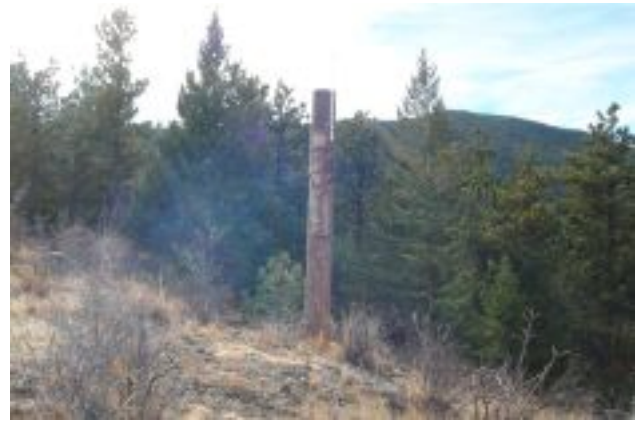
4090 - Magnolia - a

| Site ID | Site Name | Latitude | Longitude | Elevation | Install Date | TB Mfr. | TB Condition |
|---|---|---|---|---|---|---|---|
| 4.0 | Good rain catch, fair wind protection | | | | | | |

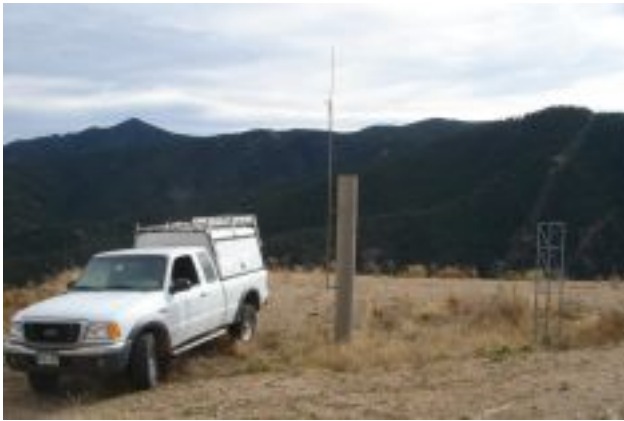
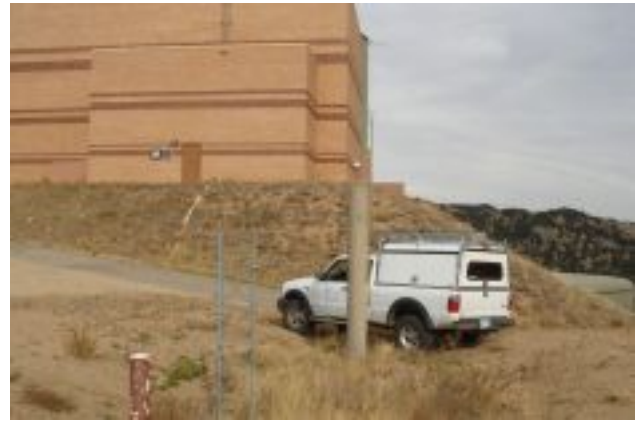
4100 - Filter Plant - a

| Site ID | Site Name | Latitude | Longitude | Elevation | Install Date | TB Mfr. | TB Condition |
|---|---|---|---|---|---|---|---|
| 4.0 | Good rain catch no wind protection | | | | | | |

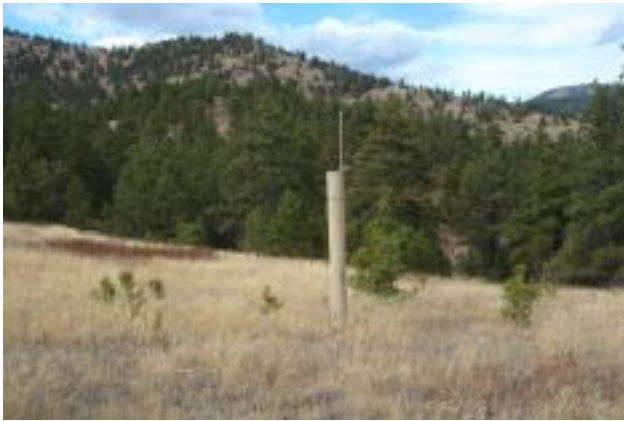
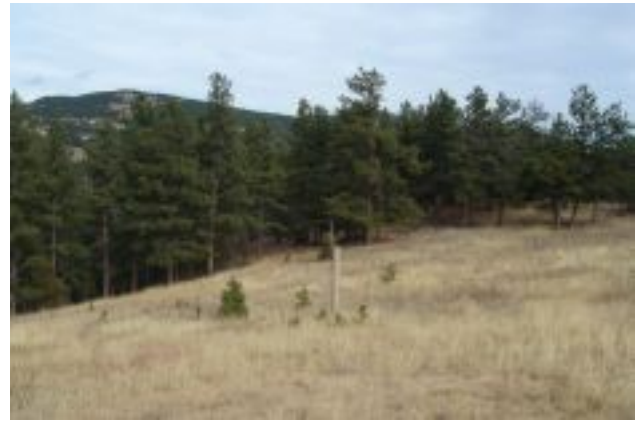
4110 - Betasso - a

| Site ID | Site Name | Latitude | Longitude | Elevation | Install Date | TB Mfr. | TB Condition |
|---|---|---|---|---|---|---|---|
| 5.0 | Good rain catch and fair wind protection | | | | | | |

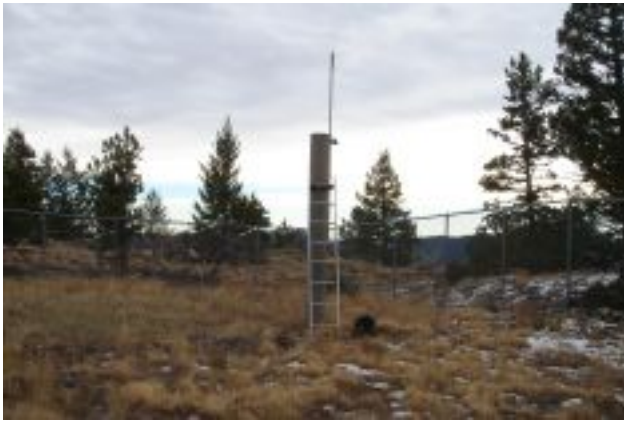
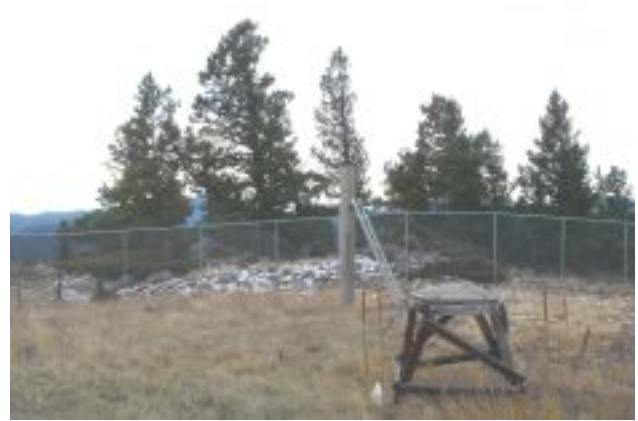
4130 - Swiss Peaks - a

| Site ID | Site Name | Latitude | Longitude | Elevation | Install Date | TB Mfr. | TB Condition |
|---|---|---|---|---|---|---|---|
| 5.0 | Good rain catch and wind protection | | | | | | |

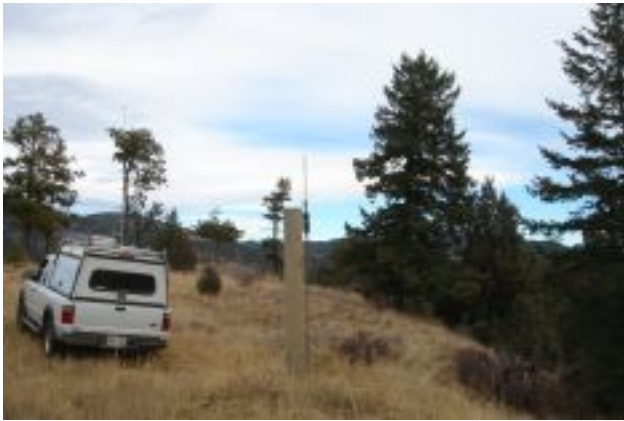
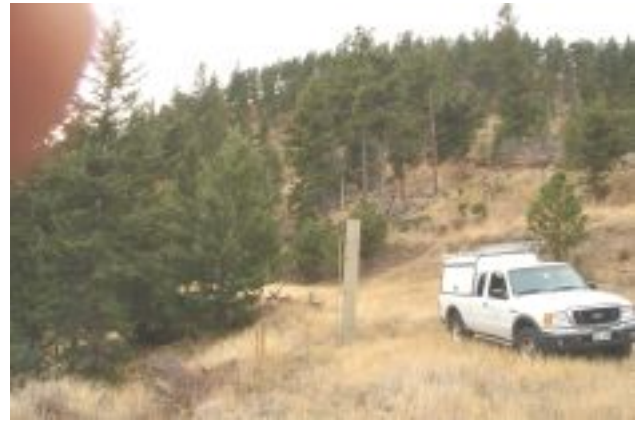
4140 - Logan Mill - a

| Site ID | Site Name | Latitude | Longitude | Elevation | Install Date | TB Mfr. | TB Condition |
|---|---|---|---|---|---|---|---|
| 5.0 | Good rain catch and wind protection | | | | | | |

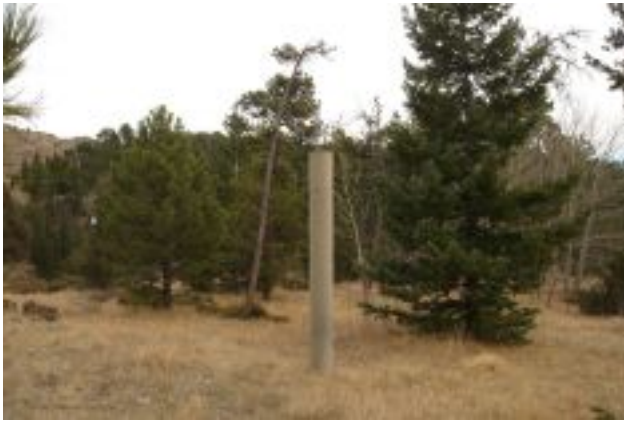
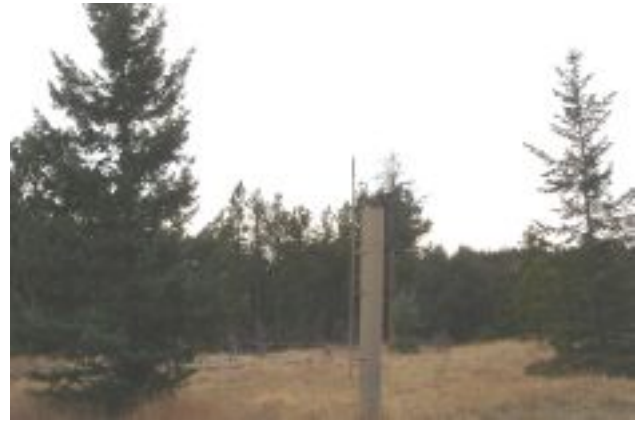
4150 - Gold Hill - a

| Site ID | Site Name | Latitude | Longitude | Elevation | Install Date | TB Mfr. | TB Condition |
|---|---|---|---|---|---|---|---|
| 5.0 | Good rain catch and wind protection | | | | | | |

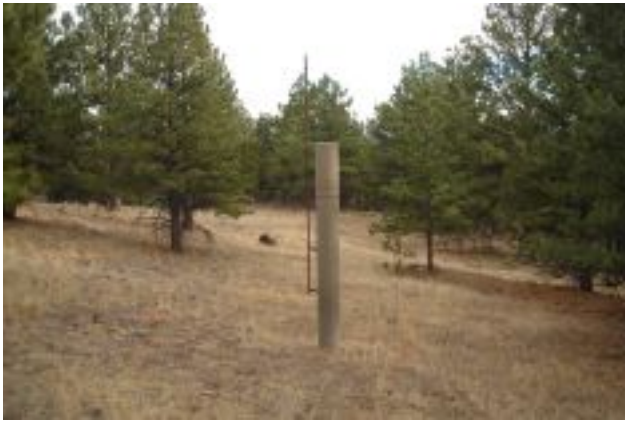
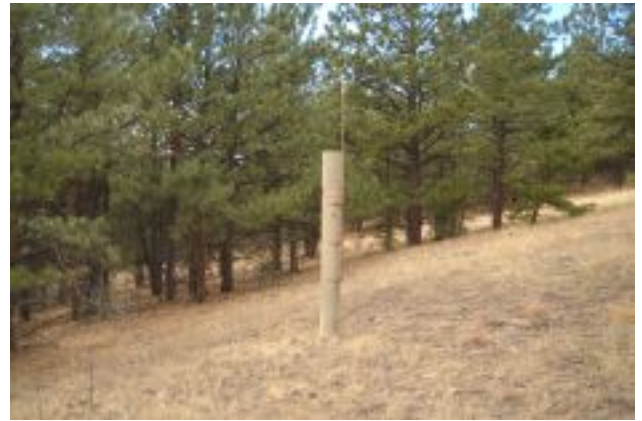
4160 - Sunshine - a

| Site ID | Site Name | Latitude | Longitude | Elevation | Install Date | TB Mfr. | TB Condition |
|---|---|---|---|---|---|---|---|
| 5.0 | Good rain catch and wind protection | | | | | | |

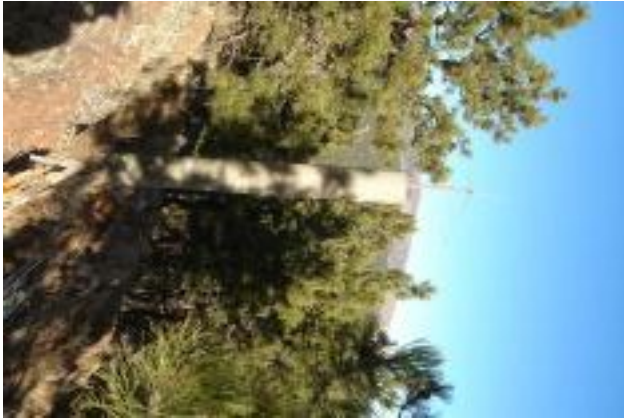
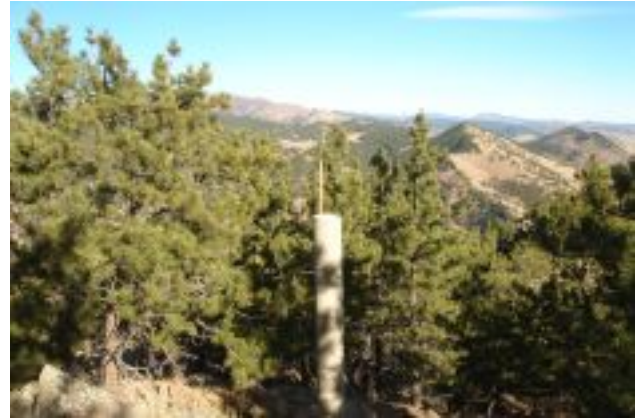
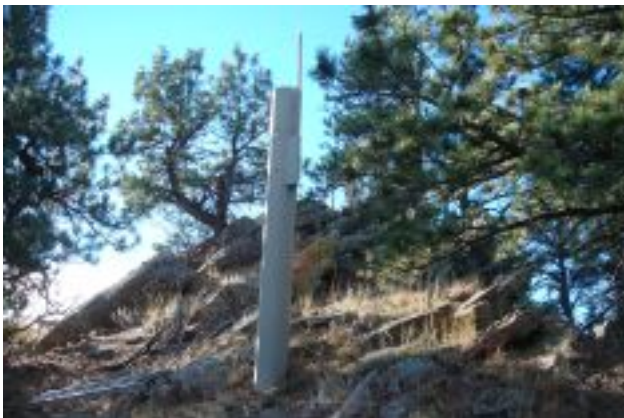
4170 - Pinebrook - a

| Site ID | Site Name | Latitude | Longitude | Elevation | Install Date | TB Mfr. | TB Condition |
|---|---|---|---|---|---|---|---|
| 4.0 | Pine trees on 3 sides near cone angle, little wind protection (on ridge) | | | | | | |

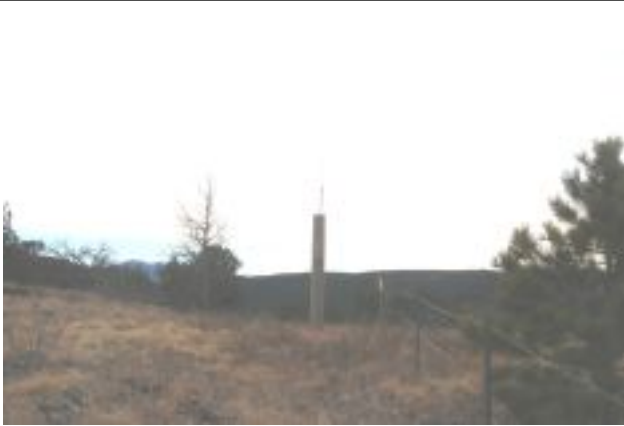
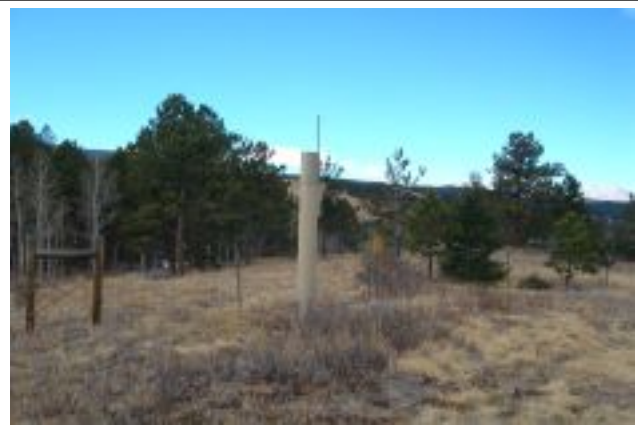
4240 - Sunset - a

| Site ID | Site Name | Latitude | Longitude | Elevation | Install Date | TB Mfr. | TB Condition |
|---|---|---|---|---|---|---|---|
| 5.0 | Good rain catch and fair wind protection | | | | | | |

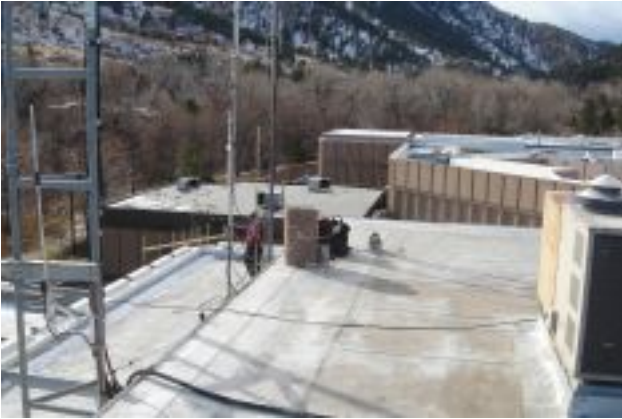
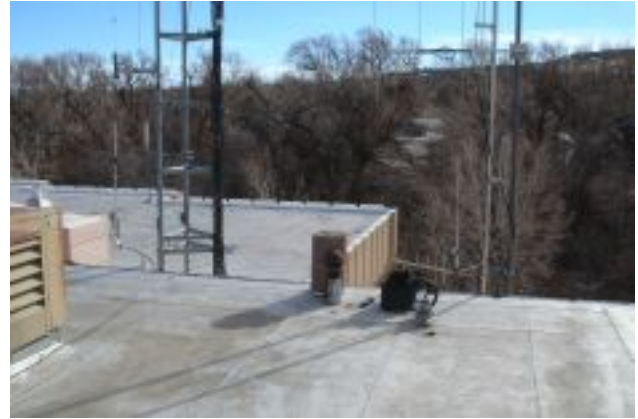
4360 - Justice Center - a

| Site ID | Site Name | Latitude | Longitude | Elevation | Install Date | TB Mfr. | TB Condition |
|---|---|---|---|---|---|---|---|
| 3.0 | On top of, at edge of roof next to a tower, no wind protection | | | | | | |

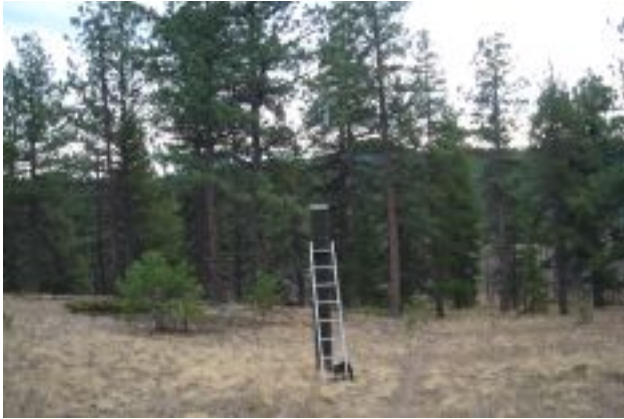
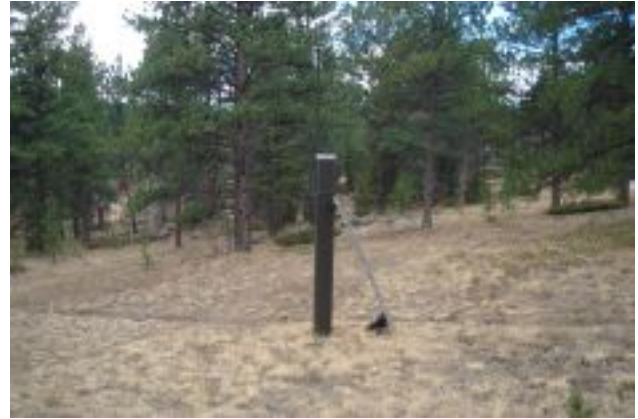
4530 - Winiger Ridge - a

| Site ID | Site Name | Latitude | Longitude | Elevation | Install Date | TB Mfr. | TB Condition |
|---|---|---|---|---|---|---|---|
| 5.0 | Good rain catch and wind protection | | | | | | |

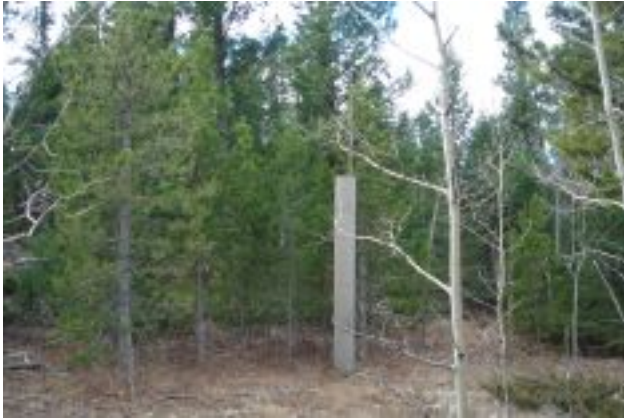
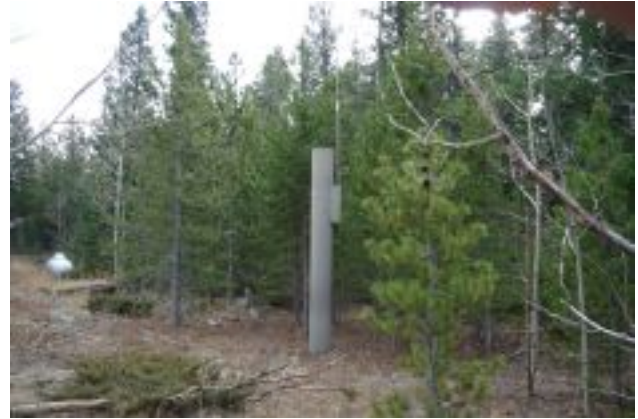
4570 - St. Antons - a

| Site ID | Site Name | Latitude | Longitude | Elevation | Install Date | TB Mfr. | TB Condition |
|---|---|---|---|---|---|---|---|
| 3.0 | 3 trees in cone angle, fair wind protection | | | | | | |

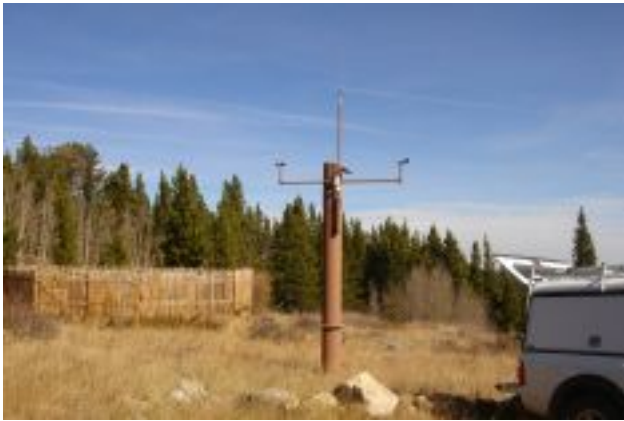
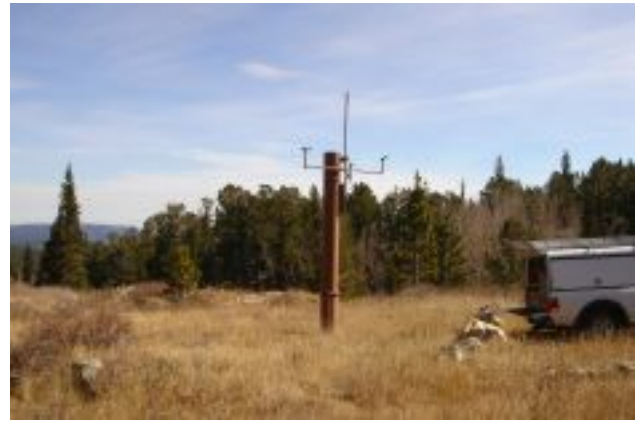
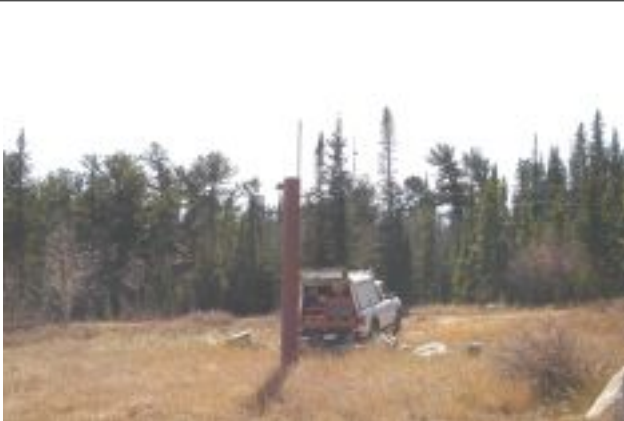
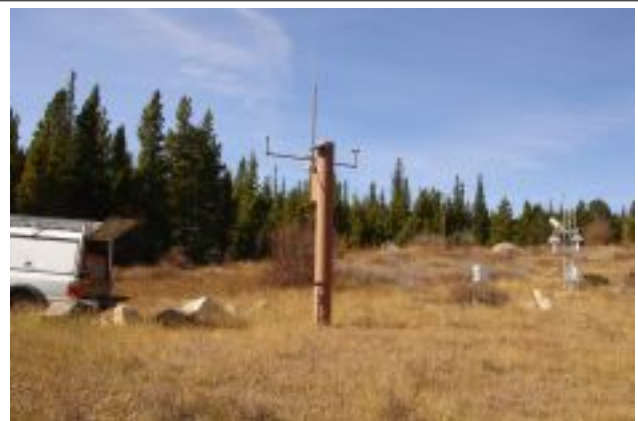
4710 - Hills Mills - a

| Site ID | Site Name | Latitude | Longitude | Elevation | Install Date | TB Mfr. | TB Condition |
|---|---|---|---|---|---|---|---|
| 4.0 | Good rain catch little wind protection | | | | | | |

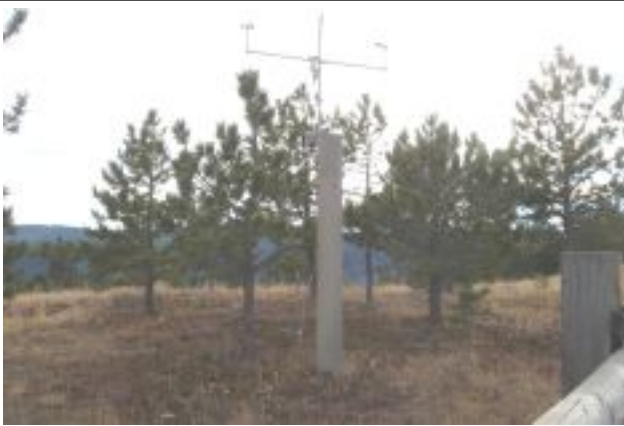
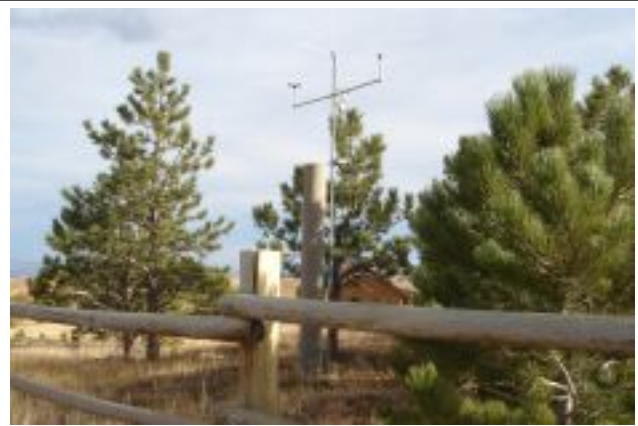
4730 - Sugarloaf - a

| Site ID | Site Name | Latitude | Longitude | Elevation | Install Date | TB Mfr. | TB Condition |
|---|---|---|---|---|---|---|---|
| 4.0 | Good rain catch little wind protection | | | | | | |

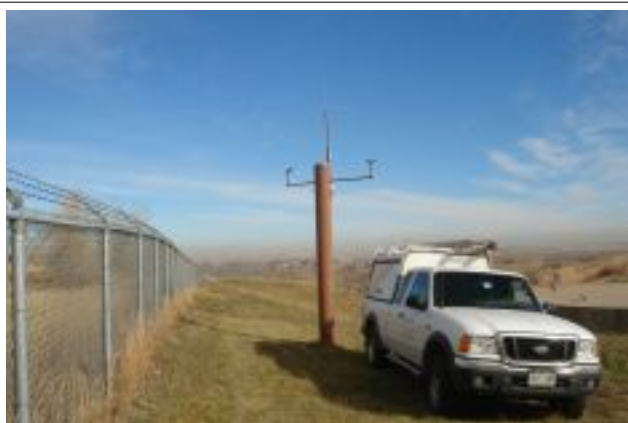
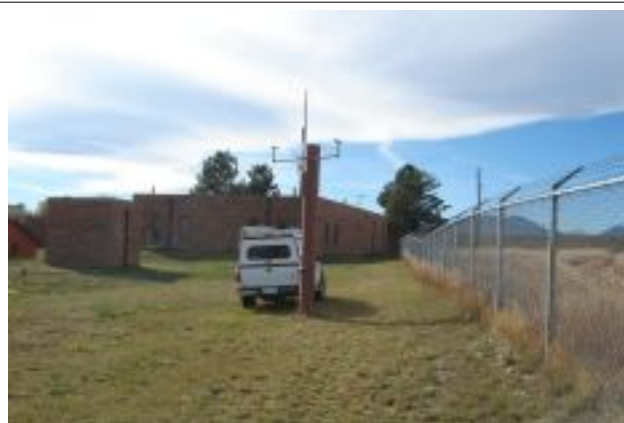
4750 - Louisville WTP - a

| Site ID | Site Name | Latitude | Longitude | Elevation | Install Date | TB Mfr. | TB Condition |
|---|---|---|---|---|---|---|---|
| 4.0 | Good rain catch no wind protection | | | | | | |

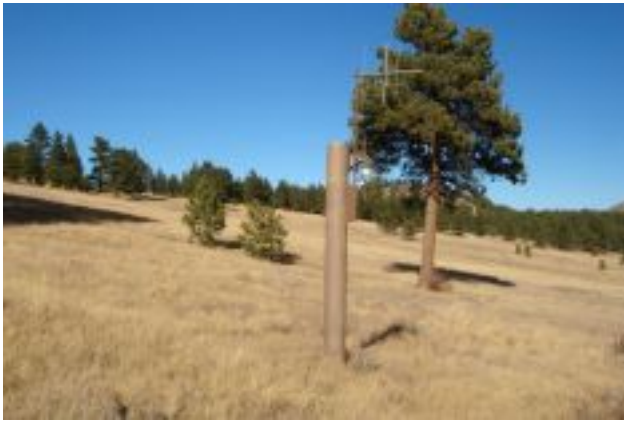
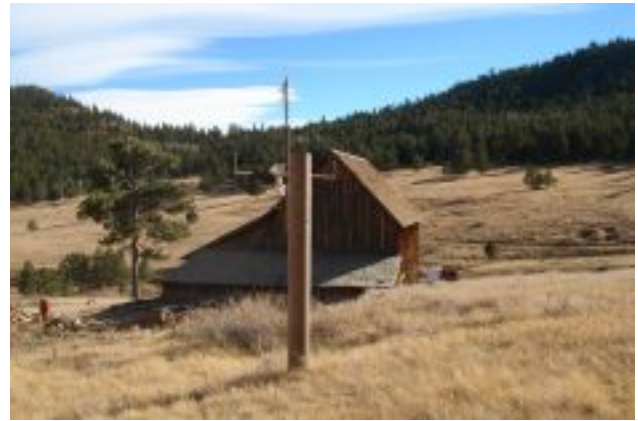
| Site ID | Site Name | Latitude | Longitude | Elevation | Install Date | TB Mfr. | TB Condition |
|---|---|---|---|---|---|---|---|
| 5.0 | Good rain catch and fair wind protection | | | | | | |

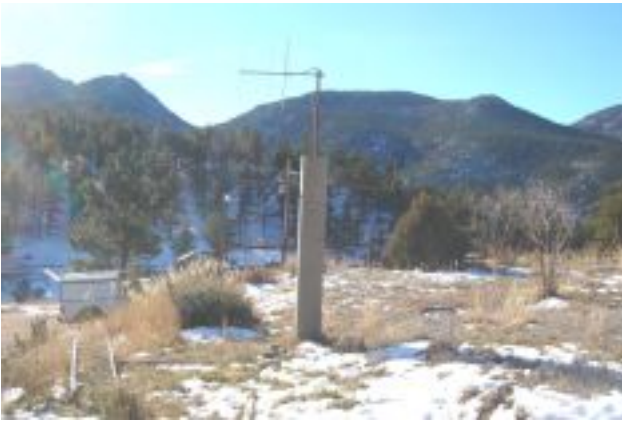
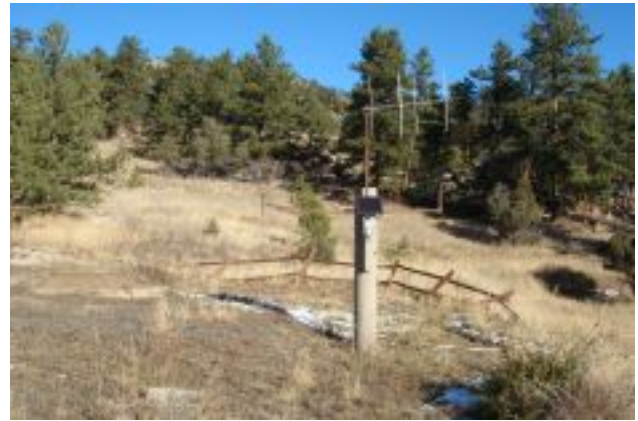
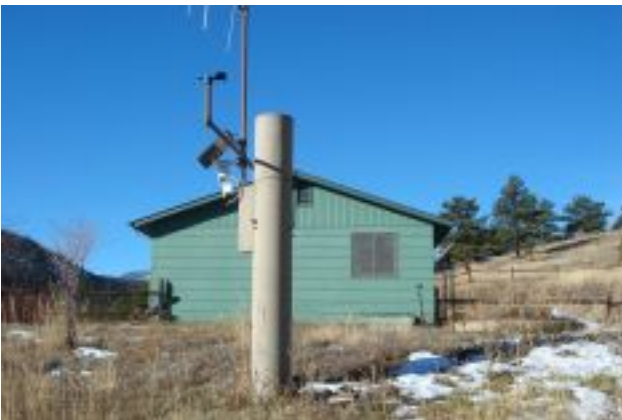
| Site ID | Site Name | Latitude | Longitude | Elevation | Install Date | TB Mfr. | TB Condition |
|---|---|---|---|---|---|---|---|
| 4.0 | Good rain catch and fair wind protection | | | | | | |

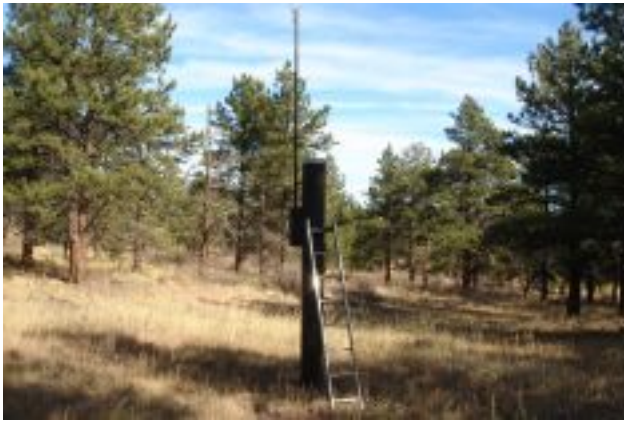
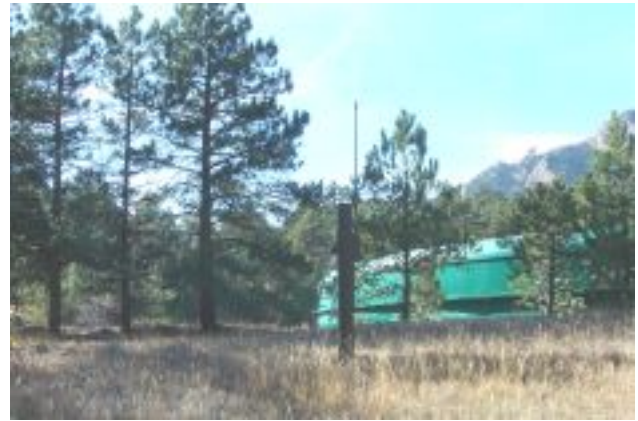
| Site ID | Site Name | Latitude | Longitude | Elevation | Install Date | TB Mfr. | TB Condition |
|---|---|---|---|---|---|---|---|
| 5.0 | Good rain catch and wind protection | | | | | | |

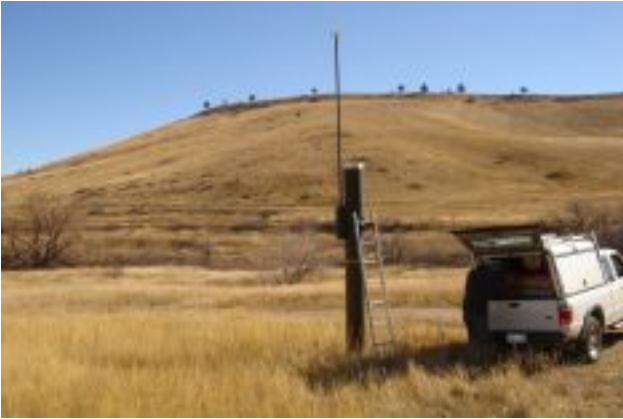
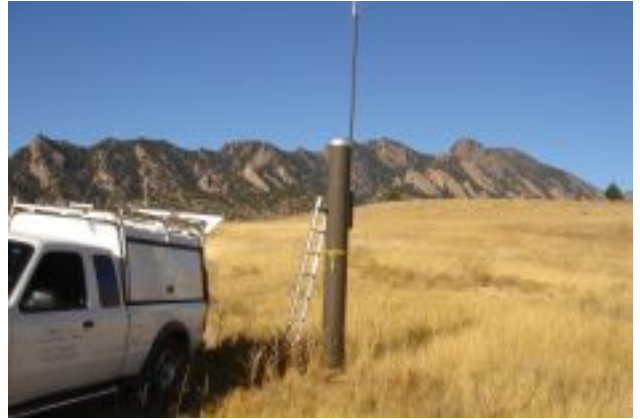
| Site ID | Site Name | Latitude | Longitude | Elevation | Install Date | TB Mfr. | TB Condition |
|---|---|---|---|---|---|---|---|
| 4.0 | Good rain catch no wind protection | | | | | | |

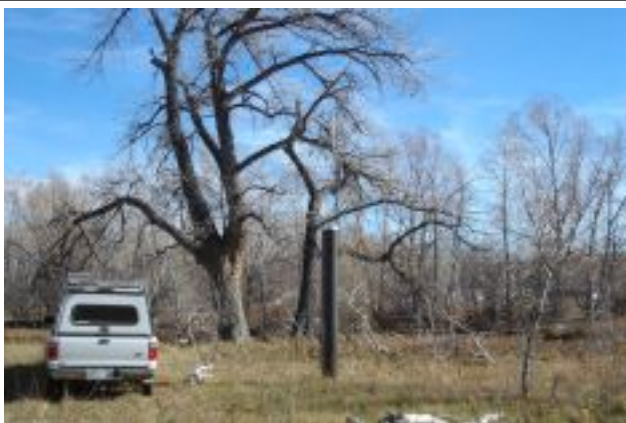
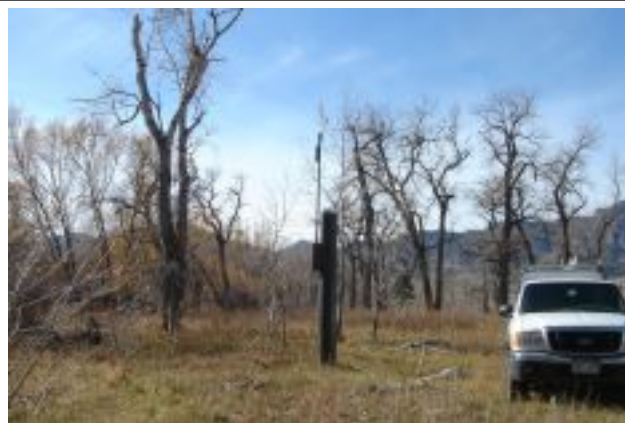
| Site ID | Site Name | Latitude | Longitude | Elevation | Install Date | TB Mfr. | TB Condition |
|---|---|---|---|---|---|---|---|
| 5.0 | Good rain catch and wind protection | | | | | | |

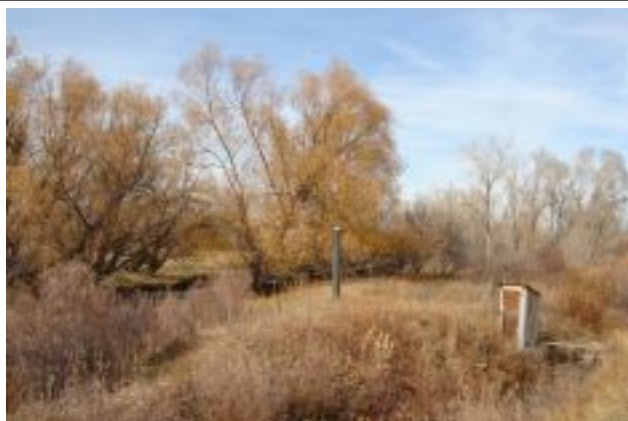
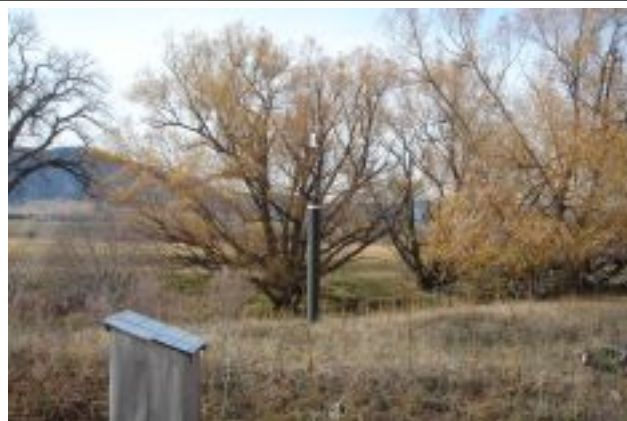
| Site ID | Site Name | Latitude | Longitude | Elevation | Install Date | TB Mfr. | TB Condition |
|---|---|---|---|---|---|---|---|
| 5.0 | Good rain catch and wind protection | | | | | | |
