# Urban Drainage and Flood Control District

## E-19 Surveys

Orodell Gage  
ALERT ID: 4403  
LID: ODBC2

**HDR Engineering, Inc.**  
303 E 17<sup>th</sup> Ave. Suite 300  
Denver CO, 80203

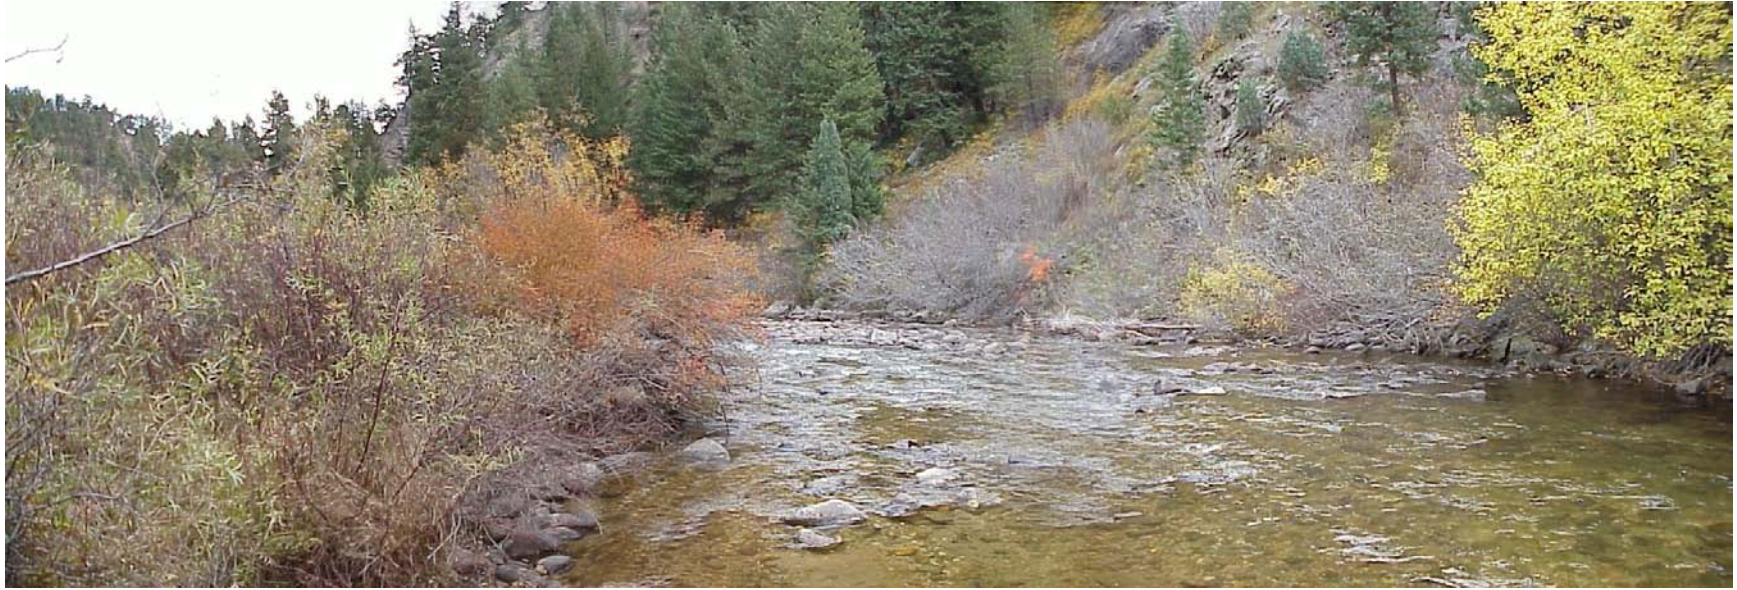
**Figure – 3 Looking Downstream**

Several digital photographs were taken of the site and several panorama views were created based on the site photographs. Figure 3 shows Boulder Creek at the gage location looking downstream. Figure 4 shows Boulder Creek at the gage location looking upstream. Figure 5 shows and the left overbank including Highway 119 where the ground elevations were surveyed. Figure 6 shows the gage house where the stilling well and transmitters are located.

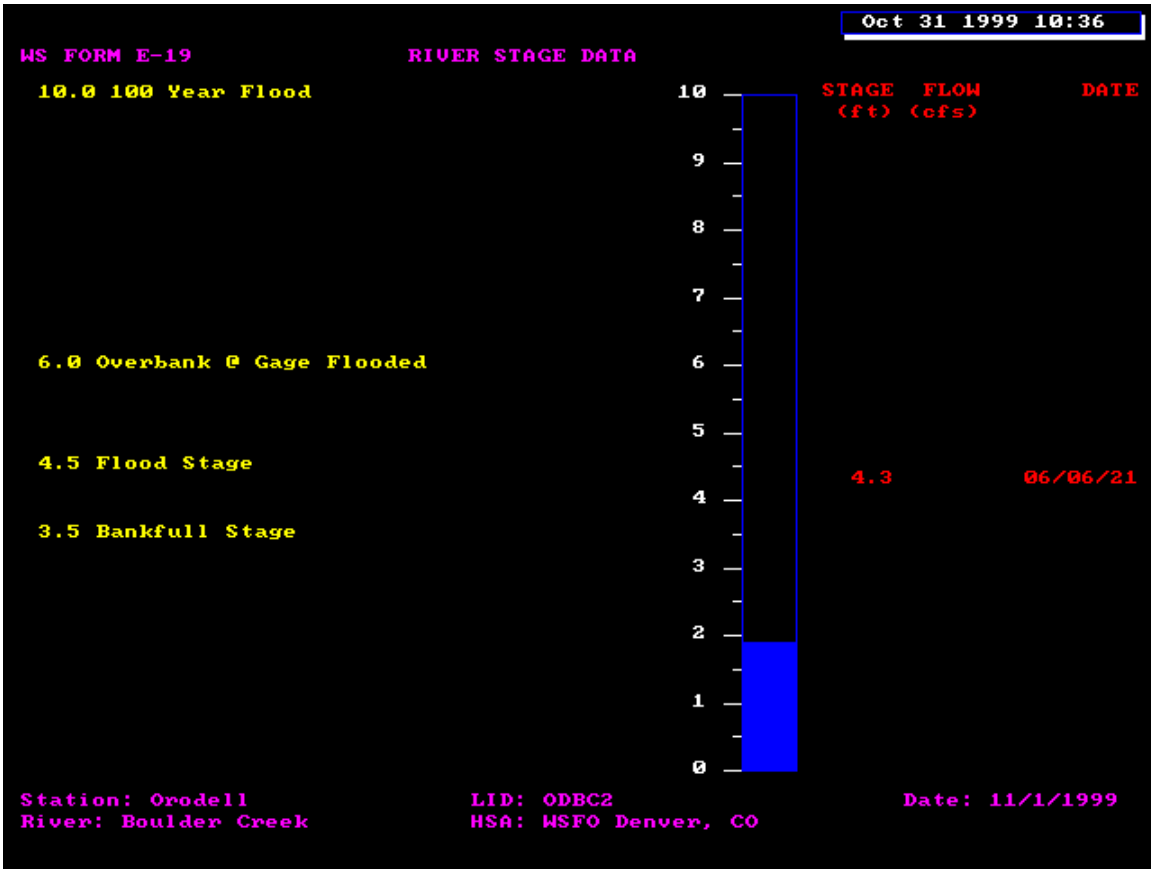
Figure - 7 Graphic Template

The graphics template was created based on the surveyed information, historic records, another information supplied by the Urban Drainage and Flood Control District and the National Weather Service. The graphics template is compatible with the flood warning system and has been created and installed on the District's WebServer. This template is named 4403web.tpt and is located in the appropriate directory in the District's WebServer. Figure 7 shows the graphics template online from the WebServer.
