December 4, 2000

Maintenance activities on the ALERT Gauging Network for 2000 have been completed under Agreement 00-01.17. During the 2000 operating season, DIAD generated 699 maintenance reports for the combined UDFCD/Boulder County network. Of these, 38 (5.4%) were unscheduled service calls; the remainder documented standard maintenance activities.

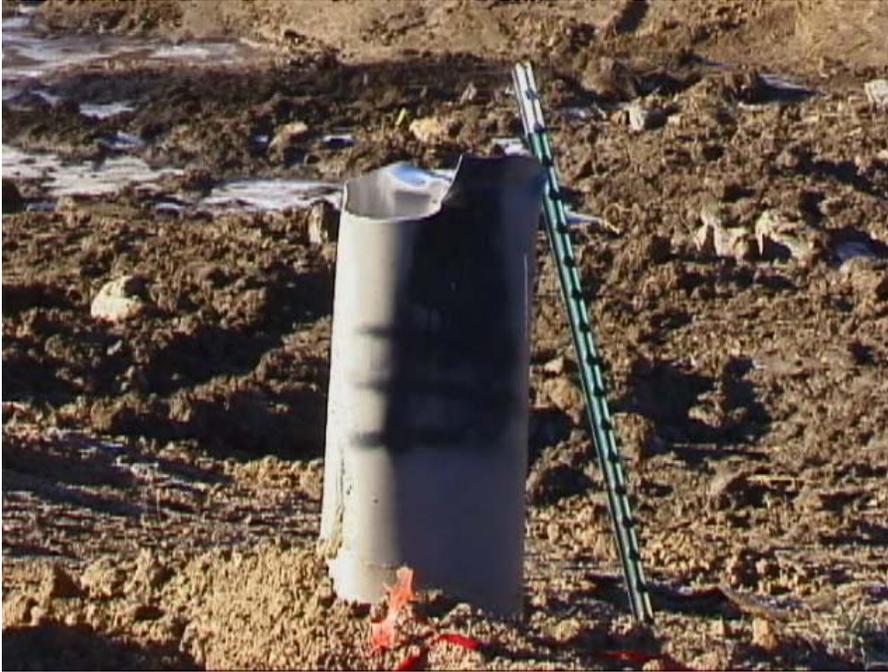
The combined UDFCD/Boulder County network received its normal dose of damage via both vandalism and heavy equipment malpractice during the 2000 season. The Mission Viejo site was taken out in June by an out-of-control truck boom that sheared the standpipe off 36" above grade (Figure 1). Aside from cabling, all the equipment was salvaged. At last inspection, heavy equipment was still all over the place. The site will be reinstalled when construction is complete. Expo Park was taken out of service early in 2000 in order to accommodate the reconstruction of the detention pond there. Construction is nearing completion and the site shall be brought back to life for the 2001 season. Harvard Gulch received destructive influences from either vandals or Denver maintenance crews. The PT conduit had been bent and breached at 2 different locations, leaving the pressure transducer cable fully exposed. We suspect the real culprit was a park maintenance snowplow that got a bit carried away. Polypipe that runs from the standpipe to the culvert headwall was near ground level on the culvert end, and was not buried deep enough to survive a wayward plow blade. The breaches were repaired and the conduit is buried deeper and extends farther out from the wall before it mates to the polypipe, making it more secure than before.

**Figure 1. Negligent destruction of Mission Viejo standpipe**

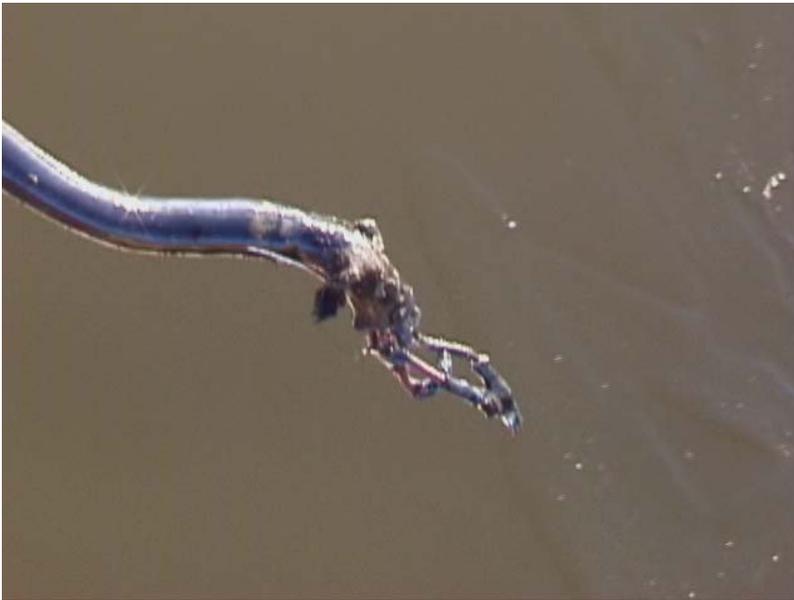
Utah Park stopped reporting around October 11<sup>th</sup> due to devious vandals. The pressure transducer had been ripped off of its cable (Figure 2) at the housing end, and the cable was reinserted into the water inside the PT housing. (The cap was reinstalled on the riser to make it appear that all was well.) The resulting short caused damage to the splice box and fried the 5050 logic board. In addition, the antenna was missing. All components (with the exception of the tipping bucket) at the site will require replacement. In more minor incidents, the solar panel was shot to bits (again) at Big Elk Park (along with the antenna base and the mast). Two ground planes were MIA at Red

**Figure 2. Utah Park vandalism**

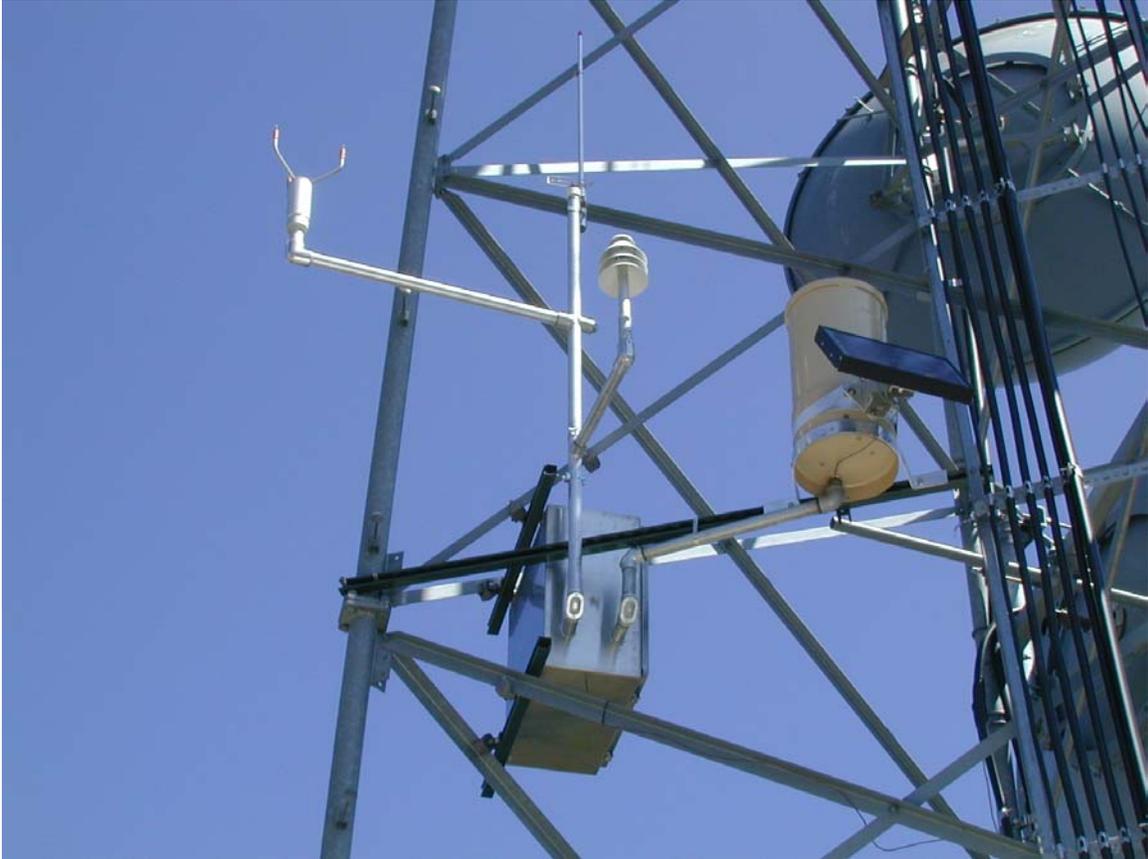
A Handar weather suite was installed at the 20' level on the State of Colorado telecommunications tower at Squaw Mountain in early June (Figure 3). After resolving initial RF issues, the site performed reliably through the summer and early fall. However, concurrent with colder temperatures, wind data has become somewhat less

**Figure 3. Squaw Mountain weather suite. Omni antenna is now mounted on opposite plane of tower facing SE.**

reliable. A gap in wind data correlated with the passage of a cold, wet front on September 20, 2000. Wind speeds of 181 mph were reported for several hours. We hypothesize that the sonic wind device was subject to ice buildup, effectively inhibiting its functionality until warmer conditions eliminated the ice. Similar wind data were noted at Elbert as well, again correlating with probable ice buildup. It seems likely that in order to eliminate these gaps in wind data, the sonic devices will require heating during those periods where ice buildup will otherwise occur. Handar offers a heated version of the 425, called the 425AH. The transducer heads are internally heated when a temperature sensor in the 425AH senses some predetermined value. The Handar 425-7006 power supply provides the recommended 36V required by the sensor. Depending on importance of wind data, the District may want to consider acquiring the 425AH, at least for Squaw Mountain. Eliminating ice buildup at Elbert would be less cost effective since the problem is very likely less frequent there. The cost of one heated sonic wind sensor/power supply combo plus cable is close to \$3,000 (ouch!). If replaced, the original 425 could either serve as a spare unit for Elbert, or could replace the conventional vane/anemometer configuration at Hiwan.

The Squaw Mountain installation is by far subject to the most extreme environmental conditions in the UDFCD network. Unfortunately, it is also by far the most difficult site to maintain in the entire system as well, even in optimum weather. Maintenance/service activity can become hazardous in just a matter of minutes with rapidly changing weather conditions. This stems partly from its location on the tower, which requires full extension of a 24' ladder to reach. Even after tying the ladder to the tower, the person providing maintenance still must use great care ascending to and descending from the NEMA enclosure and sensors. High wind and precipitation make the situation increasingly risky. Once the road to the site has drifted in with snow later in the year, winter and early spring access to the site is impossible with a 4WD vehicle. We are entirely dependent on "hitching a ride" with the State of Colorado snowcat, which takes occasional trips to Squaw to maintain and service their own equipment. The State will not provide trips on the snowcat until they are required to go there for their own work. Thus, after requesting a "trip" with the State, it could conceivably be weeks before we could get to the site. And, upon arrival, poor weather could possibly preclude effective service. We know this sounds like serious whining, but we simply want to stress that both "scheduled" and "unscheduled" maintenance for Squaw Mountain involves a unique set of logistics and working conditions, thus the District cannot expect the usual response time to service requests for this weather station during the winter and early spring.

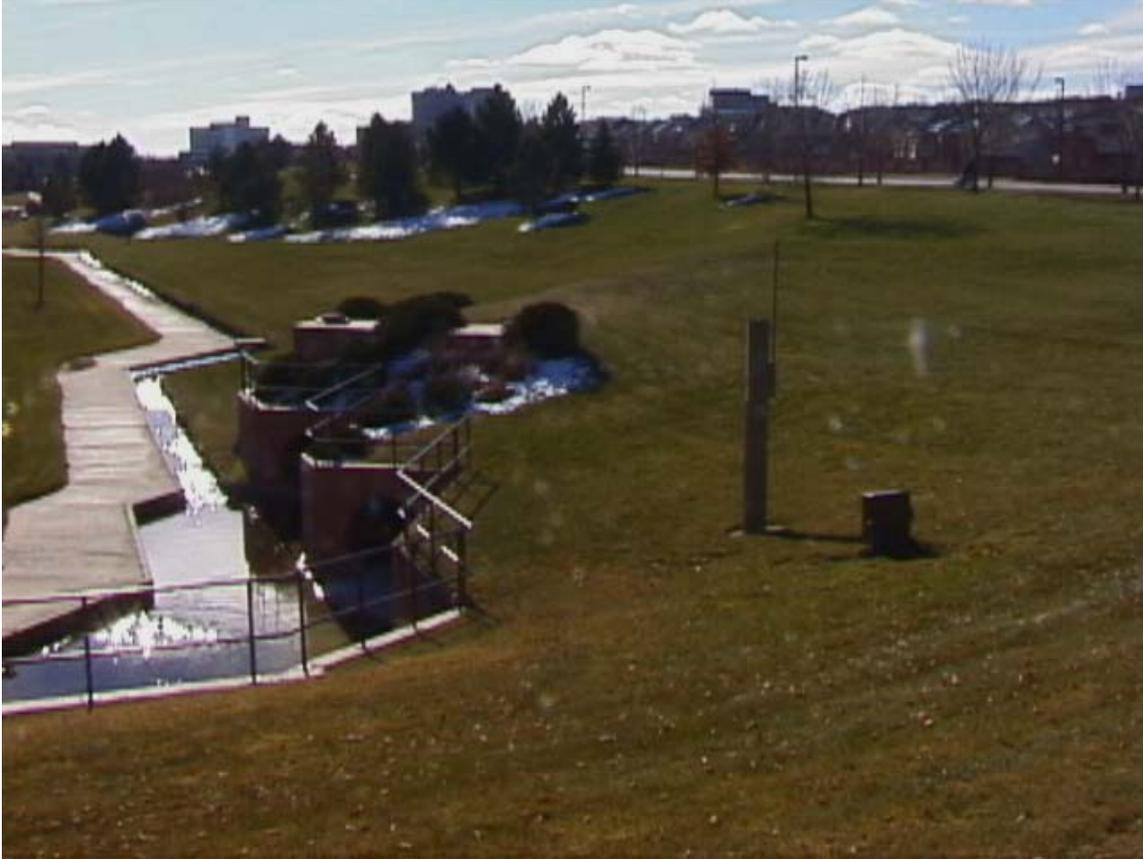
In July, the Temple Pond precipitation and stage site was successfully relocated from the north side of Union Street to the south side, about 15 feet from the pressure transducer housing (Figure 4). The relocate transformed this site from one of the most difficult to maintain in the system to one of the simplest. The PT cable run was reduced from 330+ feet to less than 40 feet. Contamination from irrigation at the new location occurs at about the same degree as that of the old location.

**Figure 4. Result of Temple Pond relocation.**
